CATCHMENT INVESTIGATIONS GROUP ONE

Catchment Area of Outfall: OF_206

**Westford, Massachusetts
November 2023**

Tighe & Bond

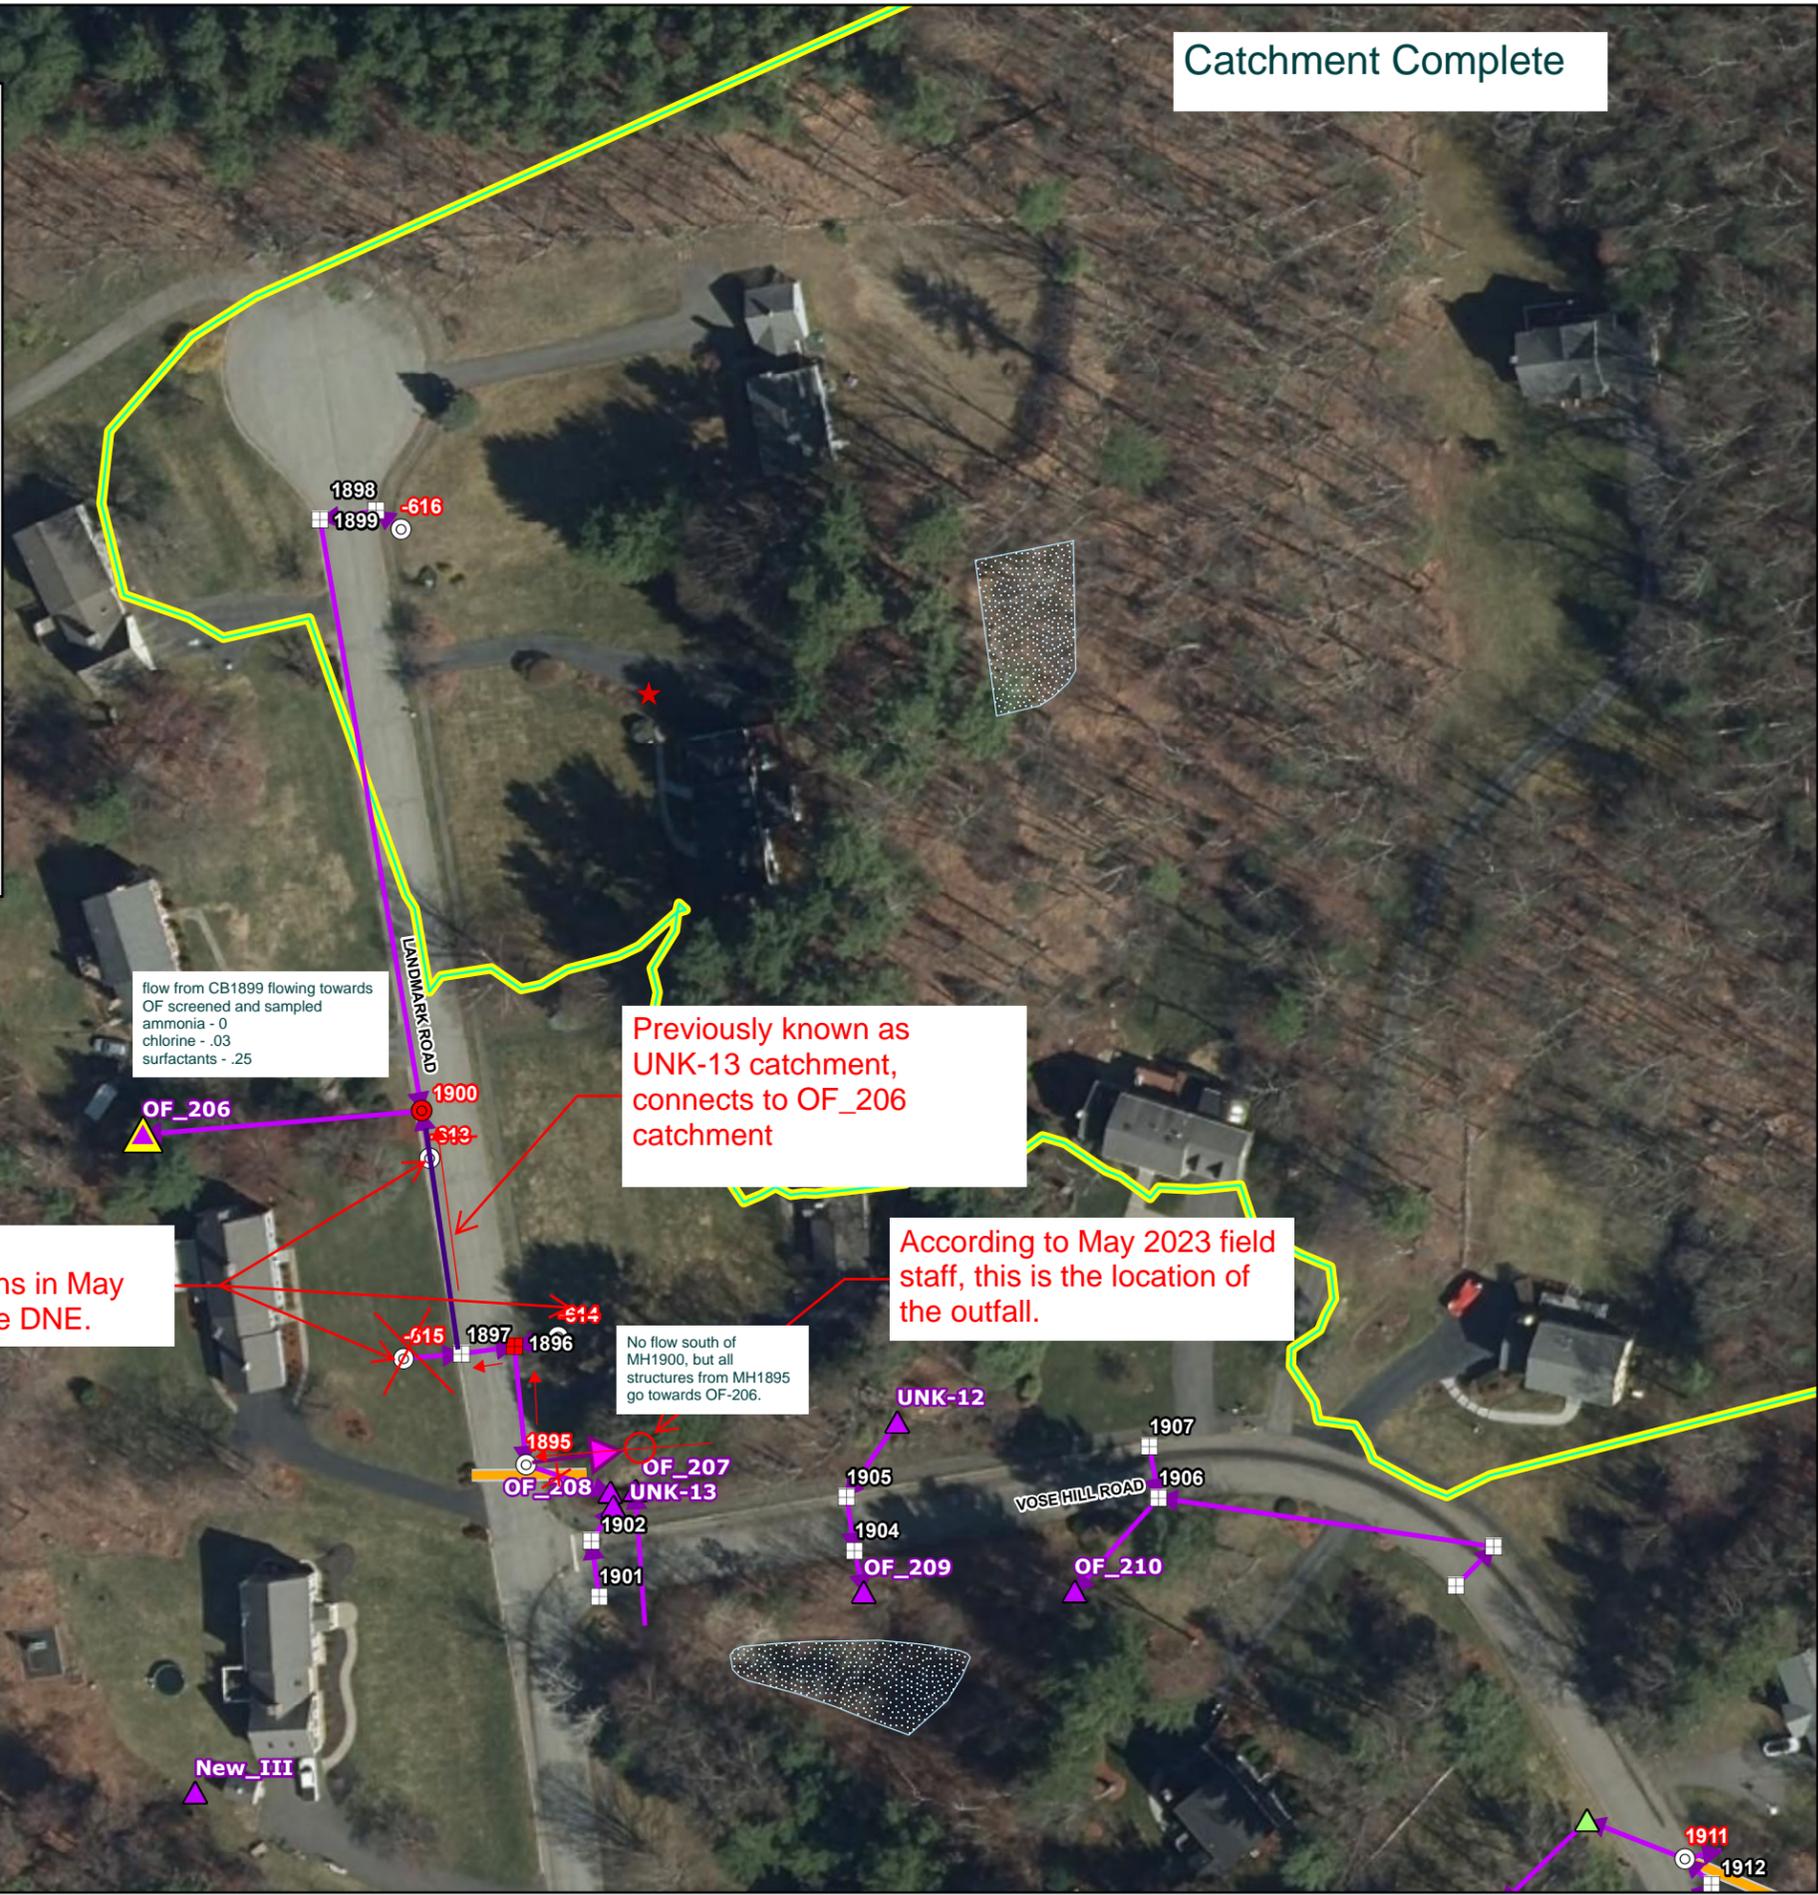
Catchment Complete

1) Screen KJMH - please bring supplies to be able to sample potential flow in a deep manhole.

2) May 2023 field staff indicated catchment is connected to UNK-13 catchment. Please confirm the direction of flow - i.e. is OF_206 the correct outfall or UNK-13? Which way is the direction of flow?

3) Does there appear to be an unmapped BMP in the region of UNK-13, OF_207, OF_208, etc.? No need to spend too much time here, Town can investigate further.

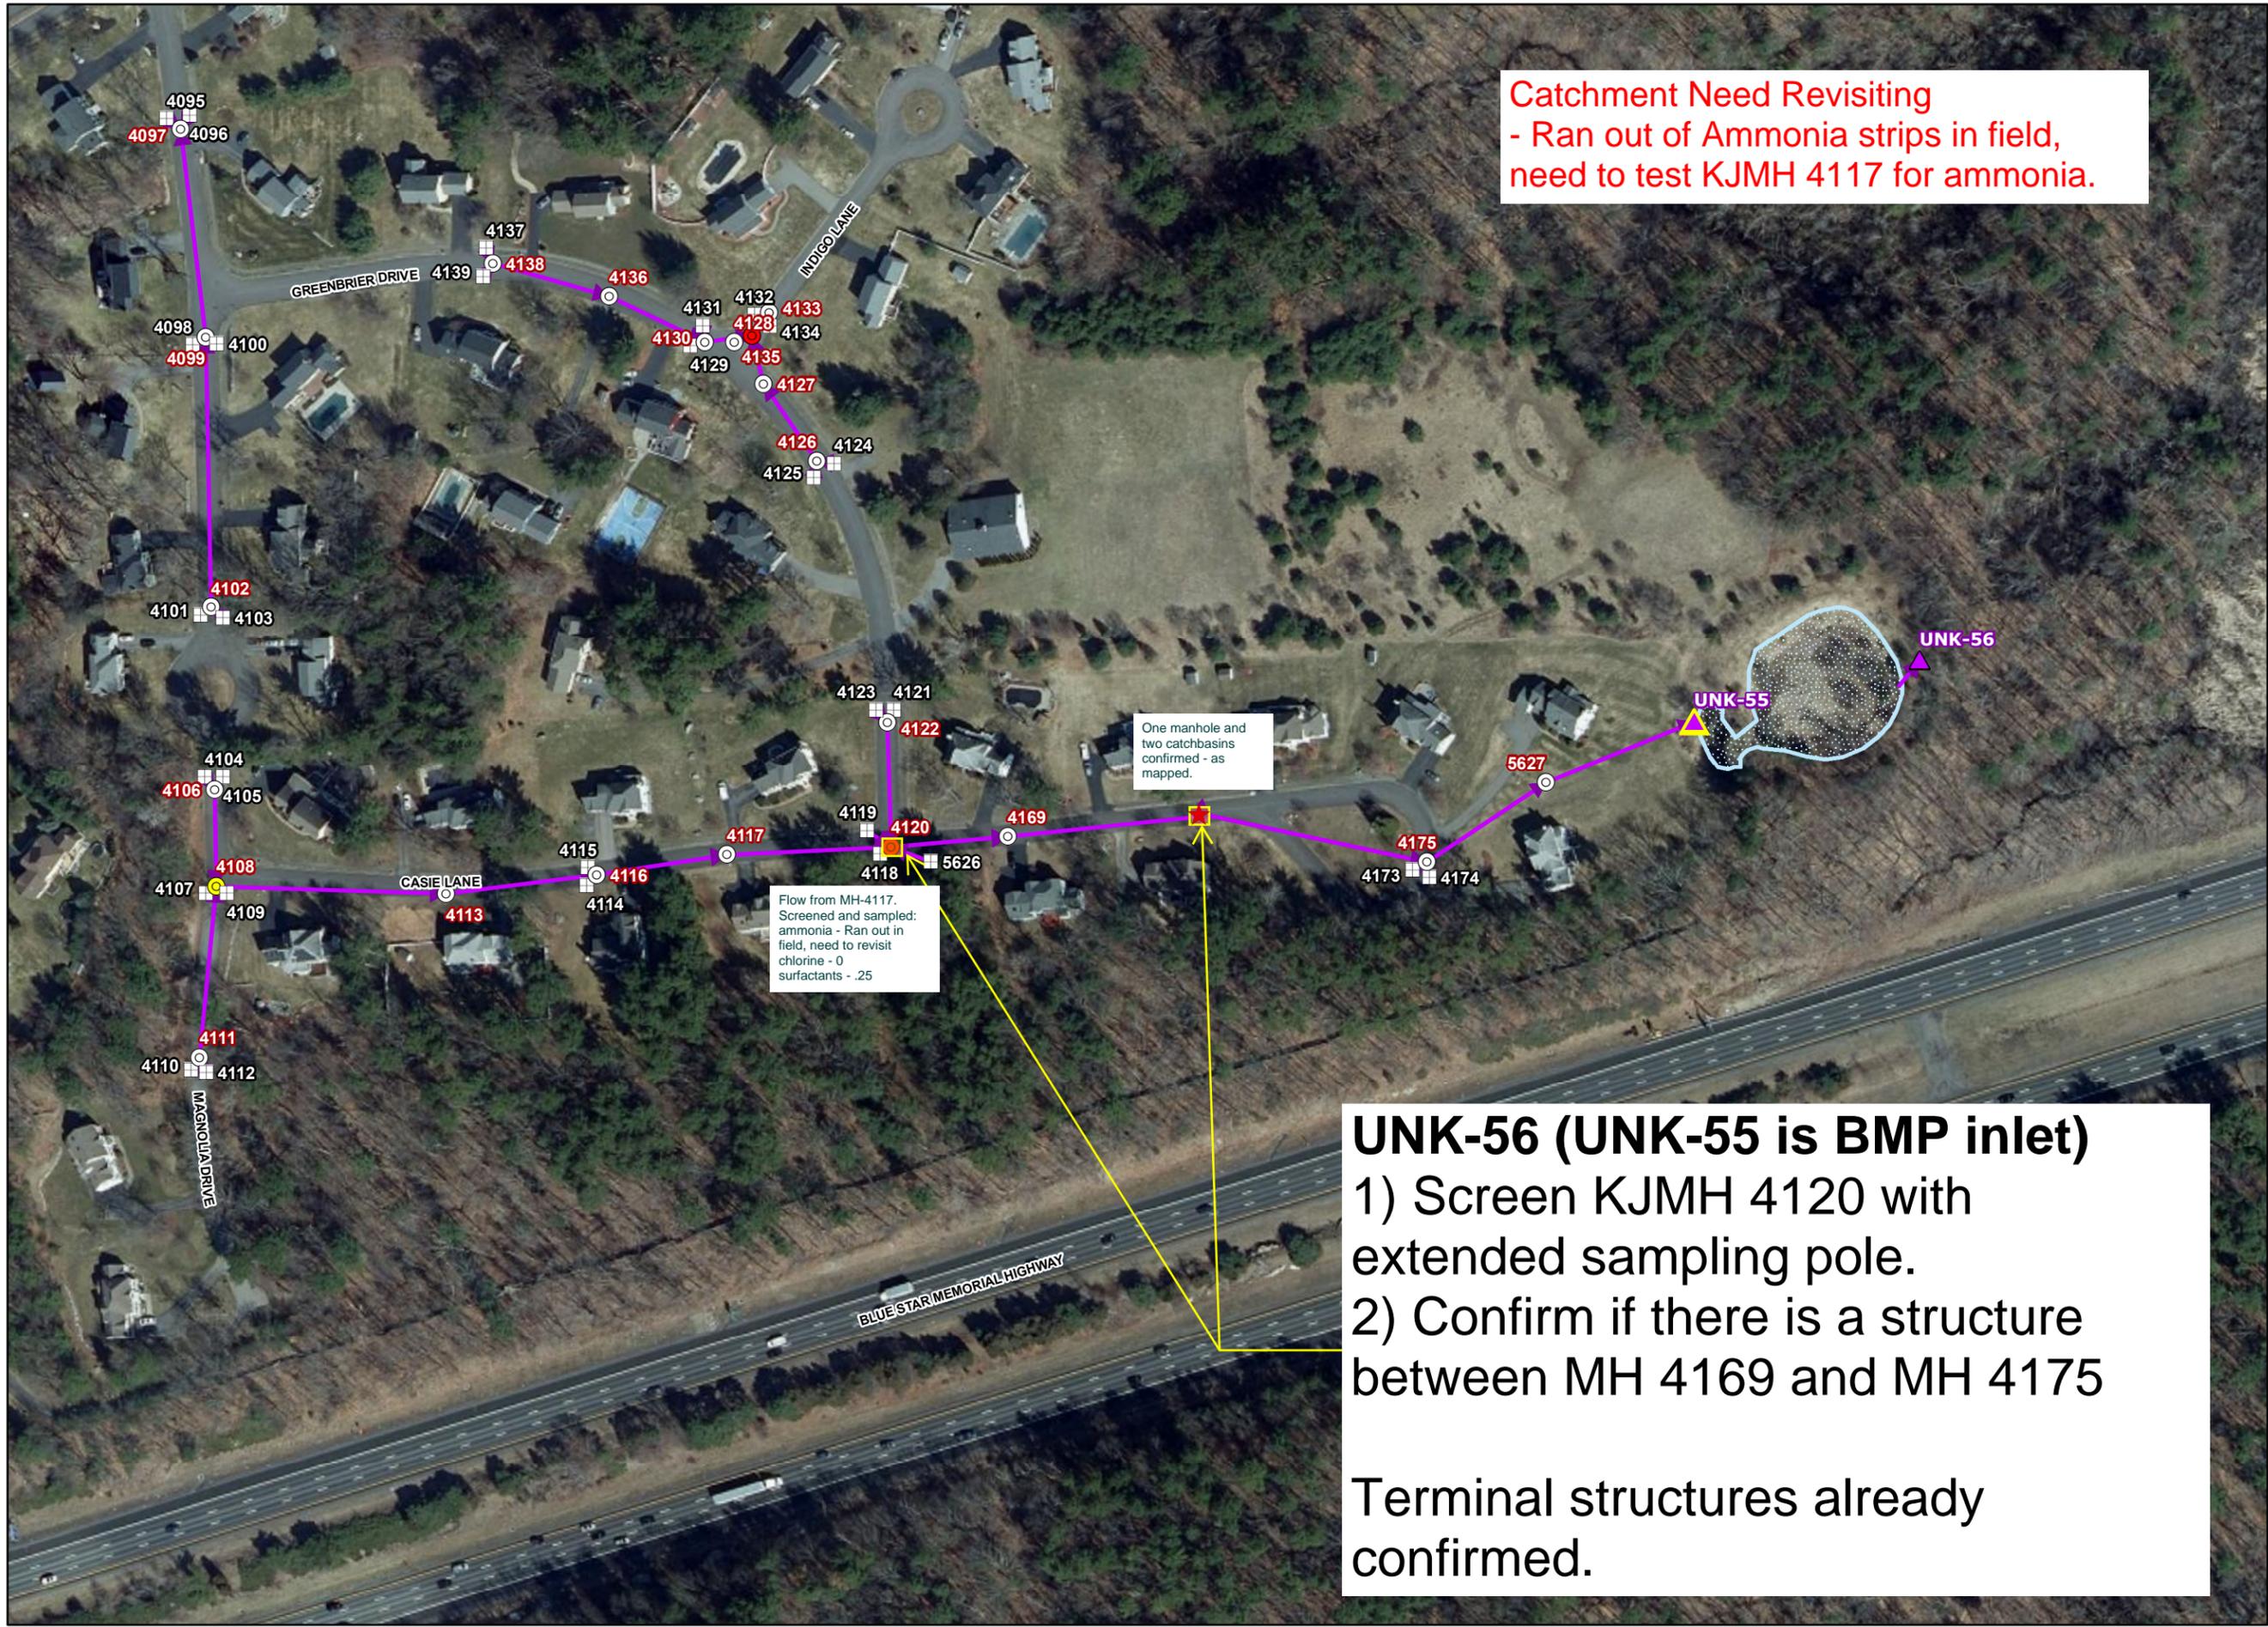
Catchment Area of UNK-56

Catchment Need Revisiting
 - Ran out of Ammonia strips in field,
 need to test KJMH 4117 for ammonia.

UNK-56 (UNK-55 is BMP inlet)
 1) Screen KJMH 4120 with
 extended sampling pole.
 2) Confirm if there is a structure
 between MH 4169 and MH 4175
 Terminal structures already
 confirmed.

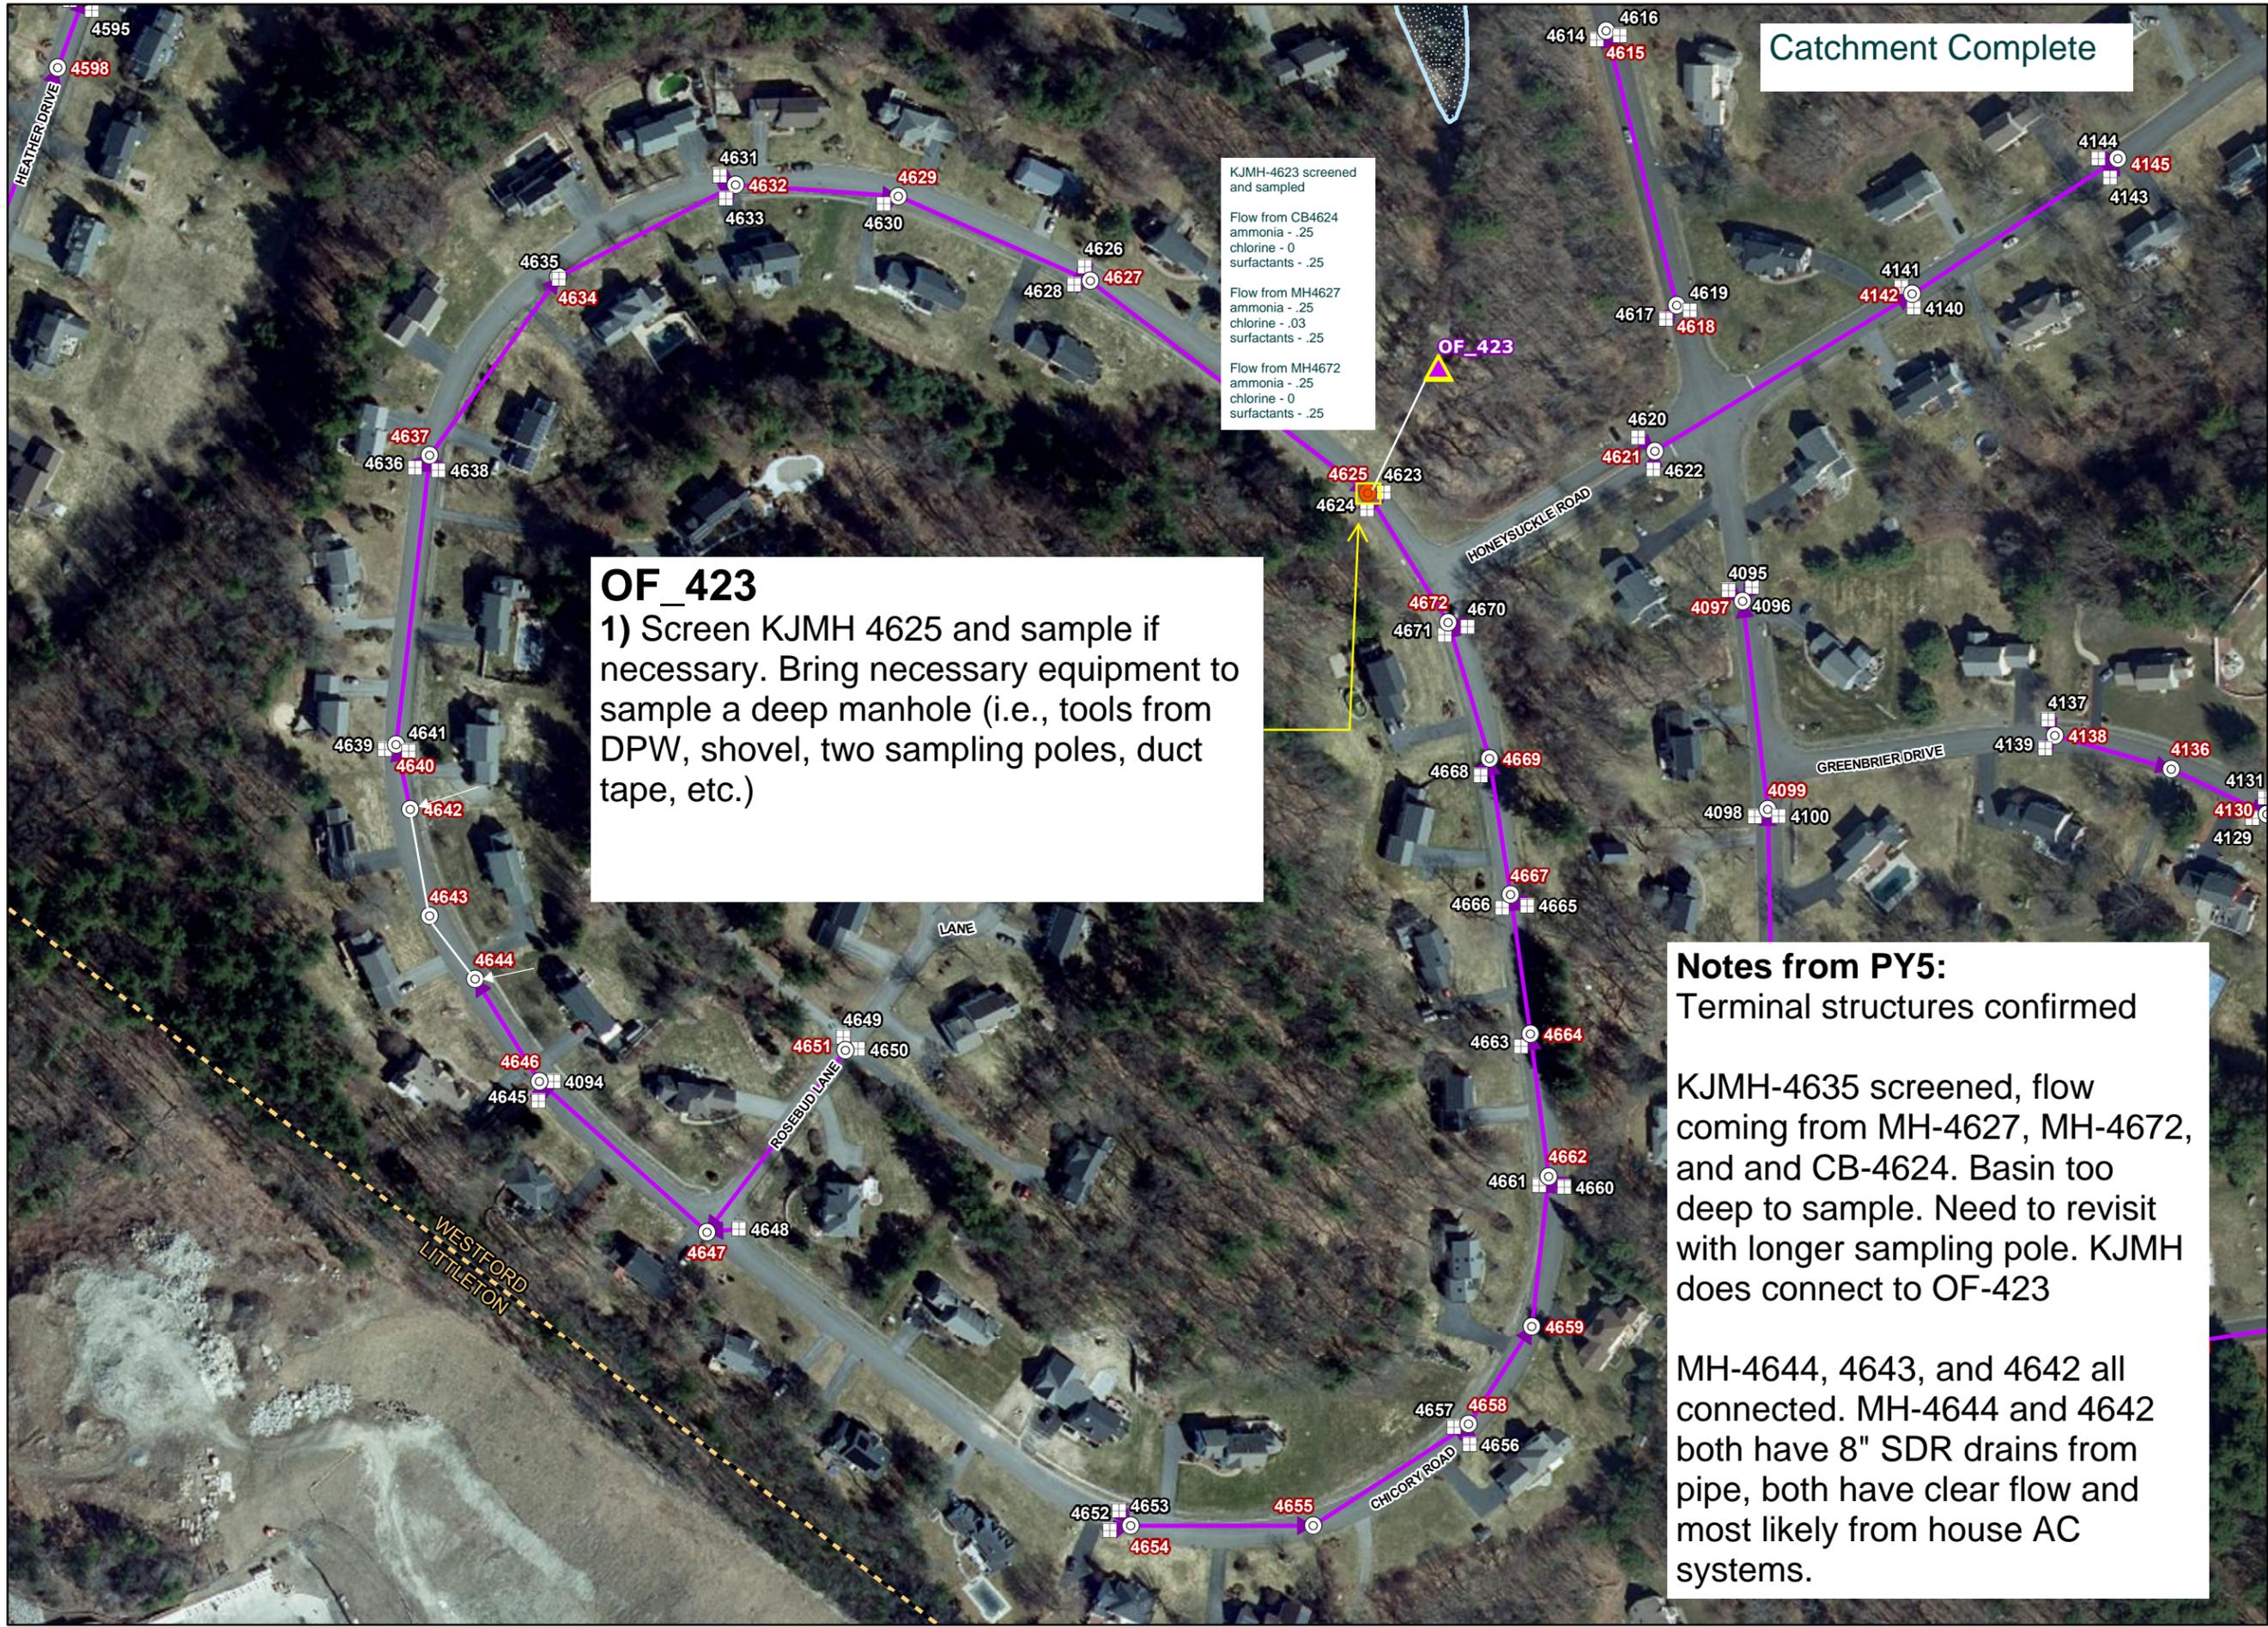
Catchment Area of OF_423

Catchment Complete

KJMH-4623 screened and sampled
 Flow from CB4624
 ammonia - .25
 chlorine - 0
 surfactants - .25
 Flow from MH4627
 ammonia - .25
 chlorine - .03
 surfactants - .25
 Flow from MH4672
 ammonia - .25
 chlorine - 0
 surfactants - .25

OF_423
 1) Screen KJMH 4625 and sample if necessary. Bring necessary equipment to sample a deep manhole (i.e., tools from DPW, shovel, two sampling poles, duct tape, etc.)

Notes from PY5:
 Terminal structures confirmed
 KJMH-4635 screened, flow coming from MH-4627, MH-4672, and and CB-4624. Basin too deep to sample. Need to revisit with longer sampling pole. KJMH does connect to OF-423
 MH-4644, 4643, and 4642 all connected. MH-4644 and 4642 both have 8" SDR drains from pipe, both have clear flow and most likely from house AC systems.

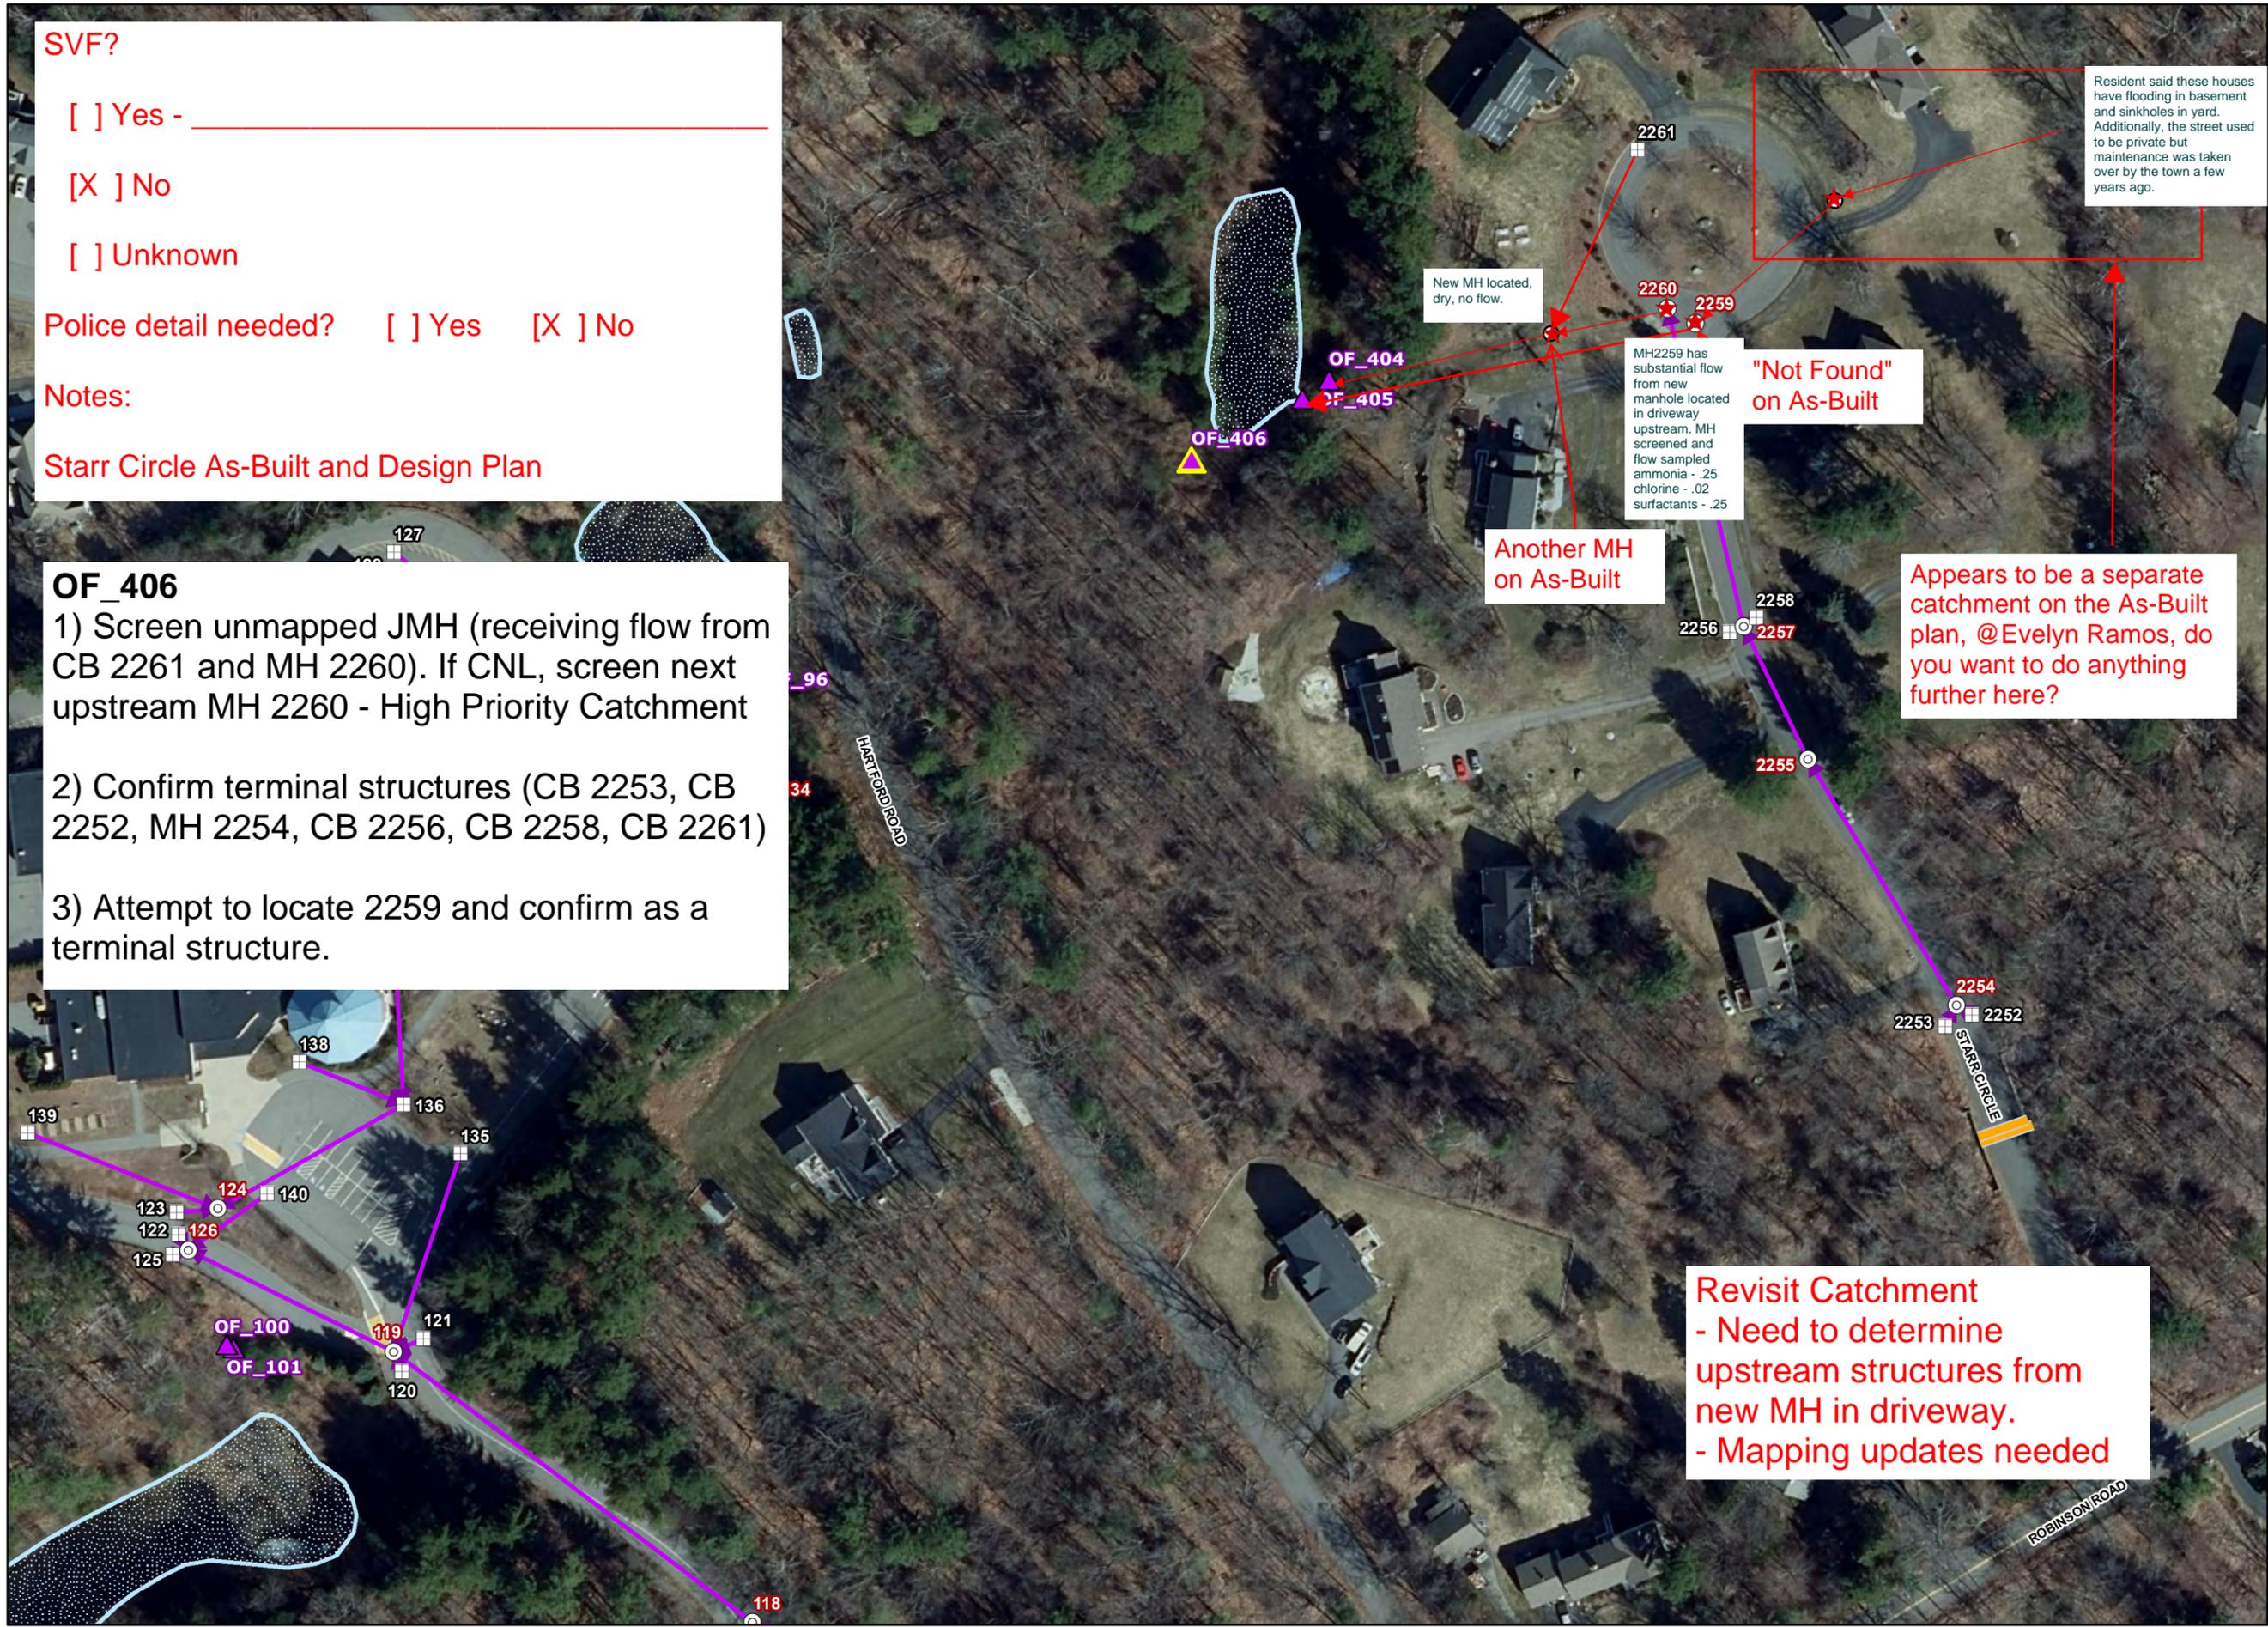
Catchment Area of Outfall: OF_406

OF_406

1) Screen unmapped JMH (receiving flow from CB 2261 and MH 2260). If CNL, screen next upstream MH 2260 - High Priority Catchment

2) Confirm terminal structures (CB 2253, CB 2252, MH 2254, CB 2256, CB 2258, CB 2261)

3) Attempt to locate 2259 and confirm as a terminal structure.

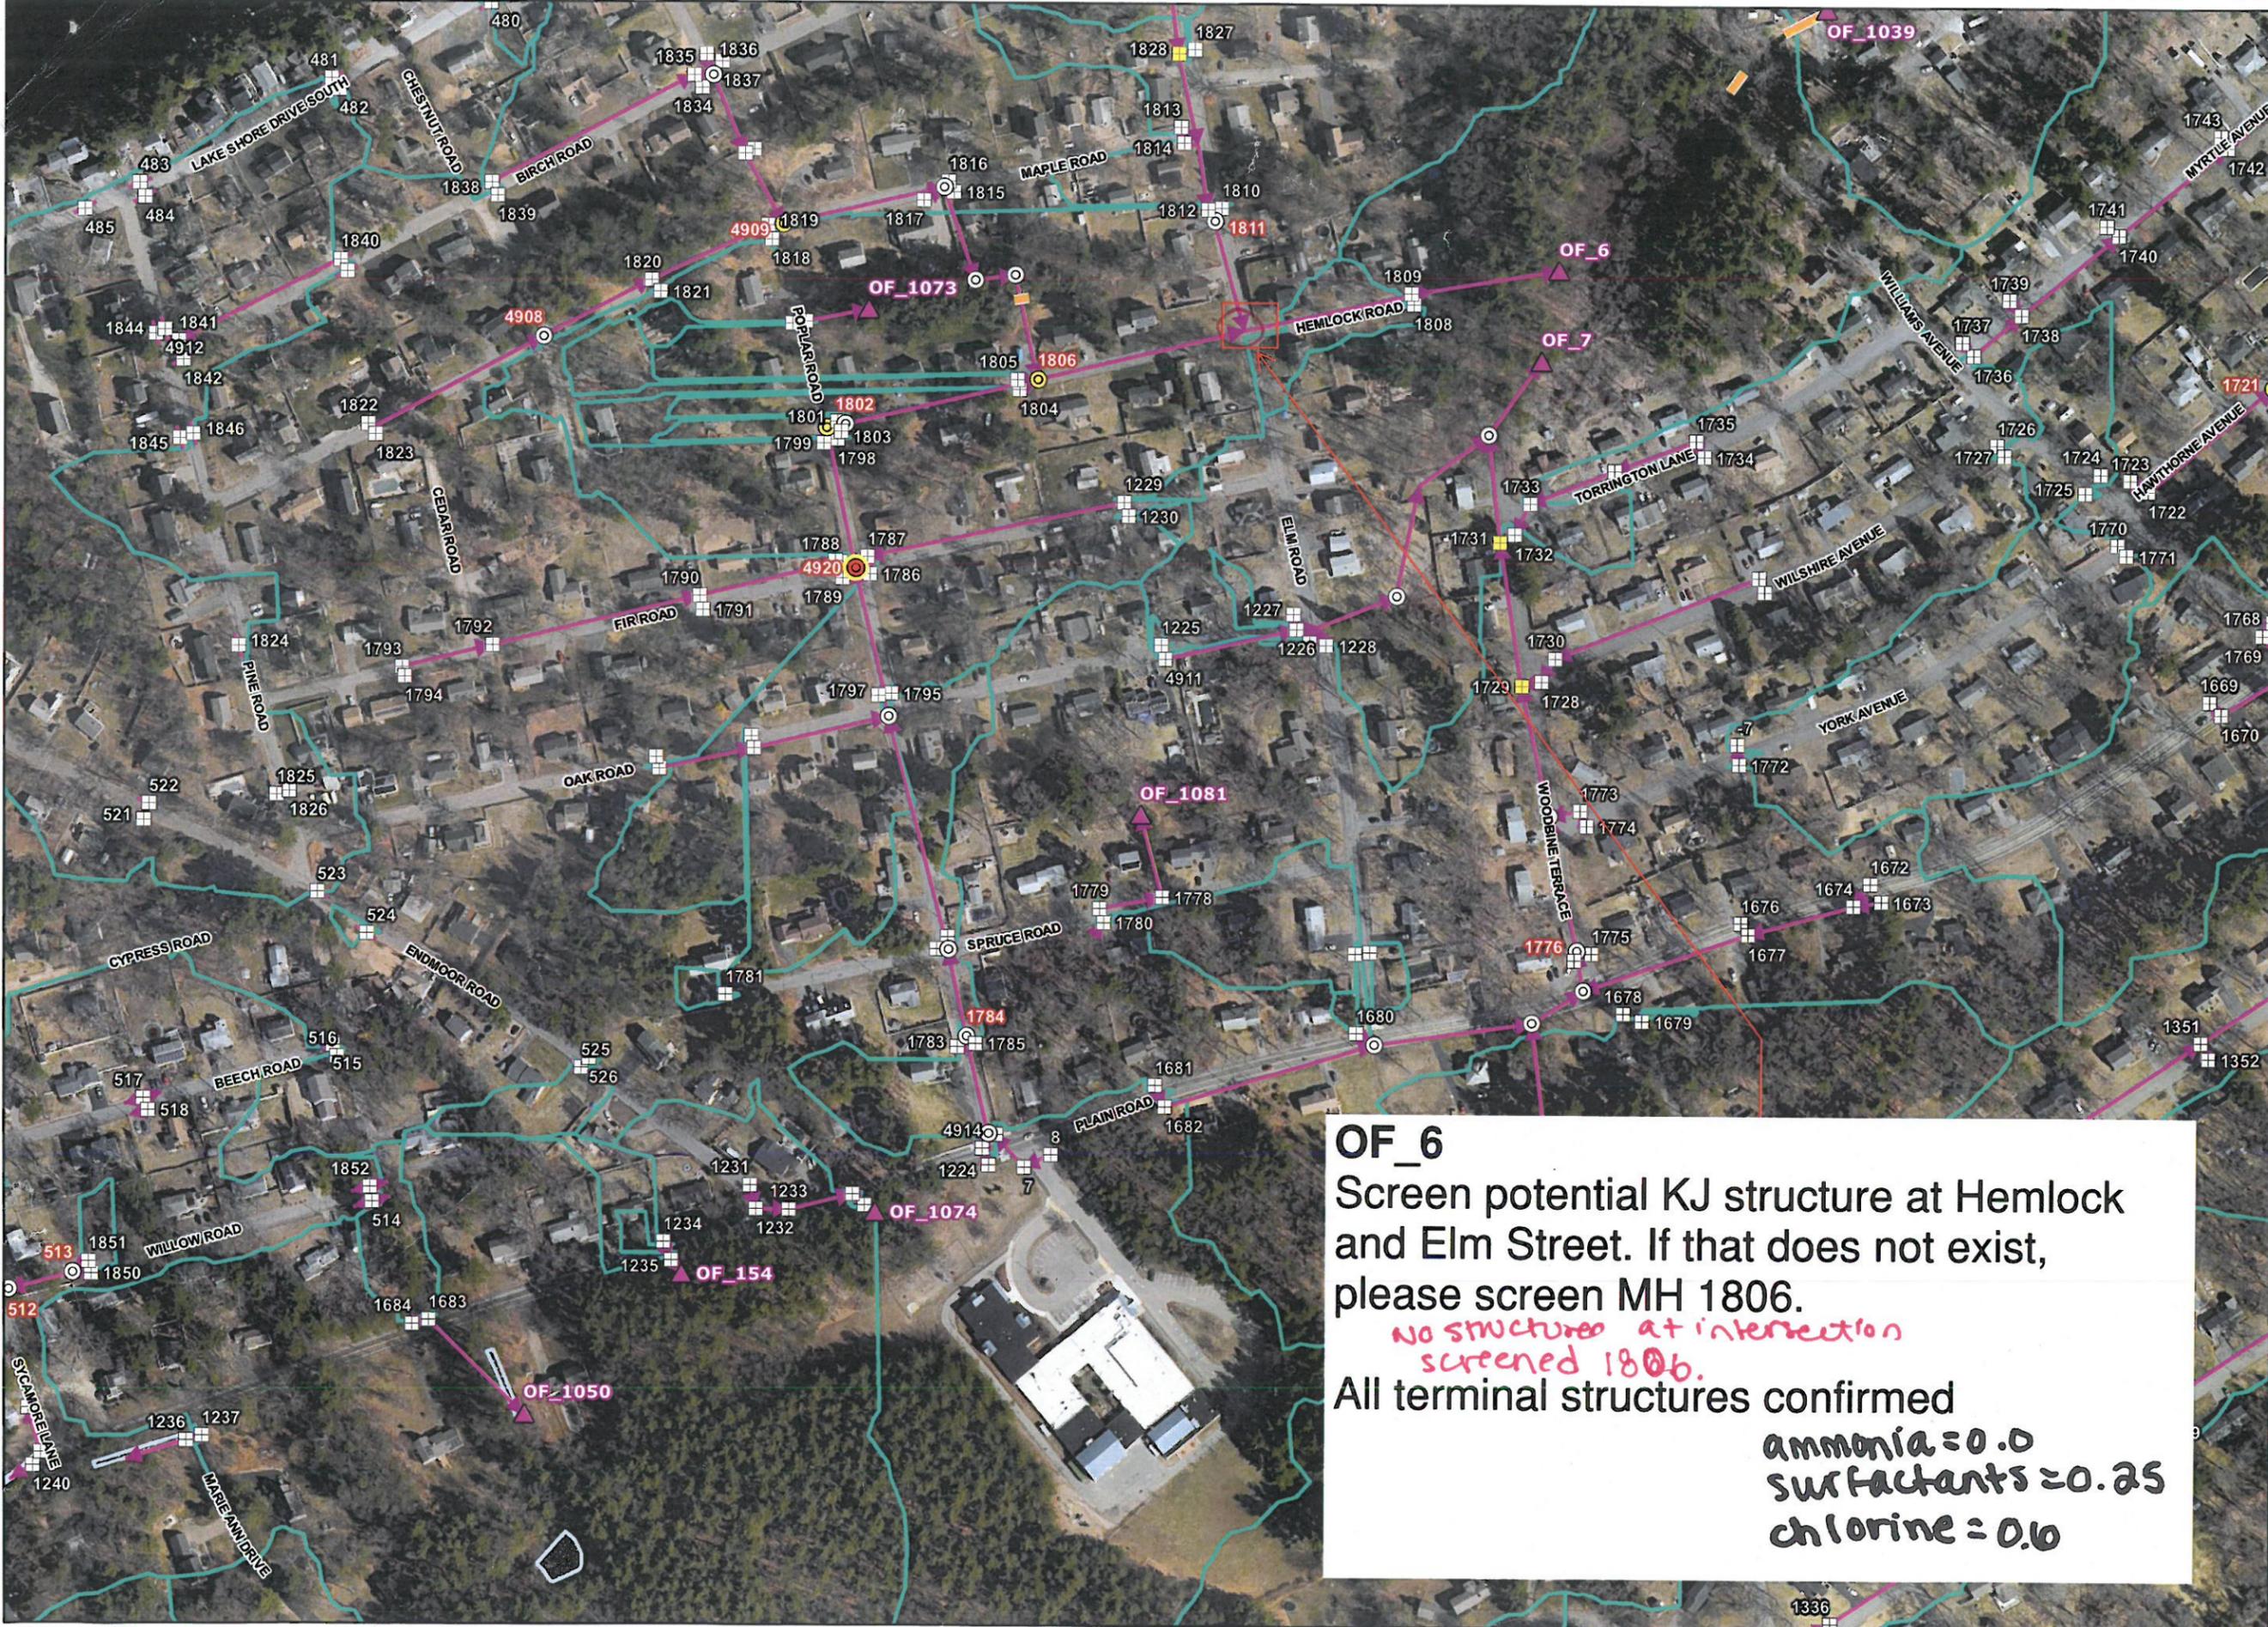
OF_6
Screen potential KJ structure at Hemlock and Elm Street. If that does not exist, please screen MH 1806.
no structure at intersection screened 1806.
All terminal structures confirmed
ammonia = 0.0
surfactants = 0.25
chlorine = 0.6

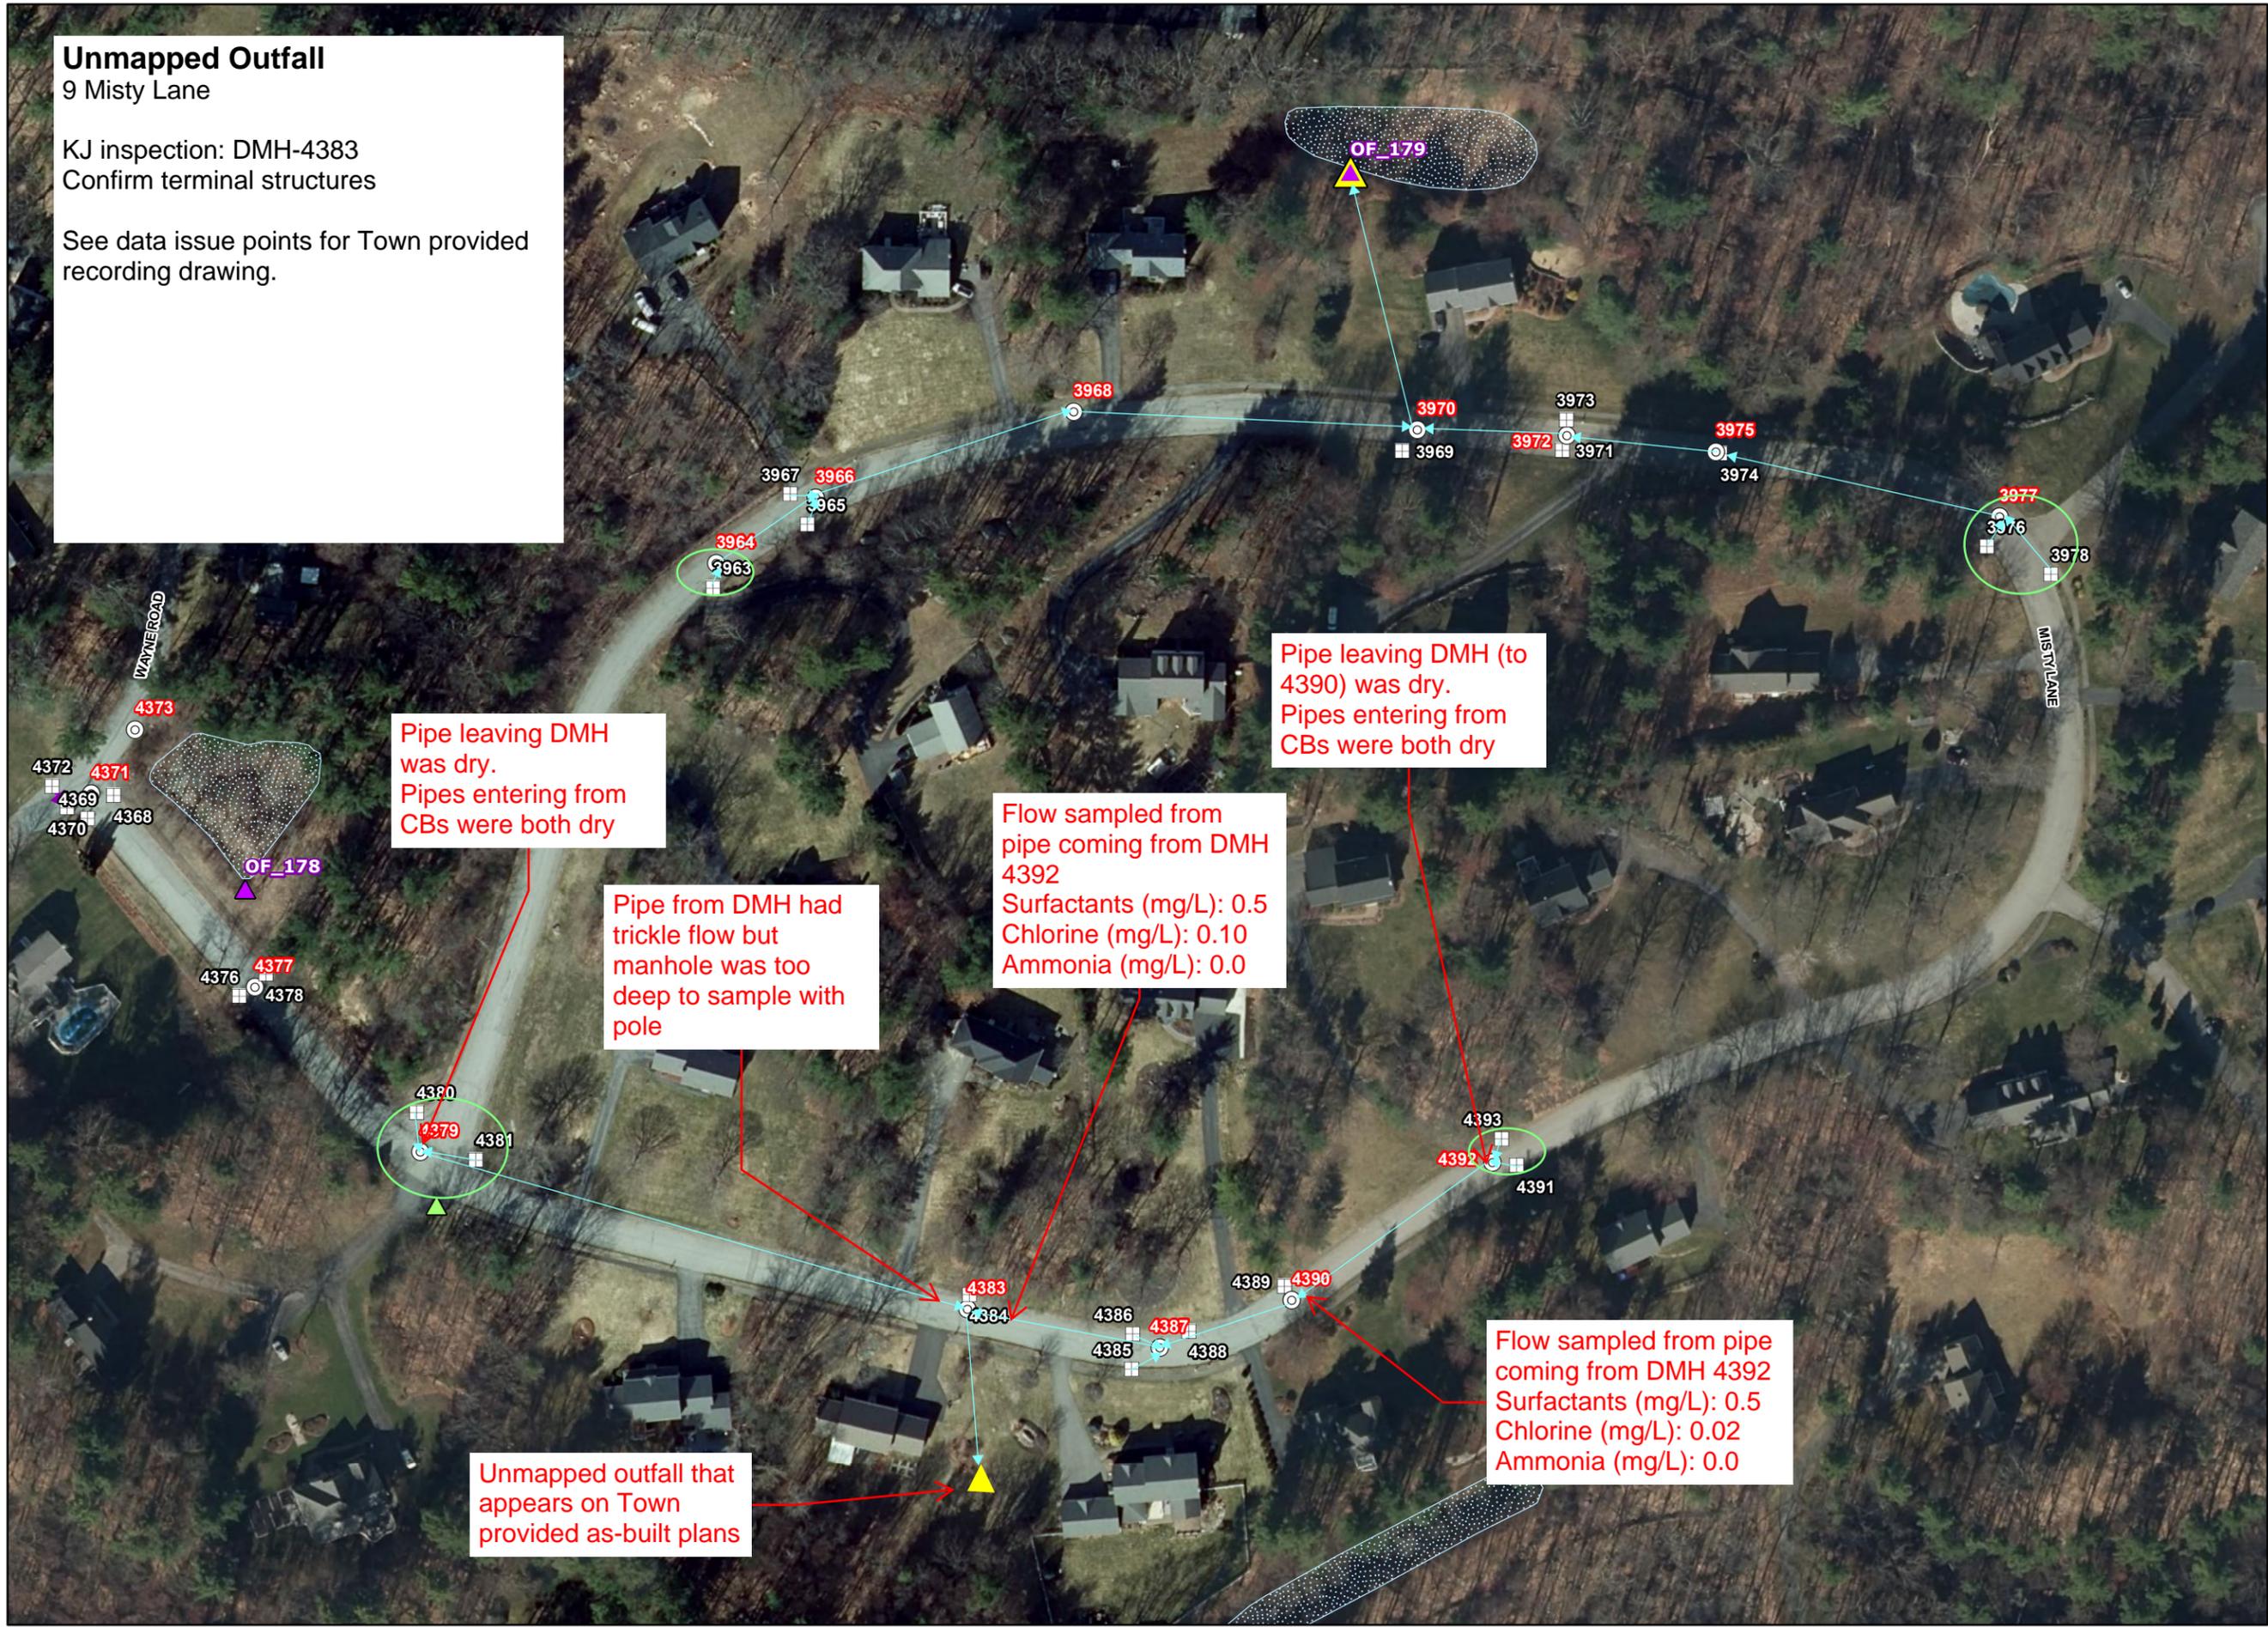
Pipe leaving DMH was dry.
Pipes entering from CBs were both dry

Pipe leaving DMH (to 4390) was dry.
Pipes entering from CBs were both dry
