CATCHMENT INVESTIGATIONS GROUP ONE

Catchment Area of Outfall: OF_206

**Westford, Massachusetts
November 2023**

Tighe & Bond

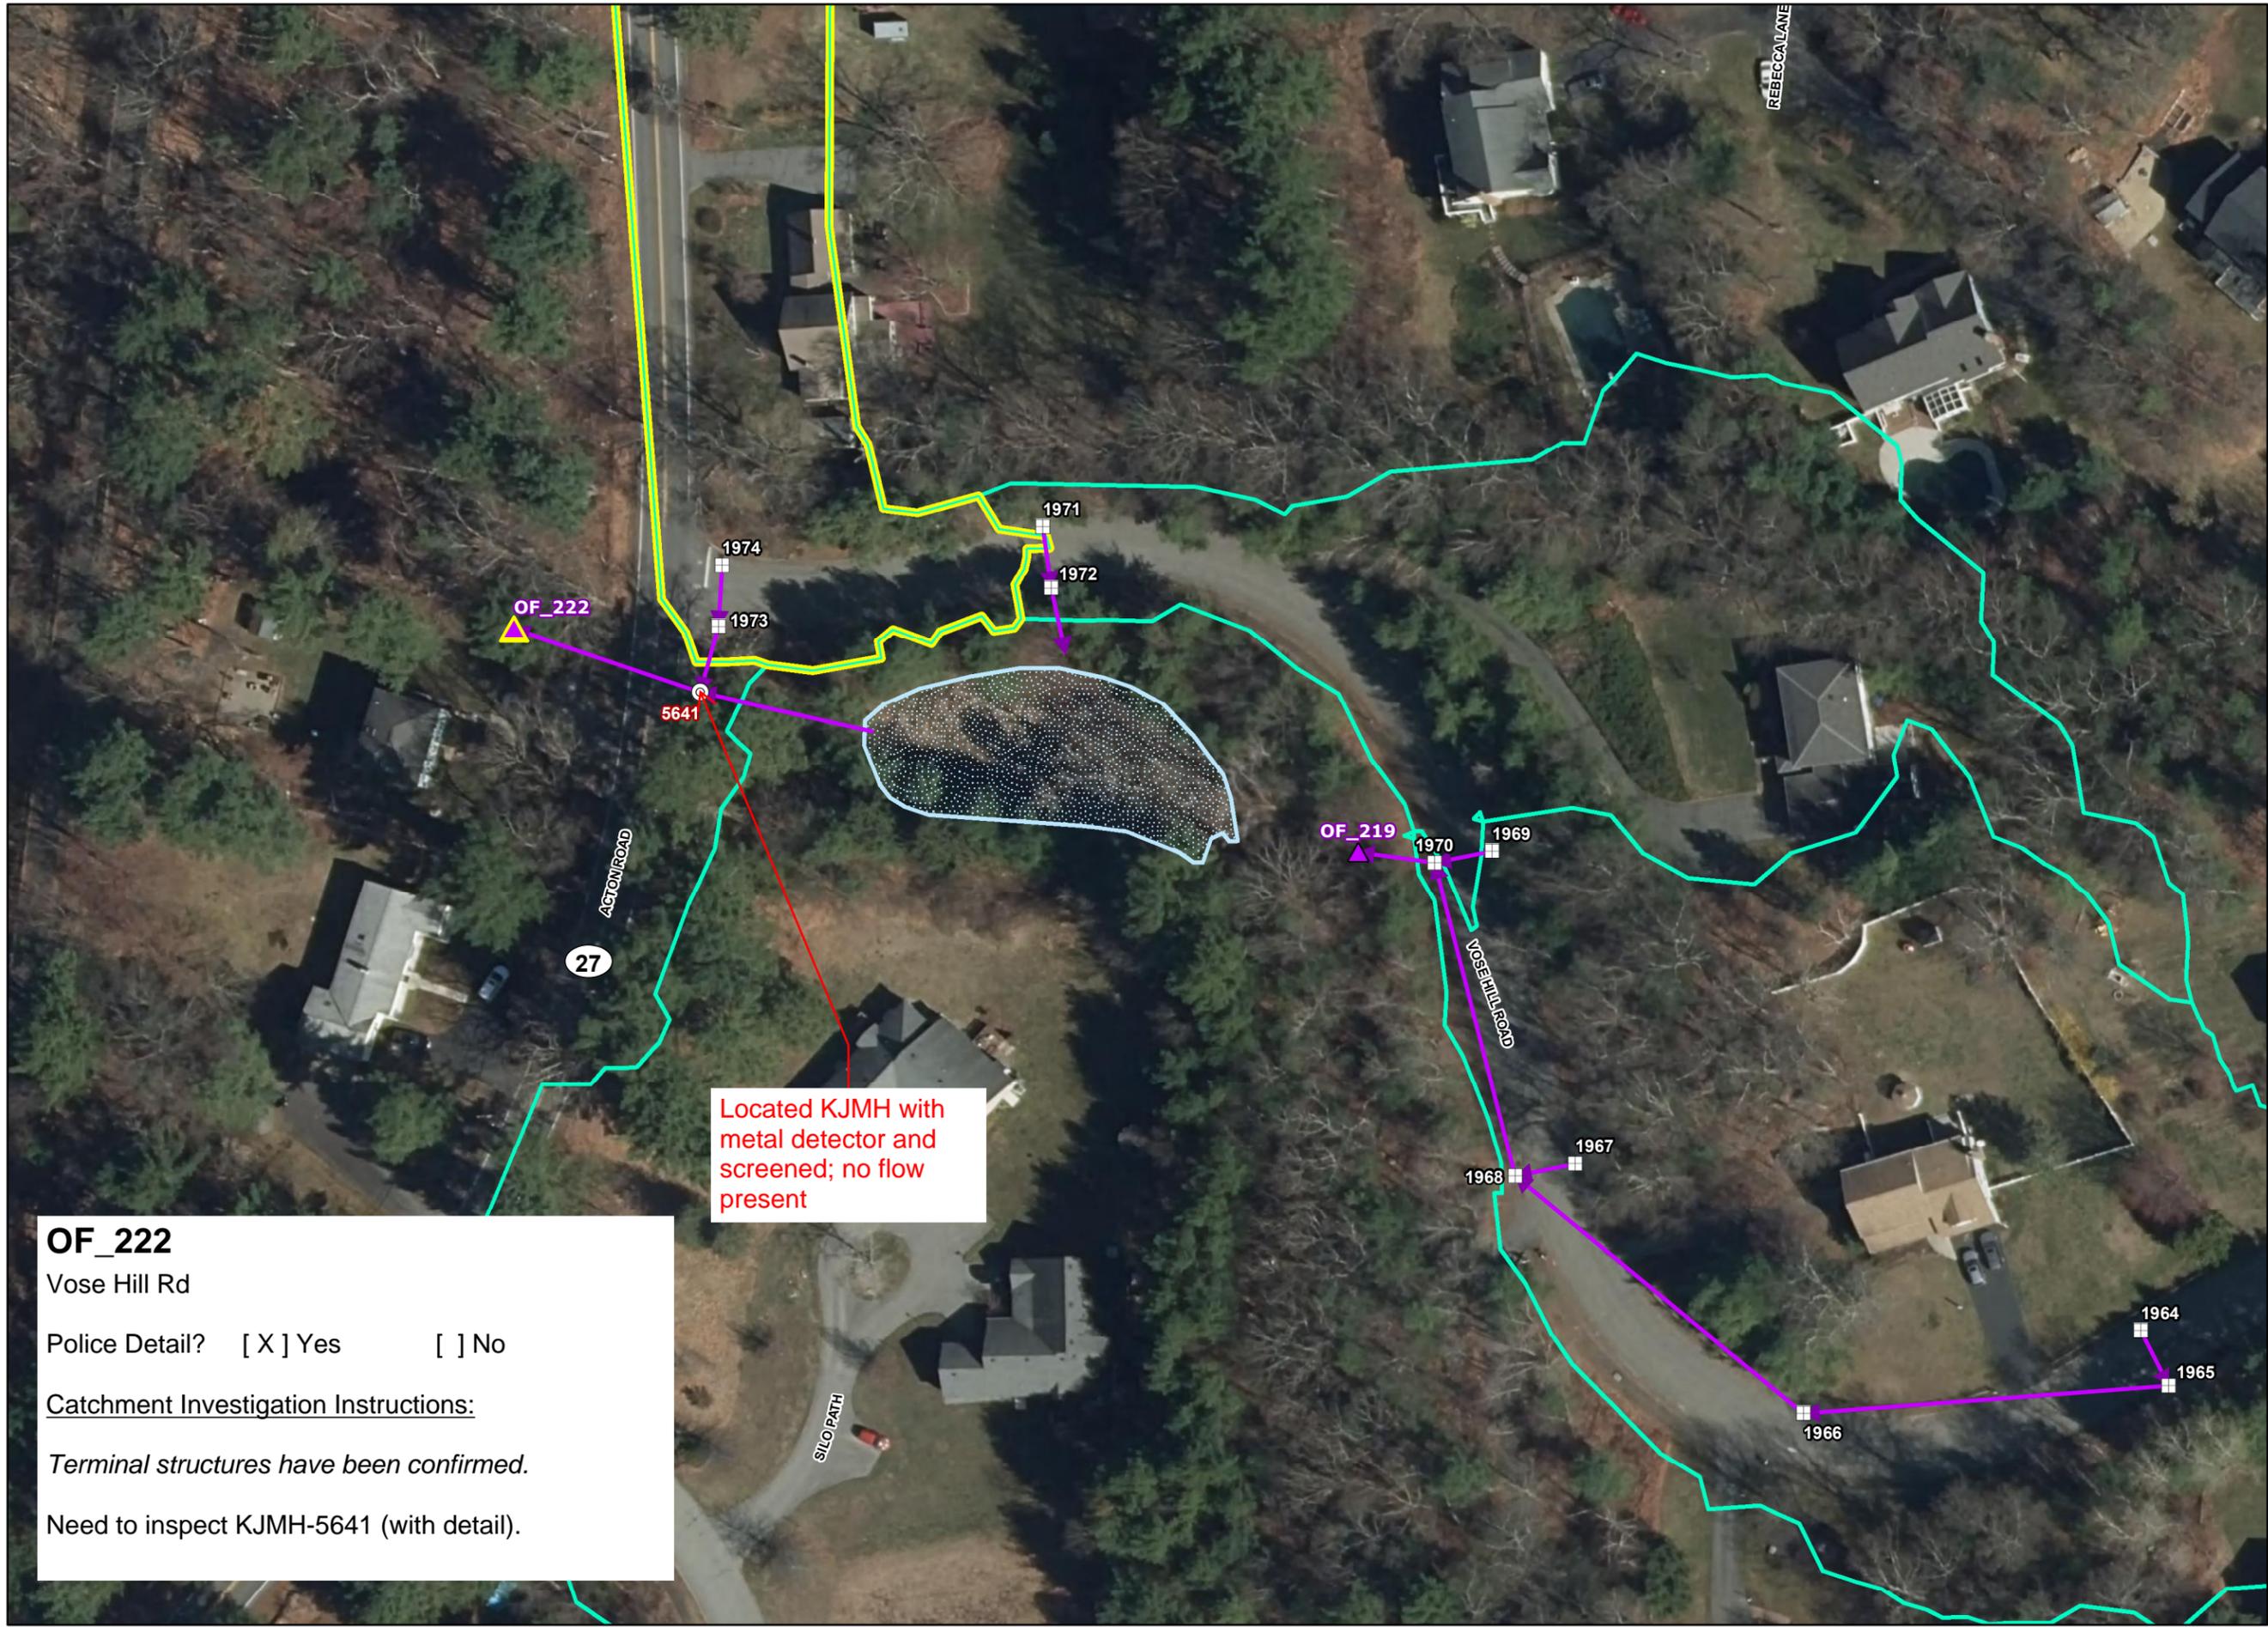
Located KJMH with metal detector and screened; no flow present

OF_222
Vose Hill Rd

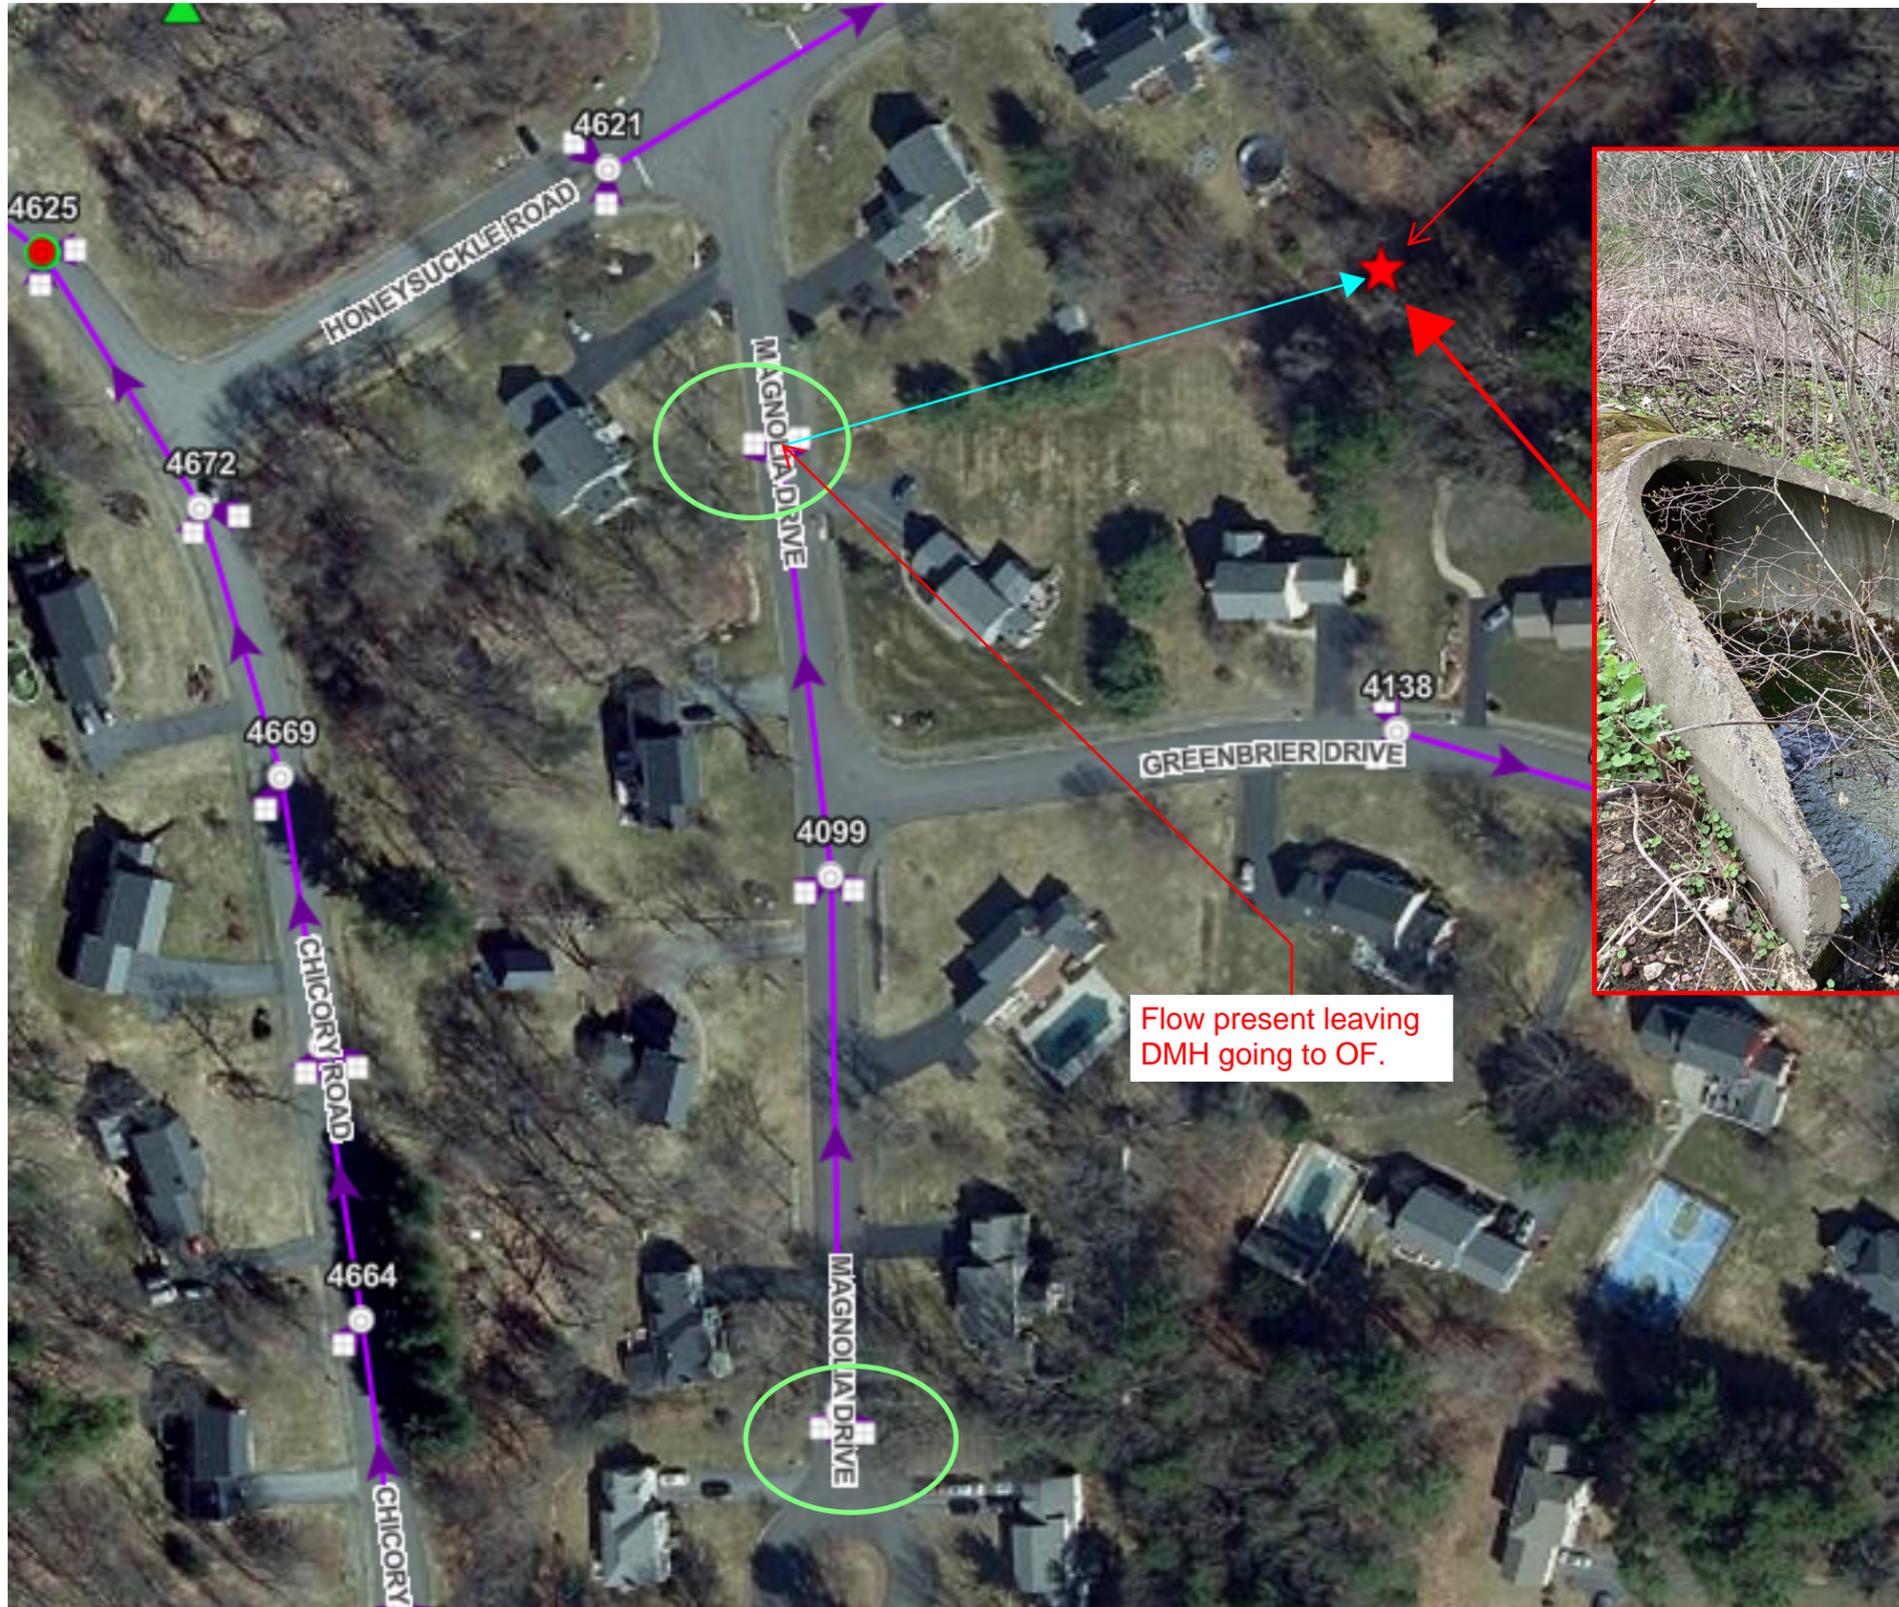
Unmapped outfall located and flow was present.

Referring to this as Unmapped Outfall 7 on my tracking spreadsheet ECO 5/1/24
I think this still needs SVF review and dry weather outfall screening

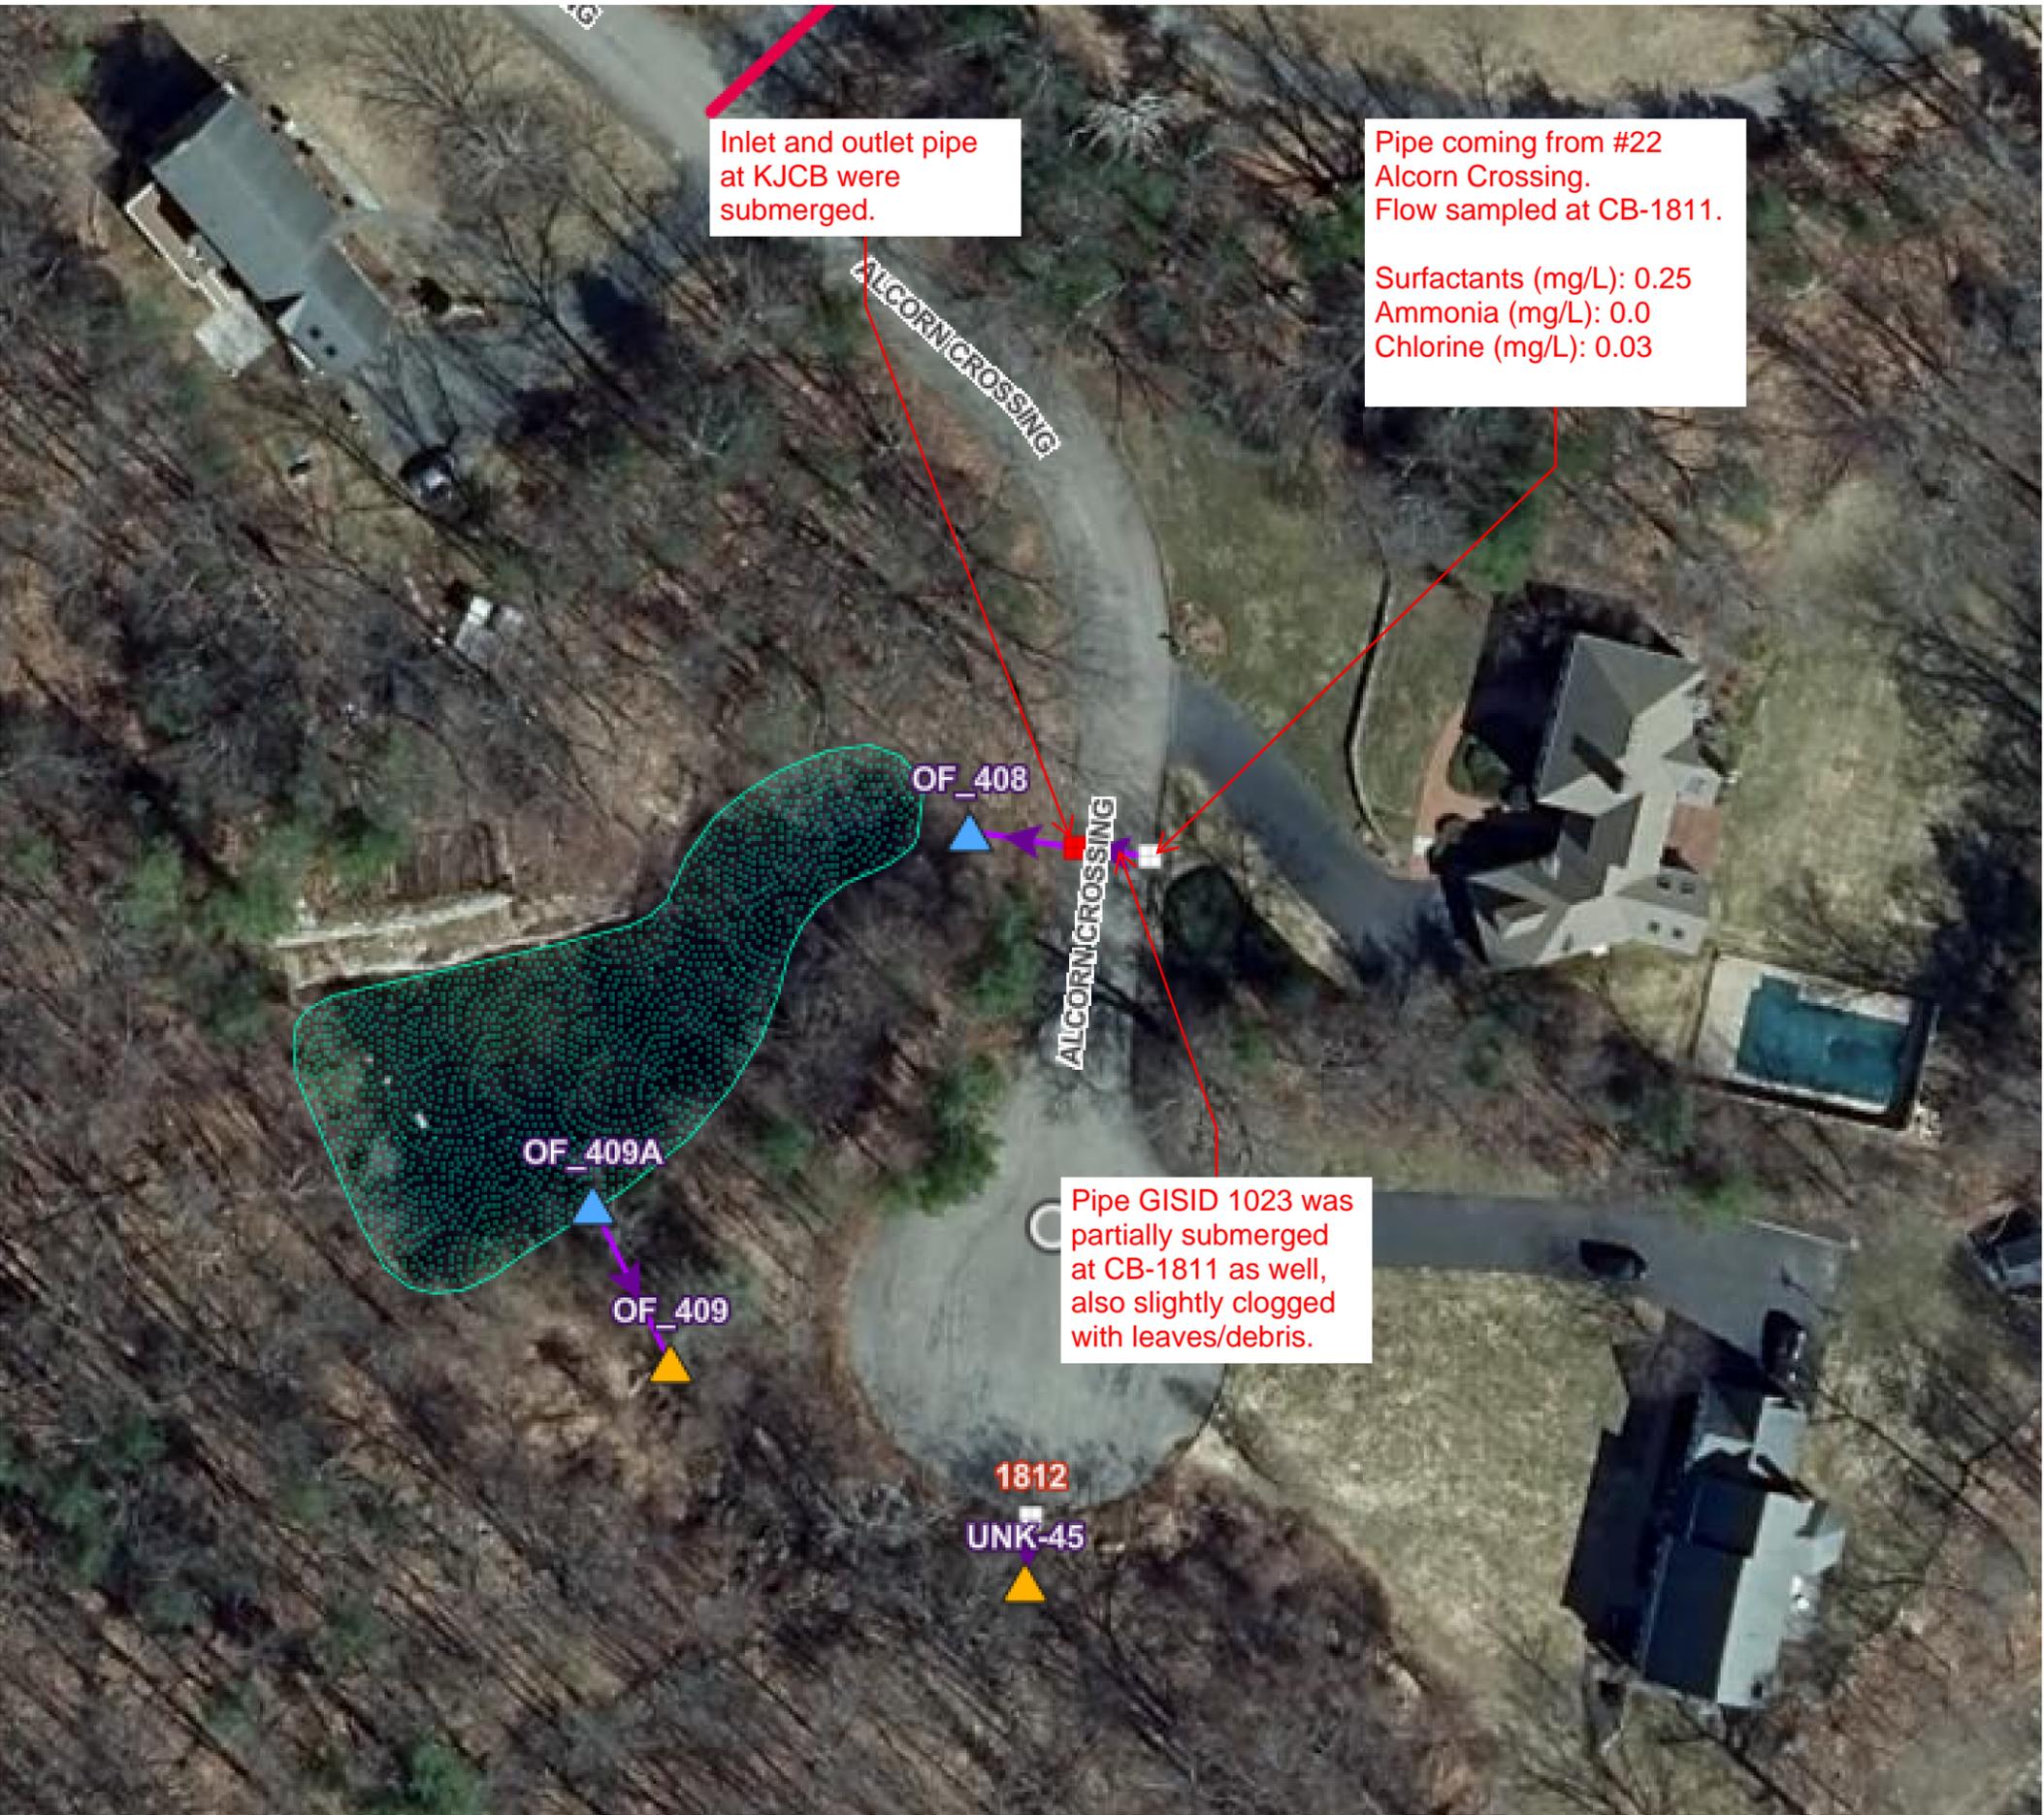
Inlet and outlet pipe at KJCB were submerged.

Pipe coming from #22 Alcorn Crossing. Flow sampled at CB-1811.
Surfactants (mg/L): 0.25
Ammonia (mg/L): 0.0
Chlorine (mg/L): 0.03

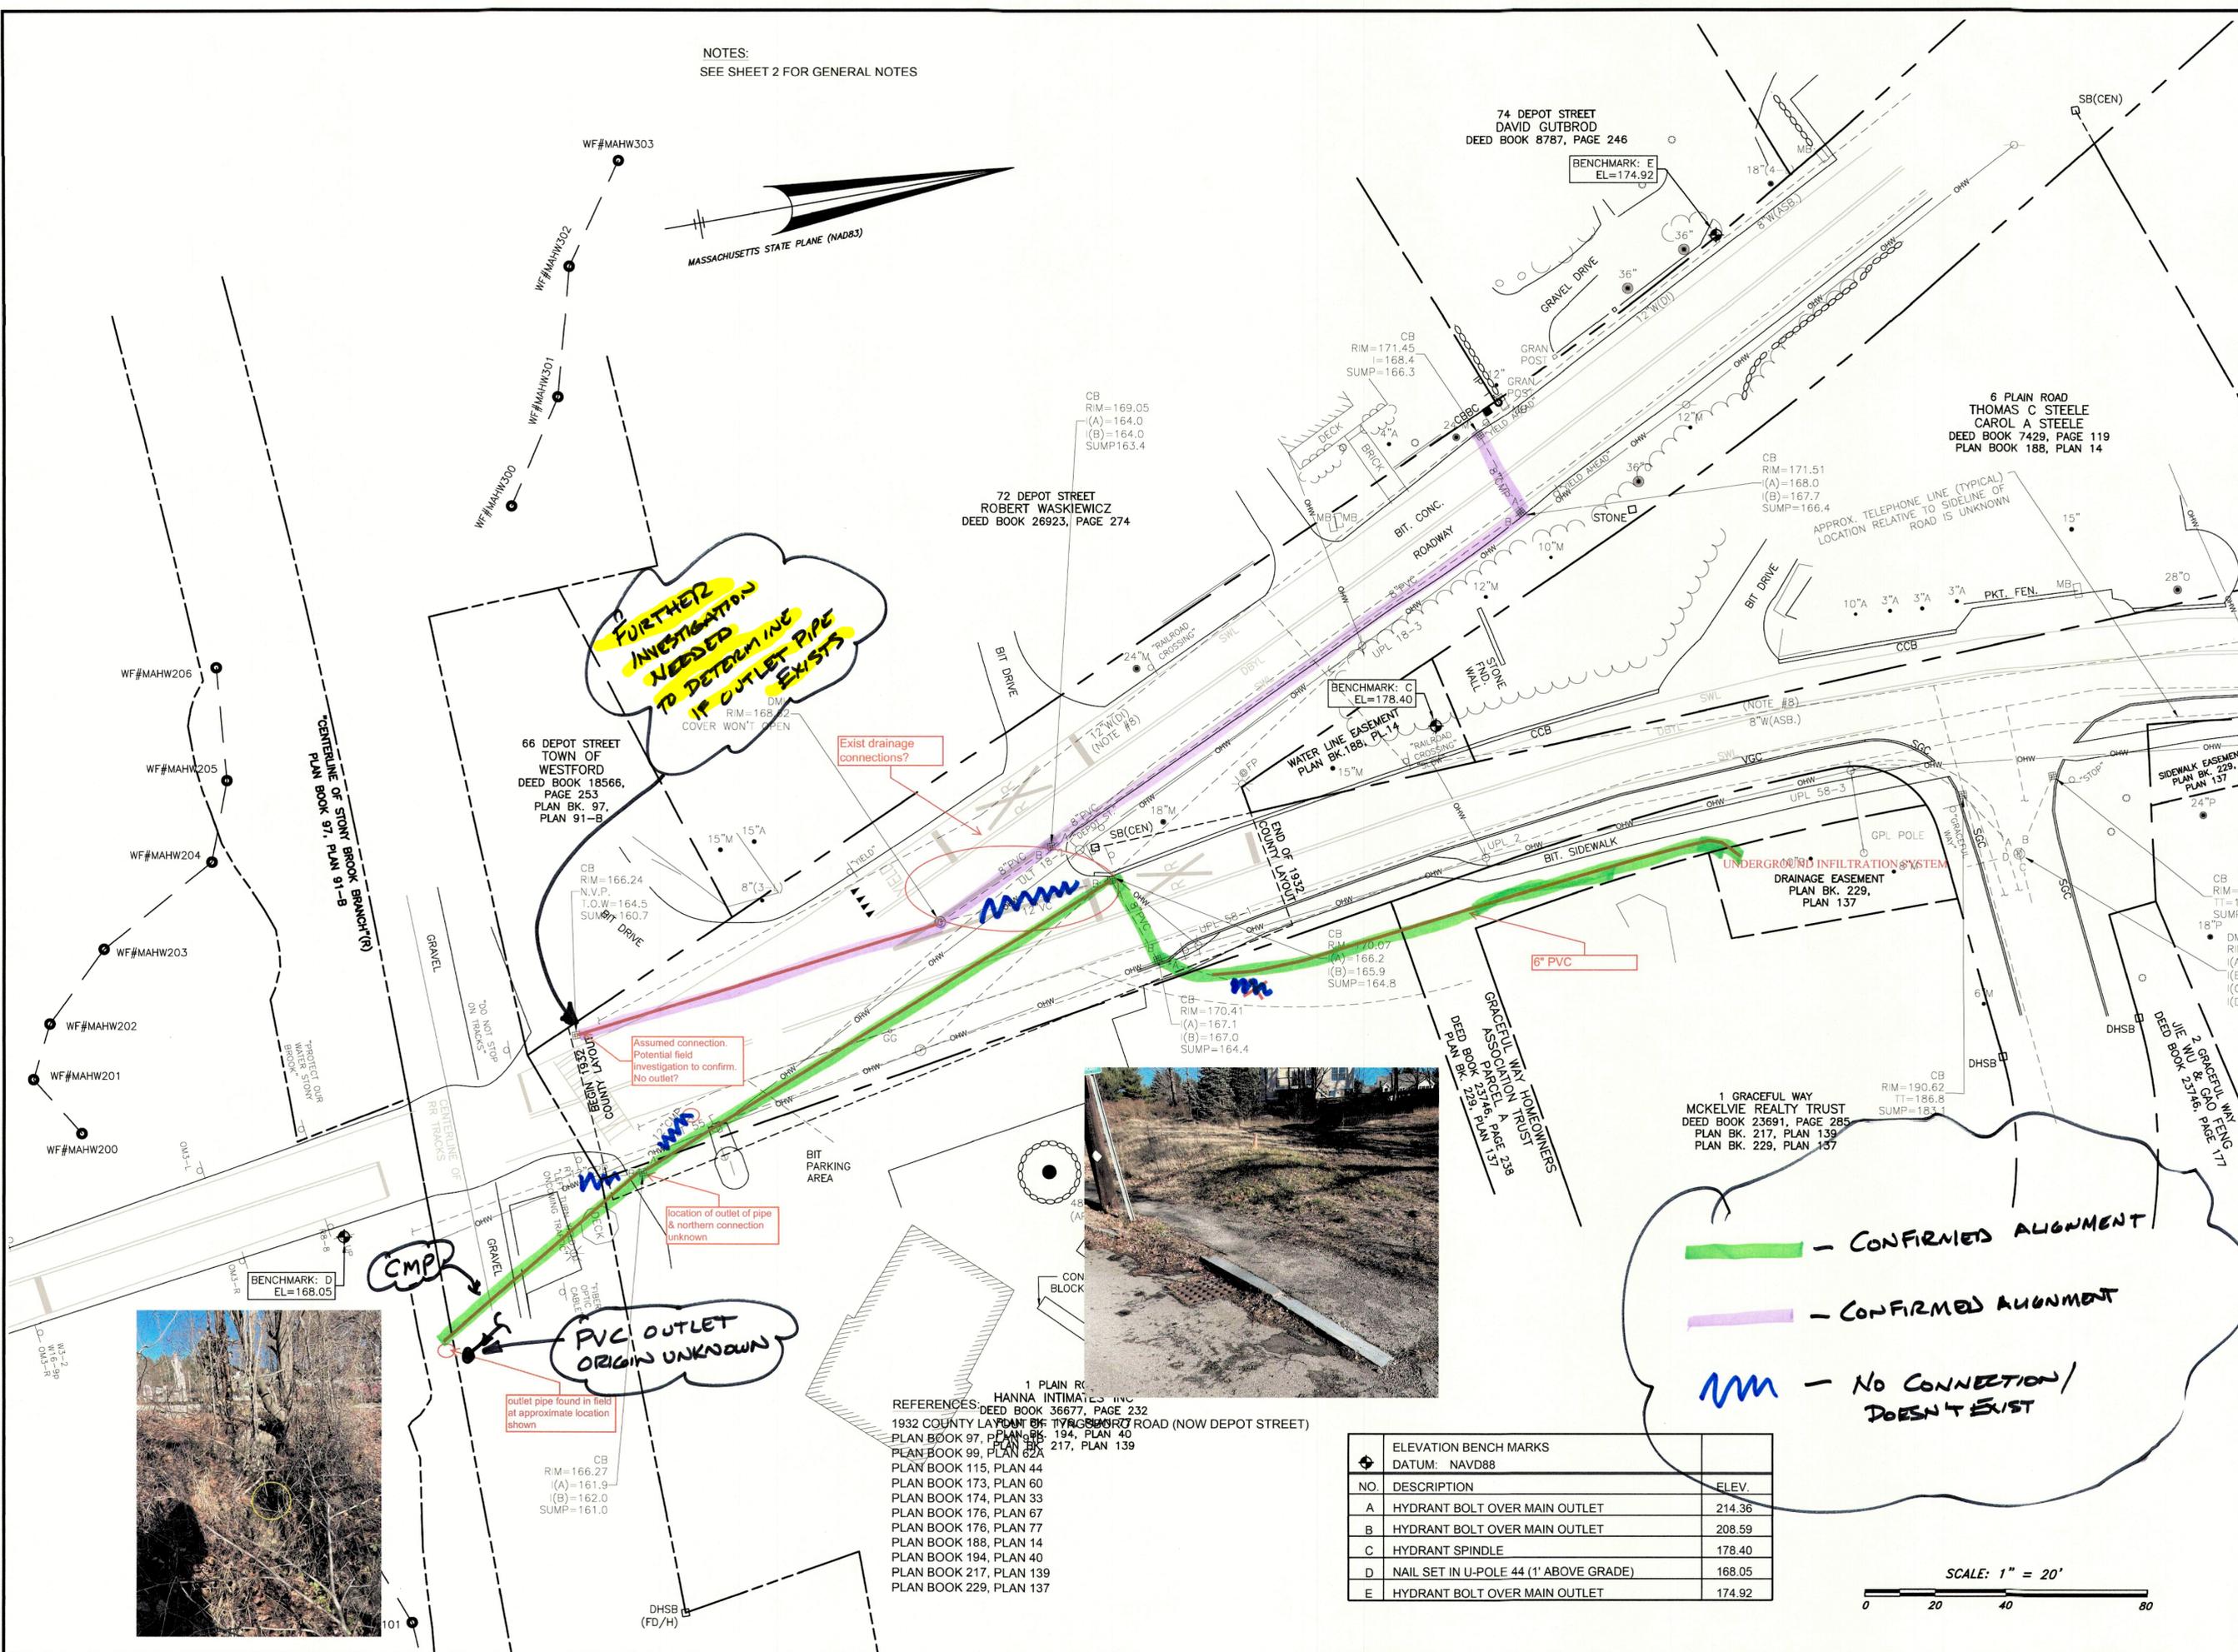
FURTHER INVESTIGATION NEEDED TO DETERMINE IF OUTLET PIPE EXISTS

PVC OUTLET ORIGIN UNKNOWN

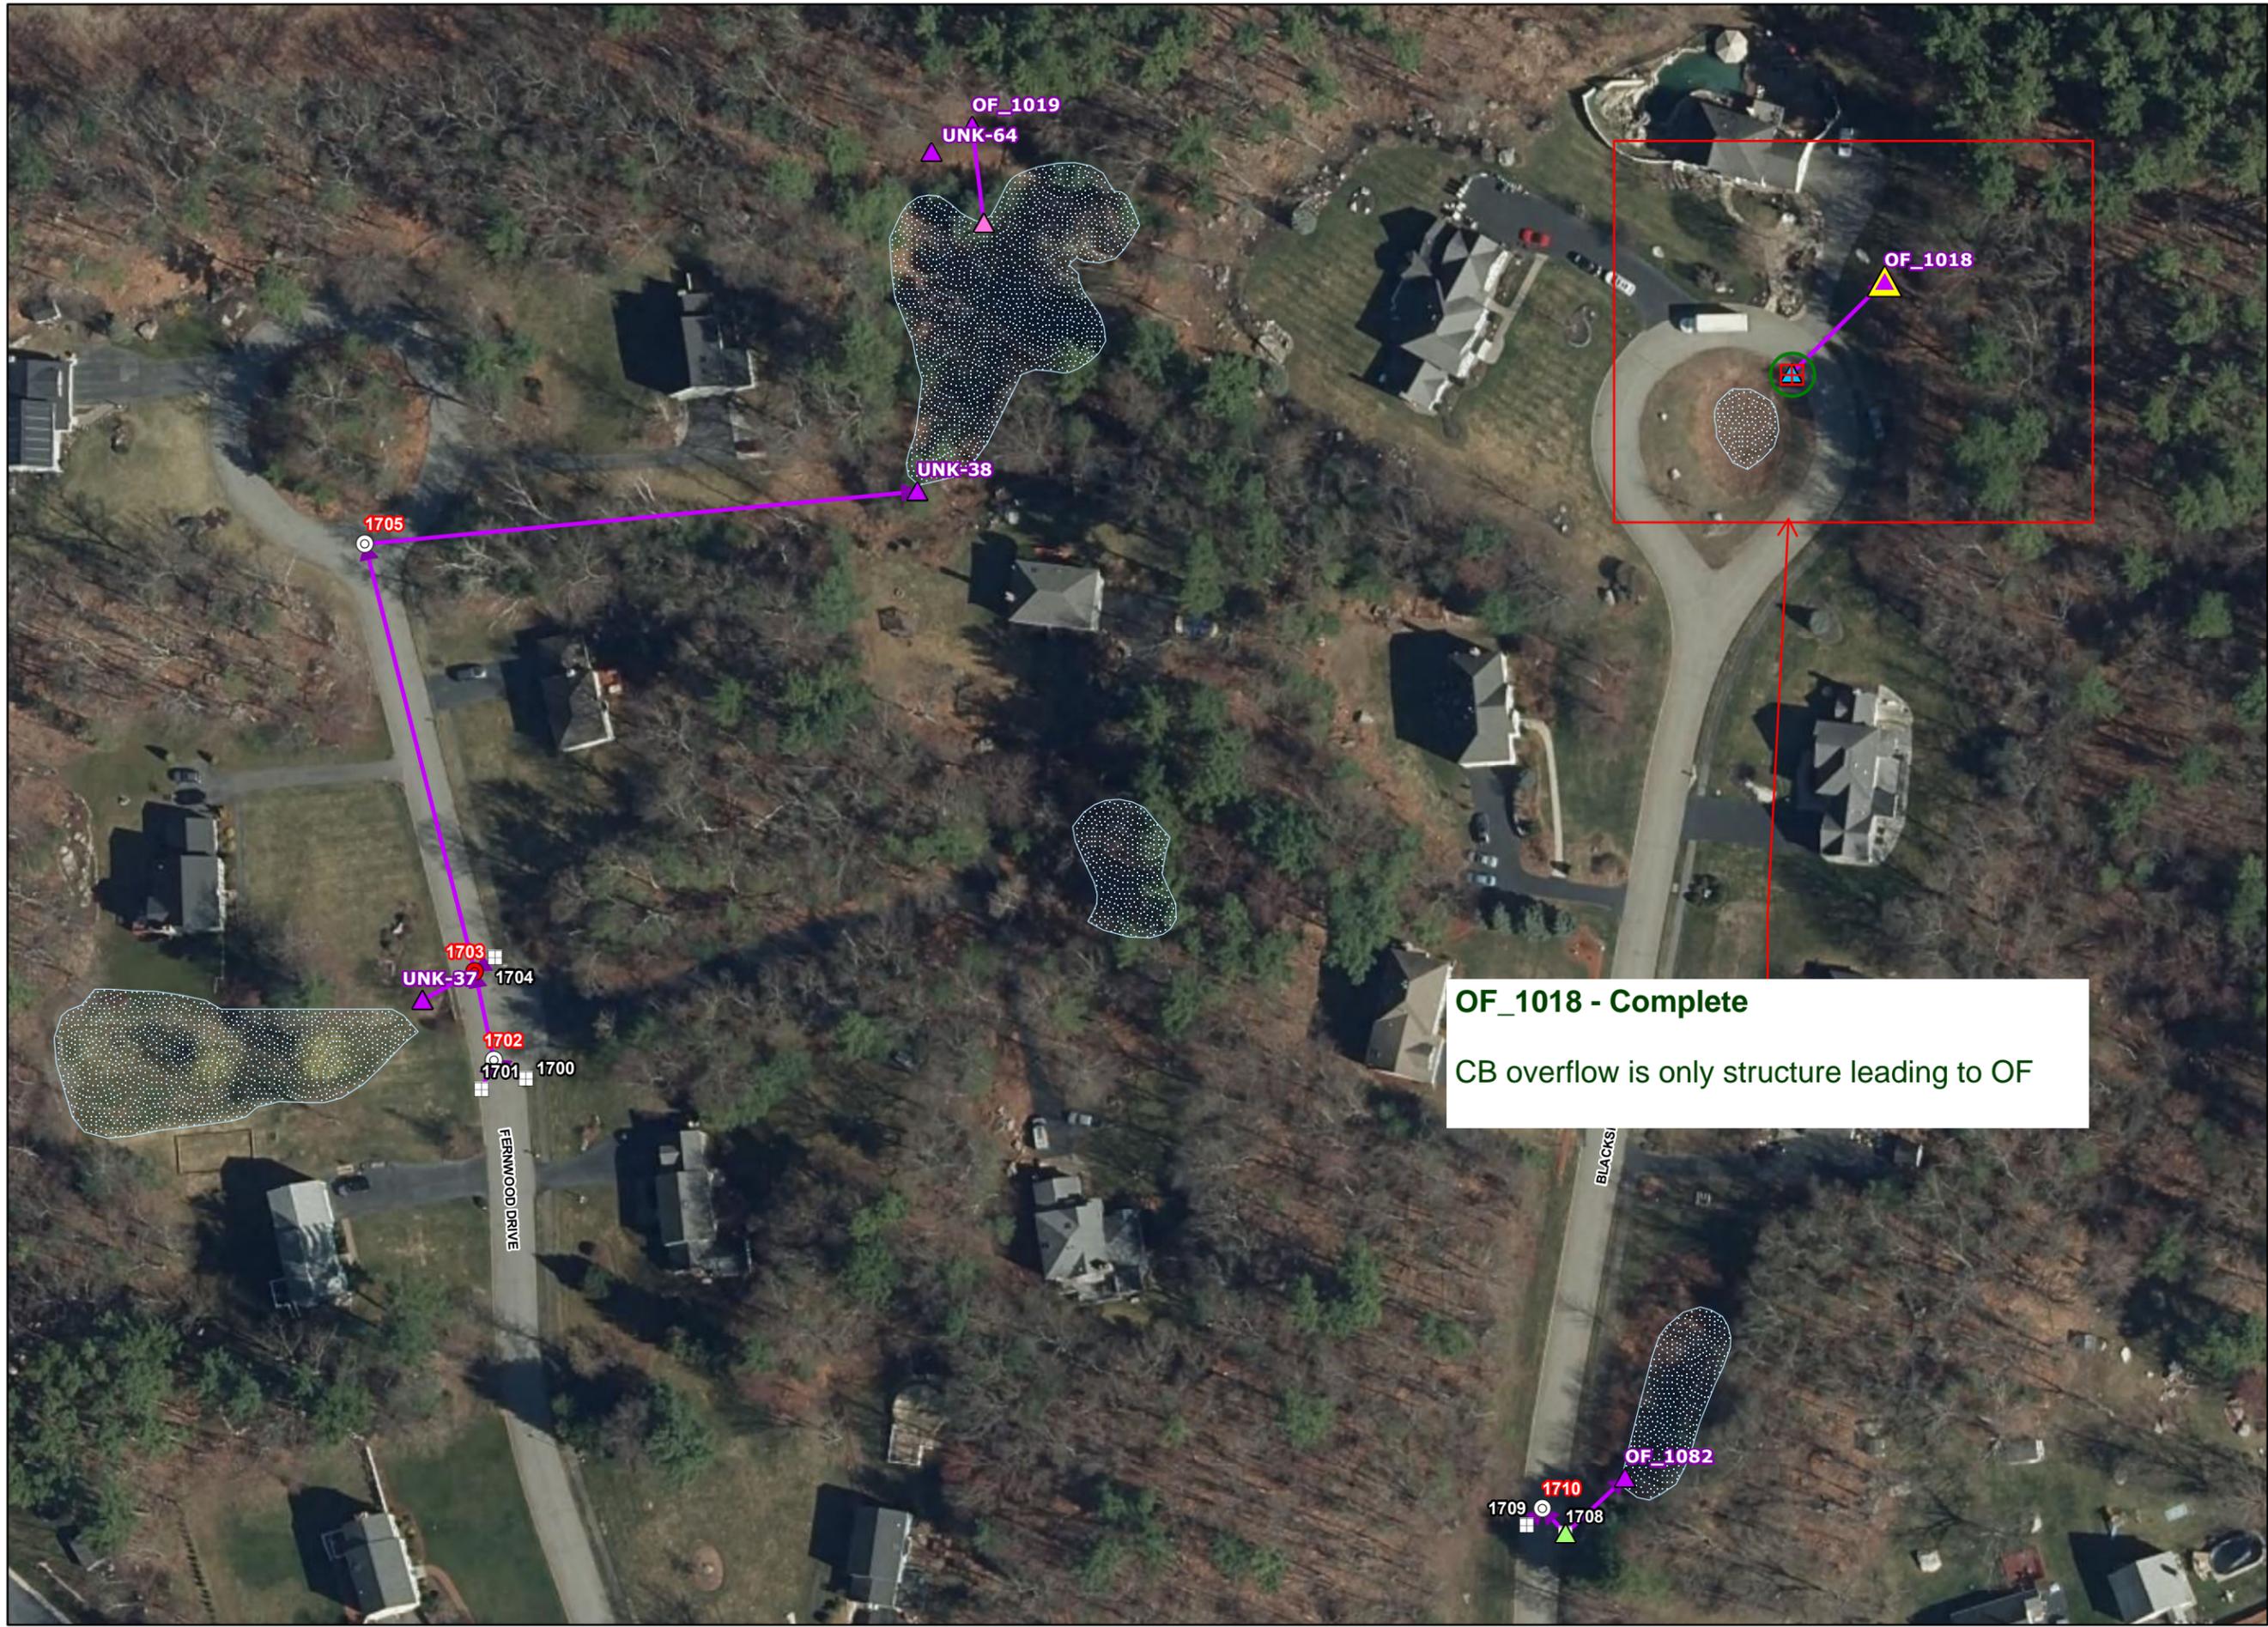
OF_1018 - Complete
 CB overflow is only structure leading to OF

CB does not lead to an OF, only inlet and outlet pipe cannot determine which pipe is inlet/outlet.
 CB submerged in sediment, block any potential flow.
 No structures found nearby.

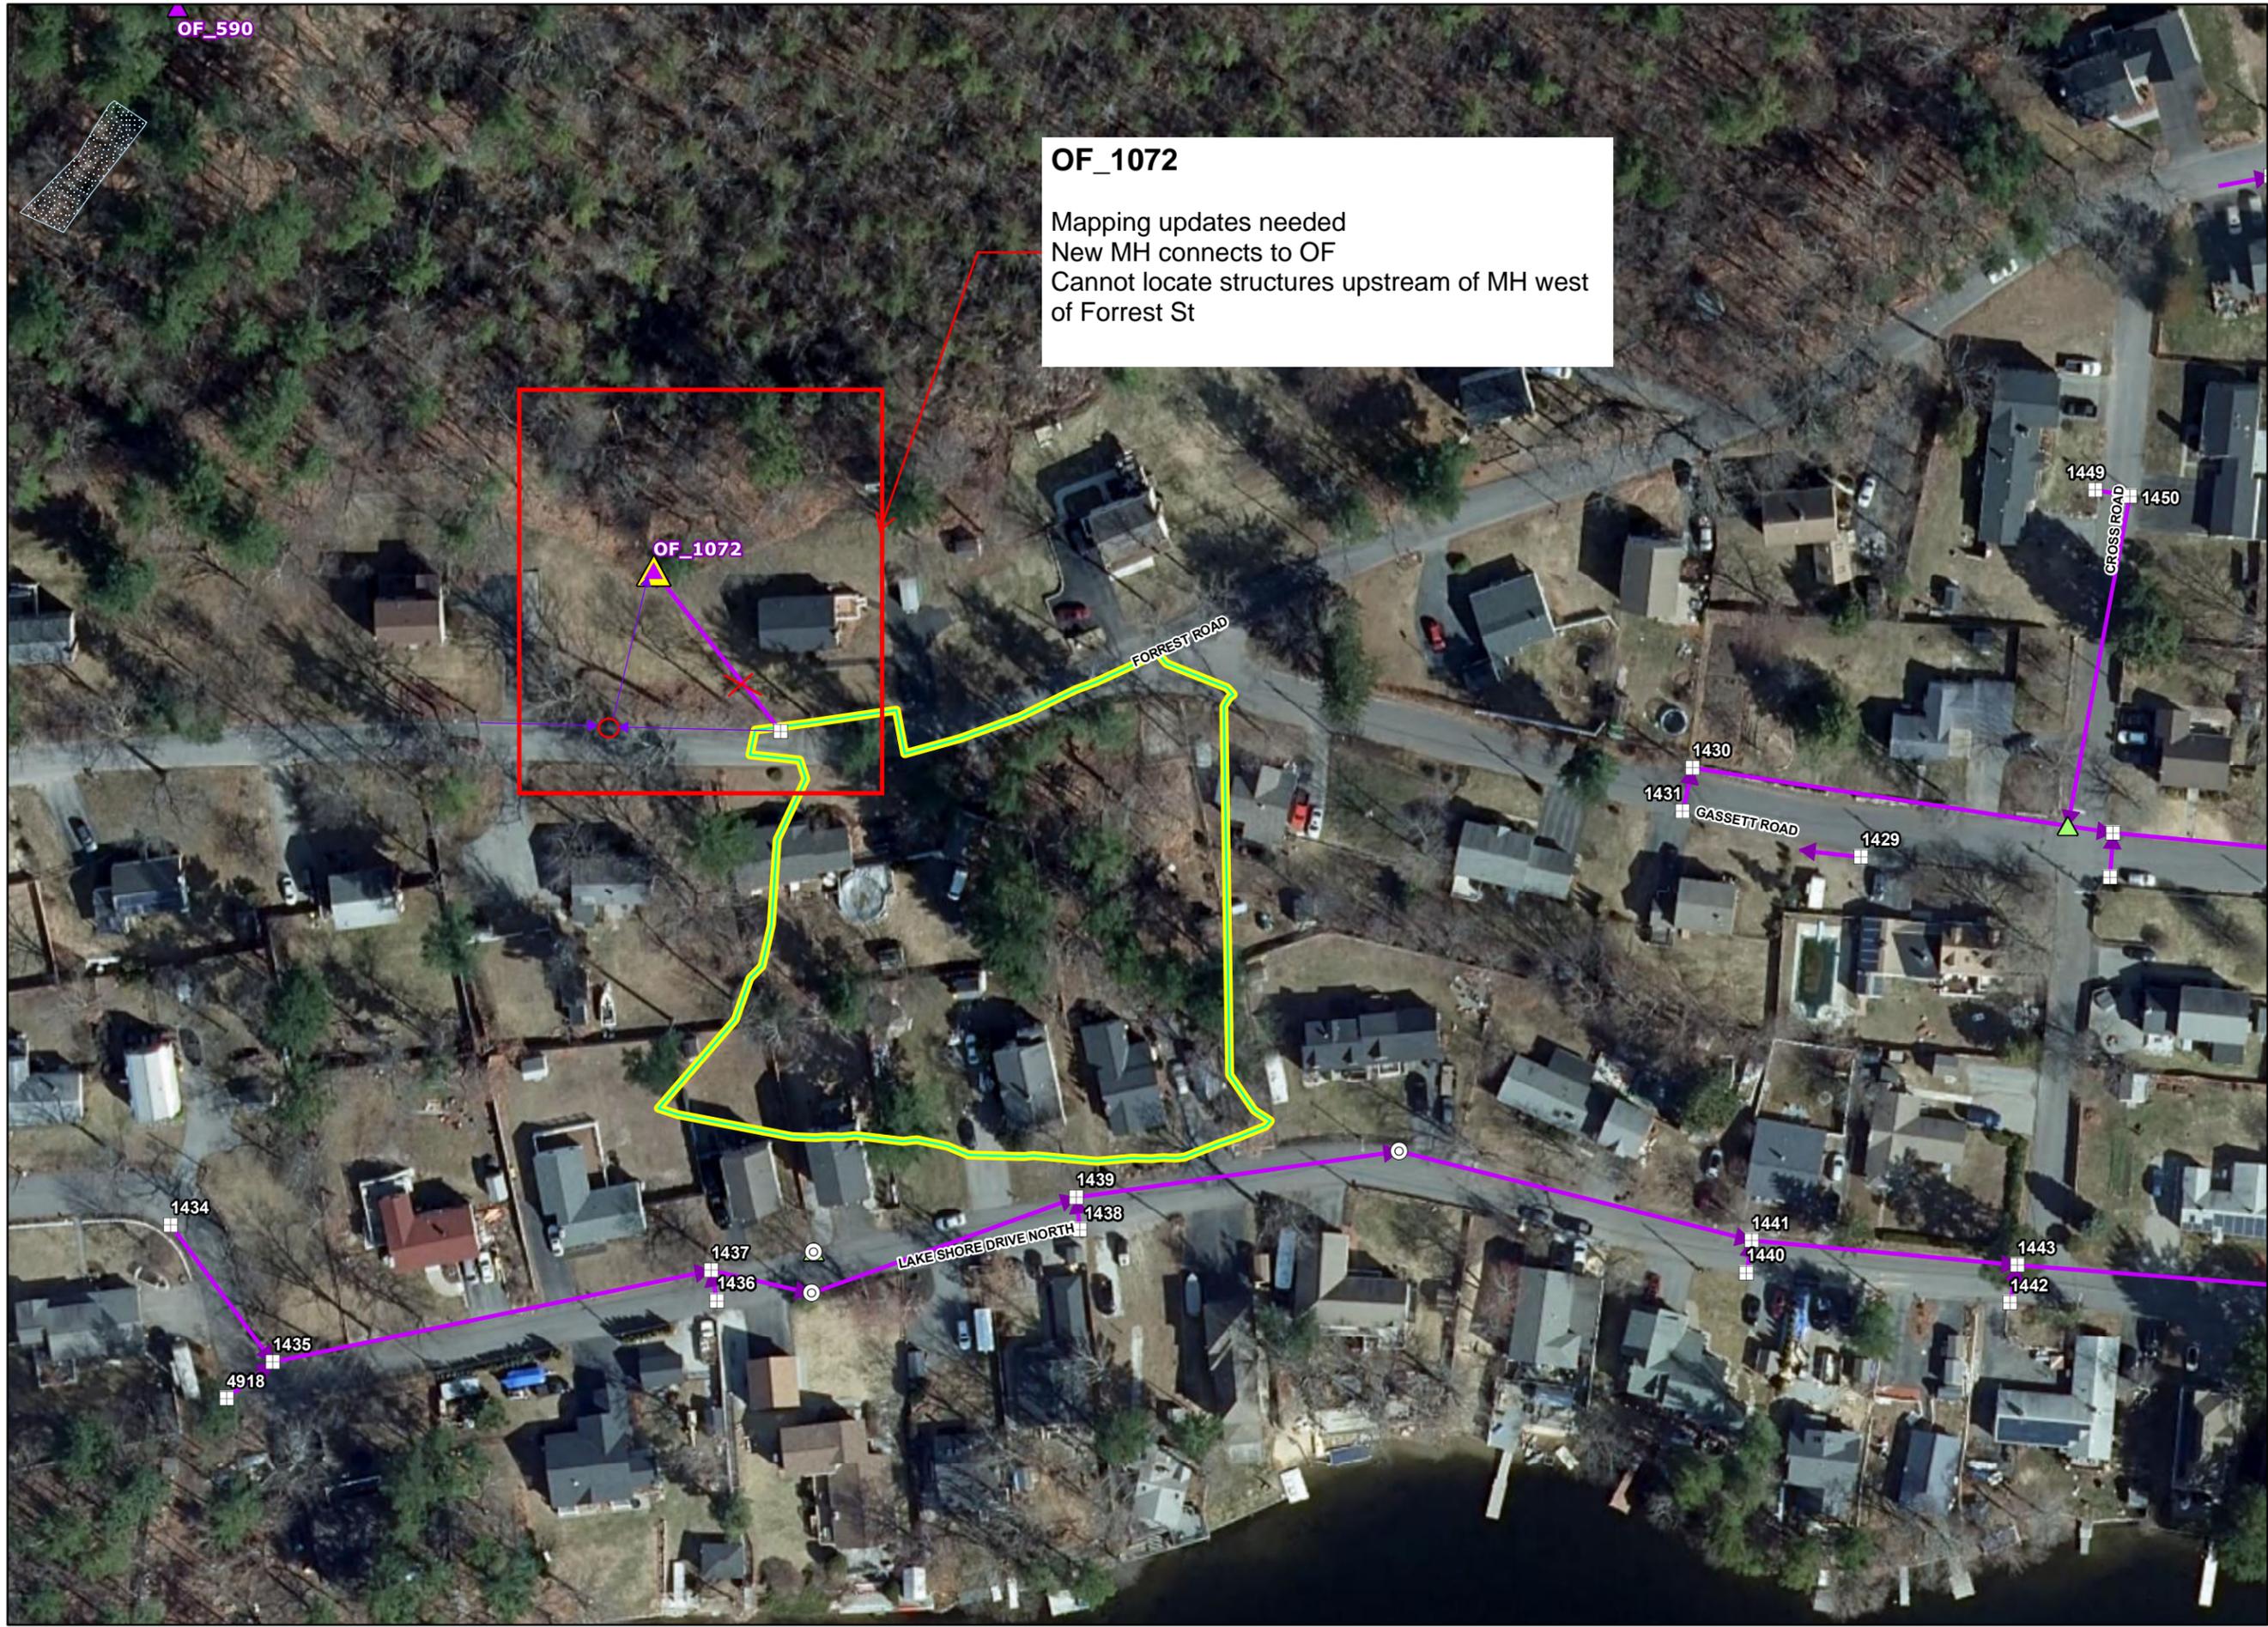
OF_1072
 Mapping updates needed
 New MH connects to OF
 Cannot locate structures upstream of MH west of Forrest St
