CATCHMENT INVESTIGATIONS GROUP ONE

Catchment Area of Outfall: OF_206

**Westford, Massachusetts
November 2023**

Tighe & Bond

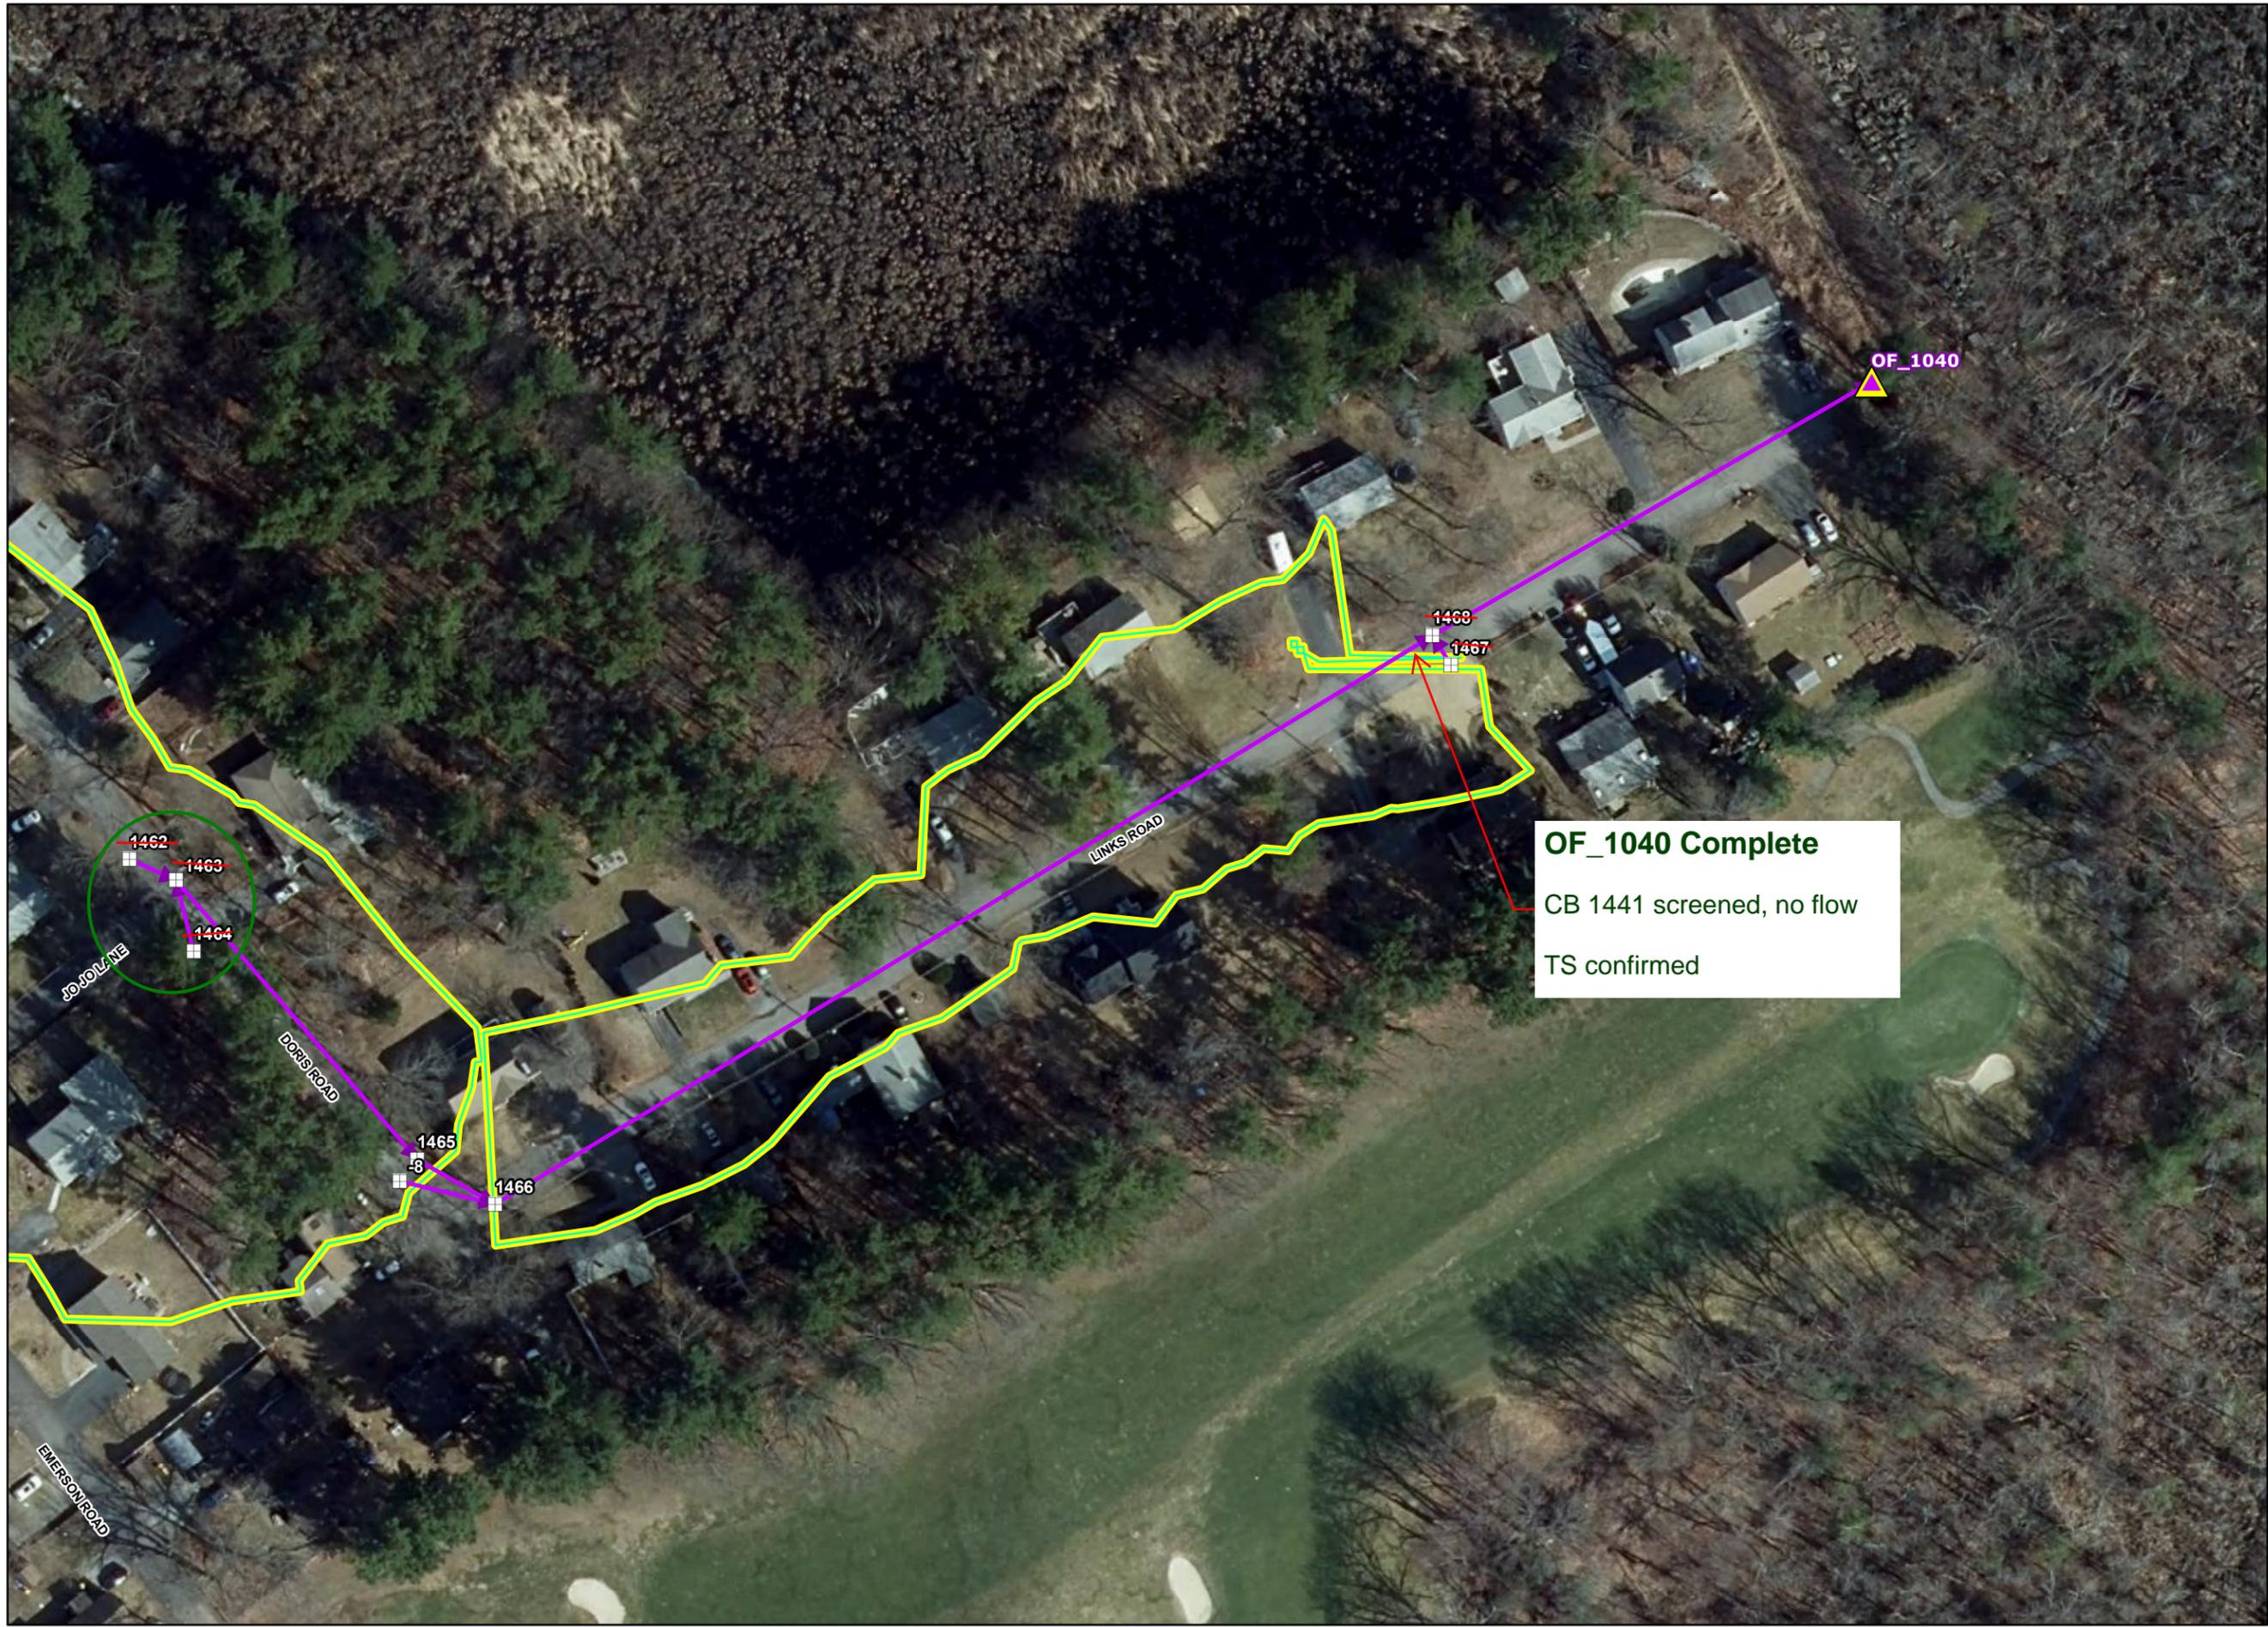
OF_1040 Complete
CB 1441 screened, no flow
TS confirmed

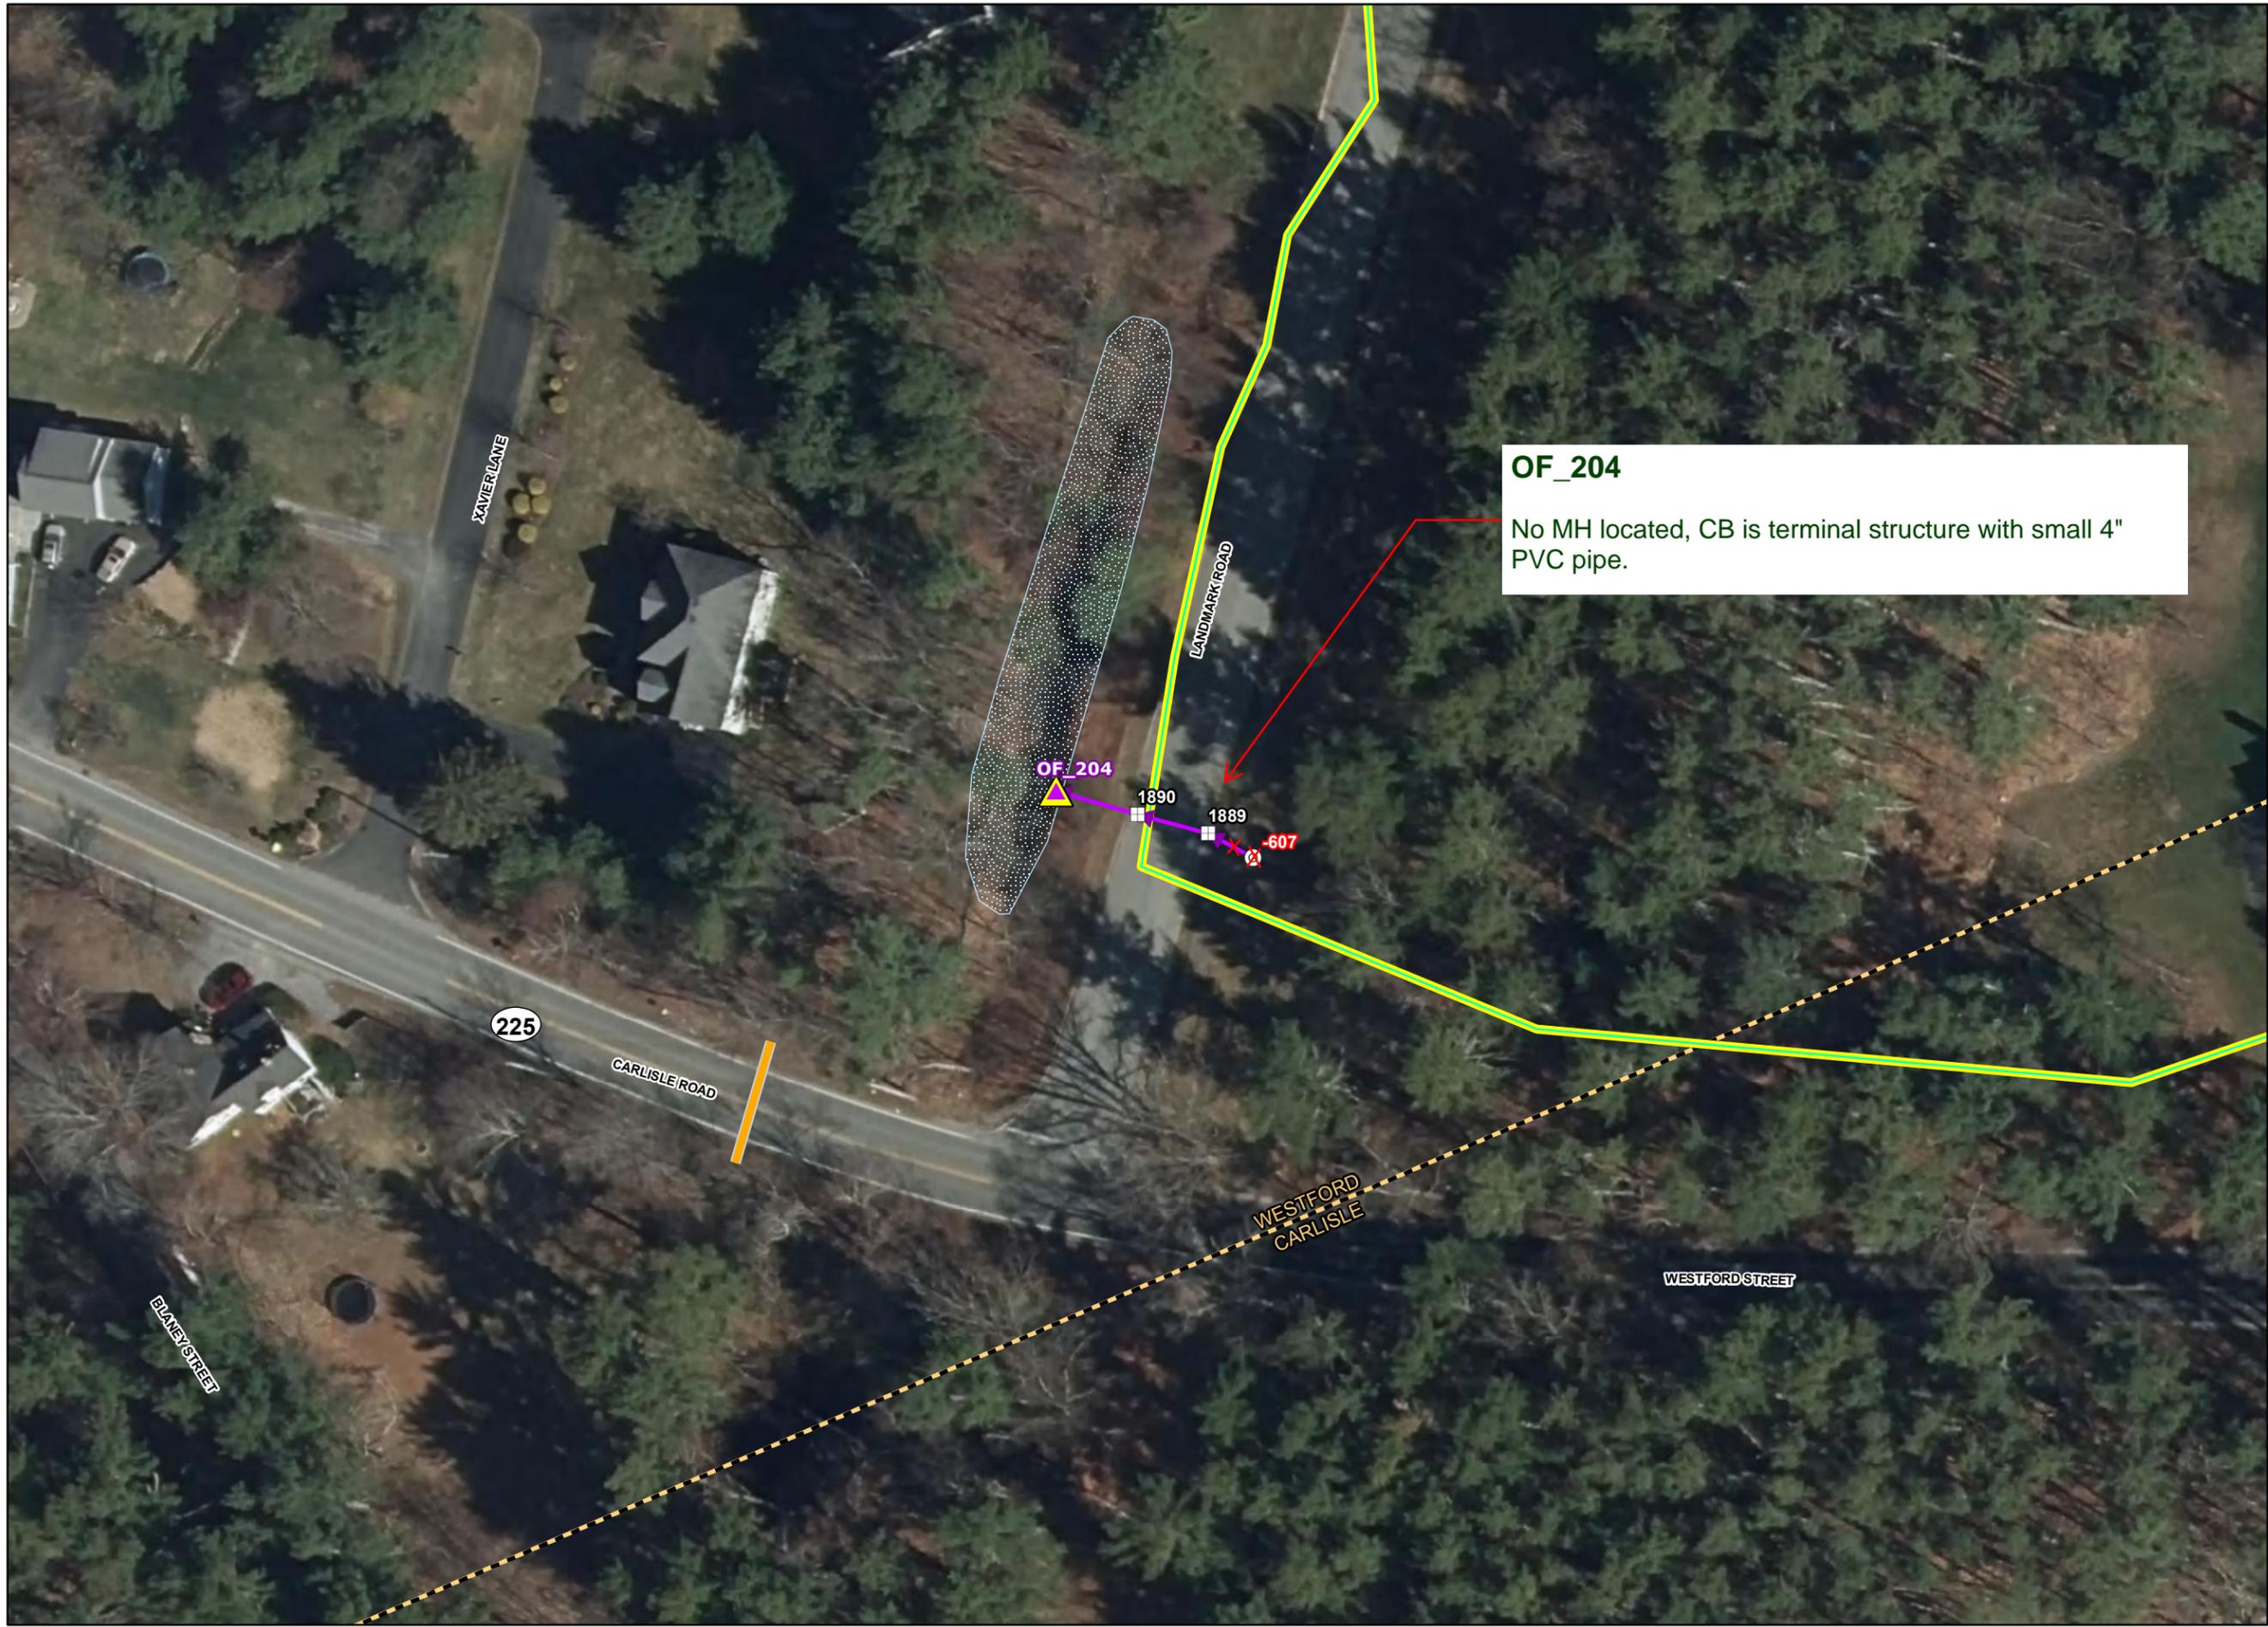
OF_204
 No MH located, CB is terminal structure with small 4" PVC pipe.
