Proj: Limited Structural Assessment of 12 North Main Street, Westford, RFQ #20-15  
Re: Limited Structural Assessment Report  
CBI Job No. CB200291

In accordance with our Contract, CBI Consulting, LLC, a SOCOTEC Company (CBI), has prepared this limited structural building assessment of the abandoned historic mill building located at 12 North Main Street in Westford, Massachusetts.

**Limited Structural Assessment  
12 North Main St., Westford, MA  
Photo Index  
CBI Job No.: CB200291  
December 4, 2020**

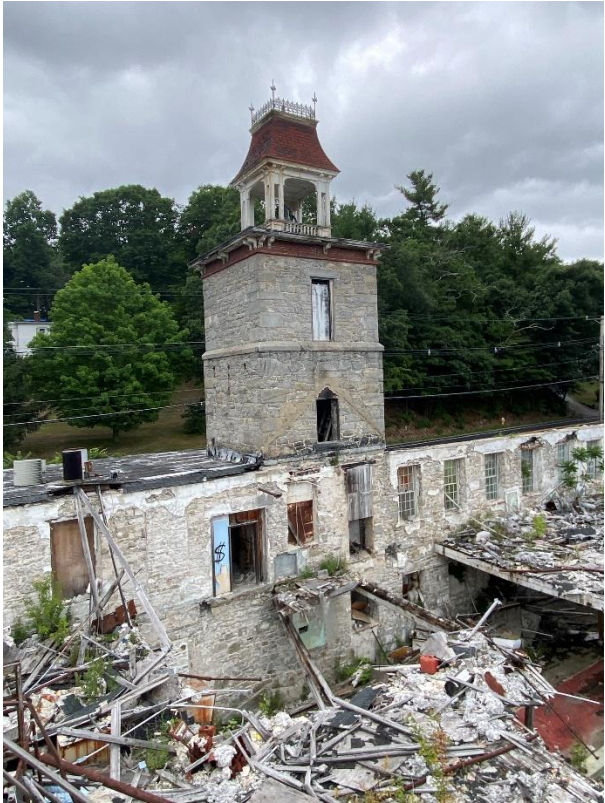
| 3 | A photograph showing a stone bell tower with a red-tiled roof and a small balcony. The tower is part of a larger, partially ruined stone building. Debris and rubble are visible in the foreground, and trees are in the background under a cloudy sky. | <p>Partial overall photo taken from the lift showing the south and west elevations of the bell tower.</p> |

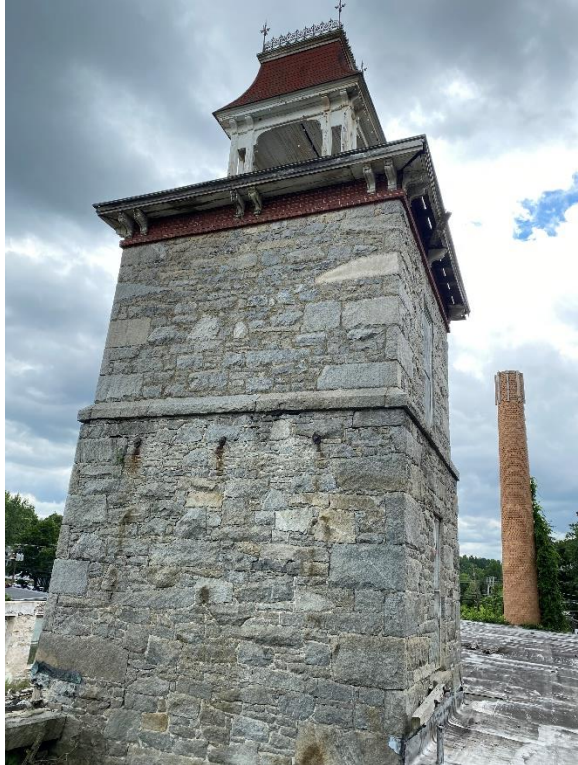
| 4 | A photograph showing the stone bell tower from a different angle, highlighting its north and east elevations. The tower is made of rough-hewn stone and has a red-tiled roof. A tall, narrow brick chimney is visible in the background to the right. The sky is cloudy. | <p>Partial overall photo taken from the lift showing the north and east elevations of the bell tower.</p> |

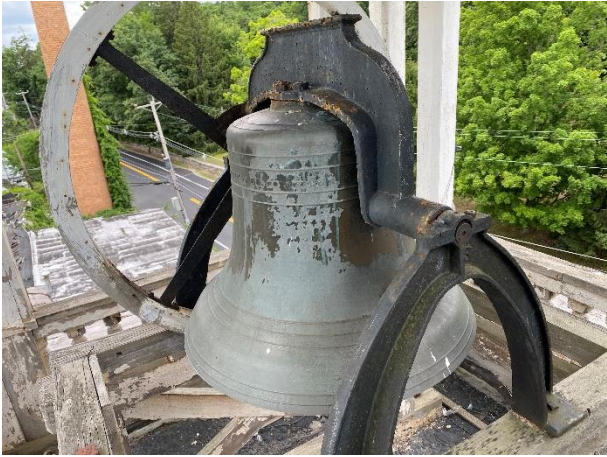
| 5 | | <p>Close up photo taken from the lift showing the existing bell that still remains in the belfry.</p> |

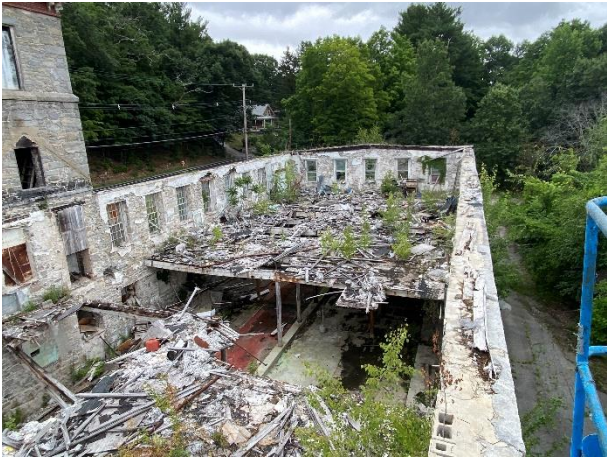
CBI observed the original timber beams, and plank decking to be in poor condition and deteriorated with signs of wood rot and moisture damage. This is typical of the existing wood framing throughout the building.

| 6 | | <p>Photo 1 of 3 – Partial overall photo of the east portion of the Central Mill first floor framing taken from a lift.</p> |

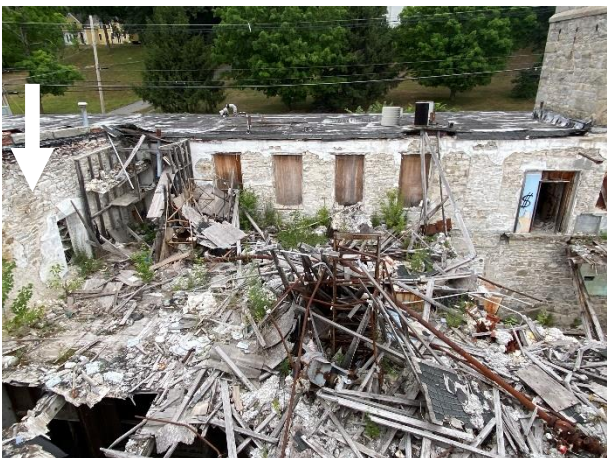
| 7 | | <p>Photo 2 of 3 – Partial overall photo of the east portion of the Central Mill first floor framing taken from a lift. Note the demising wall (arrow) separating the east and west sections of the Central Mill.</p> |

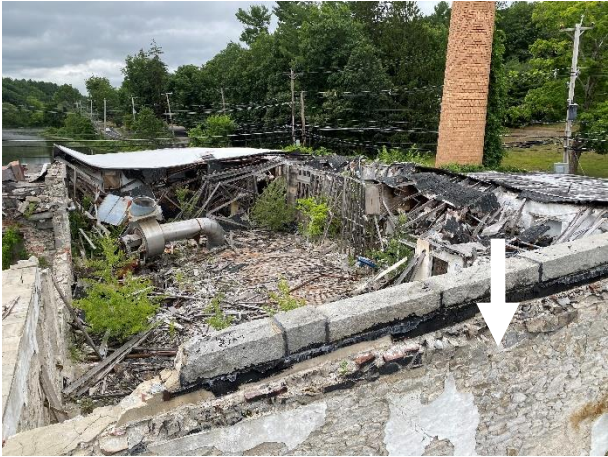
| 8 | | <p>Photo 3 of 3 – Partial overall photo of the west portion of the Central Mill first floor framing taken from a lift. Note the demising wall (arrow) separating the east and west sections of the Central Mill.</p> |

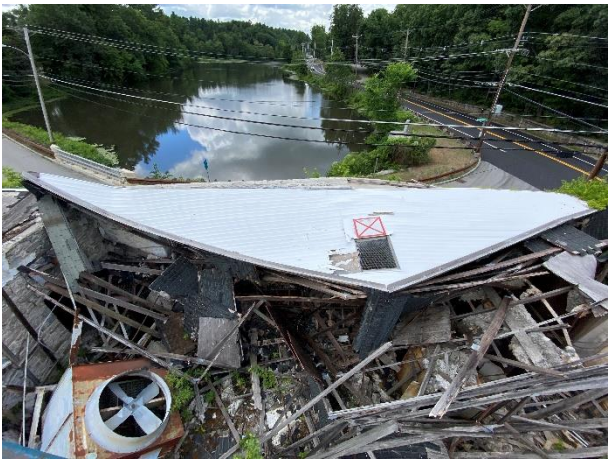
the 2015/2016 stabilization efforts. This is most notable in the area of the Central Mill to the east of the stone demising wall running north south. Based on previous reports and photos, a portion of the gabled roof to west, above Broadway St., was left in place during the stabilization efforts, and it is CBI's understanding that the gable end has since been purposefully pushed over into the interior of the building as it was determined to be a public safety hazard. These materials are still observed to be in place resting on the first-floor framing at the west end of the Central Mill.

| 9 | | <p>Close up photo taken from the lift showing the Central Mill roof system and gable end that was pushed over and resting on the first floor framing below.</p> |

- With an approved NTAWP, CBI recommends that the remaining materials and debris resting on the first-floor framing at the west end of the Central Mill be carefully removed and abated as specified in order to reduce the excess load acting on the existing first-floor framing. The contractor is to be careful not to damage any of the existing first floor structural framing during this process. Additionally, the contractor shall safely remove and abate the materials and debris that will potentially impede or be touched by any personnel during the completion of the groundwater study. This includes contractors, consultants, and machinery. See Appendix B for conceptual work plan.

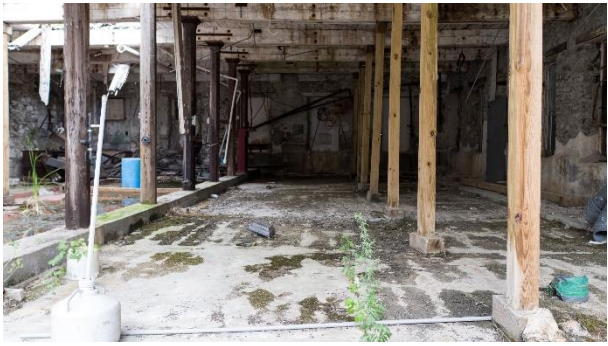
| 10 | | <p>Interior photo 1 of 3 taken with the drone from inside the east portion of the Central Mill showing the timber shoring posts that were installed to support the first-floor framing during the 2015/2016 stabilization efforts in good condition.</p> |

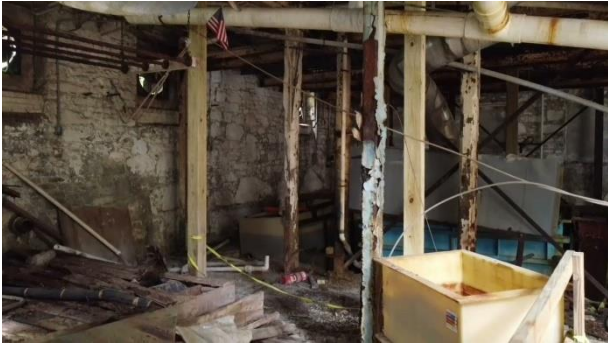
| 11 | | Interior photo 2 of 3 taken with the drone inside the west portion of the Central Mill showing the timber shoring posts that were installed during the 2015/2016 stabilization efforts in good condition. Note the abandoned materials and debris that will need to be removed and abated for to provide ESM access to complete their groundwater study. |

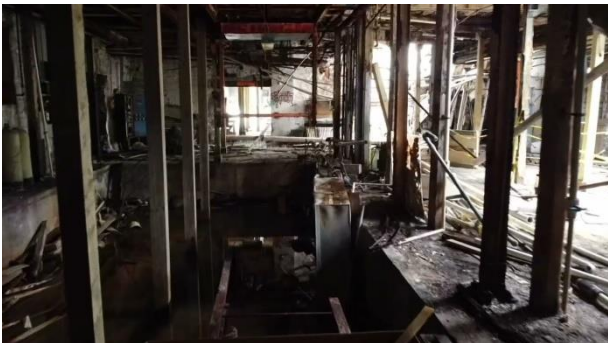
| 12 | | Interior photo 3 of 3 taken with the drone taken inside the west portion of the Central Mill showing the timber shoring posts that were installed during the 2015/2016 stabilization efforts in good condition. Note the abandoned materials and debris that will need to be removed and abated for to provide ESM access to complete their groundwater study. |

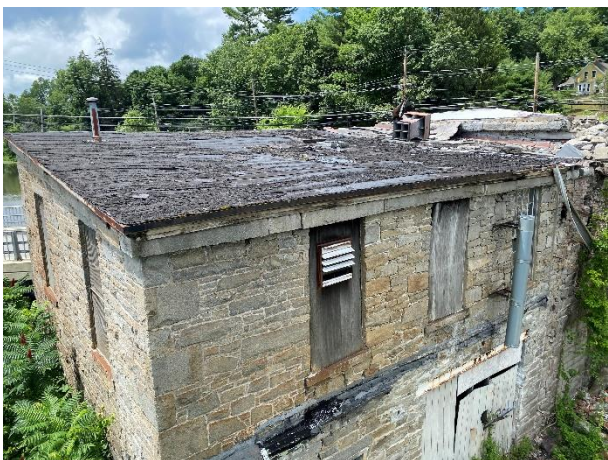
The roof systems on the North Addition and South Wing were observed to be in poor condition but are still intact, with exception to isolated areas, where the timber plank deck has deteriorated creating voids in the roof system. The roof covering the bell tower was observed to be in fair to poor condition.

| 13 | | Partial overall photo of South Wing roof taken from the lift. |

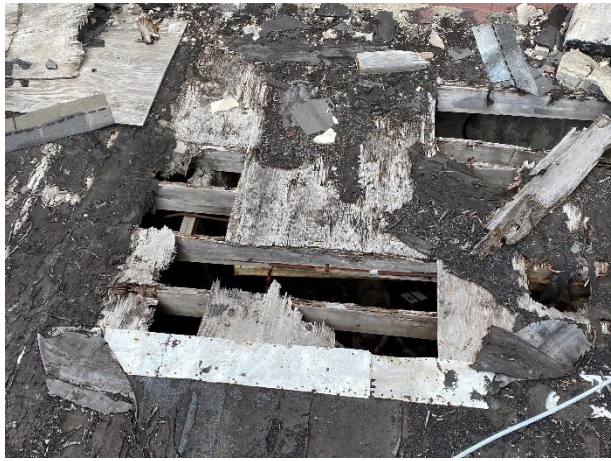
| 14 | | <p>Up close photo taken from the lift of one of the voids observed in the existing South Wing roof.</p> |

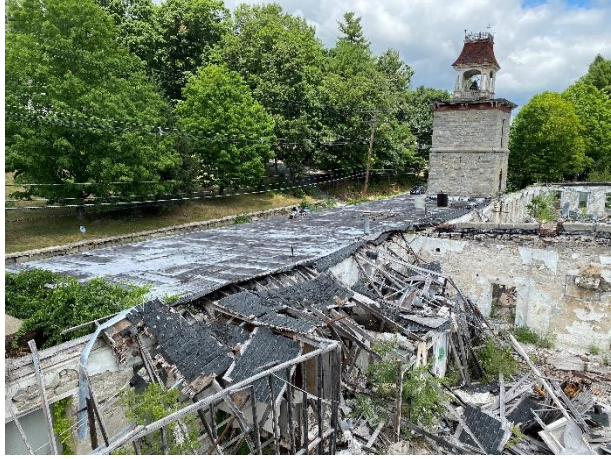
| 15 | | <p>Overall photo of the North Addition Roof taken from the lift.</p> |

- Perform further investigation to interior of north addition and determine if additional repairs or supplemental framing is required.
- Provide protective netting over North Addition, secured to cast in place concrete footings on each side of building.

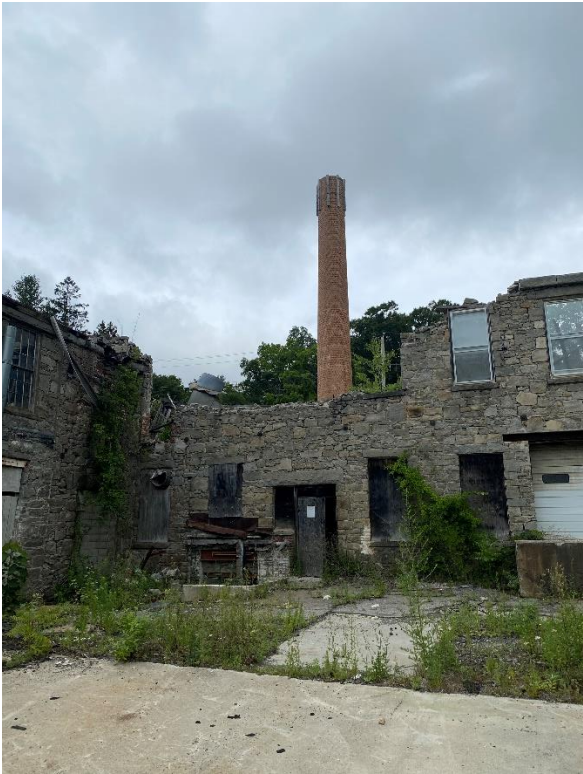
- At the south side of the building, where the south perimeter wall of the Central Mill meets the South Wing, the stone wall and brick masonry was observed to be deteriorated. This section of the wall, approximately 30 feet in length, appears to have collapsed down to the first-floor framing at some point since the previous stabilization efforts. The mortar at these areas was observed to be missing and has likely eroded over time due to exposure to rain, snow, and freeze thaw leaving some areas of the wall held in place by abandoned embedded steel that is showing signs of oxidation (rust).

| 16 | | <p>Partial view of south elevation taken from the ground showing the section of wall that has collapsed. This wall is located at the intersection of the Central Mill south elevation and the South Wing east elevation.</p> |

- At the south side of the building, where the south perimeter wall of the Central Mill meets the South Wing, the stone wall and brick masonry was observed to be deteriorated. CBI recommends that all of the loose stone, masonry, and embedded steel on this section of the wall, which is approximately 30 feet in length, be removed.

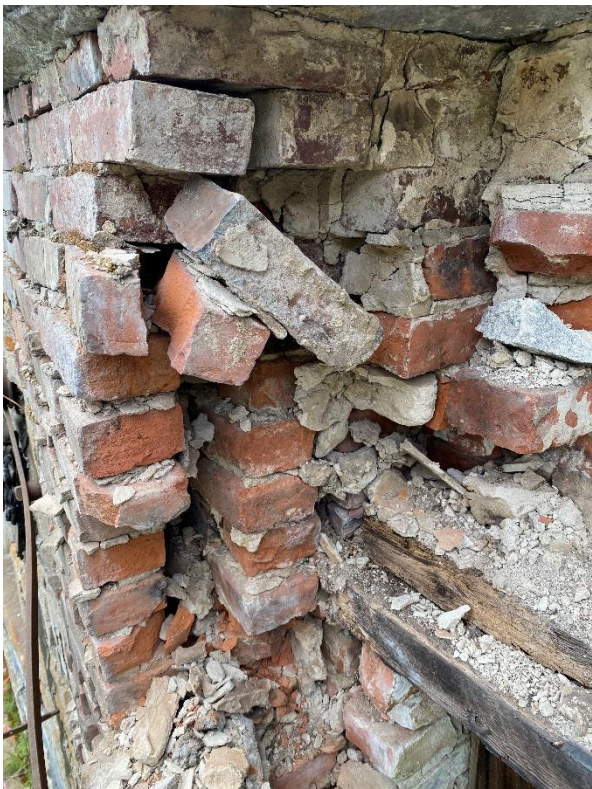
| 17 | | <p>Photo 1 of 4 – Partial up-close view taken from the lift showing the collapsed wall on south elevation adjacent to the South Wing. Note the loose materials and debris that pose as potential fall hazards.</p> |

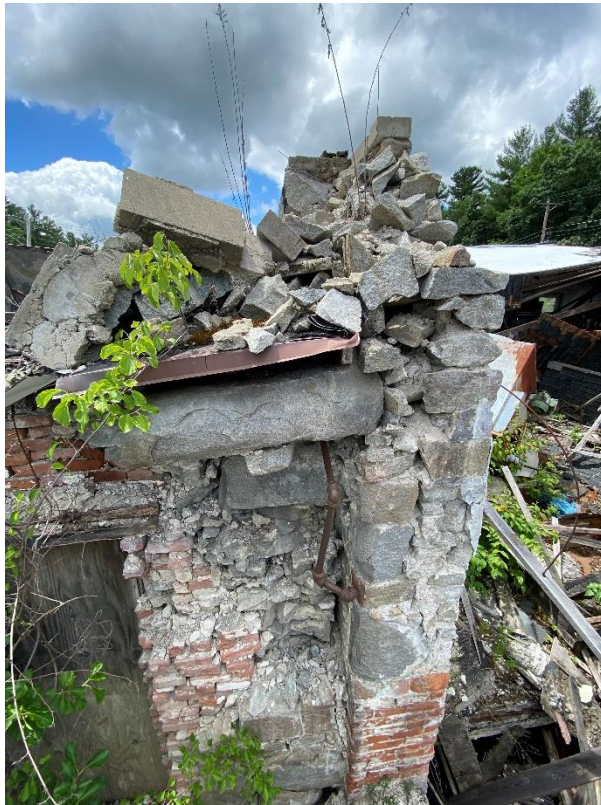
18

Photo 2 of 4 – Partial up-close view taken from the lift showing the collapsed wall on south elevation adjacent to the South Wing. Note the loose materials and debris that pose as potential fall hazards.

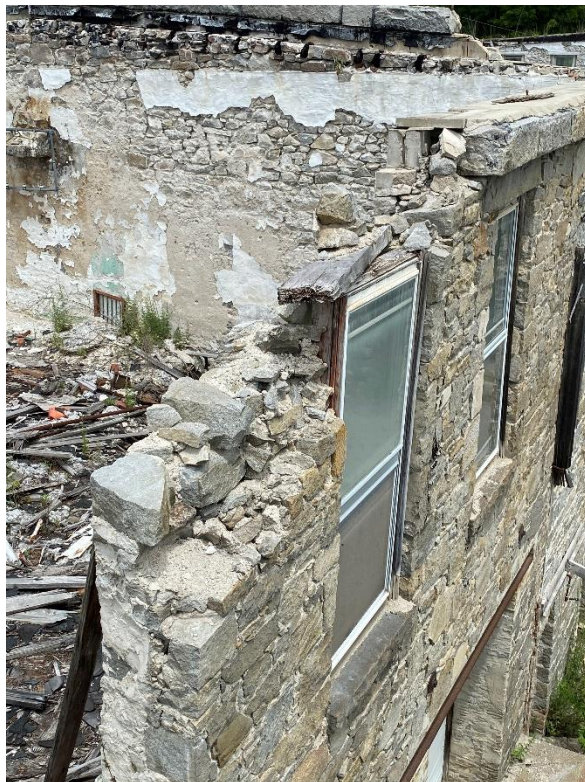
19

Photo 3 of 4 – Partial up-close view taken from the lift showing the collapsed wall on south elevation adjacent to the South Wing. Note the loose materials and debris that pose as potential fall hazards.

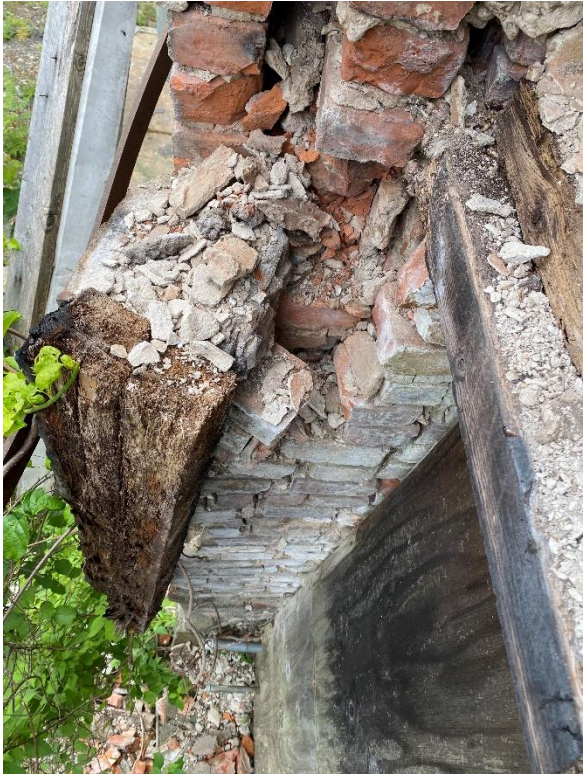
| 20 | | <p>Photo 4 of 4 – Partial up-close view taken from the lift showing the collapsed wall on south elevation adjacent to the South Wing. Note the loose materials and debris that pose as potential fall hazards.</p> |

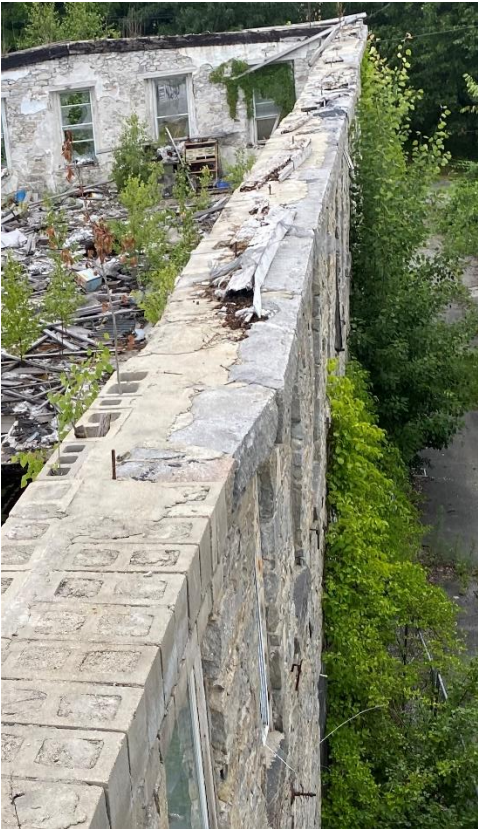
- A granite stone band was observed along the perimeter of the Central Mill stone wall. The stones were observed to be in good condition, but stones were observed to be missing in various locations, undermined by deteriorated mortar, and/or leaning to the exterior of the building and pose potential fall hazards.

| 21 | | <p>Photo of the top of the Central Mill south wall where the existing granite stones were observed to be bowing to the exterior of the building.</p> |

- A granite stone band was observed along the perimeter of the Central Mill stone wall. The stones were observed to be in good condition, but the stones were observed to be missing in various locations, undermined by deteriorated mortar, and/or leaning to the exterior of the building and pose as a potential fall hazard. CBI recommends at a minimum that a layer of mortar be placed along the top of the Central Mill perimeter wall in order to temporarily secure loose stone and masonry construction until further repairs can be made. This section of the wall appears to have collapsed at some point since the previous stabilization efforts down to the first-floor framing.

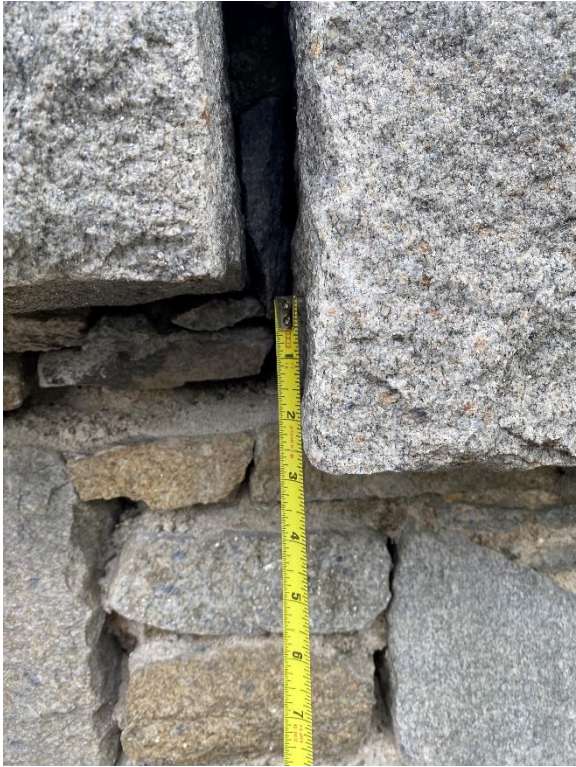
| 22 | | <p>Close up photo showing one of the granite stones at the top of the Central Mill south wall where the existing granite stones has been displaced approximately three (3) inches and appeared to be leaning away from the building. Note the sand like consistency of the remaining mortar.</p> |

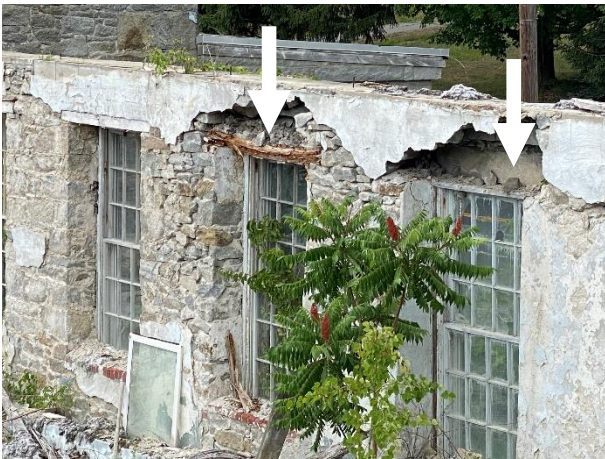
- The punched window openings were observed to be framed with a granite stone lintel above the window opening on the exterior of the building, and timber header beam on the interior. The timber headers were observed to be in poor condition and in many locations have deteriorated, which resulted in undermining and collapsing of the stone or masonry construction above.

| 23 | | <p>Photo taken from the lift showing one of the locations where the wood headers above the Central Mill punched window openings has deteriorated, undermining the stone and masonry construction above.</p> |

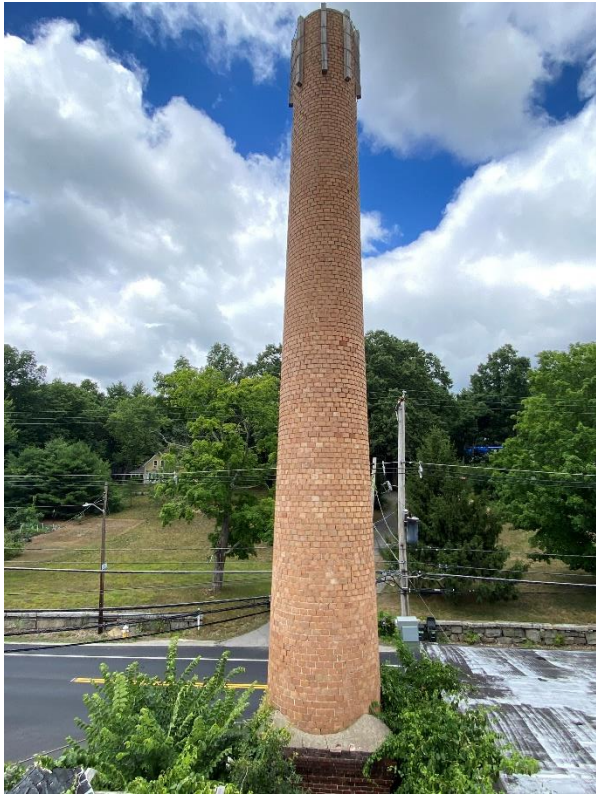
| <p>24</p> | | <p>Partial overall photo of the Smokestack taken from the lift.</p> |

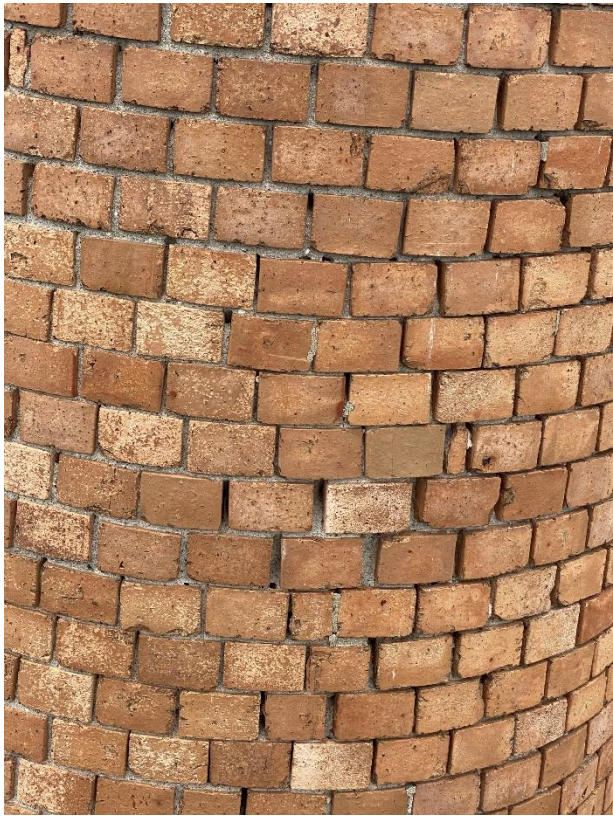
- Using drone footage, CBI observed that the interior and exterior mortar joints of the smokestack are severely deteriorated and missing in some areas.

| <p>25</p> | | <p>Up-close photo of the Smokestack taken with the drone showing the deteriorated mortar joints.</p> |

- Engage a masonry contractor, and crane, to access the Bell Tower to remove or secure any materials that may pose as potential fall hazards. Additionally, the existing brick masonry smokestack requires deep mortar joint repointing from the exterior. Once the building has been determined safe for interior access, the interior of the Smokestack should also require 100% deep mortar joint repointing to ensure long term structural stability of the structure.

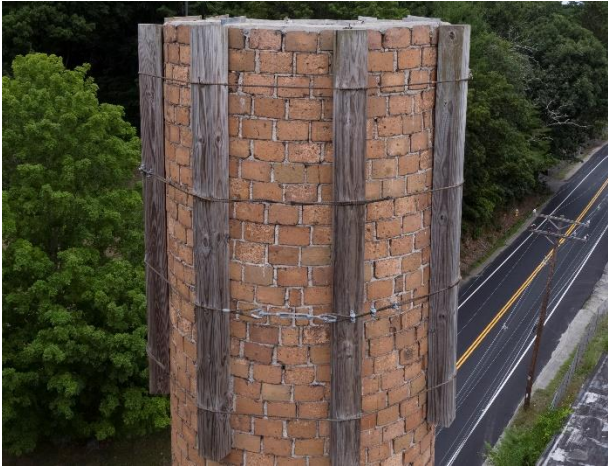
| 26 | | Up-close photo of the top of the Smokestack taken with the drone showing the previous stabilization repairs that were made in 2015/2016. |

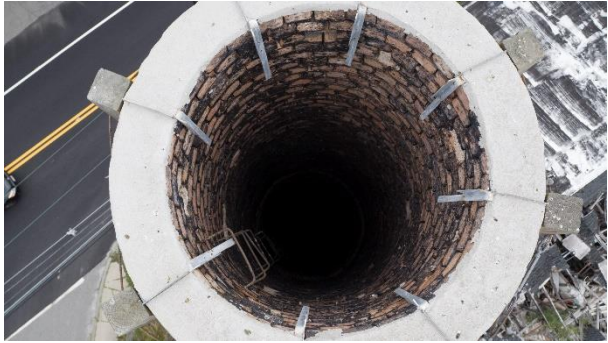
| 27 | | Overall photo taken from the drone looking down on the Smokestack. |

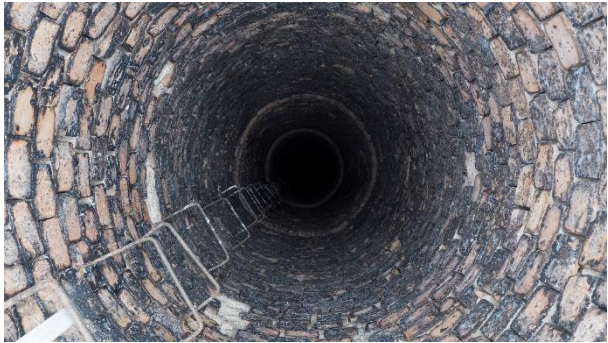
| 28 | | Interior photo 1 of 2 taken from the drone inside of the Smokestack. |

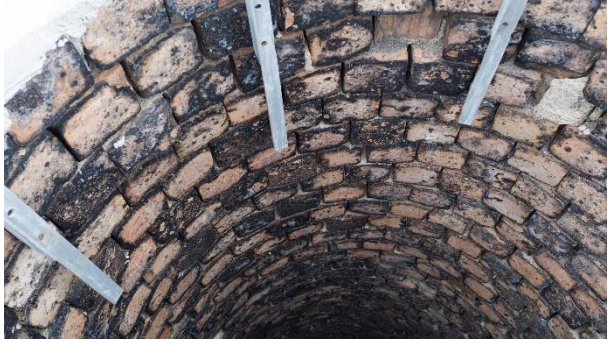
| 29 | | Interior photo 2 of 2 taken from the drone inside of the Smokestack. Note the deteriorated mortar joints. |
