Community Preservation Funding Application — Fiscal Year 2026

Project Name: First Parish Church United Meetinghouse Historic Preservation

PROJECT:
FIRST PARISH CHURCH UNITED
CONDITIONS ASSESSMENT
#2411-R

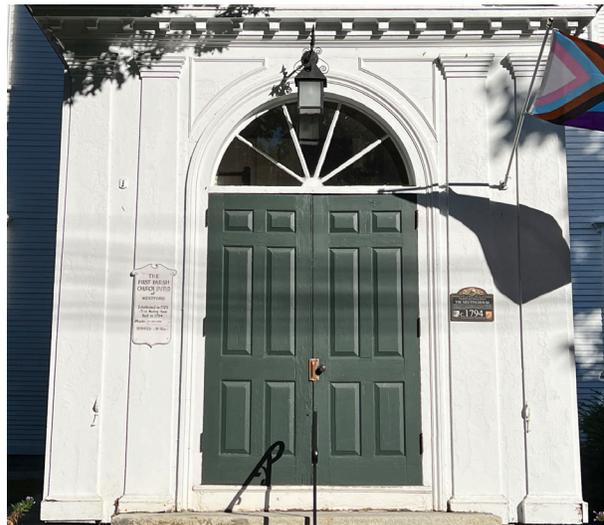
Image 40: View of the main entrance to the Meetinghouse, showing the overall condition and replacement hardware.

- Replace existing wood threshold in kind at main entrance.
- Restore wood door at the east tower elevation as described above. Restore existing door hardware including strap hinges and thumb latch.
- Remove existing wood stairs at the north elevation and re-build using either metal or pressure treated lumber. Color to be selected by the architect.

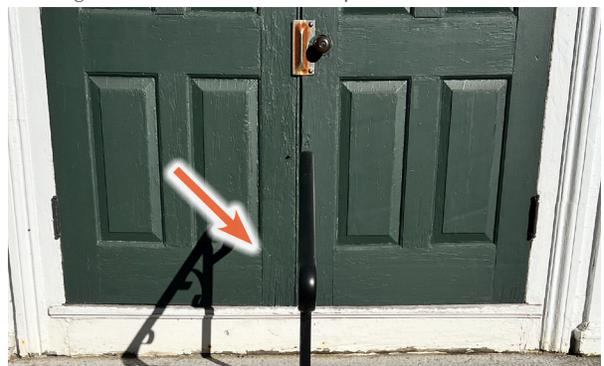
Image 41: The bottom of the doors show signs of splitting and cracking as a result of moisture infiltration through the end grain.

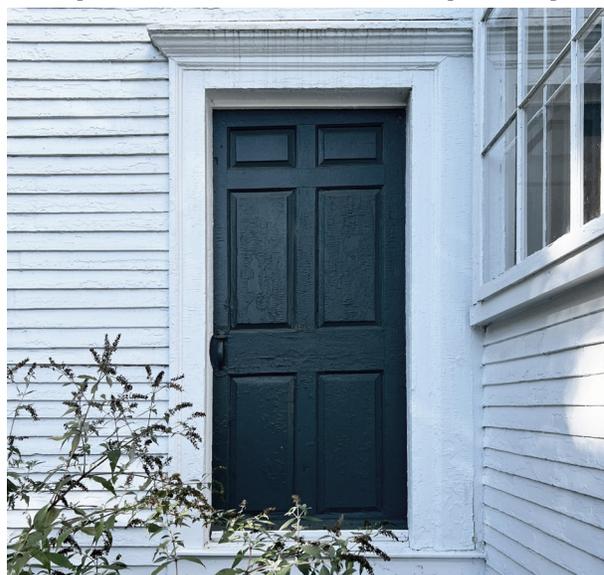
Given the age of the door, and its proximity to overgrown vegetation, it is not surprising that this door is in poor condition compared to the main set of doors. Like the main doors, this one does not sit square in its frame and has a distinct drop on the latch side. Like elsewhere on the building, the paint is scaled and peeling, and the wood itself shows signs of cracking and weathering. The worst of the deterioration can be seen at the base of the door, where the sill and stiles are checking, there are gouges in the central stile, and the moulding around the lower raised panels are damaged or missing [Image 43]. The planks on the interior are showing signs of aging as well. There is a large crack running through one of the planks and several scars where the door has been patched or repaired [Image 44].

Image 42: View of the east tower door, believed to be one of the original entrances to the Meetinghouse.

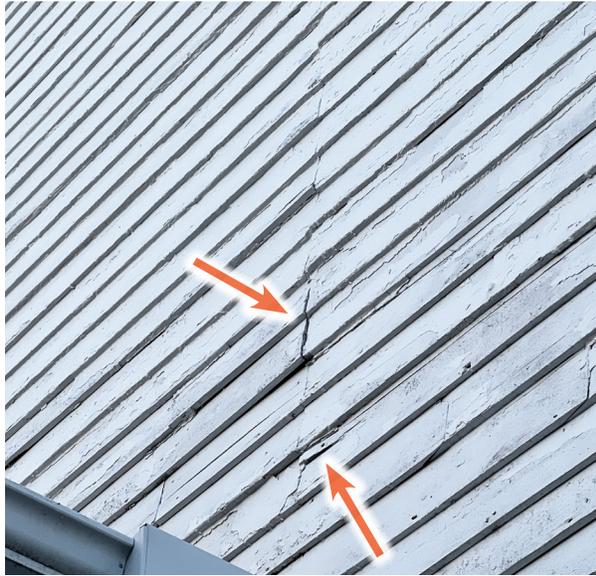
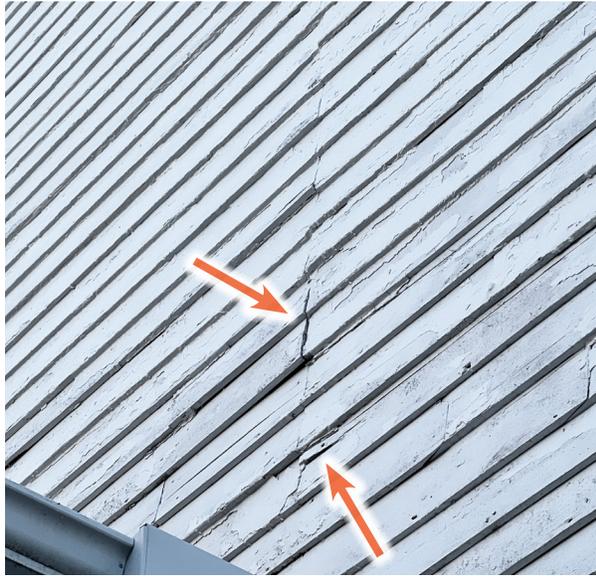
Image 13: Damaged and split clapboards where previous window openings have been patched/filled in.

Additional damage has occurred where clapboards have been pierced by shutter hardware, or where old openings have been patched [Image 13]. In these locations, moisture has been drawn in to the siding, either through the punctured area or at the end grain, through gaps at the joints. Left alone, this siding will continue to deteriorate, leaving the wall exposed to moisture infiltration, potentially damaging not only the interior finishes but also the sheathing and structural frame beyond.

- Replace the upper and lower asphalt shingle roofs and associated flashing at the 2010 connector with standing seam metal roof.
- Selectively replace split, broken, or warped clapboards. (approx. 10% across the building)
- Upon completion of structural wood sill repairs: Repair deteriorated wood watertable using two-part epoxy system. Replace watertables damaged beyond repair via wood dutchman
- Scrape loose paint; sand and paint all wood clapboards and watertables across the building. Color to be determined by historic paint analysis.
- Clean and remove bio-growth and staining from wood watertable.

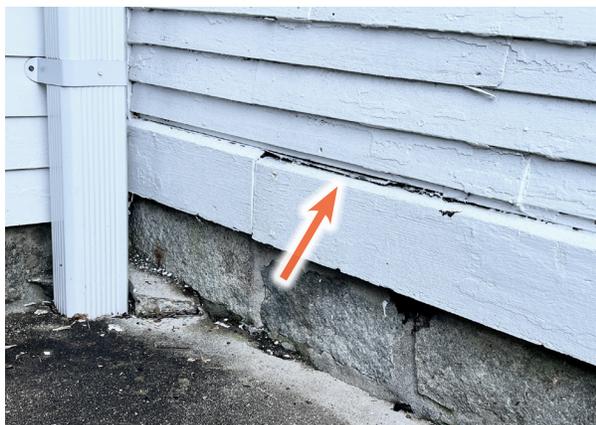
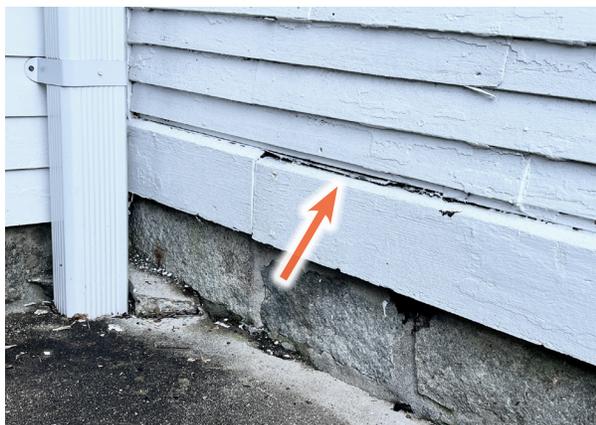
Image 14: Open joint between the watertable and clapboards, allowing water to enter the building and damage the sill beyond.

The watertable, located just above the foundation, is suffering from similar moisture related issues. In multiple locations across the building, the joint between the bottom clapboard and the watertable has opened, which could allow water to seep behind the siding and enter the wall structure [Image 14]. Additionally, at the east and west elevations of the tower, where grade is closer to the watertable and concrete or asphalt surfaces are present, there is considerable bio-growth and staining occurring on the wood's surface. This staining was likely caused by rainwater splashing up off the hard scape and against the watertable, providing a moist environment for vegetation to grow.

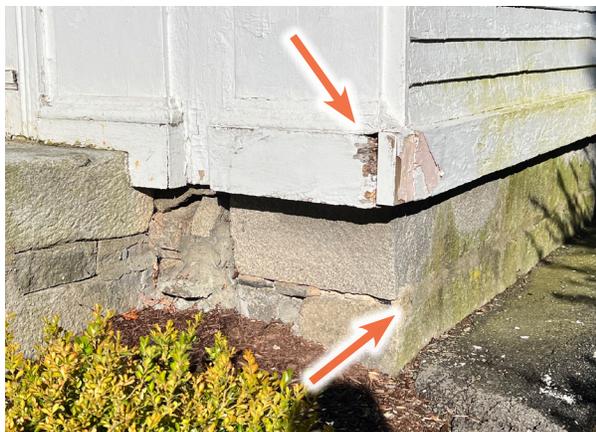
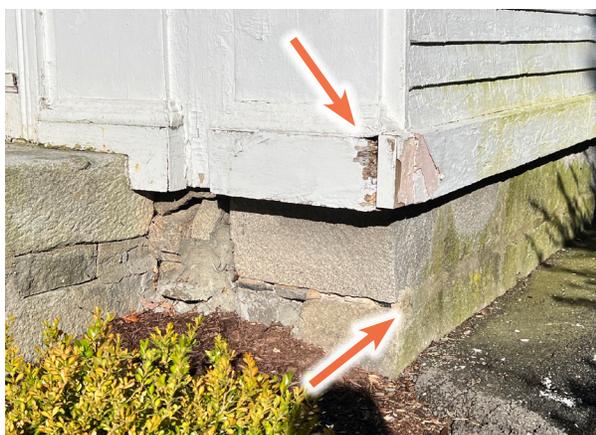
Image 15: SE corner of the tower where water splashing off the asphalt surface has caused staining, bio-growth, and wood deterioration.

A similar, more severe example of this condition can be seen at the base of the pilasters on the porch facade. Here the base of the pilasters and the riser at the bottom of the front door are consistently exposed to rainwater splashing and pooling at the top of the granite steps. The pooled water has not only rotted the underside of these boards but splashing water has entered the exposed end grain at mitered edges and joints, causing significant deterioration [Image 15].

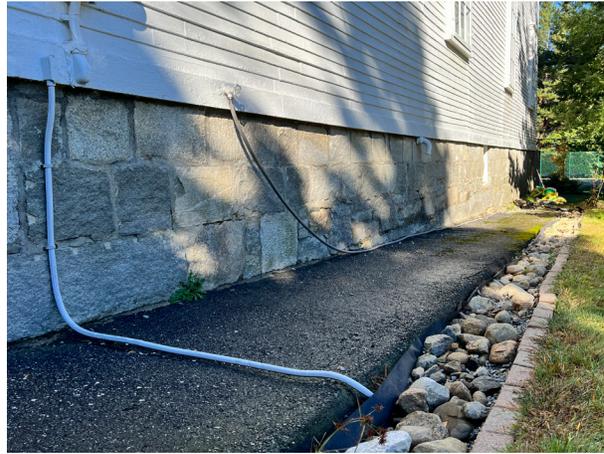
The foundation of the First Parish United Meetinghouse is primarily comprised of granite blocks and field stones, with small sections of the walls infilled with brick and CMUs along the north elevation [Image 46].

Image 46: View of the granite foundation at the east elevation of the Meetinghouse.

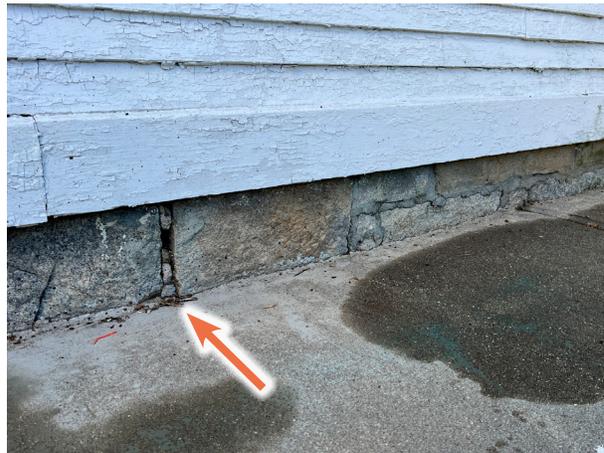
There are several locations across the Meetinghouse where the mortar joints have deteriorated to the point that the mortar has started to crumble and fall away, particularly at the tower and the east elevation [Image 47]. This deterioration was likely caused in part by rainwater splashing up off the concrete and asphalt surfaces and against the foundation walls. As the water splashes against the foundation, it gets trapped small cracks in the mortar where it will continue to freeze and thaw, further damaging the mortar until it falls way. Evidence of this moist environment can be seen at the east elevation of the tower, where there is a significant amount of staining and bio-growth on the granite walls [Image 48]. It appears as though there may have been attempts to patch the mortar in the past, though these patches were poorly cut and pointed and are likely incompatible with the original mortar.

Image 47: Mortar deterioration cause by water splashing off of the concrete pads and against the foundation.

- *In tandem with wood sill repairs:* Re-build stair substructure using cast-in-place concrete and reset granite stair treads. See the *Structural Report*.
- Cut deteriorated and poorly patched mortar joints at granite foundation. Fill gaps in with chinker stones. Re-point foundation using a mortar to match the original composition and color. See the *Structural Report*.
- Demolish existing asphalt and concrete surfaces adjacent to the Meetinghouse.
- Re-grade soil adjacent to the building to direct water away from the foundation and add crushed stone apron at grade along foundation perimeter. See *Roof and Rainwater Control*.
- Remove areas of overgrown vegetation at the southeast corner of the tower.
- Clean masonry foundation to remove bio-growth and staining.

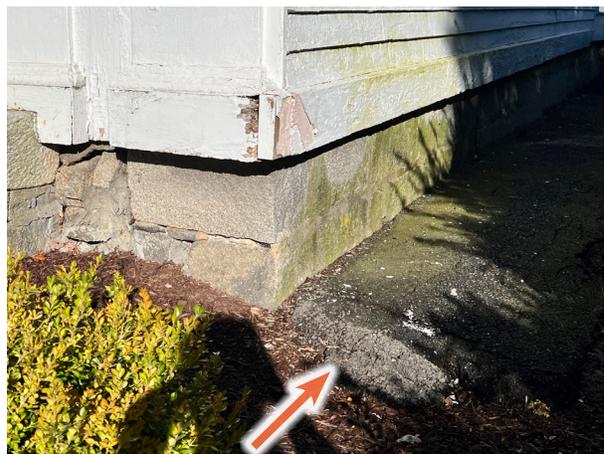
The rainwater striking the asphalt skirt is not only accelerating the deterioration of the mortar joints, but deteriorating the asphalt itself. Through the same freeze/thaw action that is occurring at the mortar joints, water is entering small fissures in the asphalt surface and creating much larger

Image 48: View of the SE corner of the tower showing extensive bio-growth and cracking at the asphalt skirt.

cracks. Settlement at the juncture of the asphalt to the foundation is also evident. This damage also corresponds with areas of substantial bio-growth where vegetation is either overgrown or overhead [Image 48].

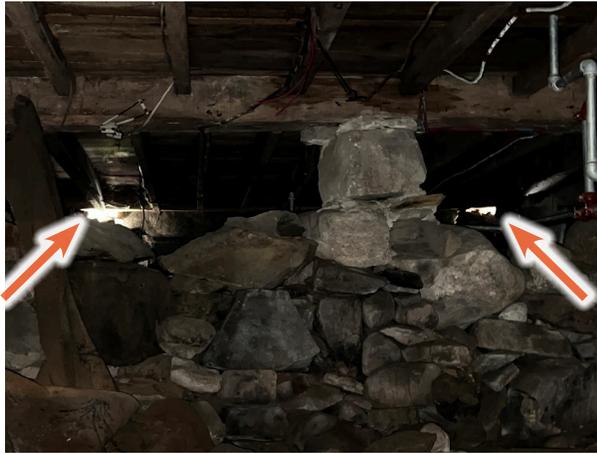
Image 49A: Daylight penetrating the Meetinghouse basement through gaps in the foundation on either side of the granite steps.

There is only one area where there are significant gaps in the foundation and that is where the granite steps meet the foundation wall at the tower porch. While not apparent from the building's exterior, there is a considerable amount of daylight pouring through to the basement on either side of steps [Image 49A]. These openings could not only allow insects and animals to enter the basement, but water as well causing further deterioration to the building's structure.

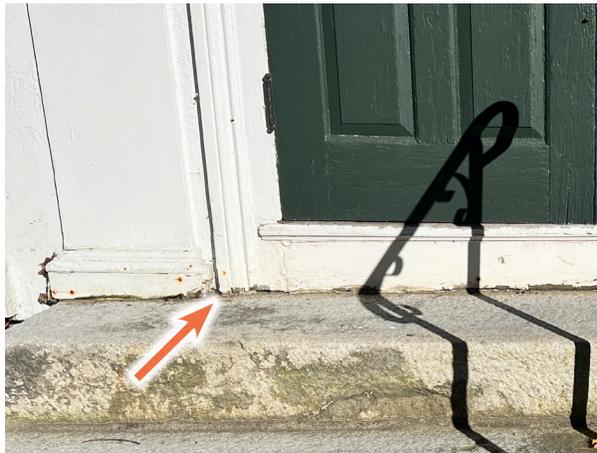
Image 49B: Damage to the wood pilasters and kickboard at the main entrance caused by water pooling on the top step.

As previously mentioned in the *Walls and Siding* section of this report, water has been pooling and collecting on top of the granite steps, against the wood pilasters and kick board below the door [Image 49B]. As noted in the *Structural Report*, this pooling indicates that the structure below the stairs is failing, causing the steps to rotate in towards the building, resulting in rot at the sill plate and mortar deterioration.

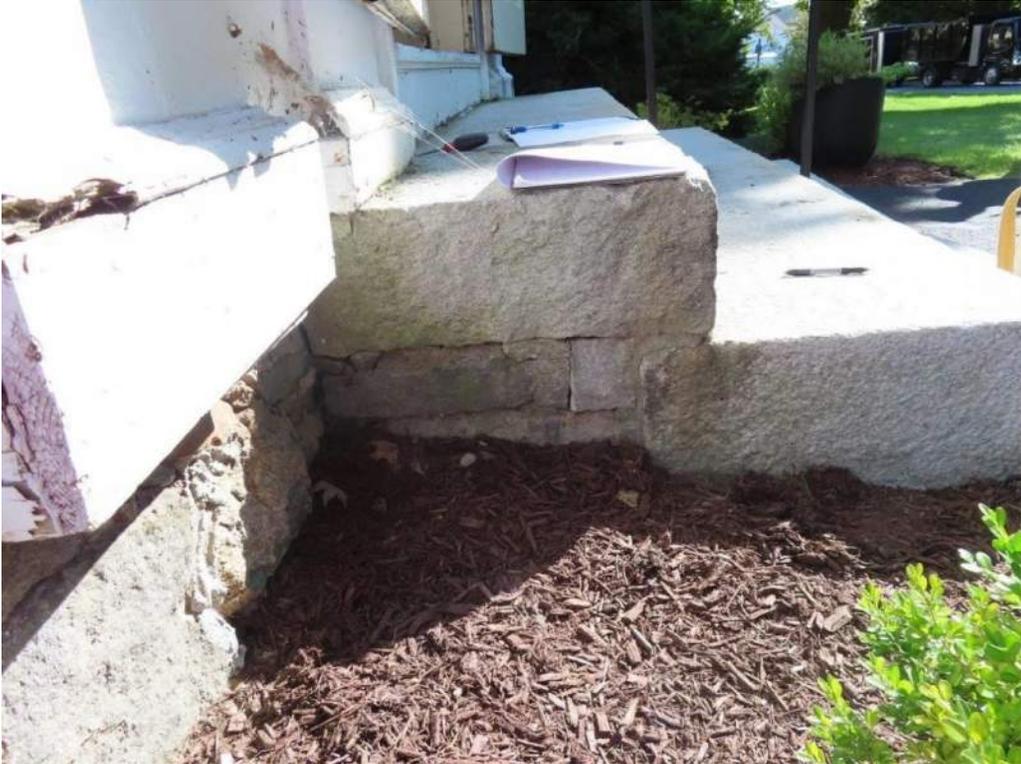
Photo 1
Rotating stair treads at south entrance and rotting wood trim

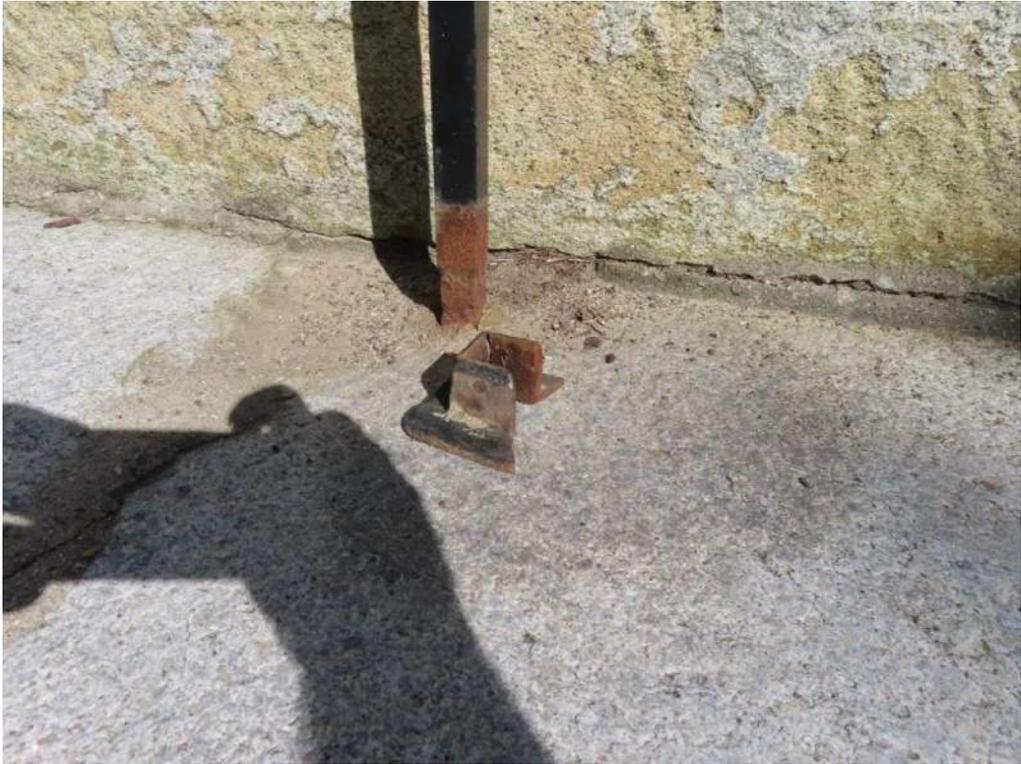
Photo 2
Rusting metal handrail

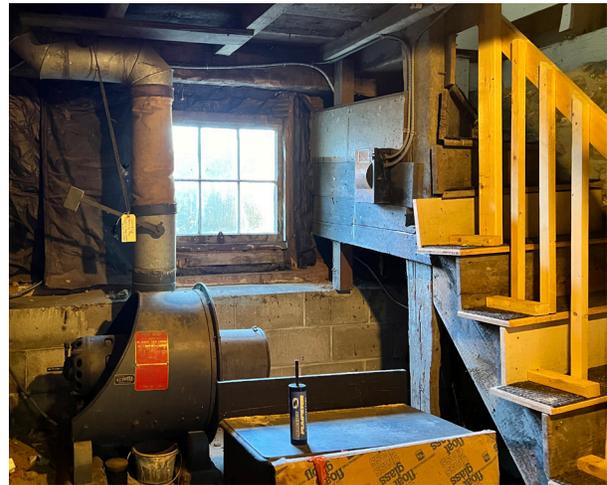
The basement can be accessed either by a wood plank door at the rear elevation or via a wood staircase at the northeast corner of the building. It is clear that this staircase has been patched and repaired several times over the decades, with several new kick boards and treads as well as a new wood railing. Despite these repairs, this staircase is still in poor condition [Image 50]. Several of the supporting members are suffering from rot, as a result of the damp conditions in the basement, and the stairs themselves appear to be tilting away from the foundation wall. Until they can be replaced, use of the stairs should be greatly limited.

Image 50: View of the deteriorating wood stairs at the NE corner of the basement. Use of these stairs should be greatly limited.

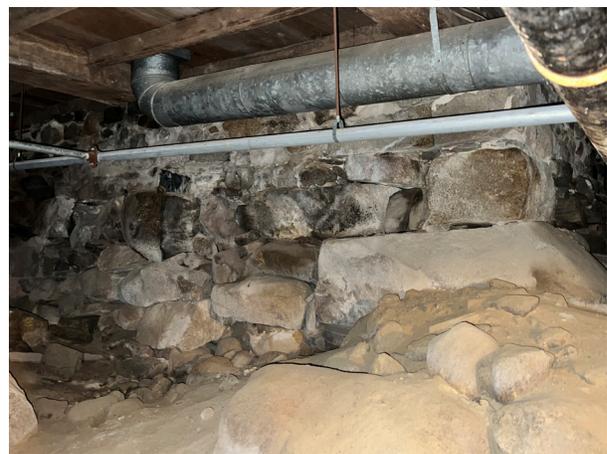
The damp condition of the basement is largely due to the fact it has a dirt floor. Moisture rises up through the ground and seeps into the basement, causing high humidity levels and creating ideal conditions for rot and mold. This kind of moisture infiltration can be exacerbated by poor grading and drainage on the exterior of the building as well as gaps in the foundation. Moisture rising up from the ground and through the gaps in the foundation have not only further deteriorated the mortar joints, but have caused the foundation and several granite footings to become undermined, leaving them unstable [Image 51].

Image 51: Sections of the granite and fieldstone foundation have been undermined as a result of moist infiltration at the basement.

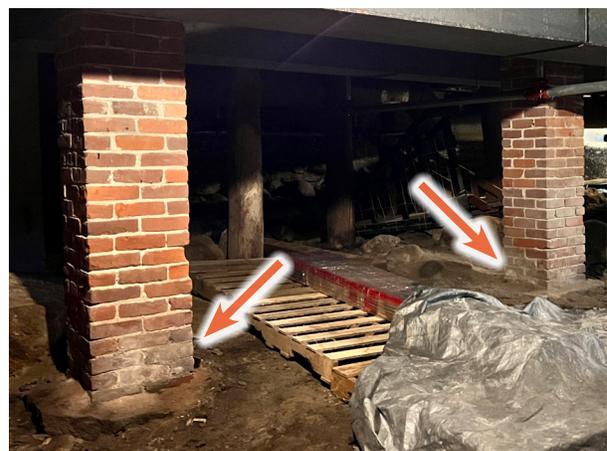
The stairs are not the only element to suffer from moisture damage in the basement. There are several brick piers that show signs of mortar deterioration and erosion, particularly at the base where the piers meet the dirt floor. Over time, moisture trapped in the dirt has caused the bottom courses to erode, leaving them at risk of further structural damage [Image 52].

Image 52: Deterioration of the brick piers and mortar joints as a result of the moisture rising from the dirt floor.

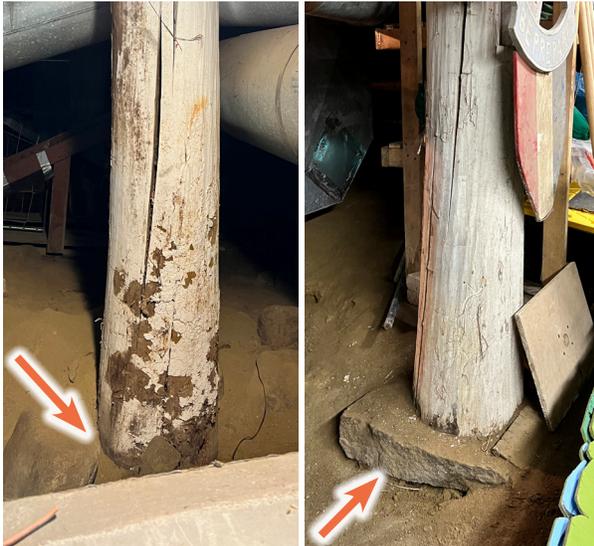
In addition to the brick piers, there are multiple wood posts scattered across the western half of the basement supporting the floor above. Much like the piers, a number of these posts are suffering from moisture damage, particularly where the posts meet the ground. In some instances, these posts sit on granite blocks, which

Image 53: Deterioration of the wood posts caused by rising damp. Note the granite block “footings” present in few locations.

act as footings, dispersing the load from the floor above. However, in many cases, these posts are buried in the dirt only increasing the rate at which they deteriorate. Without a stable footing, some of these wood posts have shifted, creating gaps between the posts and the beams they support that need to be shimmed [Image 53].

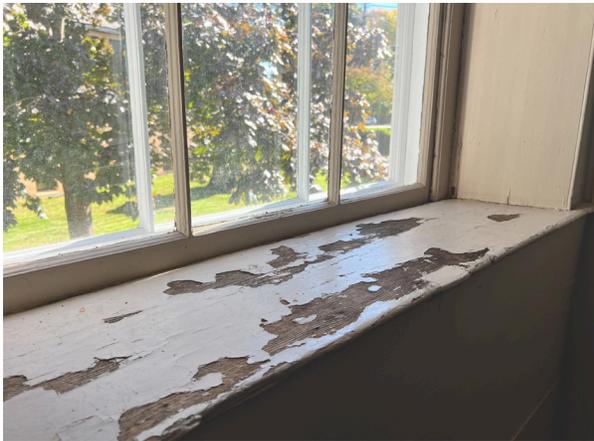
Image 54: Typical condition of the wood trim around the windows on the first floor.

The worst damage on the first floor occurs at the trim around window openings. The paint on the stools and surrounding trim work is cracked and peeling, likely due to prolonged moisture infiltration, lack of consistent climate control, and deferred maintenance [Image 54]. As the paint continues to peel away from the trim, the wood below is exposed leaving it at risk for further deterioration. Restoring the windows on the first floor will help to address the root cause of this deterioration and serve as a critical first step in its repair.

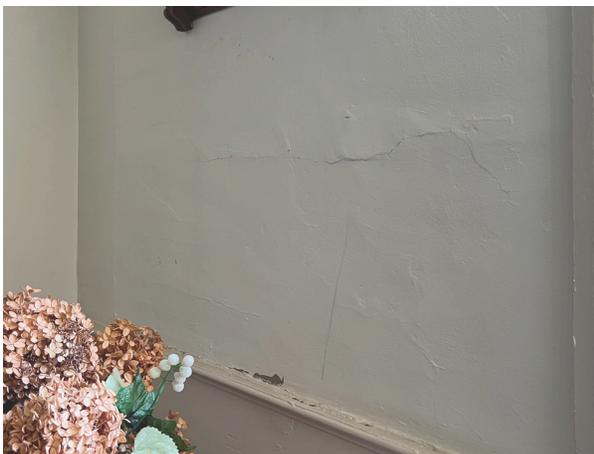
Image 55: Area of cracking plaster and deteriorated paint on the east exterior wall.

Across the first floor, there are multiple instances where the wall plaster is cracking and the paint is beginning to deteriorate [Image 55]. The worst of this damage is primarily located on the exterior walls of the building. This could be attributed to moisture entering the wall assembly through damaged or warped wood cladding, however, it is more likely due to age and poor climate control. Fluctuations in both temperature and humidity, caused by poor seals at the windows, can cause materials like plaster to expand and contract, leading to cracking and separation from the lath. Like the deterioration to the window trim, described above, the first step to addressing the plaster damage is restoring the first floor windows as well as the wood siding.

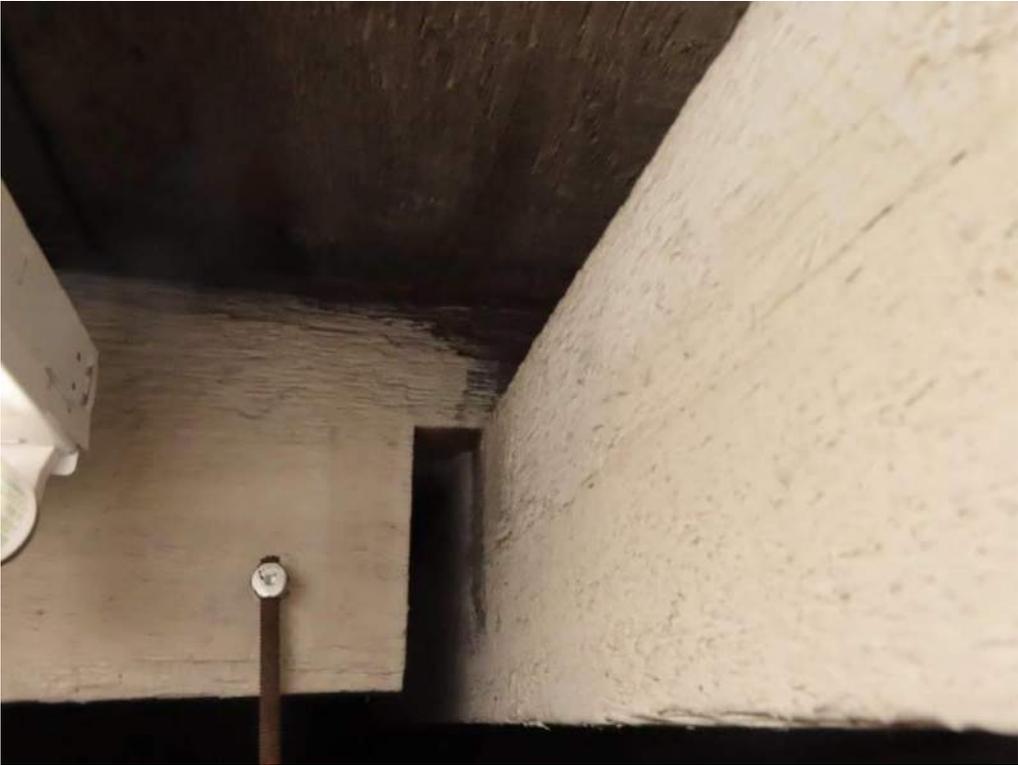
Photo 23
Joist notched on tension face

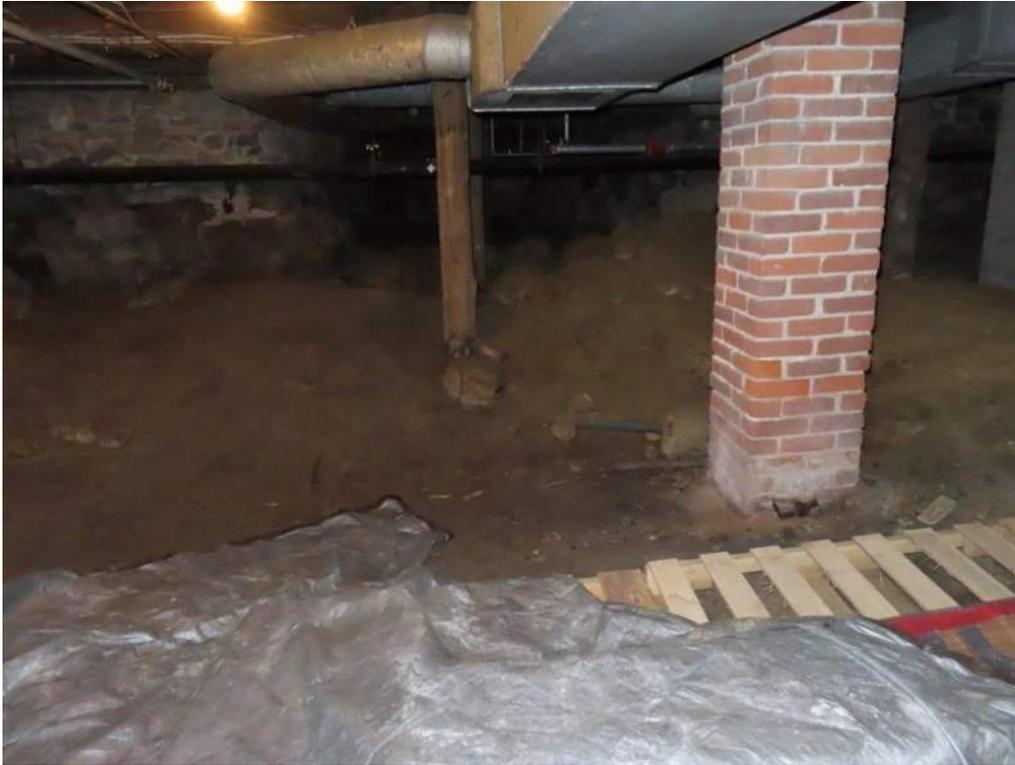
Photo 27
Deteriorating masonry at base of pier

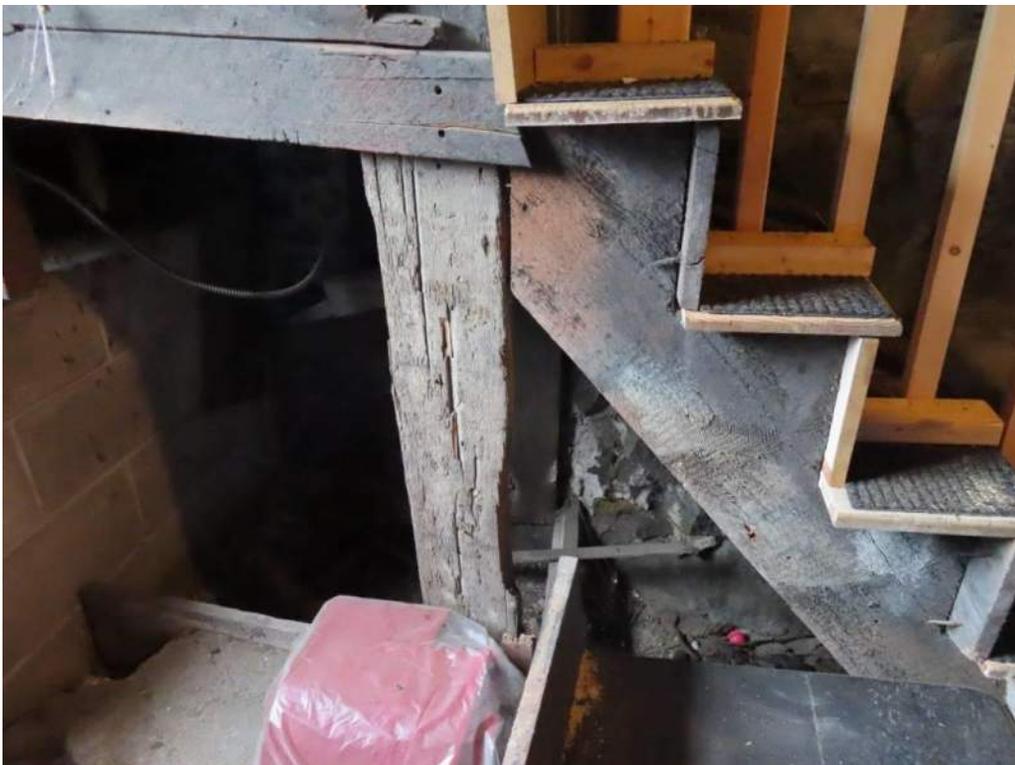
Photo 28
Scant stair framing

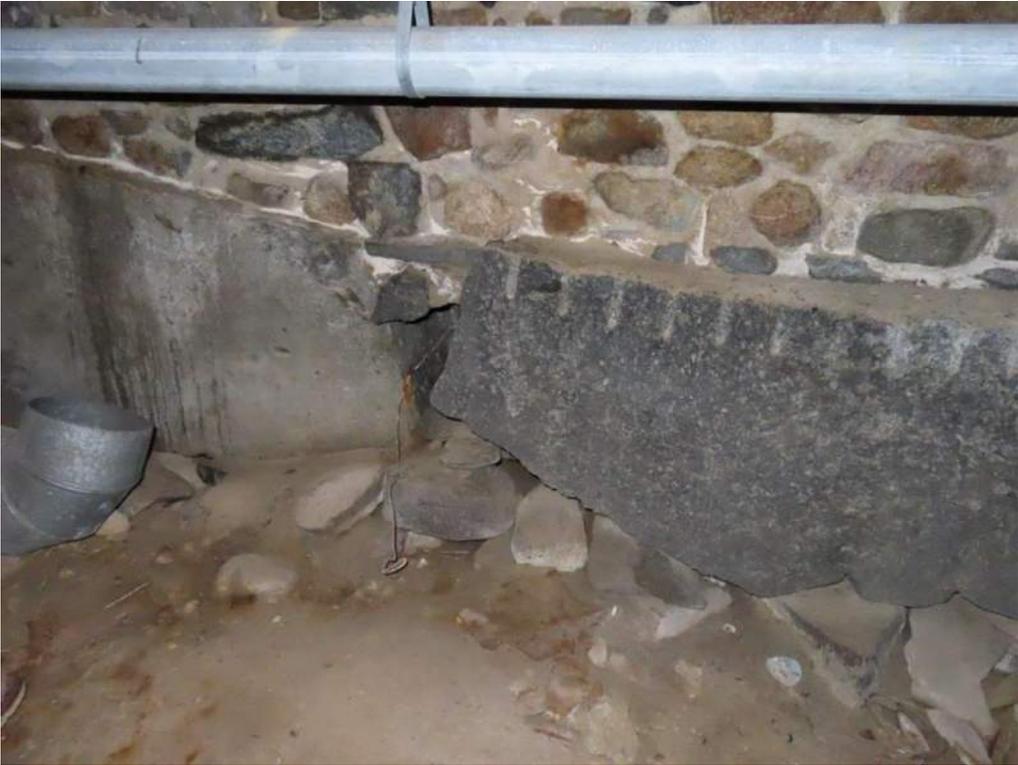
Photo 31
Undermined south elevation foundation

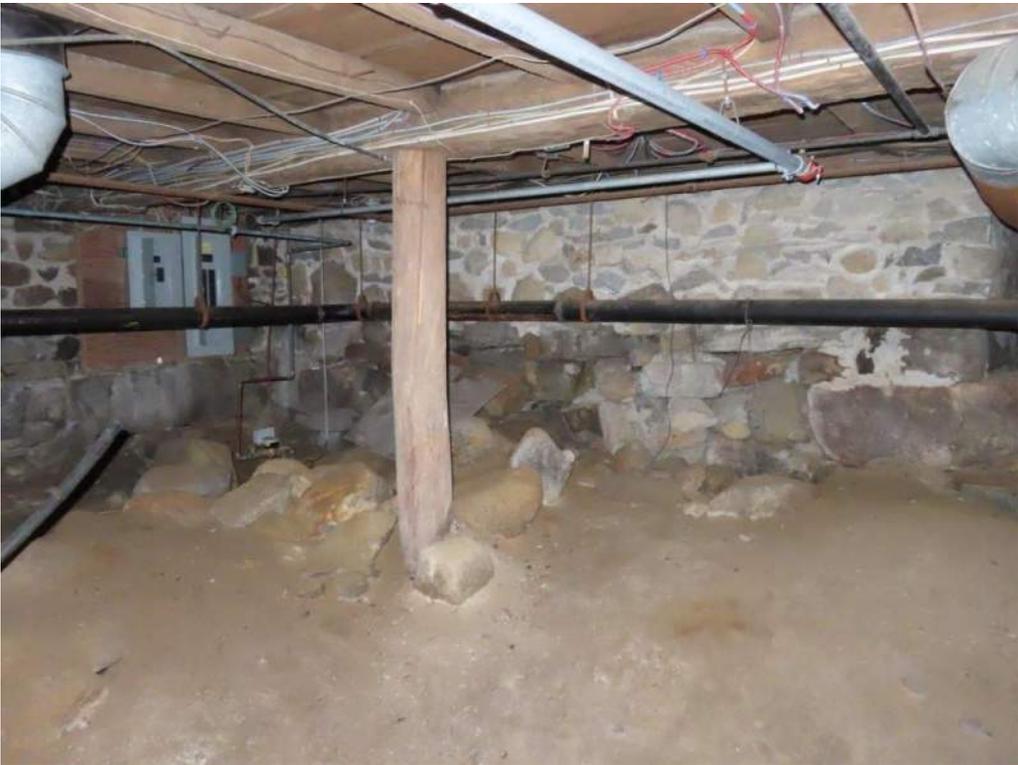
Photo 32
Undermined south elevation foundation at east end

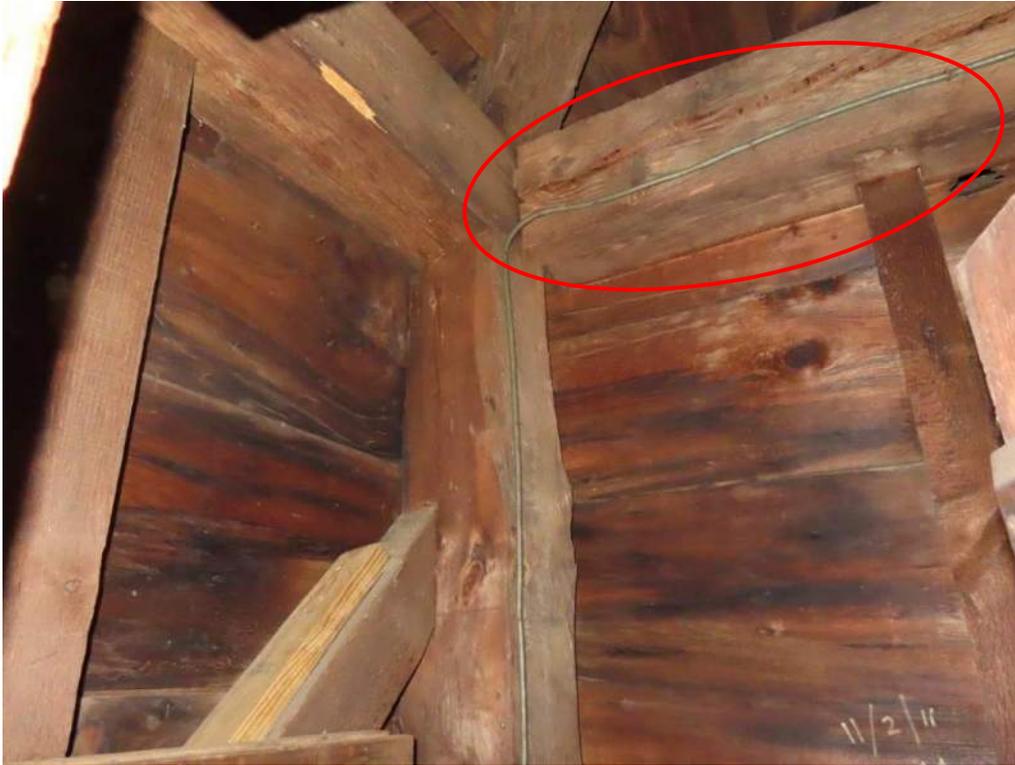
Photo 11
Poorly supported tower girt with split at end connection

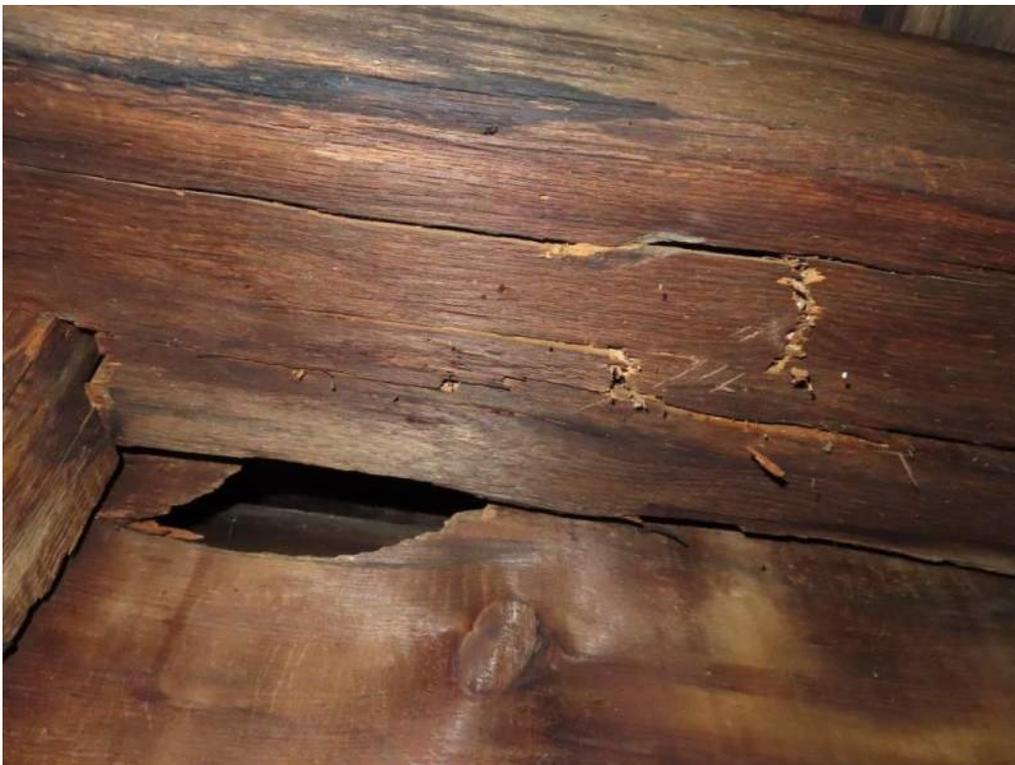
Photo 12
Rot at west side tower girt

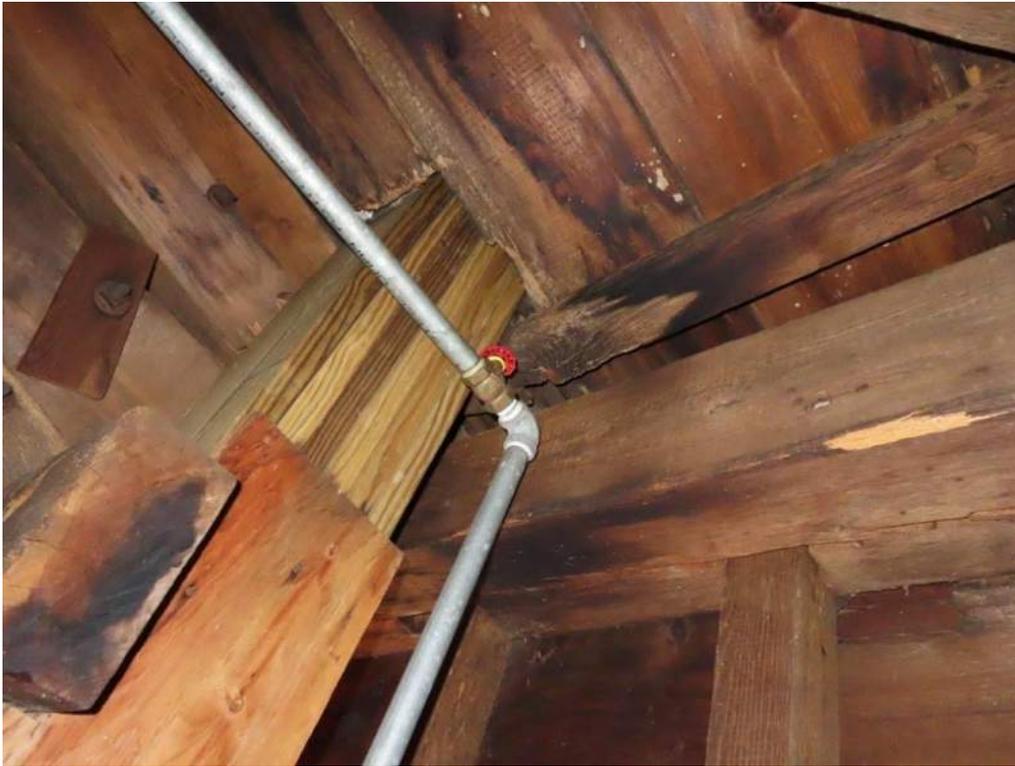
Photo 13
Rot damage at northeast corner of belfry deck framing

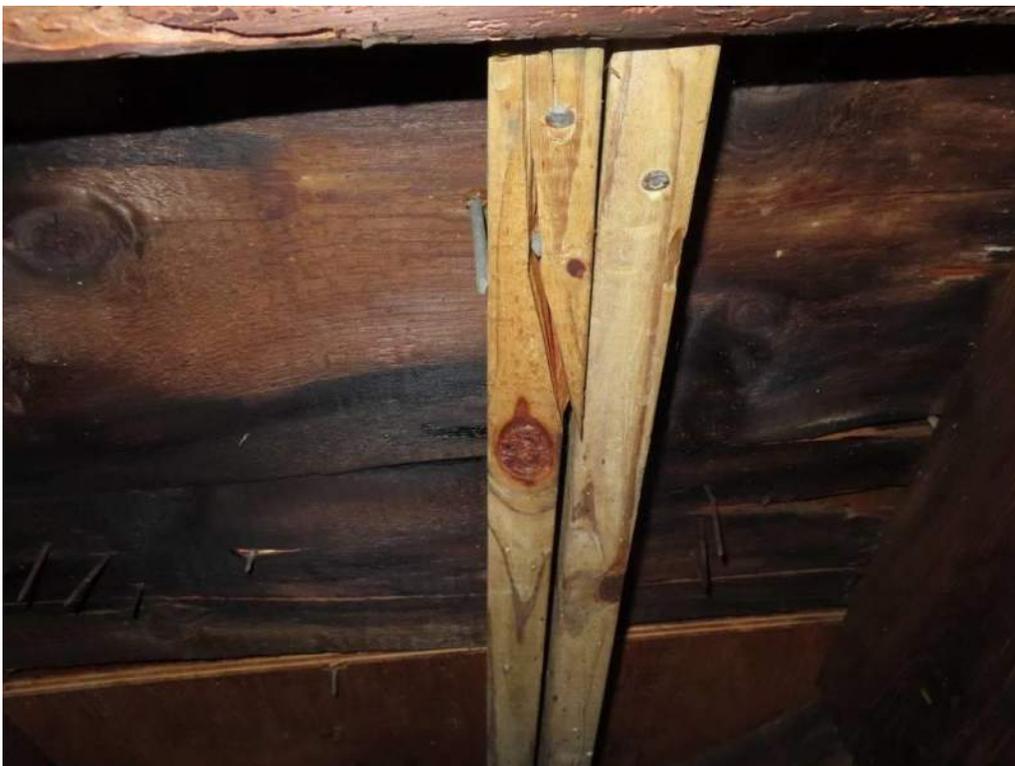
Photo 14
Split sister at belfry deck framing

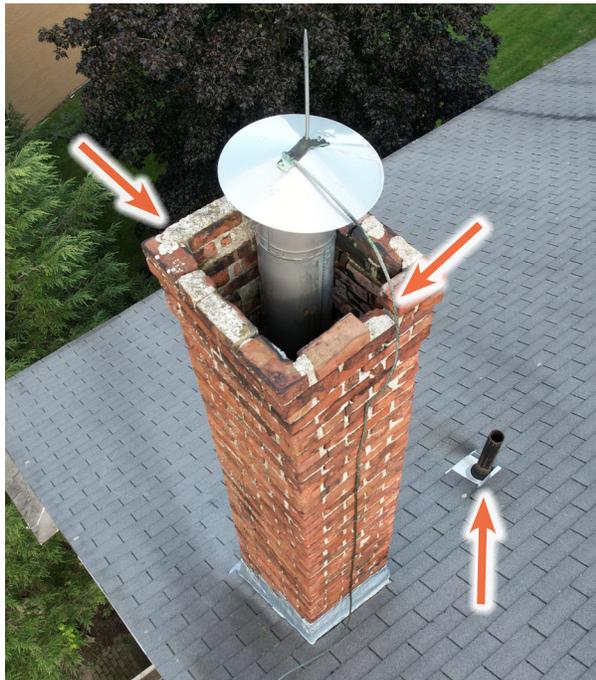
Image 04: Deteriorated brick chimney and vent pipe at the NE corner of the roof. Note the missing bricks and damaged mortar.

- Replace the asphalt shingles and associated flashing at the main roof and tower porch with new Western Red or Alaskan Yellow wood shingles and 20 oz copper flashing.
- Replace the existing wood shingle roof and associated flashing at the spire with new Western Red or Alaskan Yellow wood shingles and 20 oz copper flashing.
- Install new continuous drip edge along the perimeter of the gable and spire roofs.
- Straighten/repair the bent arrow weathervane. Apply new gold leaf to both the arrow and weathervane ball.

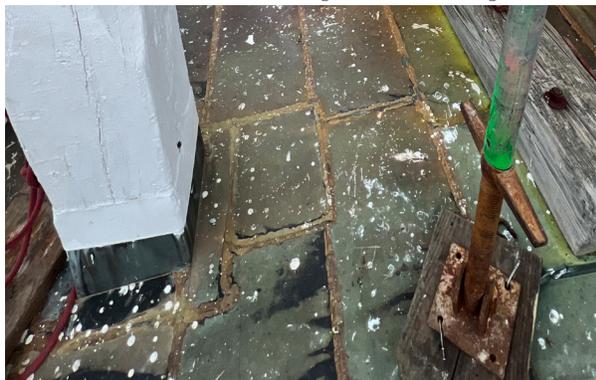
Image 05: General condition of the flat seam copper roof located at the tower's bell deck.

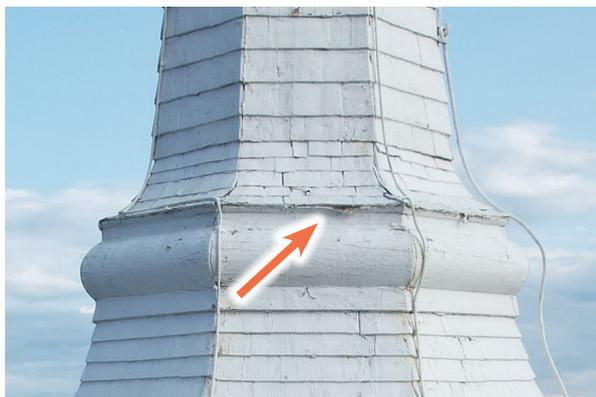
Image 06: View of the warped, cracked, deteriorated wood shingles at the spire. Note the condition of the paint.

these shingles will continue to deteriorate, allowing water to enter the spire and damage the sheathing and structure beyond.

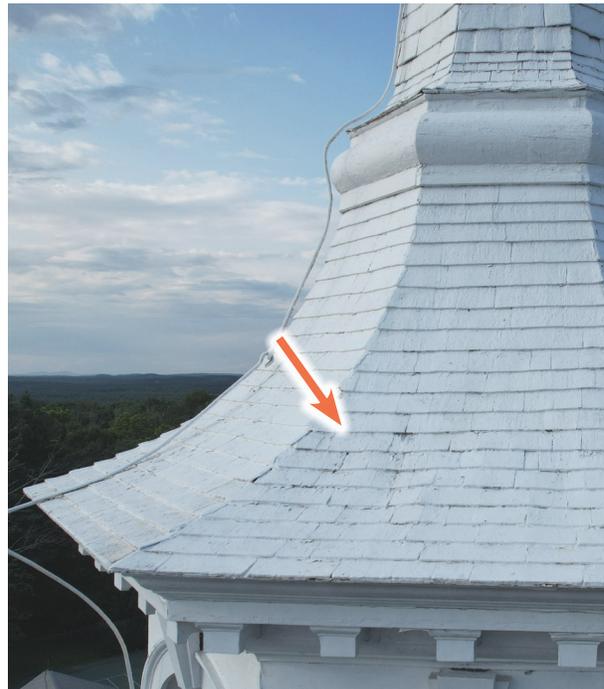
Image 07: View of the warped, cracked, deteriorated wood shingles at the spire eaves. Note the undulation of the shingles.

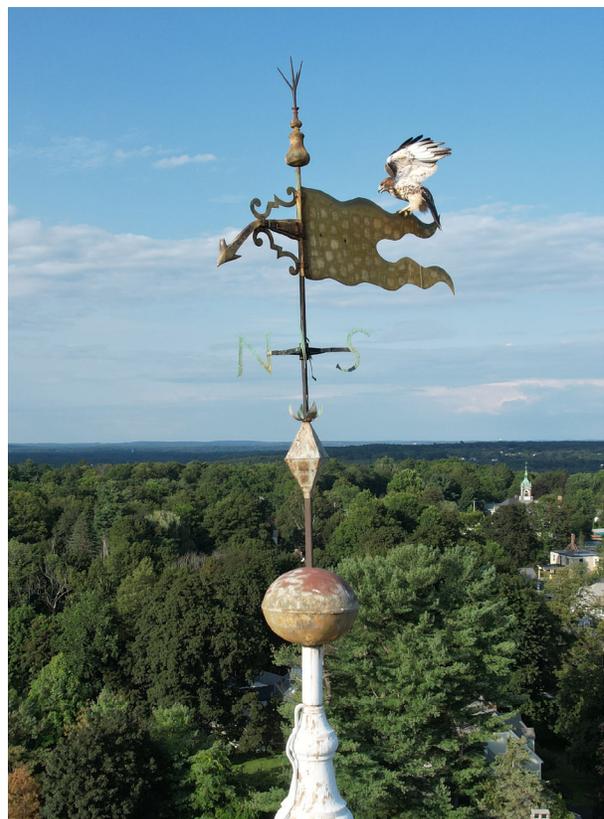
Image 08: View of the weathered arrow weathervane located at the top of the spire. Note the deteriorated condition of the metal and gilding.

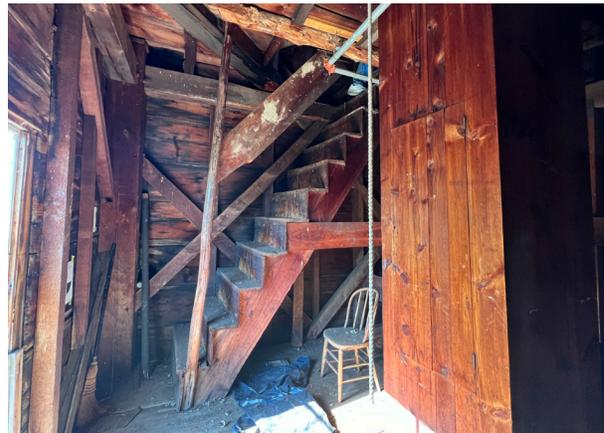
Image 16: View of the interior of the tower showing one of several steep staircase that make belfry and tower access difficult.

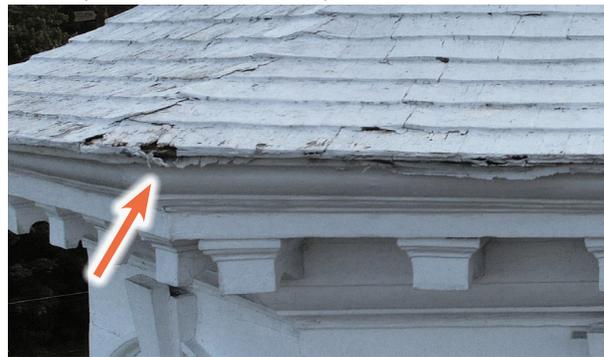
There is a significant amount of rot and deterioration at the east facing portions of the belfry, where the cornice meets the wood shingles. As rainwater sheds off the roof, it clings to the underside of the shingles and settles in the joint between the cornice and the roof. This continued exposure to water has deteriorated the paint in this area and caused severe damage to the wood cornice, particularly at the mitered corners which, by nature, are more susceptible to water infiltration. Over time, the worsening deterioration caused this section of the cornice to detach at one end, creating an opening for water and insects to enter the steeple structure [Image 17]. An exploratory opening in the belfry ceiling not only confirmed that water has been entering the steeple for quite some time, as evidenced by the rotten and

Image 17: Deterioration at the mitered joints of the belfry cornice cause by rainwater clinging to the underside of the wood shingles.

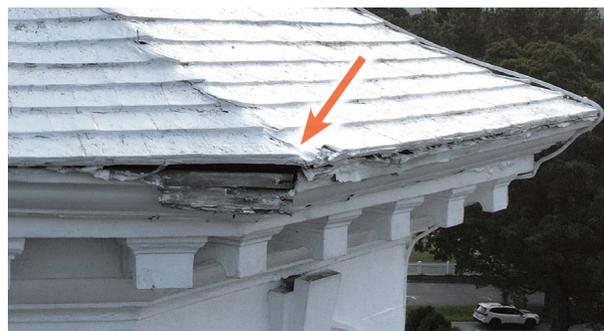
Image 18: Similar deterioration occurring at the moulding band wrapping around the middle of the spire.

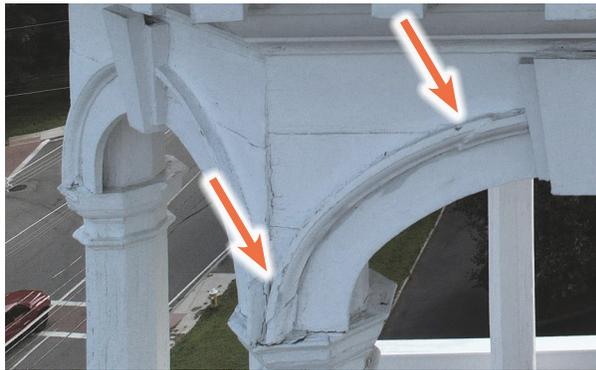
Image 20: Damage and missing mouldings at the columns capitols.

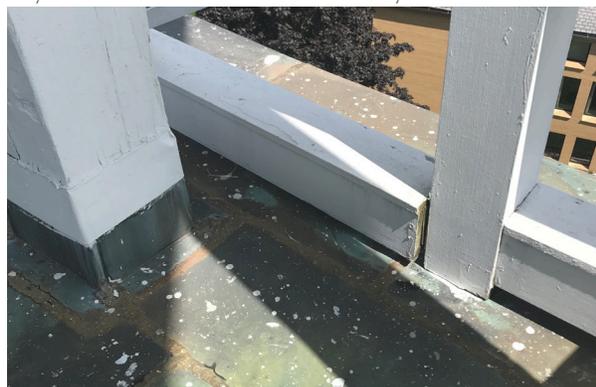
Image 22: Loose and disconnected cross bracing and posts at the railing surrounding the bell deck.

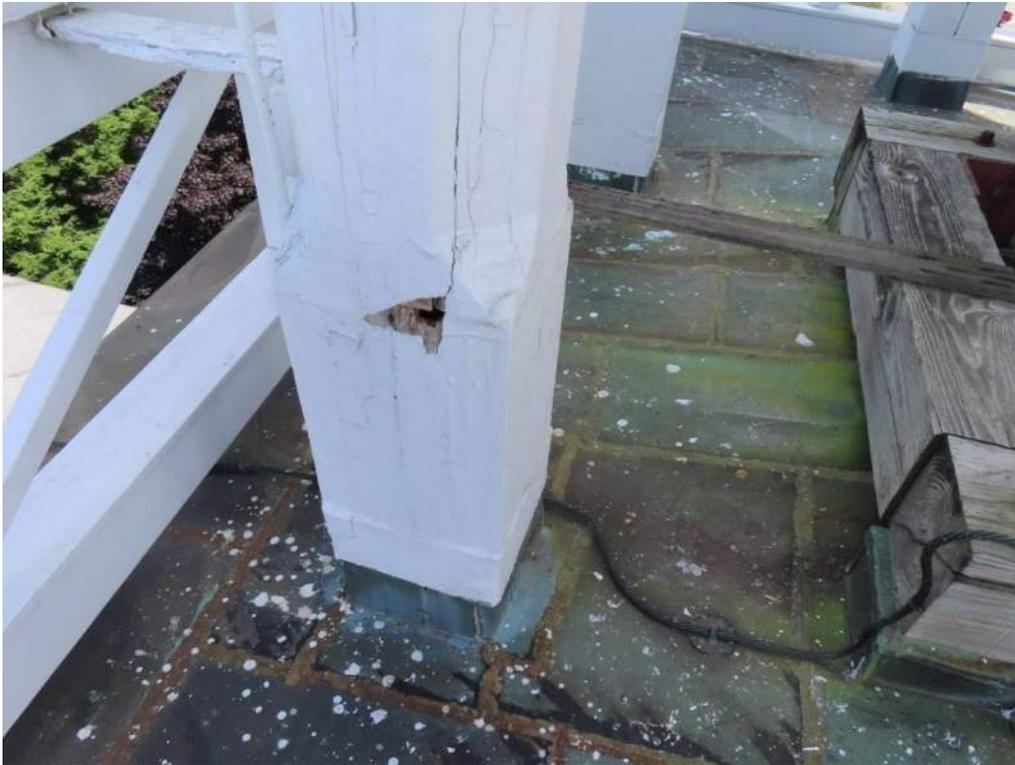
Photo 15
Rot along trim of north elevation post and poor flashing detail
