Community Preservation Funding Application — Fiscal Year 2026

Project Name: First Parish Church United Meetinghouse Historic Preservation

PROJECT:
FIRST PARISH CHURCH UNITED
CONDITIONS ASSESSMENT
#2411-R

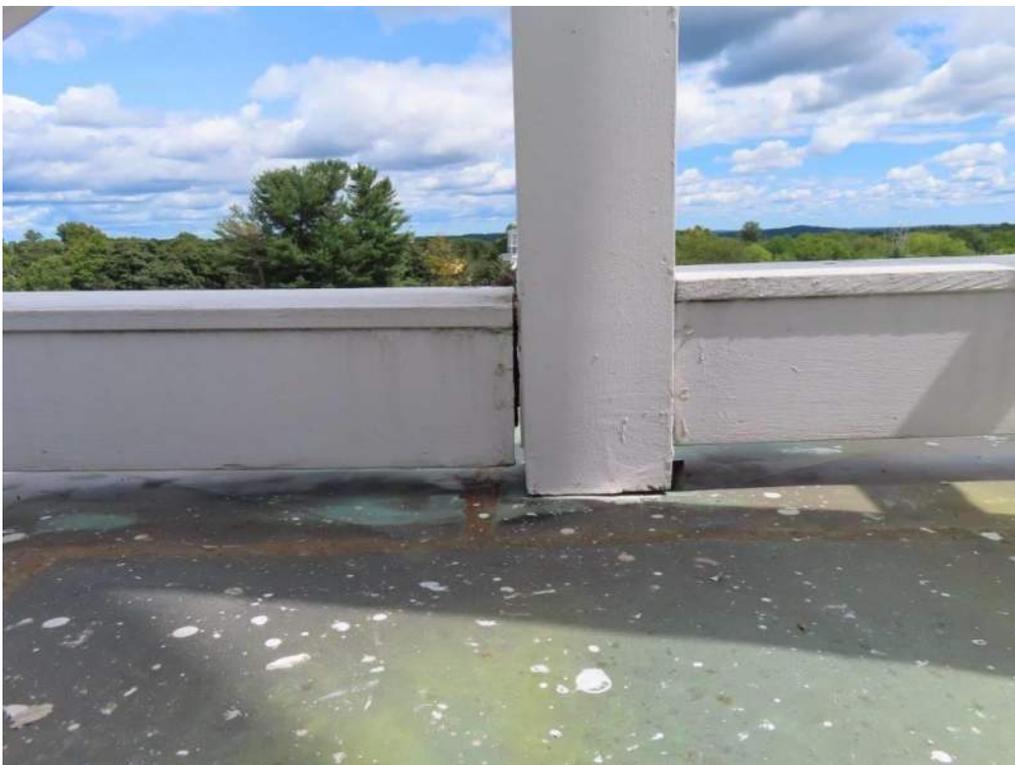
Photo 16
Poorly connected railings

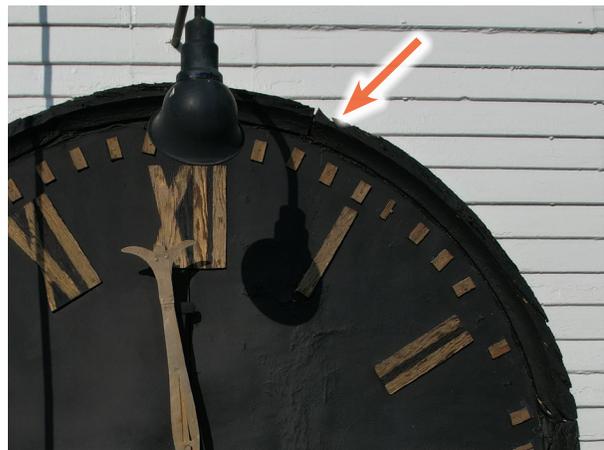
In addition to the poor condition of the faces and bezels, the numerals and tick marks are weather worn and faded. Made from wood and coated in a gold paint, many of these numbers are cracked, damaged, or altogether missing from the clock face, having been simply face nailed into the wood beyond.

Image 30: The bezel around the clock faces showing signs of rot, checking, and splitting due to weather exposure.

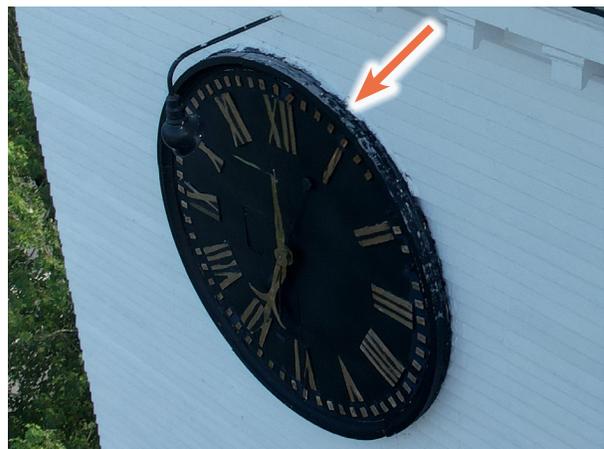
Image 31: View of the upper section of the east clock face showing the lack of flashing.

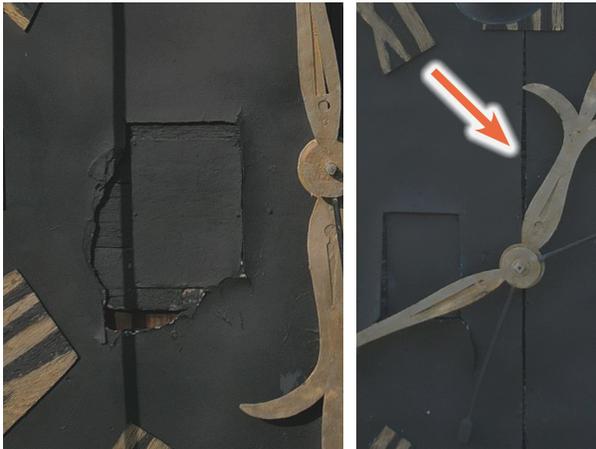
Image 32: Open seams and damage to the thick canvas covering at the access panel, exposing the wood beneath.

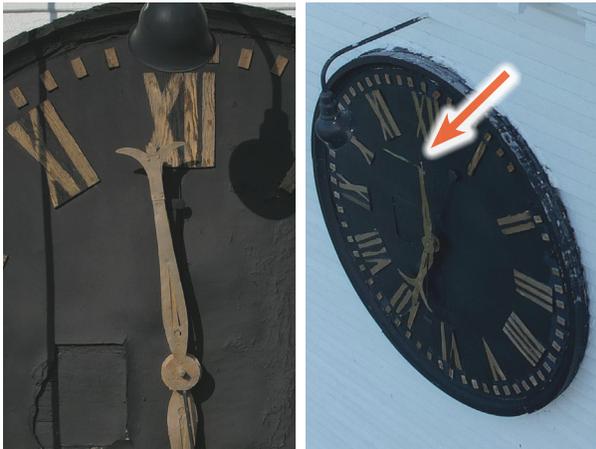
Image 33: View of the bent, warped, damaged, and faded hands, numerals, and tick marks

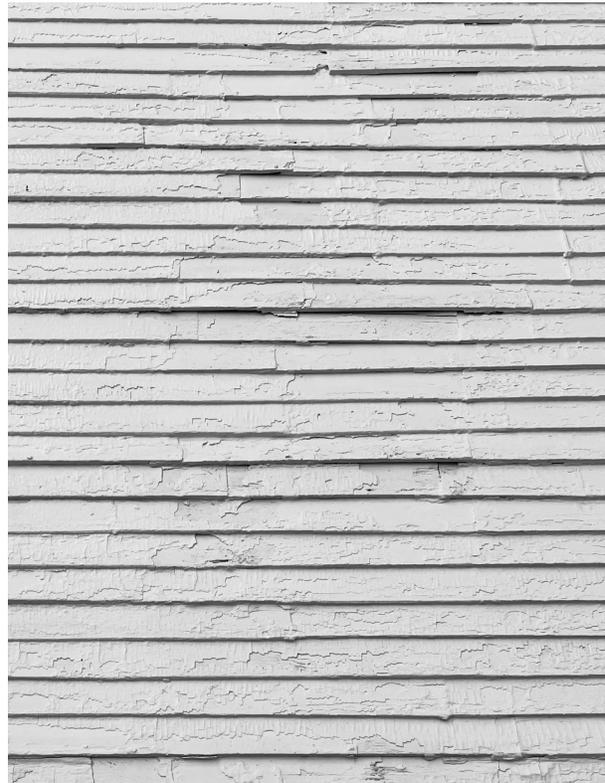
In addition to the scaly and peeling paint, there are multiple locations across the Meetinghouse where the clapboards themselves have cracked, split, or warped as a result of age and deferred maintenance. The worst damage occurs where the 2010 connector roofs meet the west elevation of the Meetinghouse; a location where the congregation has reported active leaks [Image 12]. The low pitch of the connector's asphalt roofs allows snow and ice to build up and collect against the wood clapboards. This prolonged exposure to moisture, combined with the questionable condition of the sidewall flashing, has accelerated the deterioration of these clapboards and allowed water to enter the building.

Image 11: Typical condition of the wood clapboard siding across the Meetinghouse. Note the warped boards and scaly paint.

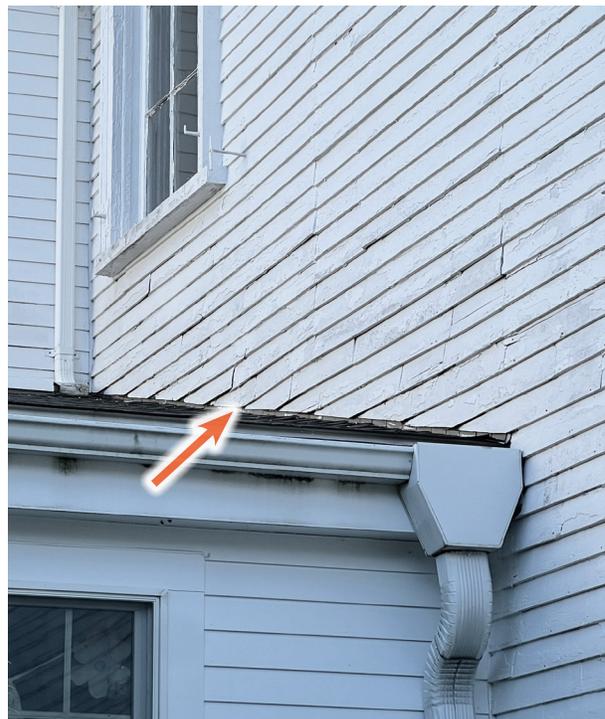
Image 12: Damaged clapboards where the 2010 connector roof meets the side wall caused by snow build up on the low roof.

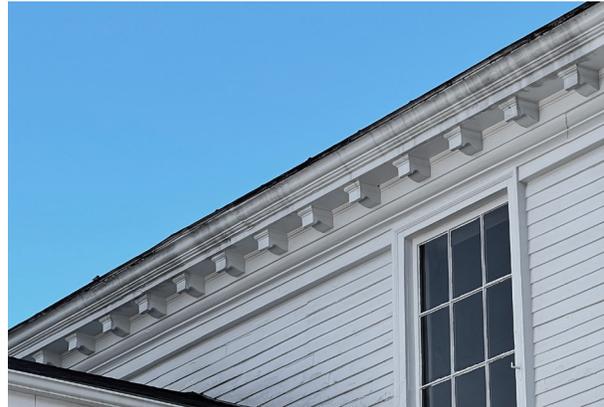
Image 23: Staining & paint damage at the wood cornice caused by rainwater running down the face of the cornice. Note the warped metal drip edge.

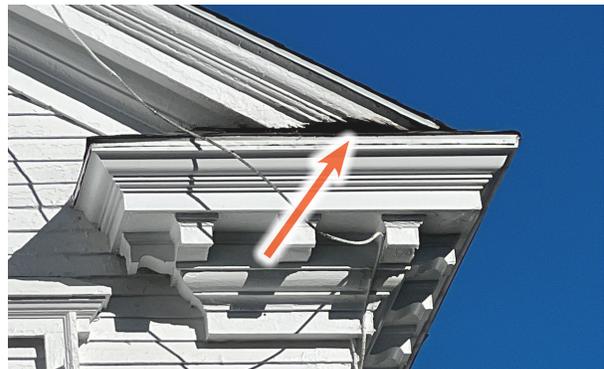
Image 24: View of the deteriorated raking cornice caused by water collecting on the top of the cornice return.

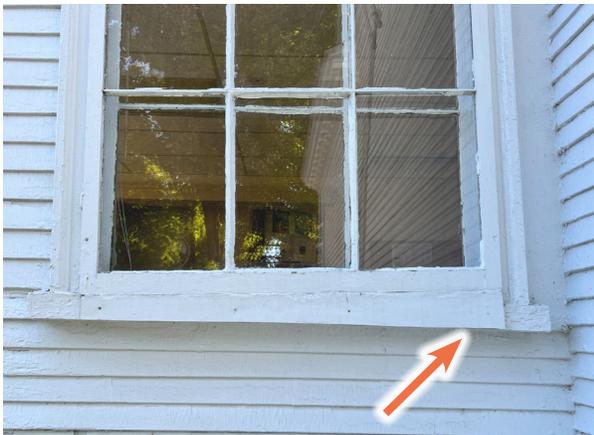
Image 28: Shims and blocking applied to the sill at the southwest elevation where the structure has settled over time.

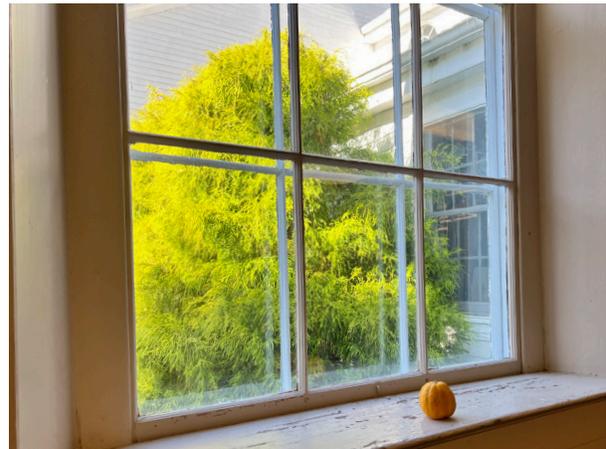
Image 34: Typical conditions of the window sashes from the interior of the Meetinghouse.

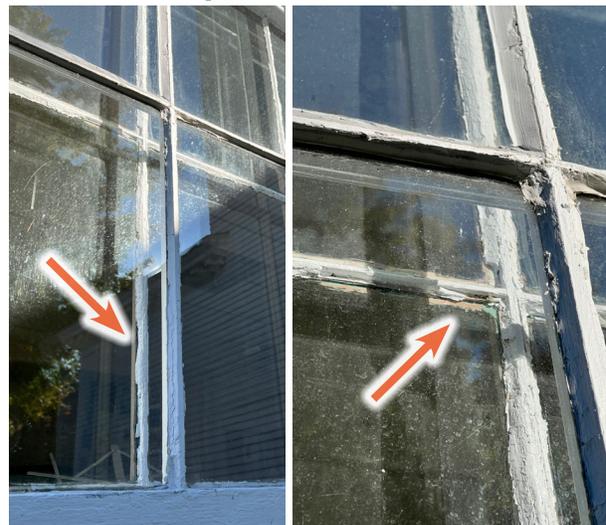
Image 35: View of the damaged muntins and deteriorated glazing on the exterior of the window sashes.

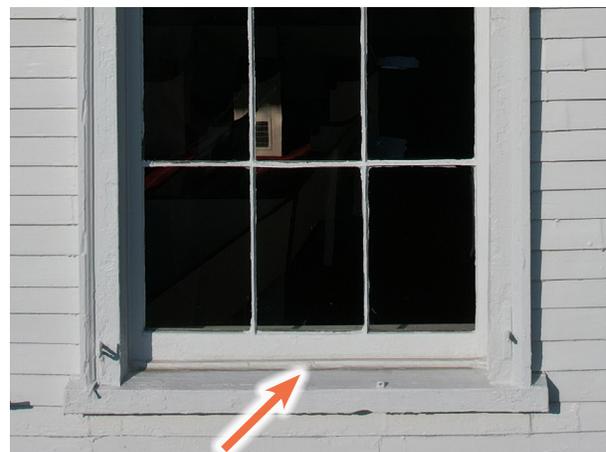
Image 36: Typical condition of the windows at the second floor. Note the secondary sill separating the bottom rail and main sill.

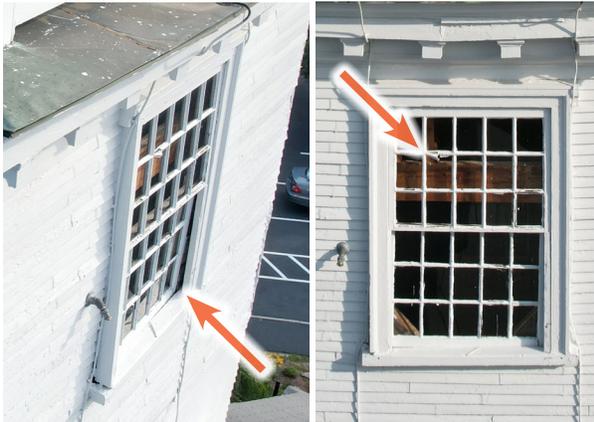
Image 37: View of the deteriorated and gaping window at the north elevation of the tower.

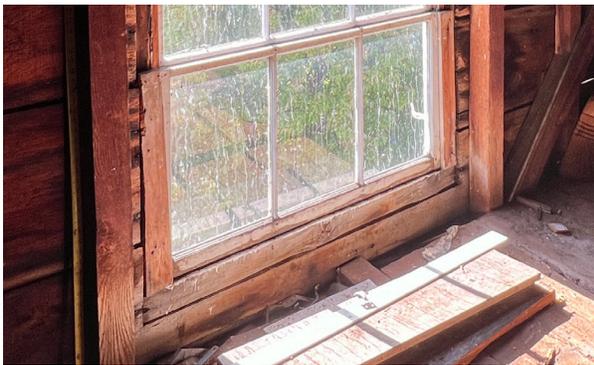
Image 38: Typical condition of the south facing tower windows. Note the staining and moisture damage at the bottom rail.

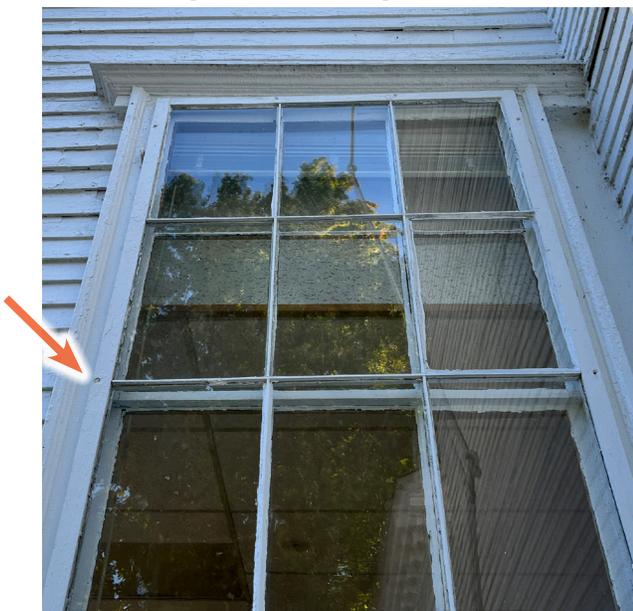
Image 39: Typical condition of the storm windows at the first floor. Note that they are inoperable and unvented.

It is also important to note that these storm windows are inoperable, as they have been fastened to the window casing. This not only restricts the occupants' ability to open these windows for ventilation, but traps both moisture and heat between the sashes and the unvented panels, putting the sashes and muntins at risk for further deterioration.

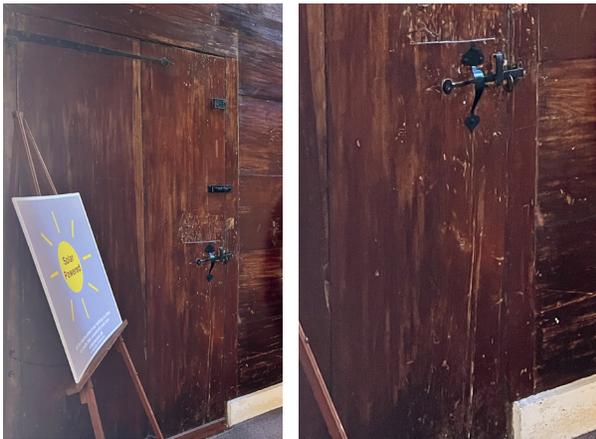
Image 44: Interior of east tower door showing signs of scratches, scarring, and patches.

- Replace existing wood threshold in kind at main entrance.
- Restore wood door at the east tower elevation as described above. Restore existing door hardware including strap hinges and thumb latch.
- Remove existing wood stairs at the north elevation and re-build using either metal or pressure treated lumber. Color to be selected by the architect.

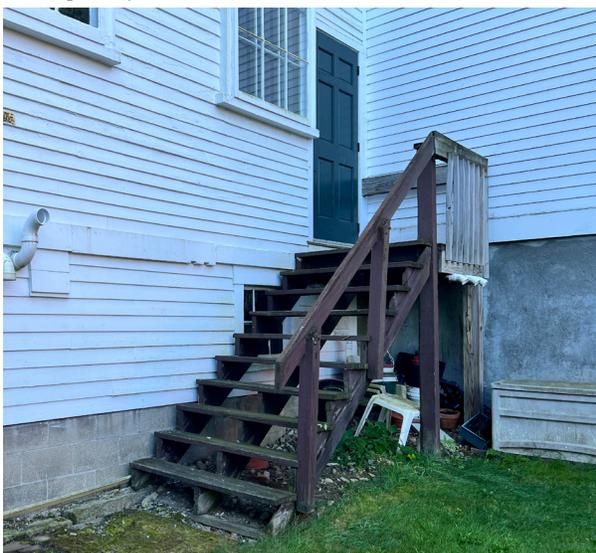
Image 45: Severely deteriorated wood egress stairs at the north elevation.

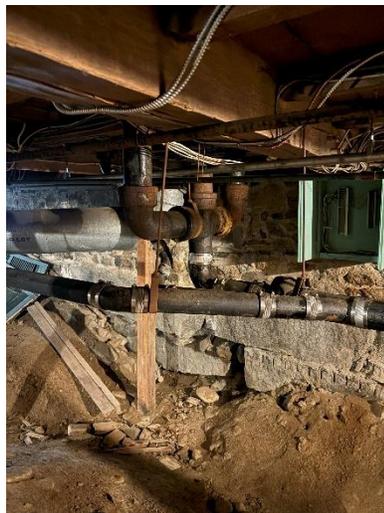
In general, the cast iron drainage piping can be reused even in a major renovation where adequately sized for the intended new use.

Typical cast iron drainage piping
