CENTER FIRE STATION

51 Main Street

Year Constructed: 1974
Year of Renovation/Addition: None
Building Type: B/S-2(R-2)
Construction Type: VB
Fire sprinklers: No
Total Floor Area: 6,825 SF
Floors: First, and Second.

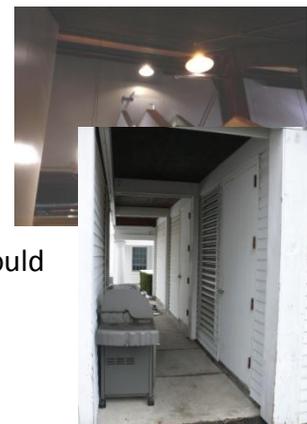
Open exit stairs are used from the dorm rooms on the second floor and discharge into the equipment bays in violation of the code. To overcome these life safety concerns the south stair needs to be enclosed with one hour fire rated construction to fully separate it from the equipment bays. The stair enclosure should extend to the exterior door. Any exposed wood covered with sheetrock. The wood ceiling in the exterior hall should be covered with exterior sheetrock and construction of the passageway

upgraded to provide a 1 hour fire rating. Any structure (steel beams, columns and rod hangers and braces) supporting the stair need to be fire-rated to 1 hour. Without fire sprinklers an area of refuge is required.
