IV EXISTING FACILITIES

The Cameron School was originally built in 1872 with an expansion made in 1908 for a total size of about 14,200 square feet. It was used as a school through the late 1980's and in 1993 it was renovated to become the home of the Westford Council on Aging.

CAMERON SENIOR CENTER FEASIBILITY STUDY, Westford, Mass.

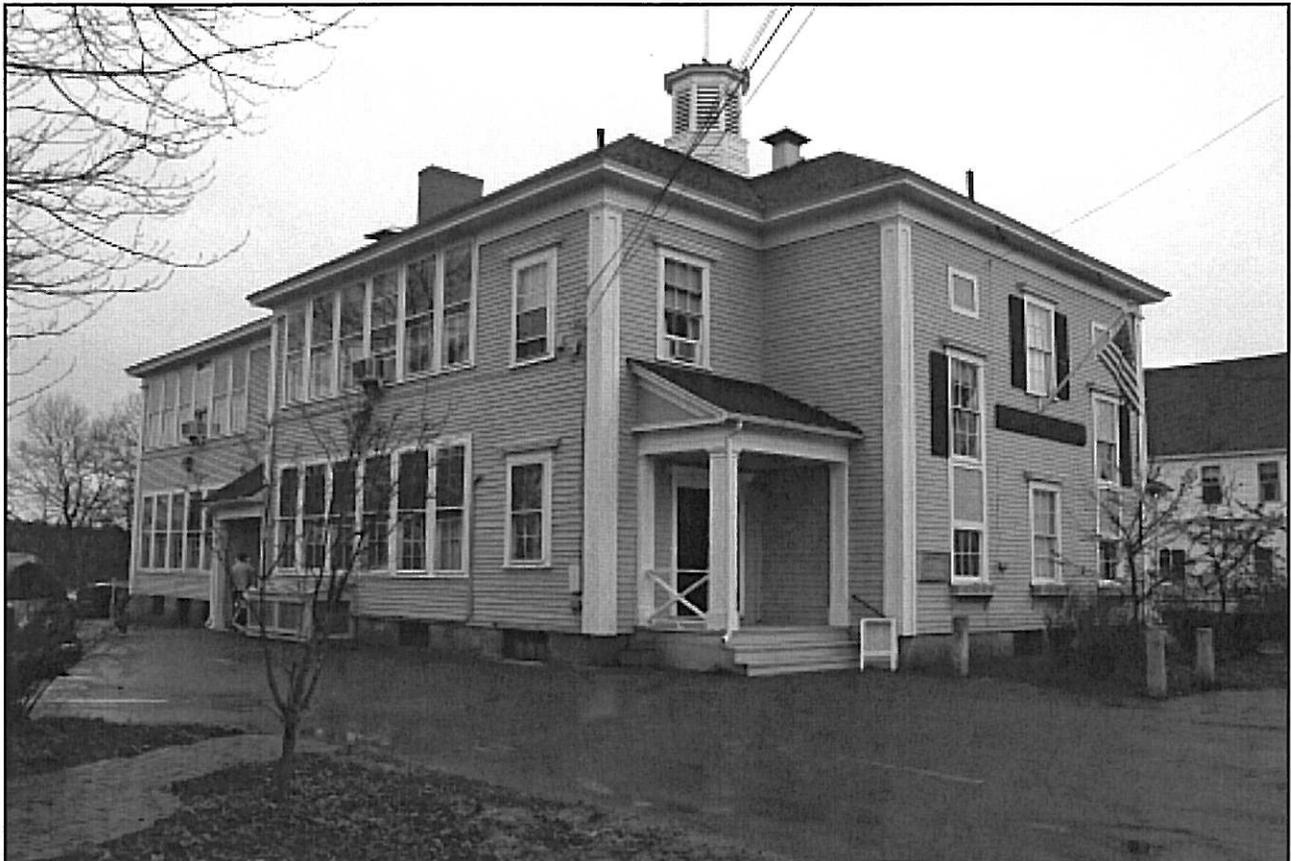
Figure 4.1 View of northeast corner of the Cameron School from Pleasant Street. Note on-grade main entrance along east side of building.

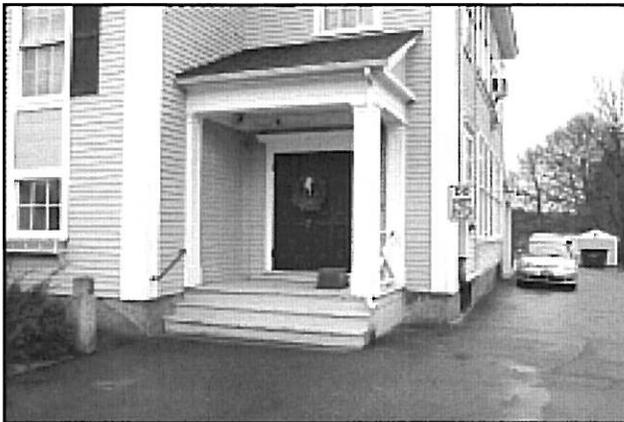
Figure 4.7 Northwest porch paneled doors.

The painted wood raised paneled double doors on the north porches appear to be original or in the original style. These are in good shape because they are somewhat protected from the weather (Fig 4.7). The west egress double doors are also painted wood (black) and have a 2/3 height light. The double doors at the east entrance are painted metal (painted grey) with a square light (Fig 4.8). The doors leading to the fire escape on the south side are single leaf, wood doors, also painted black with 6 lights (Fig 4.9).

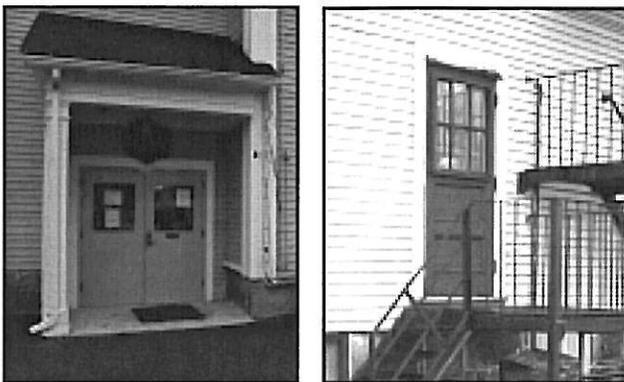
Figure 4.8 and 4.9 Main entry doors and egress door to fire escape.

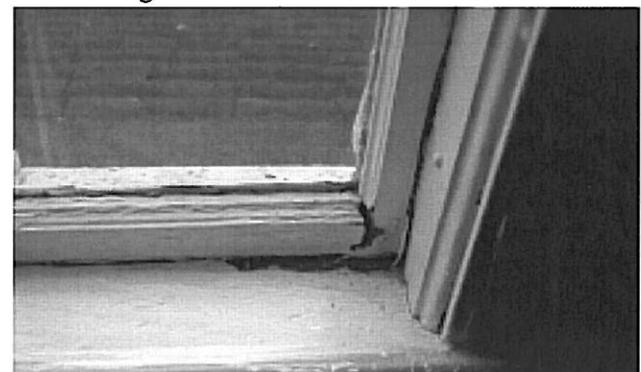
All of the windows in the building are double-hung single glazed wood window units, with a 6 over 6 light configuration. Six larger windows are ganged together in each of the classrooms for a large window wall effect. Smaller units provide light in the stair halls, offices, toilets and storage rooms. Many window shashes and sills are deteriorating (Fig. 4.45). It is recommended that all windows be replaced with insulated units.

Figure 4.45 Interior wood window sill.

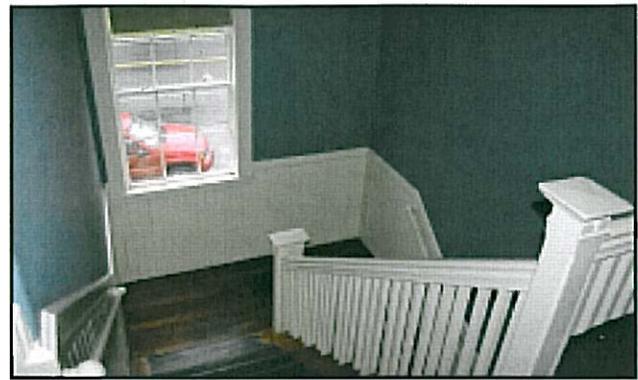
Two of the stairways that mirror each other are located on the north end of the building. These stairways connect all the floors - basement through second - and are open on the first and second levels. Offices, toilets, mechanical rooms are located off of these stairs. Office work areas are also located within this circulation area which is in violation of building code requirements.

Figure 4.25 Northeast open stair from second floor.

Under current code (780 CMR 3404.13) all required egress stairs must be enclosed. This will be addressed in the proposed design.

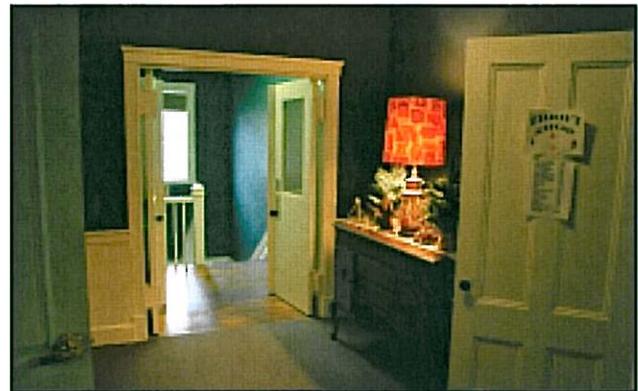
The centrally located stairway has a fire door separating it from the lobby, which was propped open with a wooden wedge. On the second floor level there are double doors separating the stairs from the main level, although these doors do not have a fire rating nor are sealed to prevent smoke from entering the stairwell. Classroom doors on the second floor also open onto the stair landing.

*Figure 4.26 Central hall / elevator lobby at second floor.
Note double doors held open at stair landing.*

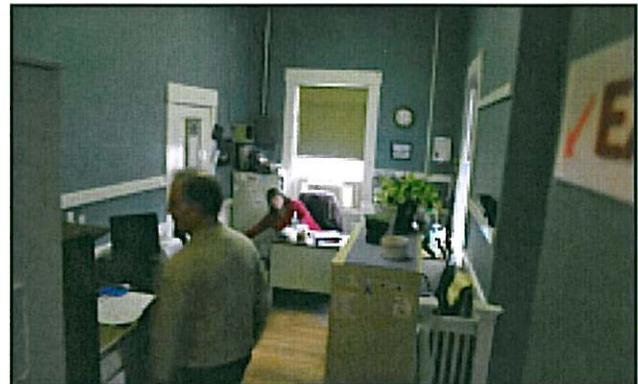
Figure 4.27 Office area in second floor north stair corridor.

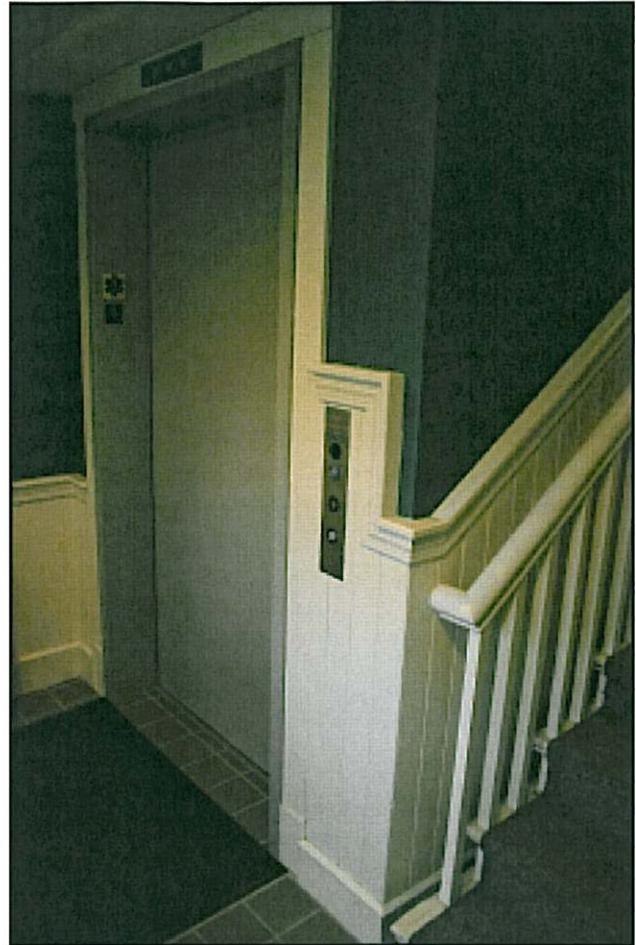
The interior cab size is 80" x 49". This is smaller than what is now required for a medical emergency elevator (80" x 54" minimum inside dimension, 524 CMR 17.40.1d), which is intended to accommodate a stretcher. This elevator would most likely be allowed for continued use. Should there be a need for public use of the basement, another stop would need to be accommodated and the existing shaft/cab size may be grandfathered. A new elevator located in the addition would be required to be stretcher accessible and meet the minimum dimensional requirements noted above.

Figure 4.29 Elevator at mid-level entry.

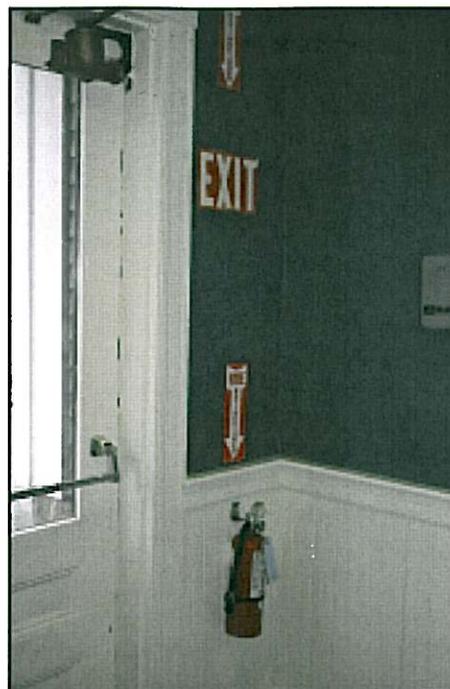
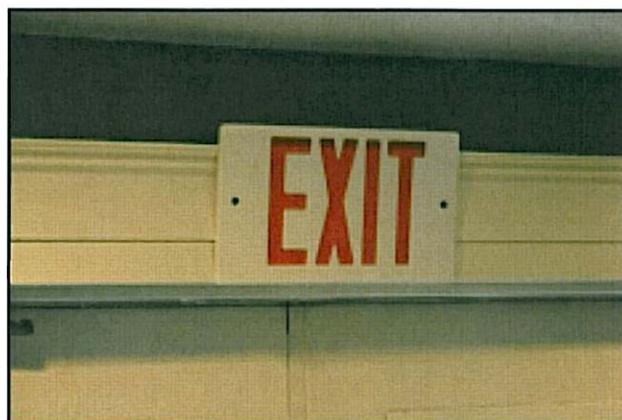
Figure 4.39

Figures 4.39 and 4.40 Non-illuminated emergency signage.

The exit signs are not illuminated and do not appear to be an approved self-luminous type which would provide evenly illuminated letters with a minimum luminance of 0.06 foot lamberts (780 CMR 1023.3). The installation of illuminated signs is required. Battery back-up emergency lighting is also required at exits for safety reasons. There is currently no emergency lighting and it will need to be added.
