# ROAD SAFETY AUDIT

Groton Road (Route 40) at Dunstable Road

Town of Westford

April 25, 2014

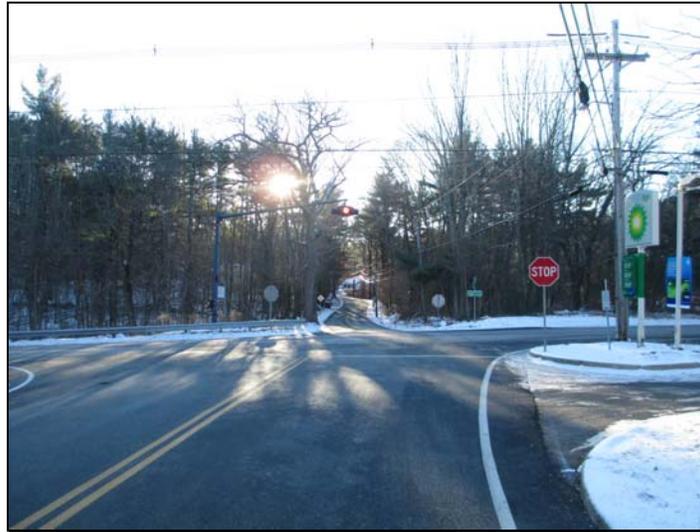
- *Dunstable Road Approach Alignment* – The Dunstable Road approaches to Groton Road are slightly offset, and therefore vehicles exiting the Dunstable Road approaches do not have a direct path to access the opposing Dunstable Road receiving lane. These movements may be difficult for unfamiliar users attempting to cross Groton Road. During multiple field visits, vehicles were observed encroaching over the double-yellow centerline (DYCL) prior to completing the maneuver into the appropriate receiving lane. No head-on collisions have occurred during the study period in the north-south direction; however the alignment was still identified as a safety issue.

Multiple audit participants described how vehicles travelling southbound on Dunstable Road will utilize the roadway as two lanes for which some motorists may be confused to which lane is acting as the through lane if a left-turning vehicle has not properly indicated a left-turn signal. As vehicles attempting to travel straight across the intersection are far-left up against the DYCL, it becomes more difficult to track across the intersection. The side-by-side vehicles on the approach presents a safety issue because of the limited sight distance, especially if the adjacent vehicle is a larger vehicle that blocks the driver’s view.

**Image 1: View of Roadway Alignment from Dunstable Road Southbound Approach**

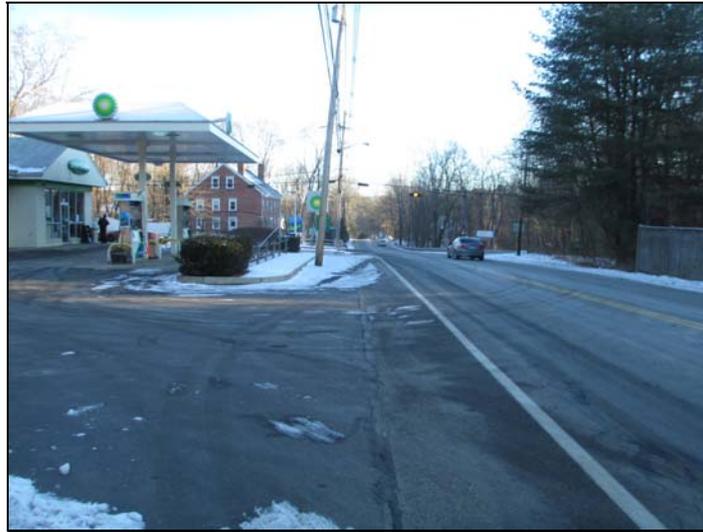
- *Proximity of Adjacent BP Driveways* – Two driveways to the adjacent BP gas station located on the northwest corner of the intersection provide access/egress to/from Groton Road. A third curb-cut is provided along Dunstable Road north of the intersection. These driveways along Groton Road are both within 170 feet of the intersection providing additional conflict points and minimal separation distance from the intersection. Five (5) collisions that occurred within the study area involved or resulted from a vehicle entering or exiting one of the BP gas station driveways.

- *BP Gas Station Driveways Entering Movements* - The owner of the BP gas station noted that vehicles will sometimes enter the Dunstable Road driveway straight from Groton Road westbound without performing the appropriate legal turning maneuvers (right-turn onto Dunstable Road then left-turn into driveway). While making this maneuver, vehicles entering the driveway cross the path of vehicles approaching the STOP line on Dunstable Road southbound. This provides a potential for conflicts with vehicles travelling southbound on Dunstable Road who may be queued or approaching the intersection with limited visibility of the driveway and turning traffic due to vegetation and curves restricting sight distances.

- *BP Gas Station Driveways for Cut-Through Traffic* - It was also mentioned that the gas station driveways are used as a “cut-through” for southbound vehicles along Dunstable Road turning into the gas station only to turn left out of the gas station onto Groton Road. This indicates there are limited gaps within Groton Road traffic and an increase frustration level with queued vehicles.

**Image 2: BP Gas Station Curb-cuts in Relation to Intersection of Groton Road / Dunstable Road**

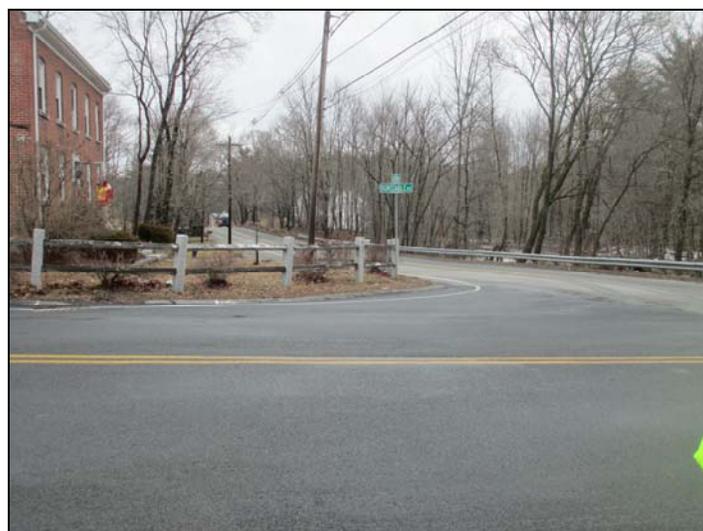
- *Visibility and Sight Distance* – Audit participants noted several challenges in regards to sight distance on all four approaches to the intersection, including:
  - *Set Back STOP Lines* – STOP lines along Dunstable Road are set back 15 feet from the edge of travel-way along Groton Road. This forces vehicles to pull-up beyond the STOP bar to view Groton Road to the east and west before proceeding.
  - *Shrubbery Along North Edge of Groton Road* – There are shrubbery/bushes located within the curb-cut island for the BP gas station and inside the granite/wood fence to the #270 Groton Road property. In season, bushes may provide obstruction to intersection sight lines from Dunstable Road southbound for smaller vehicles.

**Image 3: View of Bushes within Sightline from Dunstable Road Southbound**

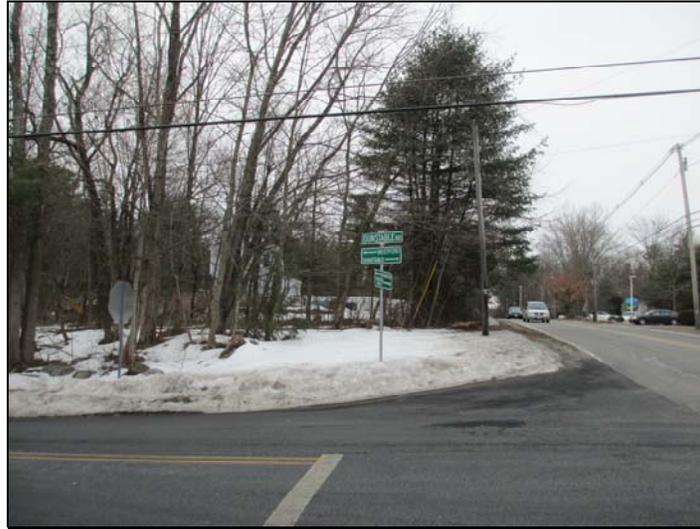
- *Gas Station Sign* – The existing BP gas station sign may block sightlines for larger vehicles on Dunstable Road southbound looking west.
- *Wooden Fence (Private)* – A wooden fence at #259 Groton Road, west of the intersection, blocks the view for vehicles exiting Dunstable Road northbound looking west if not pulled-up to the edge of travel-way.

**Image 4: View of Sight Line on Dunstable Road Northbound Looking West**

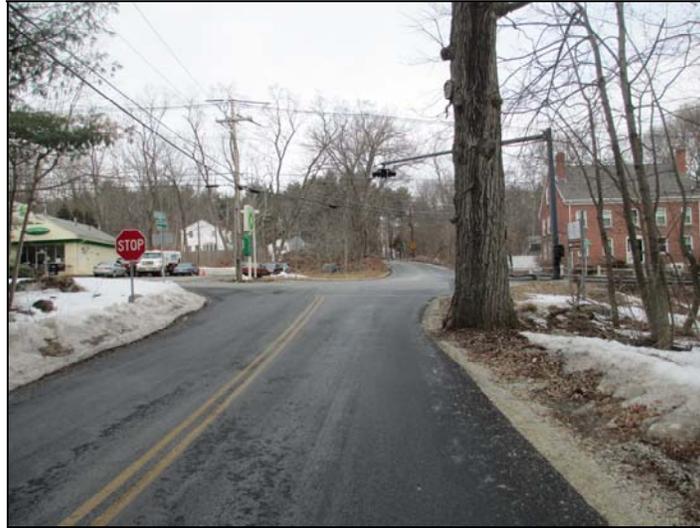
blocks the STOP sign from a point approximately 200-feet to 100-feet from the painted STOP bar.

Immediately north of Groton Road along the westerly edge of Dunstable Road, a large tree (>4' diameter) encroaches into the right-of-way and completely blocks the view of the intersection upstream on horizontal curvature of the roadway. These two trees on either side of Groton Road contribute to the side-street alignment offset at Groton Road.

**Image 5: View of Dunstable Road Northbound From Center of Travel Lane**

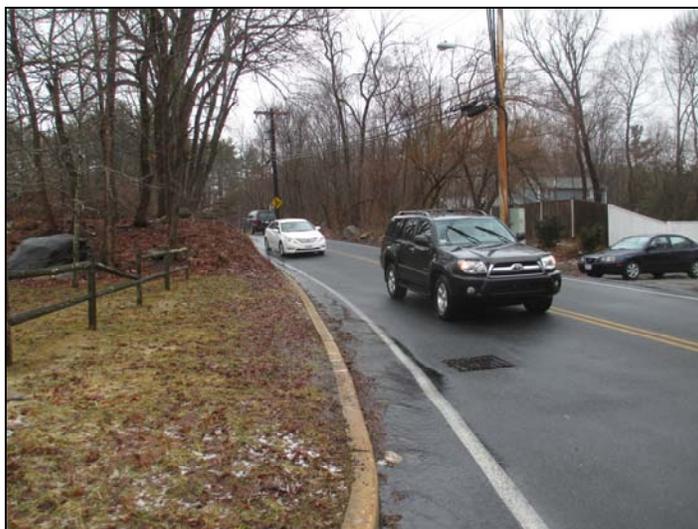
- *Stormwater Drainage and Ponding* – Stormwater drainage structures have been in place prior to the Dunstable Road southbound widening and the BP gas station separated curb-cuts. As a result the drainage structures along Dunstable Road southbound are offset 4-feet from the curb line. Based on the existing roadway crowning, the curb line acts as a gutter for Dunstable Road stormwater by-passing the existing catch basin north of the BP gas station curb-cut. The stormwater continues to the catch basin near the edge line of Groton Road, which is also 5-feet from the curb line. Minor ponding was observed near this catch basin. The crash data indicated that 26% of collisions during the study period involved wet surface roadway.

**Image 6: View of Stormwater By-Passing Catch Basin on Dunstable Road**

- Mill and overlay Groton Road at the intersection with Dunstable Road. Consideration should also be given to mill and overlay the Groton Road corridor. This will improve vehicle traction on the intersection approaches during poor weather conditions and provide a consistent roadway edge line and correct the ponding issue. This improvement is a mid-term, high-cost improvement.

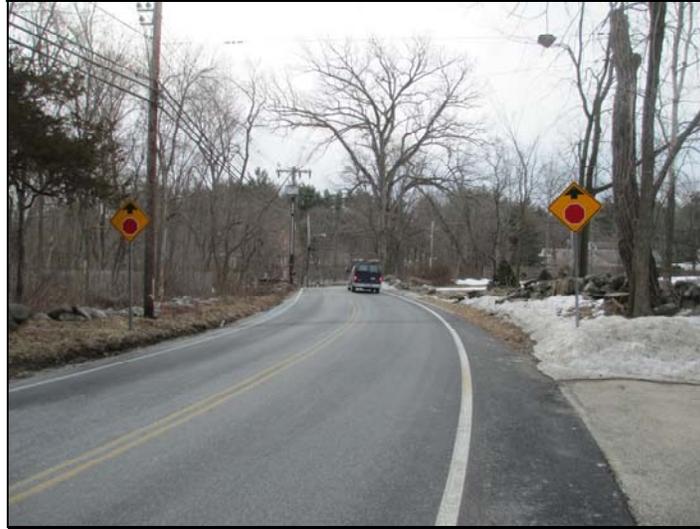
- *Advanced Warning Signage* - Advanced warning signs were recently installed along Groton Road (Route 40) [W2-1 – Intersection Warning] and along Dunstable Road [W3-1 - STOP ahead] by MassDOT in 2013. The MUTCD Section 2C.05 indicates that advanced warning signage should be placed at appropriate locations to provide adequate perception-reaction time (PRT) without being too far in advance that the message being conveyed is forgotten. The advance STOP warning signage on the Dunstable Road southbound approach is approximately 325 feet from the STOP line and may be too far back from the intersection to provide a memorable message.

**Image 7: Advanced Warning Signage Along Dunstable Road Southbound Approach**

In addition, the Dunstable Road northbound approach has three (3) separate advanced STOP warning signs. This includes two (2) signs directly opposing one another approximately 160 feet from the intersection and one (1) approximately 400 feet south of the intersection, bolted to an adjacent tree. Since the additional advance warning signage has been implemented, there is no clear indication that a reduction in collisions has occurred.

Safety Issue	Potential Safety Enhancement	Safety Payoff	Time Frame	Cost	Responsibility
Advanced Warning Signage (Continued)	Investigate the removal and replacement of ALL advanced warning signage based on appropriate visibility and queues for the potential installation of roundabout control or traffic signal control.	Medium	Long-Term	Low	Town
Lateral Offset of Signage	Reset STOP signage (pending no change in traffic control) on Dunstable Road to be compliant with MUTCD lateral offset standards.	Low	Short-Term	Low	Town
Pedestrian and Bicycle Accommodations	Consider installation of sidewalks along Groton Road and Dunstable Road and bicycle lanes / shoulders along Groton Road.	Medium	Long-Term	High	Town / Property Owners
Public Education	Utilize Town of Westford online social networks (such as Twitter) to inform public on intersection crashes, advisories, and speed.	Medium	Short-Term	Low	Town
Enforcement	Conduct a speed study to establish a legal speed limit on Groton Road to allow for easier enforcement. Based on current traffic speeds collected by ATR counts, the posted speed limit may not change from its current 40 MPH.	Medium	Short-Term	Low	Town / MassDOT

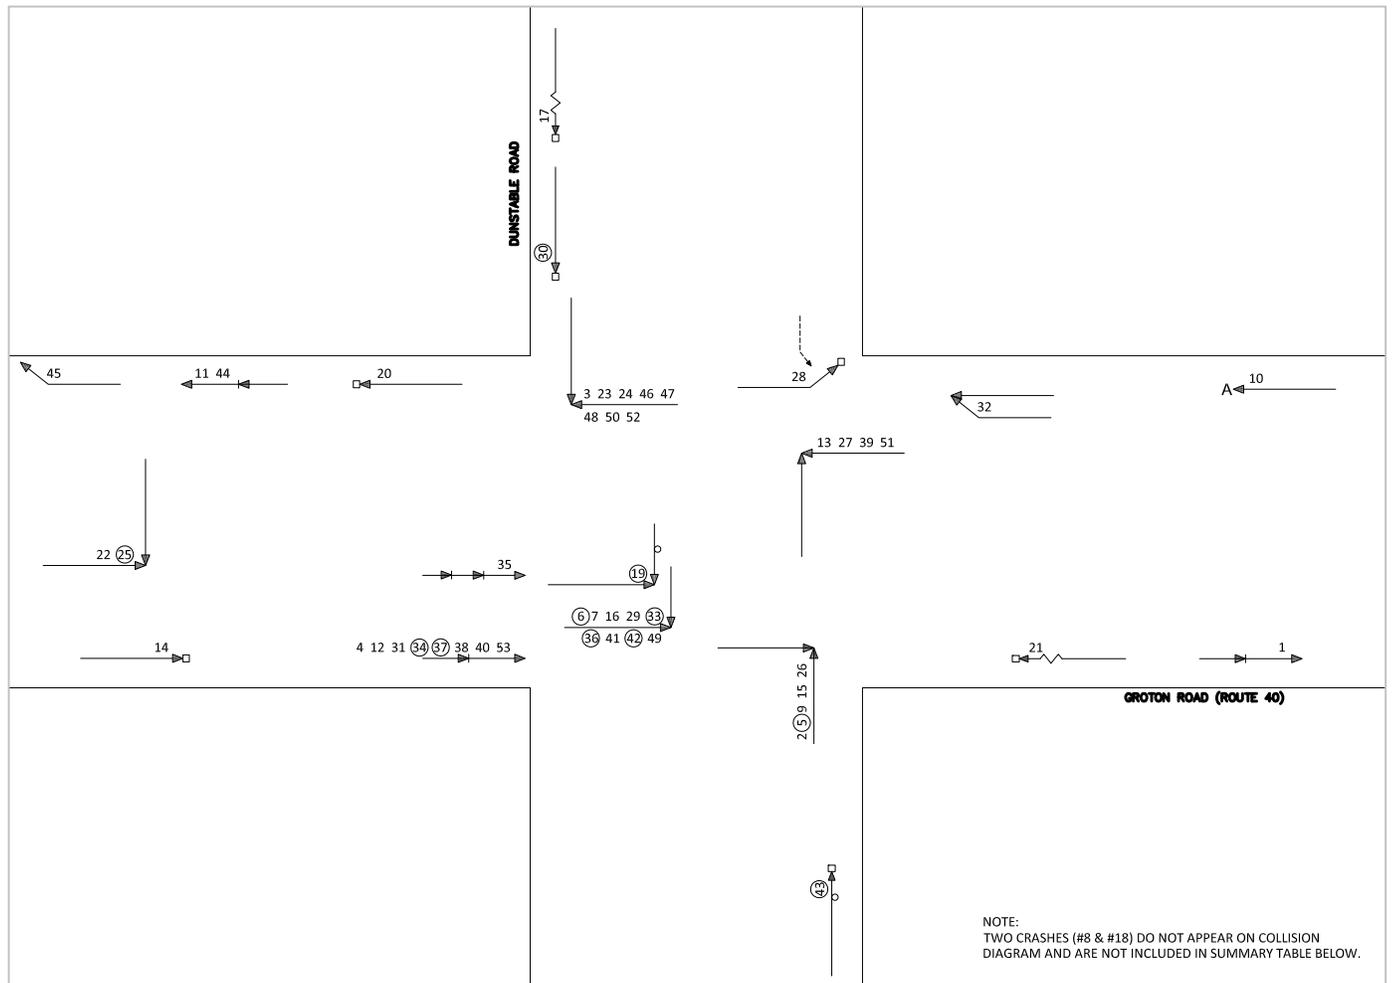
**Figure C-1**

There were twenty-nine (29) angled collisions (55%) at the intersection over the five-year period which represents the vast majority of collisions at the intersection of Groton Road / Dunstable Road. Approximately two-thirds (19 of 29) of these angled collisions were a result of failing to yield the right-of-way to the operator along Groton Road according to the narratives provided. All angled collisions at the intersection occurred during periods of daylight between 6:50 AM and 7:05 PM. Only one (1) of the angled collisions resulted in a non-fatal injury. Eighteen (18) of the angled collisions (62%) involved a vehicle exiting Dunstable Road southbound north of the intersection.
