FIELD REPORT No. 01

ROUDENBUSH COMMUNITY CENTER REHABILITATION

DATE/TIME: Nov 1 – 8, 2017
PURPOSE: Construction Progress Summary
PRESENT: Don Mills, Architect / Mills Whitaker Architects LLC
Ron Marsden, Architect's Site Rep (Clerk) / Delmont Construction Service
Bill Kennison, Owner's Project Manager / Town of Westford
Jeanne Roberts, Permanent Town Building Committee / Town of Westford (on 11/1)
Steve Salemi, Project Manager / NELCO Worldwide
Stevan Gauthier, Project Superintendent / NELCO Worldwide
LOCATION: On Site

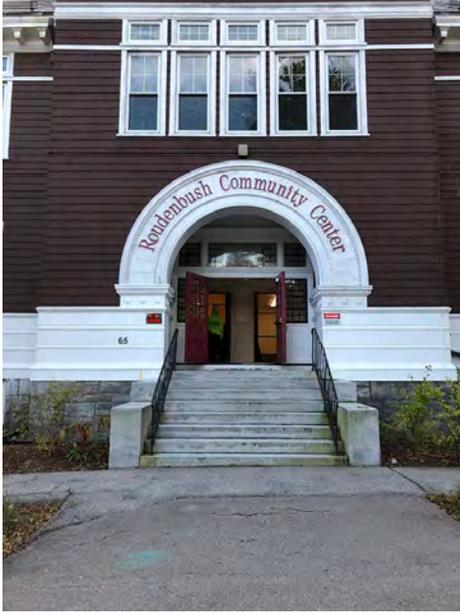
171101-IMG_7240.jpg

Front Entrance with Historic Plaques Removed For Storage and Protection During Construction

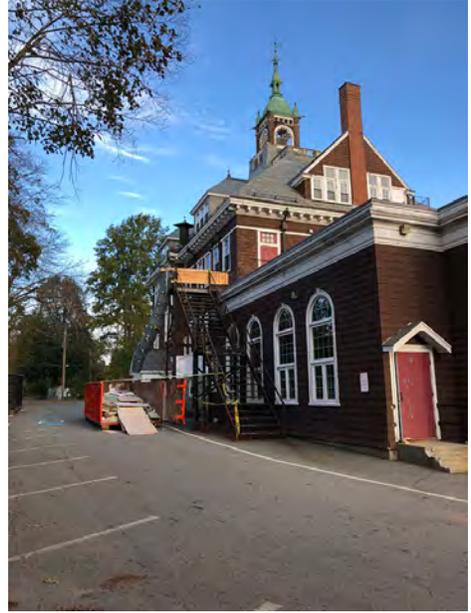
171101-IMG_7237.jpg

Entrance Driveway Side with Dumpster and Chute From Upper Level at Gym Roof for Demolition Debris

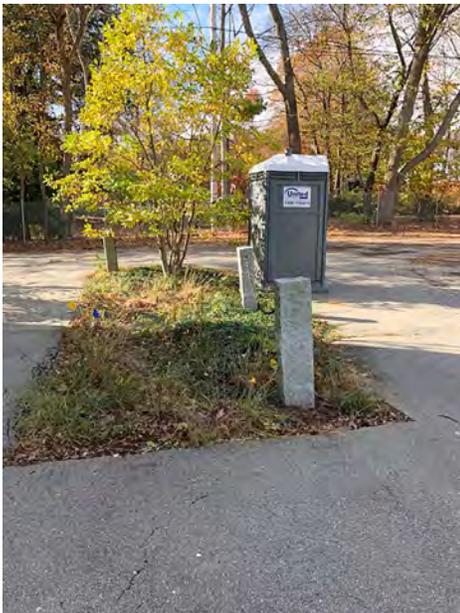
171108-IMG_6819.jpg

One of Two Portable Toilets at Front Driveway

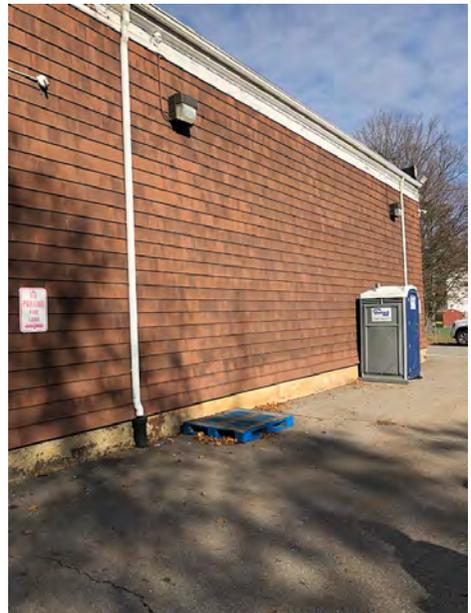
171108-IMG_0640.jpg

Two of Two Portable Toilets at Rear Facade

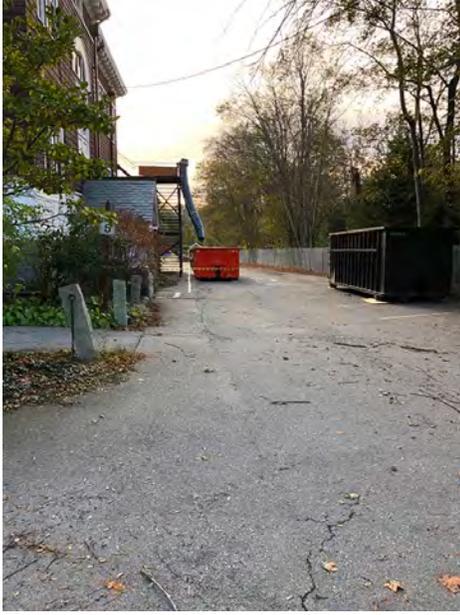
171101-IMG_7242.jpg

Two Dumpsters at Entrance Drive for Separation and Sorting of Construction Waste

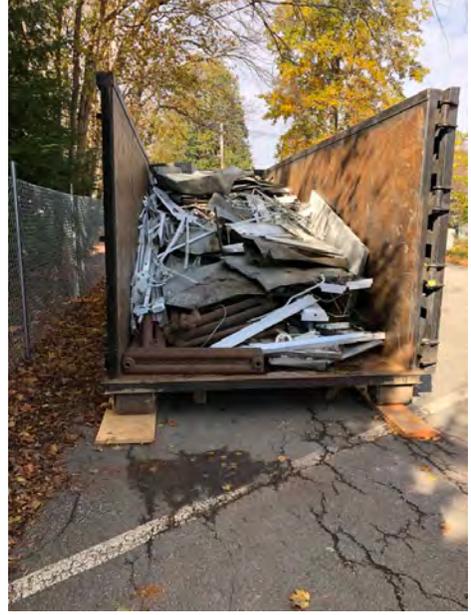
171108-IMG_6280.jpg

Metals Disposal in Separate Dumpster

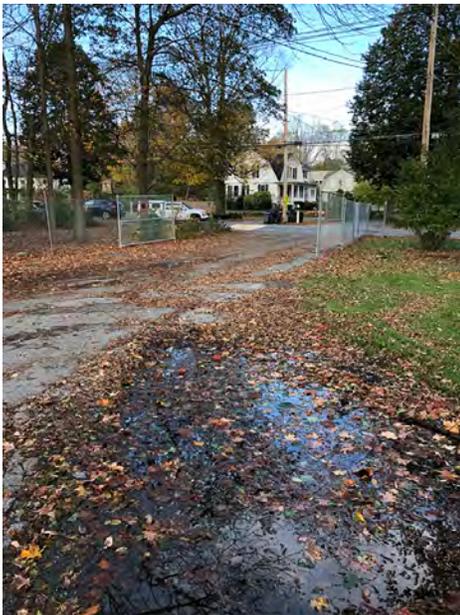
171101-IMG_7241.jpg

Entrance Driveway Gates at Temporary Fencing

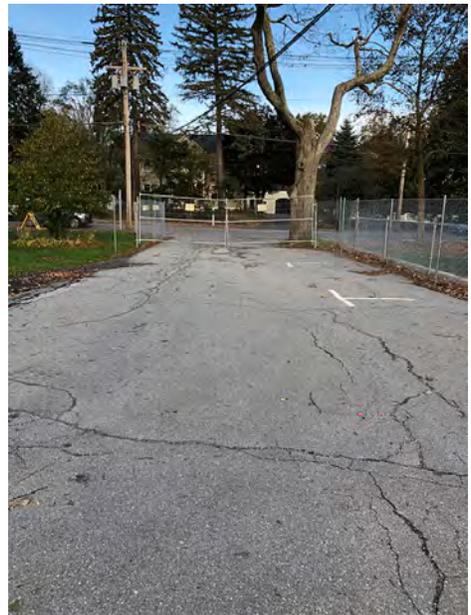
171101-IMG_7239.jpg

Exit Driveway Gates at Temporary Fencing

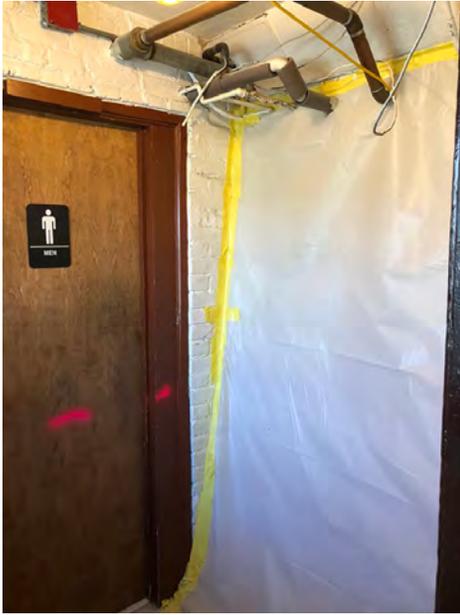
171108-IMG_1397.jpg

Asbestos Containment Adjacent to Men's Room at East Entrance Stair Landing of Ground Floor

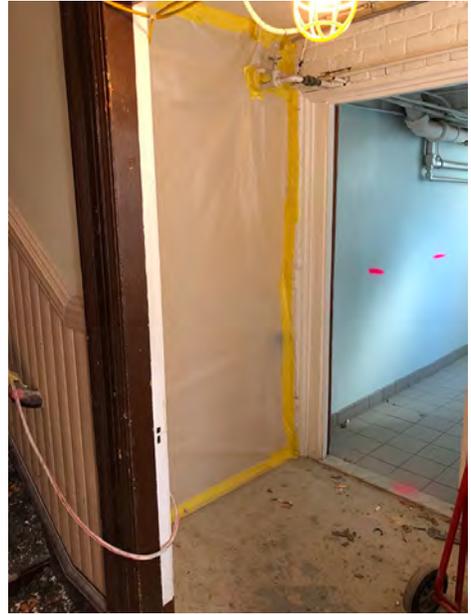
171108-IMG_3218.jpg

Asbestos Containment Adjacent to Women's Room at West Entrance Stair Landing of Ground Floor

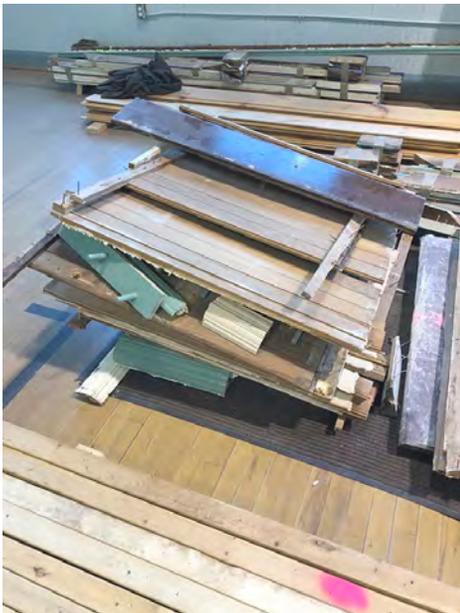
171108-IMG_3871.jpg

Salvaged Materials Stored in Gymnasium

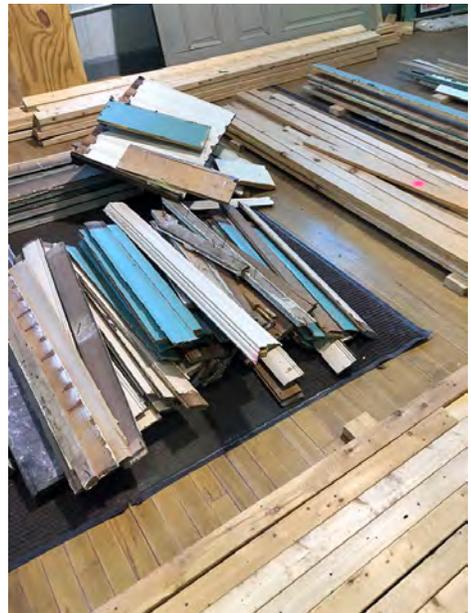
171108-IMG_8419.jpg

Salvaged Materials Stored in Gymnasium

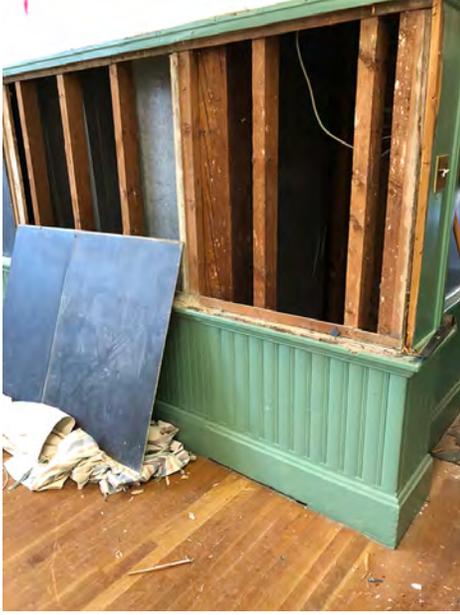
171101-IMG_7254.jpg

*Ventilation Shaft Removal in Process at Classroom 2
in Vicinity of Future Elevator Hoistway*

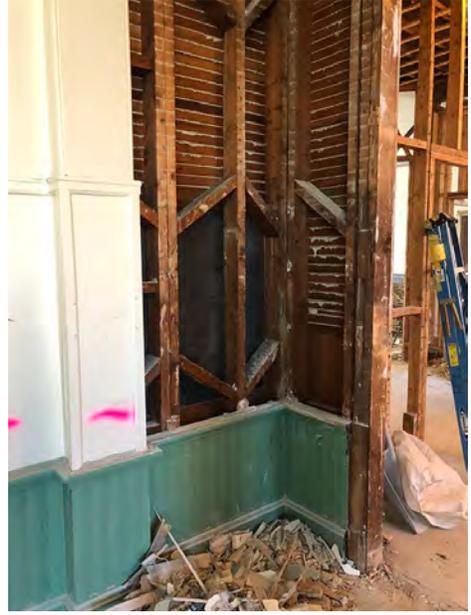
171108-IMG_1009.jpg

*Removal of Finishes in Process at Avis Lounge
at Future Central Lobby Area*

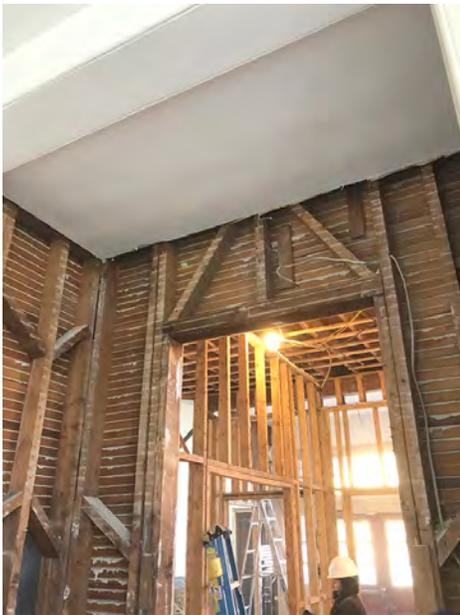
171108-IMG_7629.jpg

*Plaster and Lath Removed at Avis Lounge Entrance;
Stair Lobby and Front Vestibule Beyond*

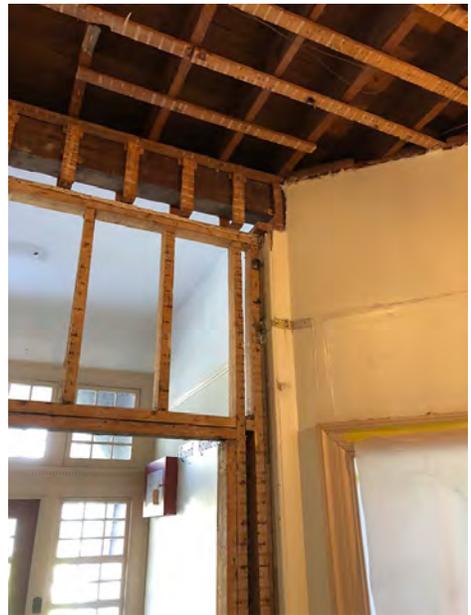
171108-IMG_1139.jpg

*Finishes Removed at Front Vestibule Adjacent
to Director's Office at Right*

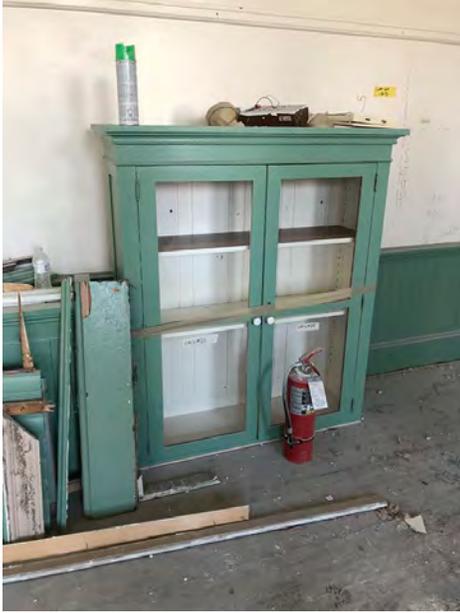
171108-IMG_7835.jpg

Avis Lounge Bookcase Salvaged for Relocation

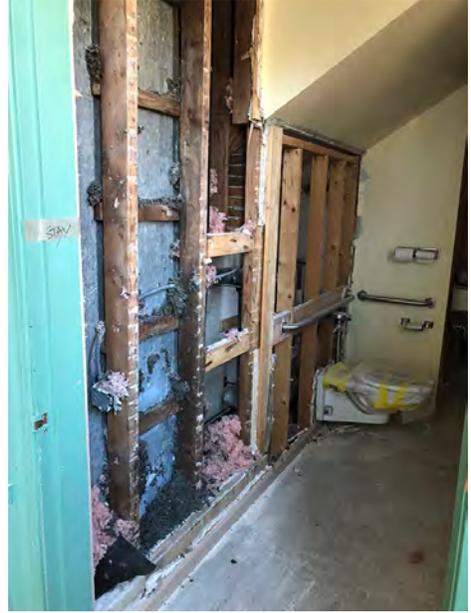
171108-IMG_1371.jpg

Accessible Toilet Room Demolition in Avis Lounge

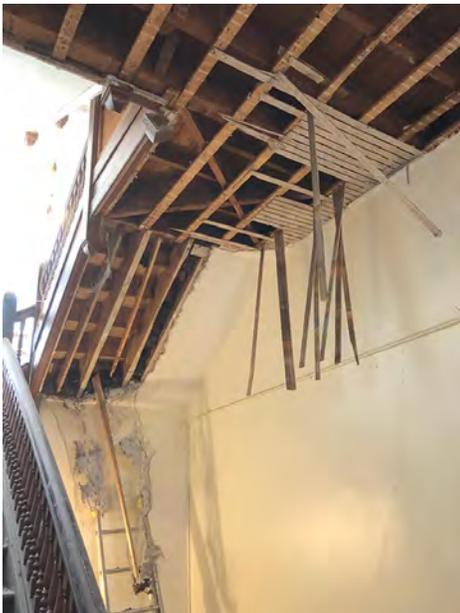
171108-IMG_4228.jpg

- 01.5 Plaster and lath was intended to be removed from the walls of the east and west stairways as noted in the new floor plans, partition note P7: "Provide gypsum wallboard in the same plane as the previous plaster." However, there was no demolition note regarding the required removal from the walls. The walls in these two stairways should be treated in the same way as the ceilings per demo note C1. Some of the plaster surfaces were already being removed due to related work, so this will extend removal to include all adjacent wall surfaces in these stairways. GC shall provide a cost proposal for this change.

Plaster and Lath Removal at West Stair Ceiling

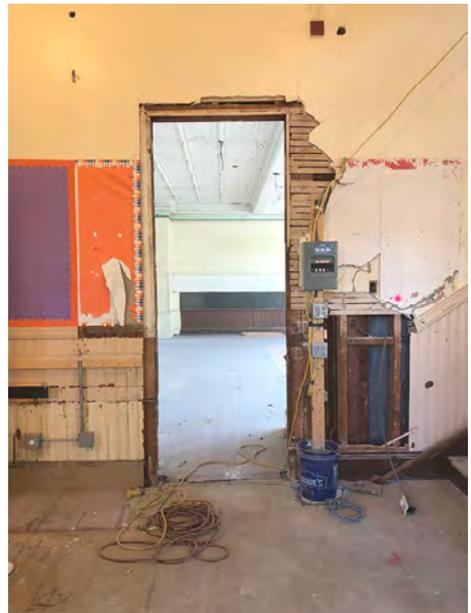
171108-IMG_6774.jpg

Demolition in Process at Stair Hall Area

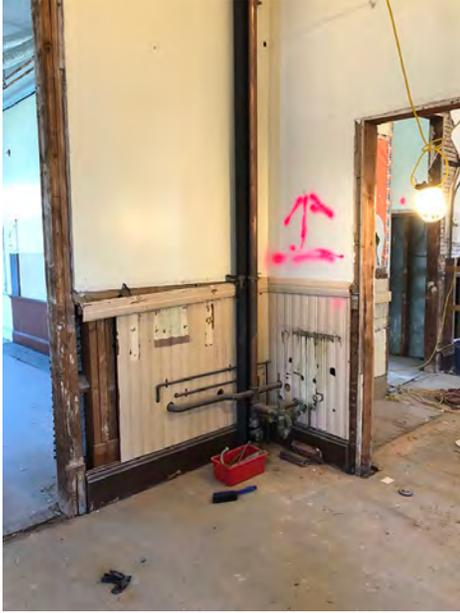
171108-IMG_8824.jpg

Janitor's Sink Removed from East Stair at Second Floor

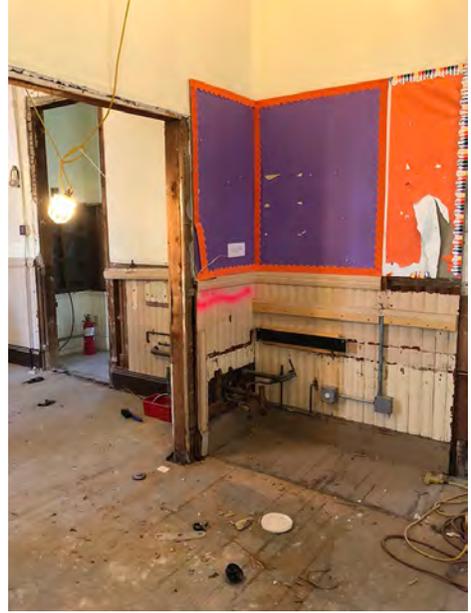
171108-IMG_4347.jpg

Kitchenette Removed from West Stair at Second Floor

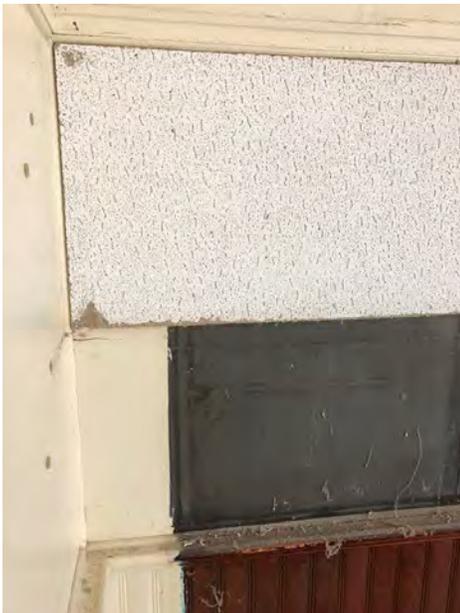
171108-IMG_0889.jpg

*Cubbies Removed from South Wall of Classroom 4
Revealing Formerly Concealed Chalkboard*

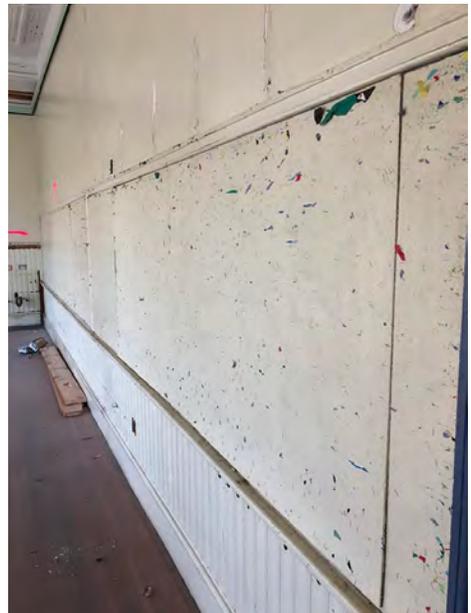
171108-IMG_0865.jpg

- 01.6 Existing painted homosote covering former chalkboards was indicated in the interior elevation drawings to be retained in most cases where walls were not being disturbed. After the tenant moved out and all former exhibits were removed from the homosote, it became clear that the materials are riddled with staples and holes and this material should be removed. The GC is requested to provide a proposal for removal and replacement of the painted homosote to match the design intent.

Typical Painted Homosote over Concealed Chalkboard

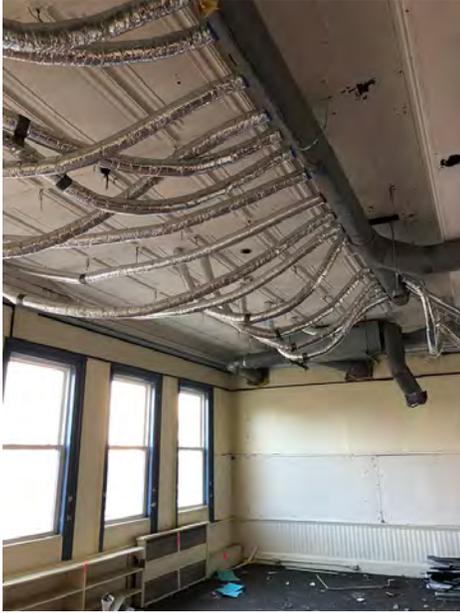
171101-IMG_7245.jpg

Second Floor Classroom 3 Following Removal of Acoustical Ceiling to Reveal High Velocity HVAC Ducts Penetrating Ceiling to Third Floor Above

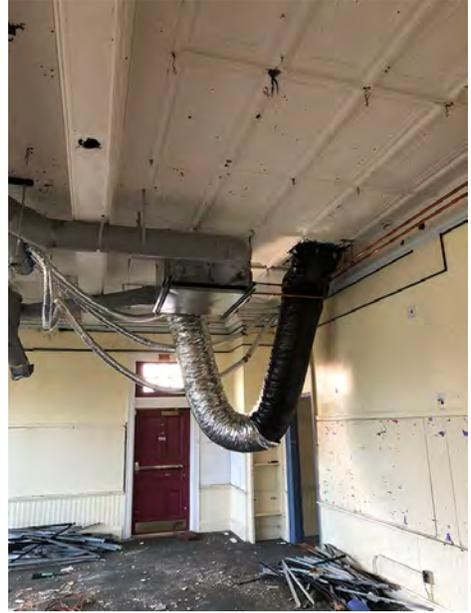
171101-IMG_7246.jpg

Second Floor Classroom 3 Following Removal of Acoustical Ceiling; Return Duct from Third Floor Above

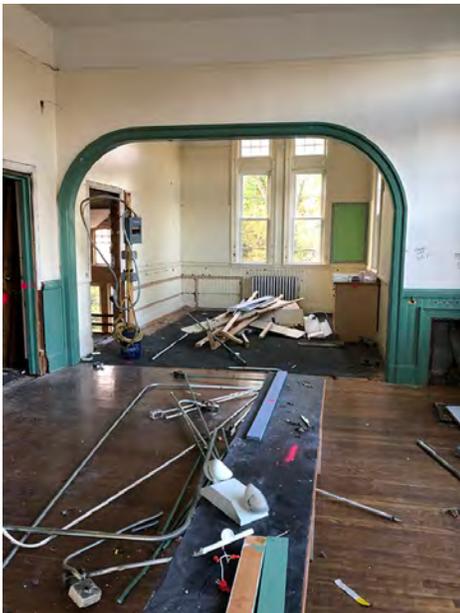
171101-IMG_7247.jpg

Looking West in Classroom 5 to Kitchen

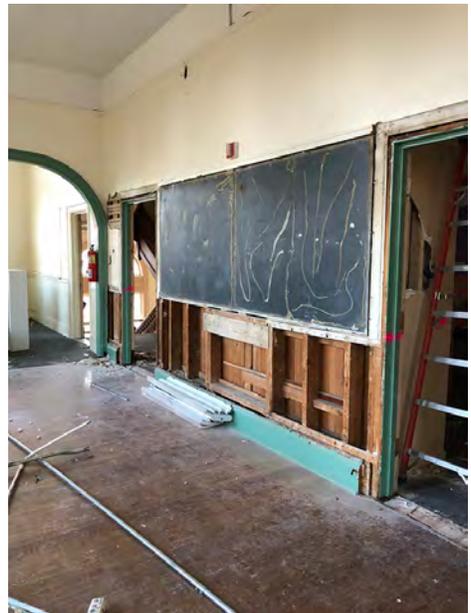
171101-IMG_7249.jpg

South Wall of Classroom 5

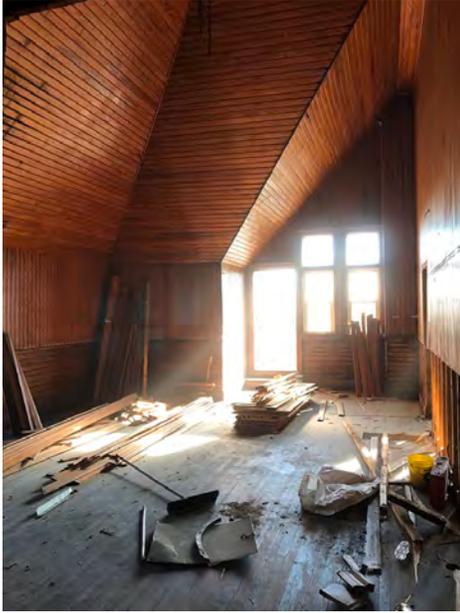
171108-IMG_1956.jpg

*Third Floor at SE Corner of Original Gym Area;
Fire Escape Exit Door Beyond to be Removed*

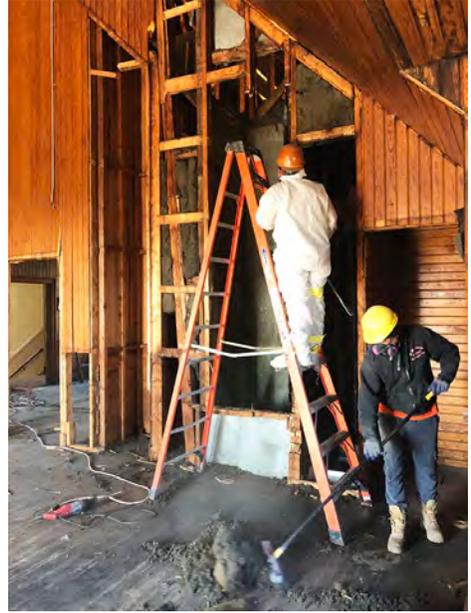
171108-IMG_0443.jpg

Removal of Ventilation Shaft at Third Floor

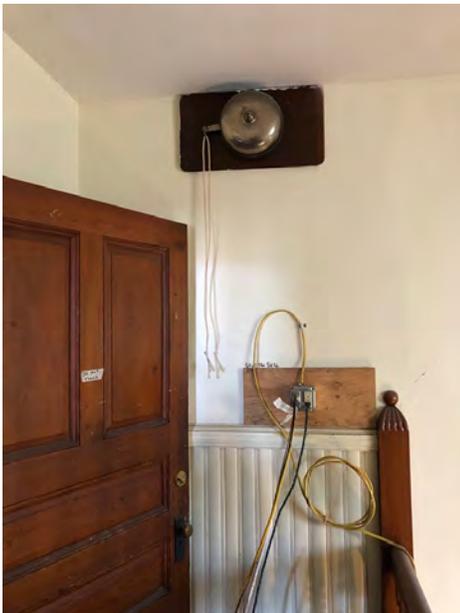
171108-IMG_6366.jpg

Original School Bell at Third Floor of West Stair

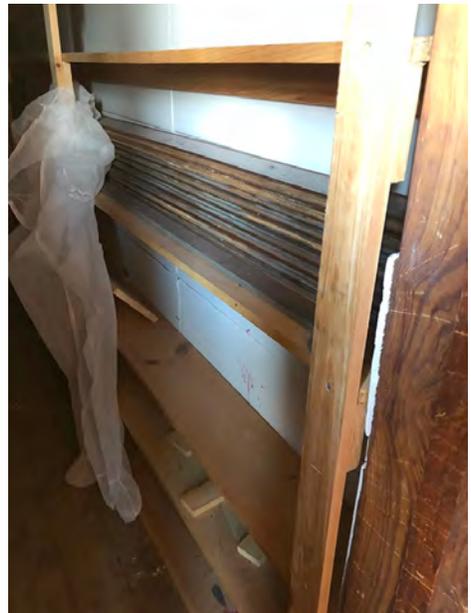
171108-IMG_1561.jpg

*Salvaged Inscribed Wainscoting Temporarily
Stacked in Closet Shelves for Reinstallation*

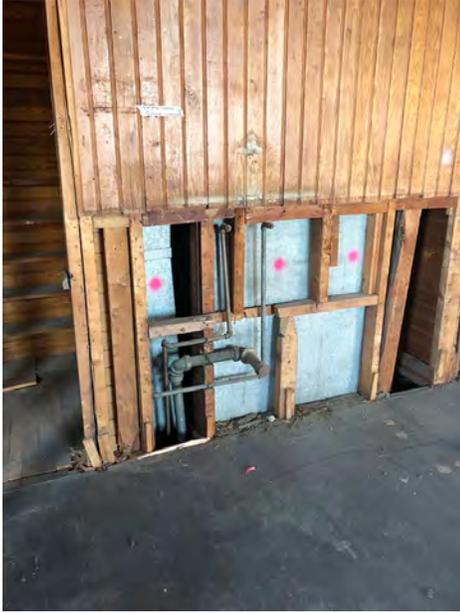
171108-IMG_4987 3.jpg

Former Plumbing and Ventilation Ducts in Shaft

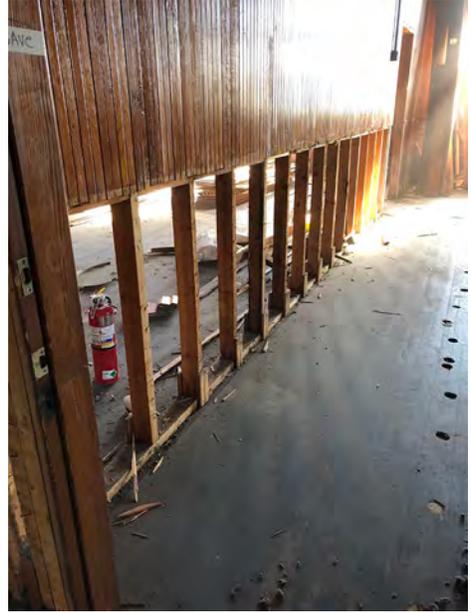
171108-IMG_5562.jpg

Lower Wainscoting Removed at 1929 Wall Between Rooms at Third Floor Former 1897 Gym

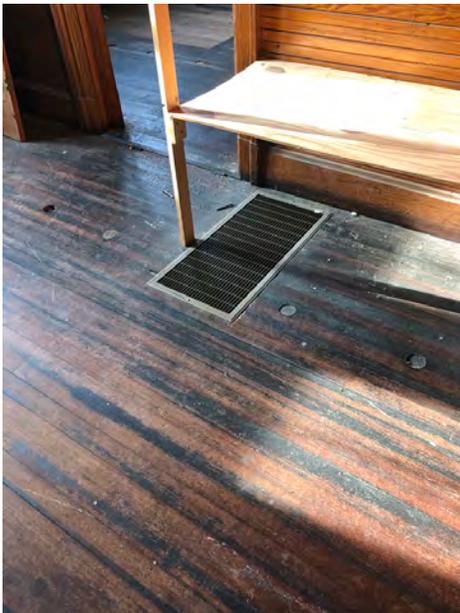
171101-IMG_7252.jpg

Return Air Grille in Third Floor

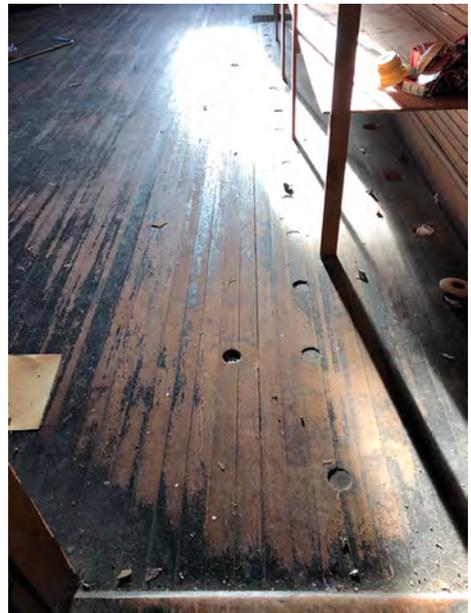
171101-IMG_7251.jpg

Drilled Holes in Third Floor Boards
