FIELD REPORT No. 02

ROUDENBUSH COMMUNITY CENTER REHABILITATION

DATE/TIME: Nov 9 – 29, 2017 (Project Meetings on Nov 15, 22 & 29)
PURPOSE: Construction Progress Summary
PRESENT: Don Mills, Architect / Mills Whitaker Architects LLC
Ron Marsden, Architect's Site Rep (Clerk) / Delmont Construction Services
Bill Kennison, Owner's Project Manager / Town of Westford
Jeanne Roberts, Permanent Town Building Committee / Town of Westford (11/22, 11/29)
Steve Salemi, Project Manager / NELCO Worldwide
Stevan Gauthier, Project Superintendent / NELCO Worldwide
Greg Nowak, Structural Designer / Structures North Consulting Engineers (11/29)
Eric Cederholm, PE (Shoring Engineer for NELCO) / Transition Engineering (11/29)

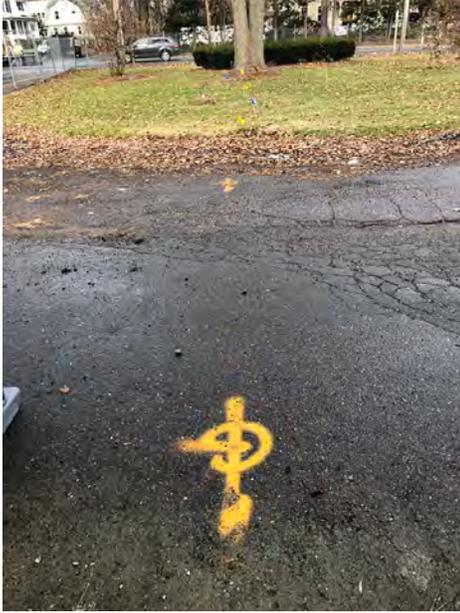
171129-IMG_7408.JPG

*Existing Gas Line Marked at Circular Driveway;
Existing Water Line is Adjacent*

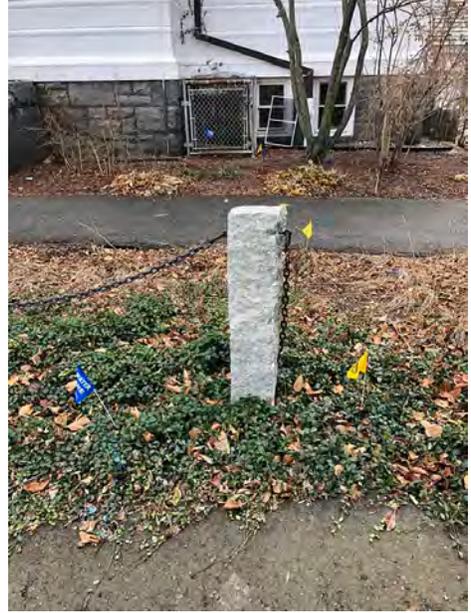
171129-IMG_7409.JPG

*Blue Flags (at Left) Designate Water Line;
Yellow Flags (at Right) Designate Gas Line*

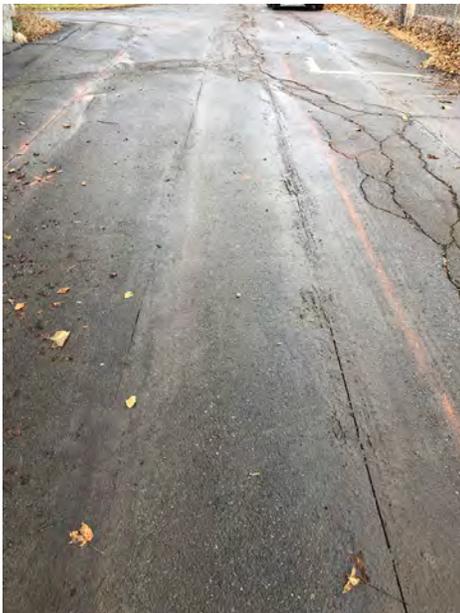
171129-IMG_7410.JPG

*Saw Cutting at Exit Drive for Pavement Removal for
New Electrical Service and Water Line Re-Routing*

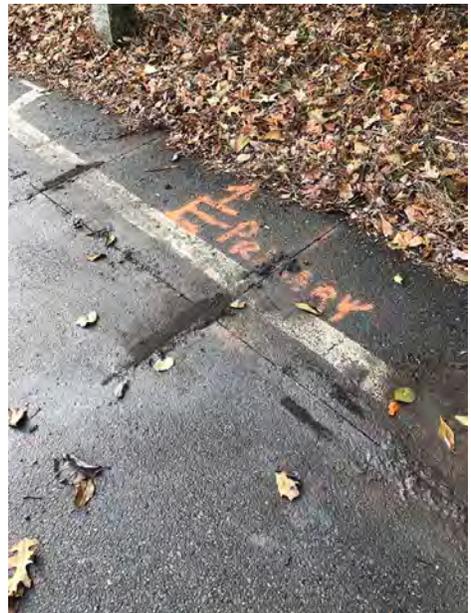
171129-IMG_7411.JPG

*Pavement Marking for Underground Electrical
Line Into Building ("Primary" is Inaccurate; Location as
Shown is for "Secondary" from Transformer into Building)*

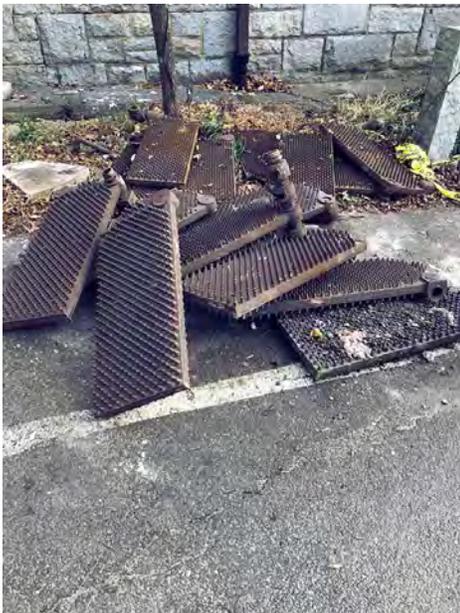
171129-IMG_7418.JPG

Cast Iron Heating Units from Base of Ventilation Shafts at Ground Floor Level

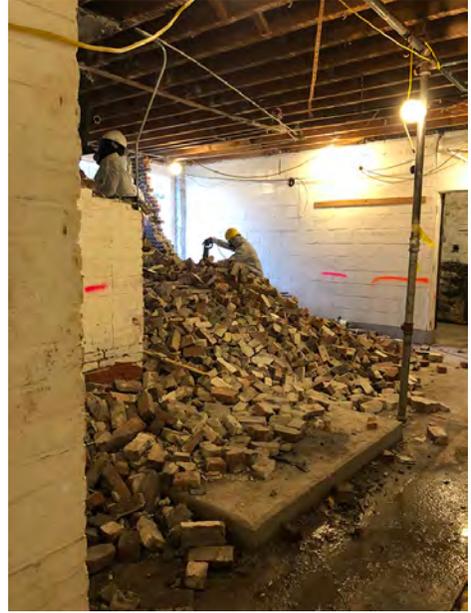
171122-IMG_7378.JPG

Boiler Room During Demolition of Men's Room Beyond

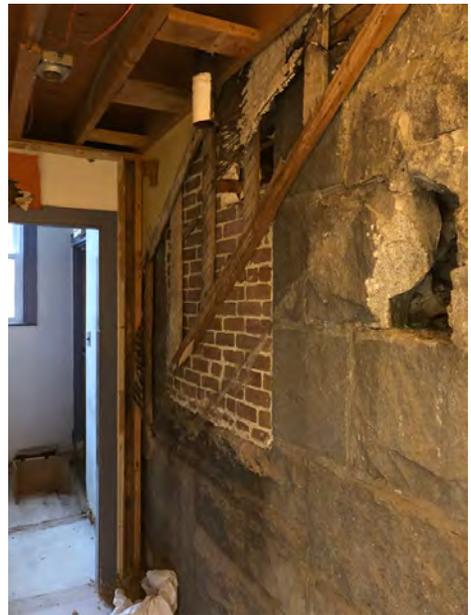
171122-IMG_7391.JPG

Previously Removed 1929 Stair at SW Corner of Original Building in Gym Addition; Removal Date Unknown

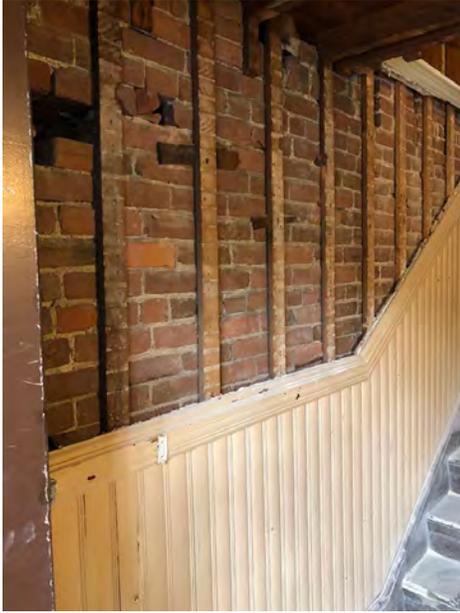
171129-IMG_7421.JPG

Former Bulky Wall-Mounted Radiator Removed from Wall at Ground Floor Landing in West Stair; Deteriorated Plaster Removed; Wainscoting Preserved

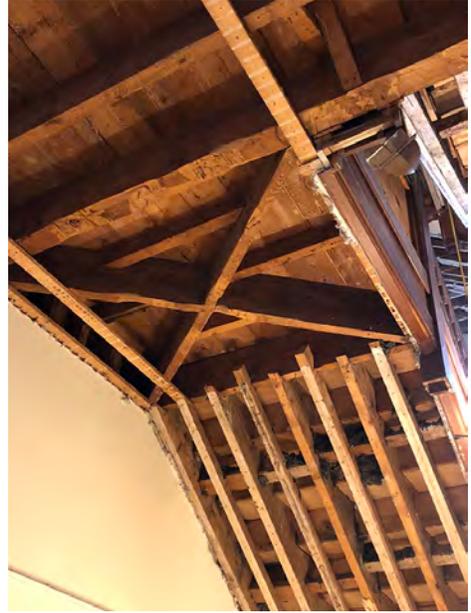
171122-IMG_7402.JPG

Diagonal Framing Below Second Floor Stair Landing Bridging Between Adjacent Newel Posts

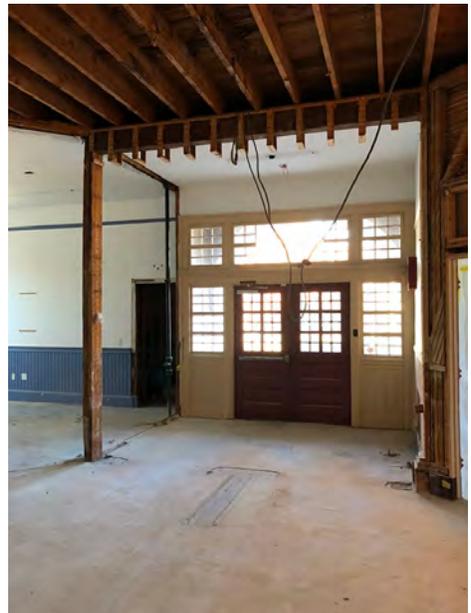
171115-IMG_7329.JPG

Entrance Vestibule Configuration to be Modified for Provision of Access Via Reception Office at Left

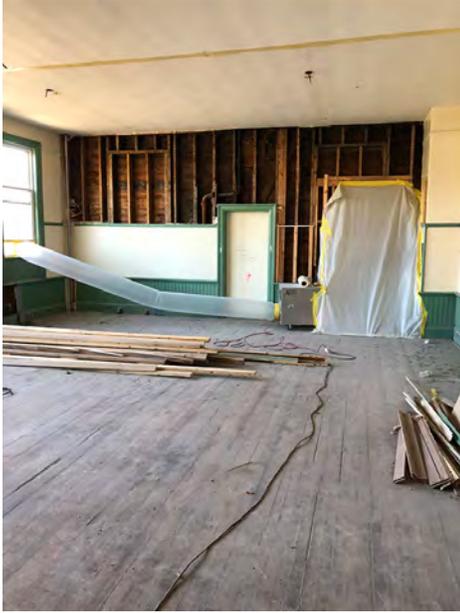
171115-IMG_7330.JPG

*Containment for Targeted Asbestos Removal;
Removal in Storage Area Beyond Avis Lounge
and Classroom 2 in Process*

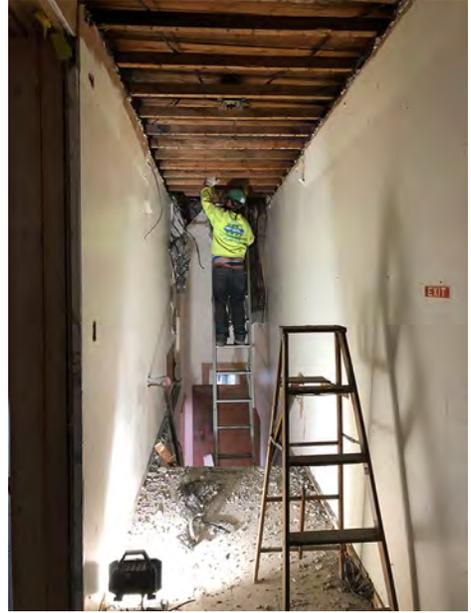
171122-IMG_7387.JPG

*Storage Hallway Behind Avis Lounge and
Classroom 2 After Asbestos Removal*

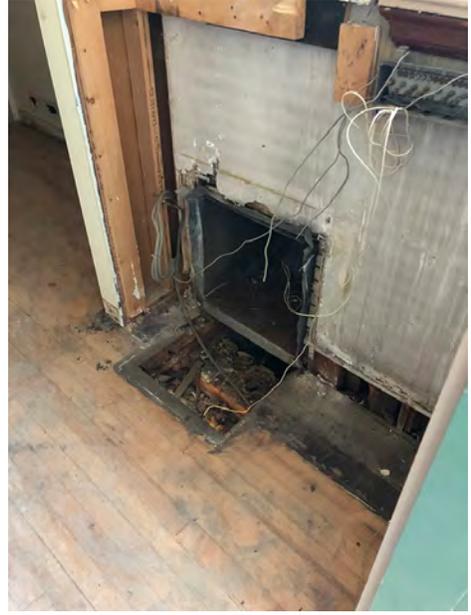
171115-IMG_7340.JPG

Former Transition of Toilet Exhaust Duct at Former Avis Lounge Accessible Toilet Room

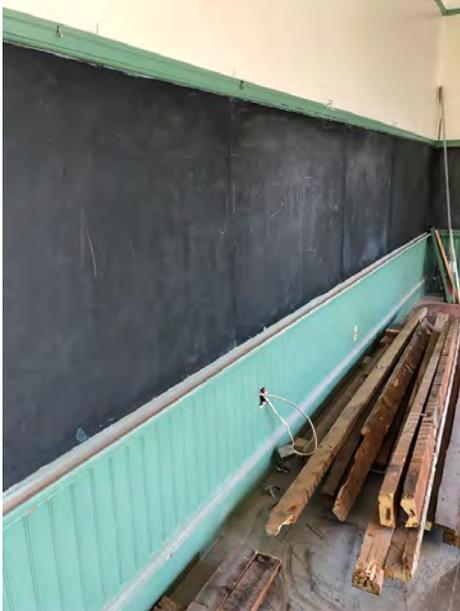
171129-IMG_7426.JPG

Wainscoting and Chalkboard at Classroom 2; Painted Homosote was Held in Place with Wood Trim at First Floor (No Adhesive Daubs)

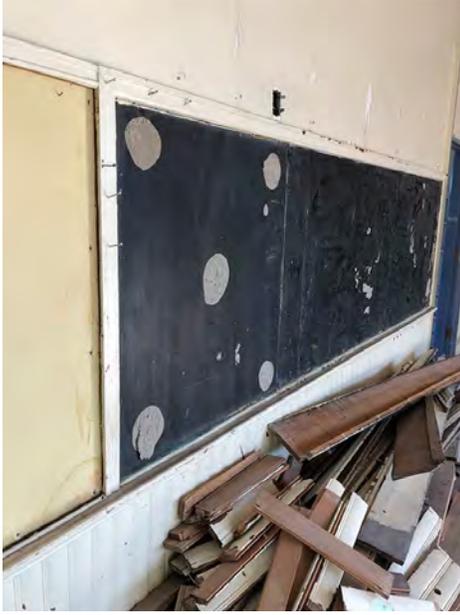
171129-IMG_7424.JPG

Adhesive Daubs on Original Chalkboards After Removal of Painted Homosote on Second Floor

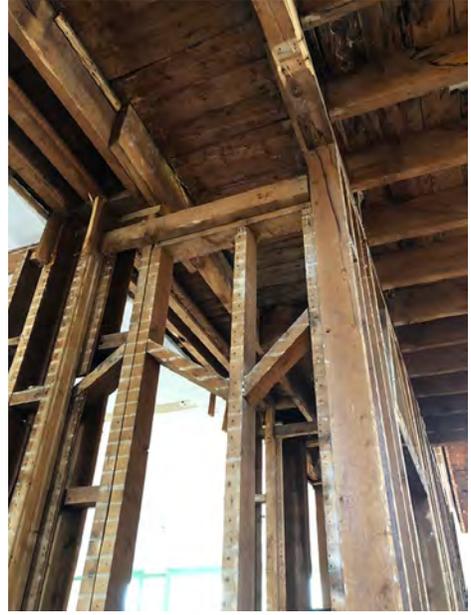
171129-IMG_7423.JPG

Duct Above Entry to Second Floor Classrooms 3 + 4 Revealed Gap in Floor Joist Spacing

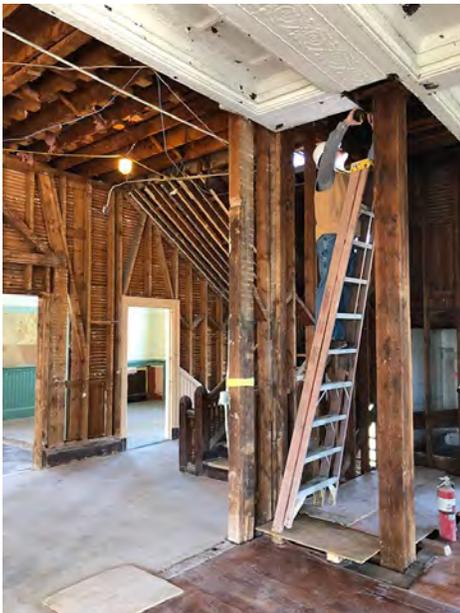
171129-IMG_7425.JPG

Tin Ceiling at Second Floor Preserved; Deteriorated Plaster Removed

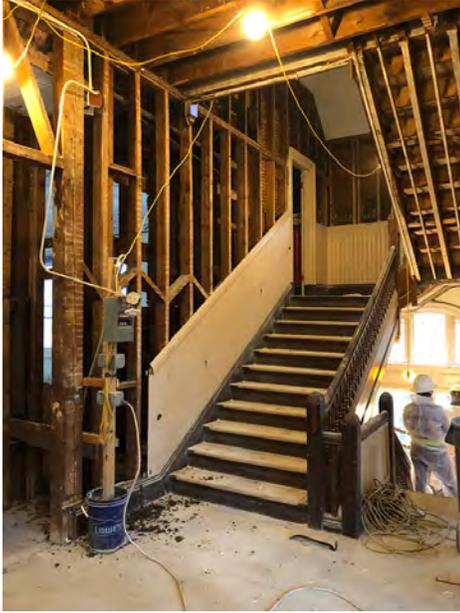
171122-IMG_7381.JPG

Deteriorated Plaster Removal in Process at West Stair on Second Floor; Wainscoting Preserved

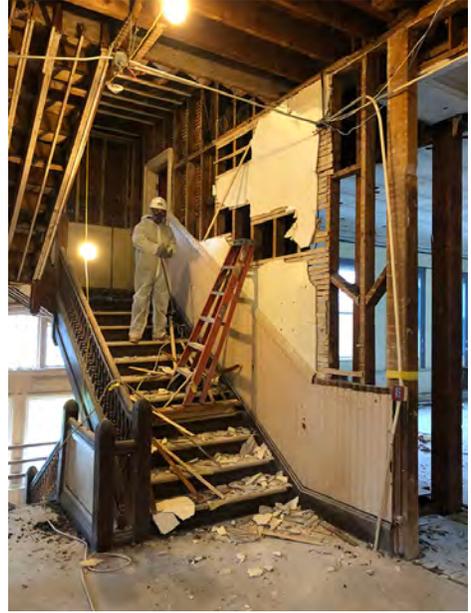
171122-IMG_7382.JPG

Deteriorated Plaster Removal in Process at East Stair on Second Floor; Wainscoting Preserved

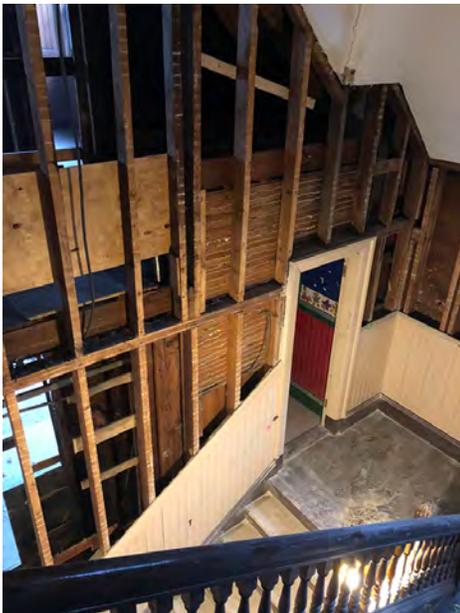
171122-IMG_7386.JPG

*Deteriorated Plaster Removed at Walls of Stairway;
Door Opening to Water Closet at Stair Landing*

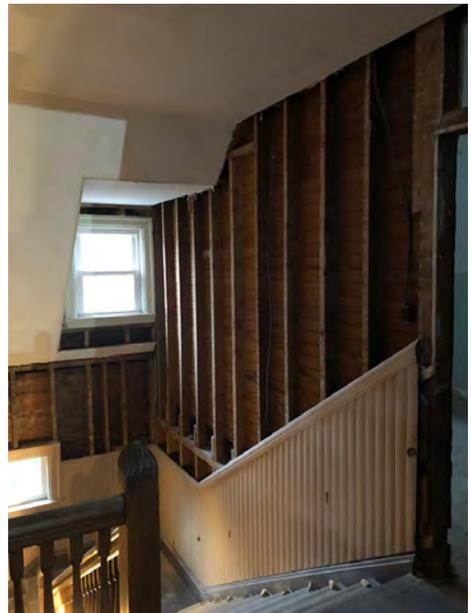
171122-IMG_7385.JPG

*Deteriorated Plaster at Stairway Walls Removed at
Third Floor; Ceilings to Follow; Wainscoting Preserved*

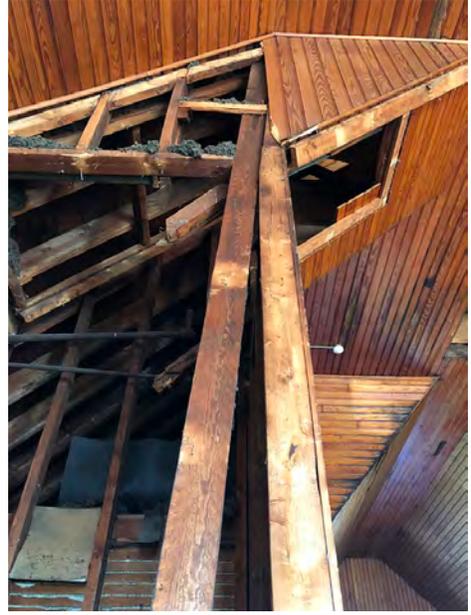
171115-IMG_7359.JPG

Angled Post Transfers Loads from Cupola Structure to Post Below at Former Ventilation Shaft; Post Below Also Support Tin Clad Steel Beam at Second Floor Ceiling
