FIELD REPORT No. 03

ROUDENBUSH COMMUNITY CENTER REHABILITATION

DATE/TIME: Nov 30, 2017 – Jan 3, 2018 (Project Meetings on Dec 6, 13, 20 & Jan 3)
PURPOSE: Construction Progress Summary
PRESENT: Don Mills, Architect / Mills Whitaker Architects LLC
Ron Marsden, Architect's Site Rep (Clerk) / Delmont Construction Services
Bill Kennison, Owner's Project Manager / Town of Westford
Jeanne Roberts, Permanent Town Building Committee / Town of Westford (12/20; 01/03)
Steve Salemi, Project Manager / NELCO Worldwide
Stevan Gauthier, Project Superintendent / NELCO Worldwide
Alexander Castelluccio, Project Administrator / NELCO Worldwide (12/06; 12/20)
Shawn Chamberlin, Safety Coordinator / NELCO Worldwide (12/06)

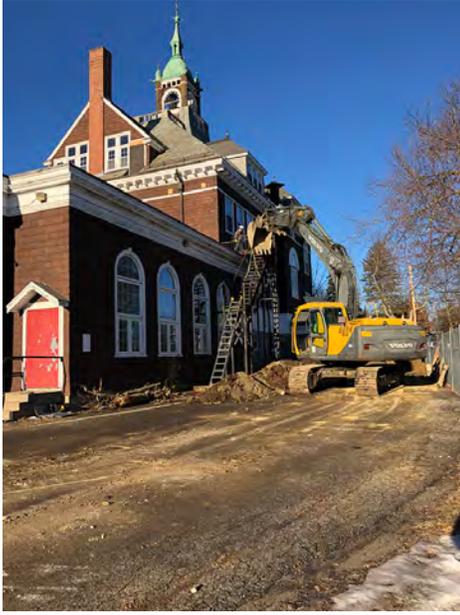
171220-IMG_7576.jpg

Fire Escape Stair Removal in Process at East Facade of Gym at Exit Driveway

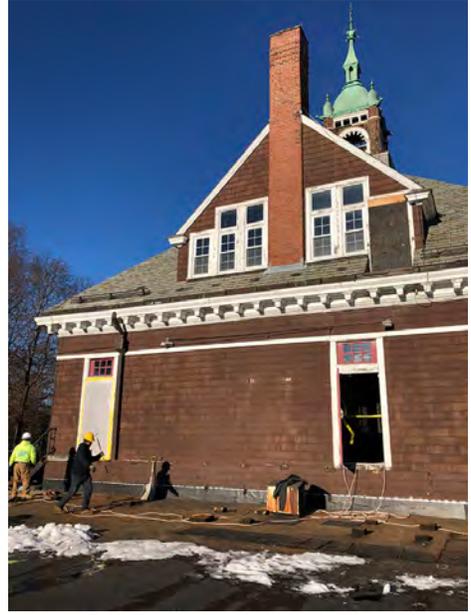
171220-IMG_7581.jpg

Upper Fire Escape at Second & Third Floors Removed From Above Gym Roof

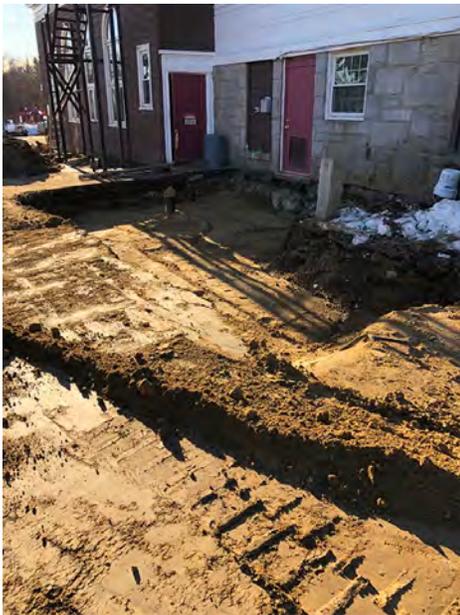
171220-IMG_7579.jpg

- 03.3 Site utility work related to relocating the water main from the front of the building to the east side has been completed. Underground conduits for the electrical work will follow. In the area of the transformer and emergency generator, the former septic tank has been removed as planned.

Backfilling After Installation of Water Supply Piping in Process at East Side of Building

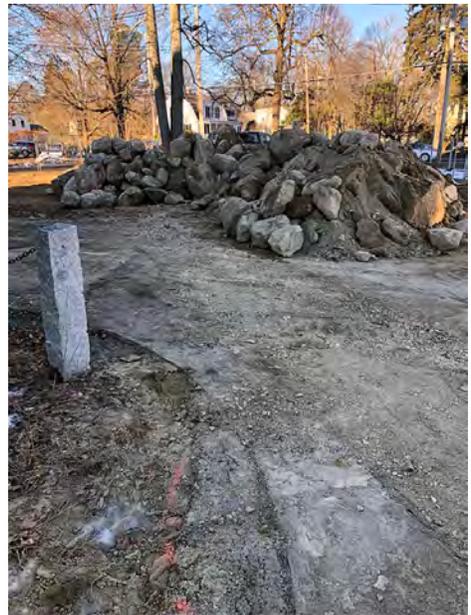
171220-IMG_7580.jpg

Temporary Stockpile of Excavated Rock Debris From Water Supply Line Trenching

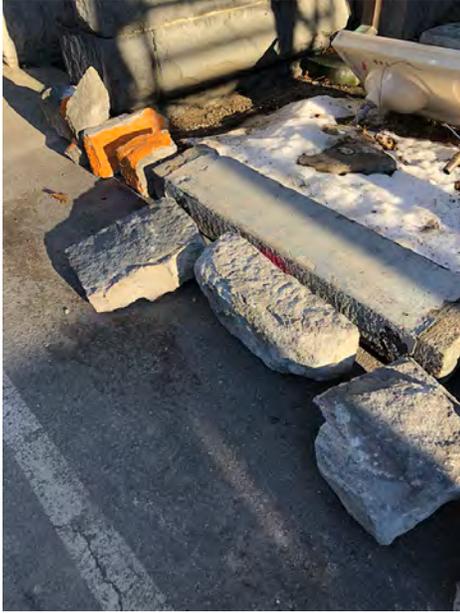
171220-IMG_7577.jpg

Granite Salvaged from Selective Demolition

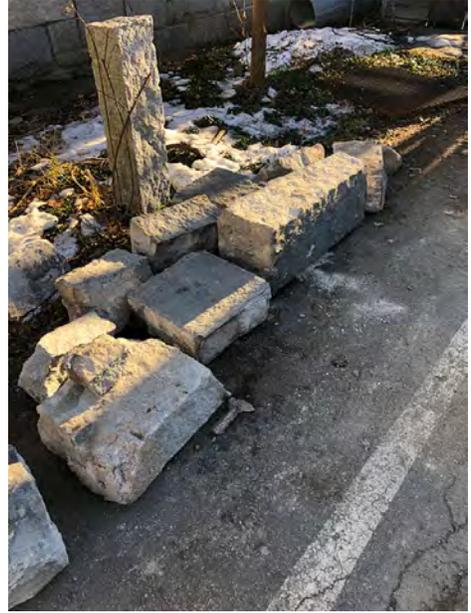
171220-IMG_7578.jpg

Granite Salvaged from Selective Demolition

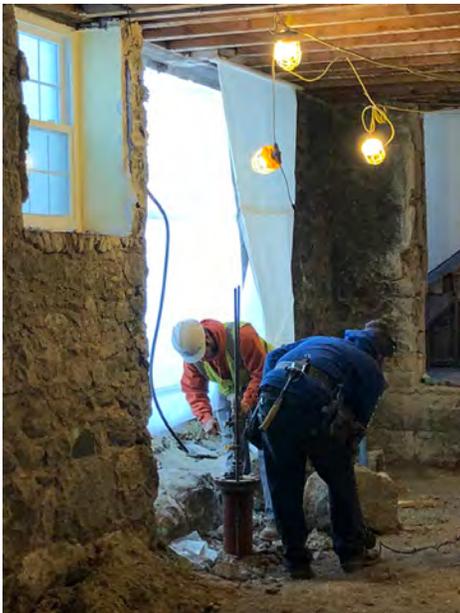
180103-IMG_7606.jpg

Water Piping Entrance to Building at Former Boiler Room Door Adjacent to Former Men's Room

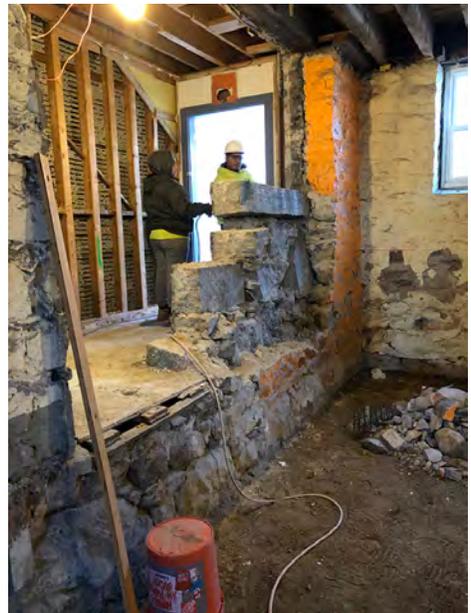
171220-IMG_7582.jpg

- 03.5 Openings in granite walls that were part of the original south façade, which became interior walls when the gym was added, have been made for creation of the lower lobby and provision of an alternate path from the exterior into the mechanical rooms (boiler, fire pump & electrical). Coursed stones and rubble backup can be reused for the restoration work at the exterior east façade where the former boiler room door was located, and where a non-original opening will be removed and original opening restored.

Former Exterior Wall at SW Corner of Original Building (Adjacent to Gym Addition) Removed for Lower Lobby

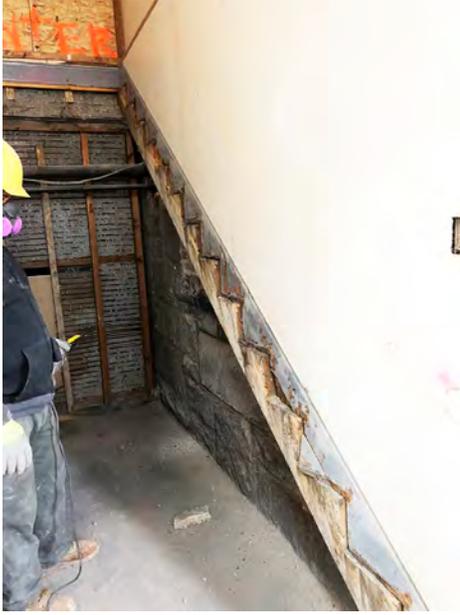
171213-IMG_7489.jpg

*Second of Two 1929 Interior Stairways Removed;
First Removed at Unknown Time*

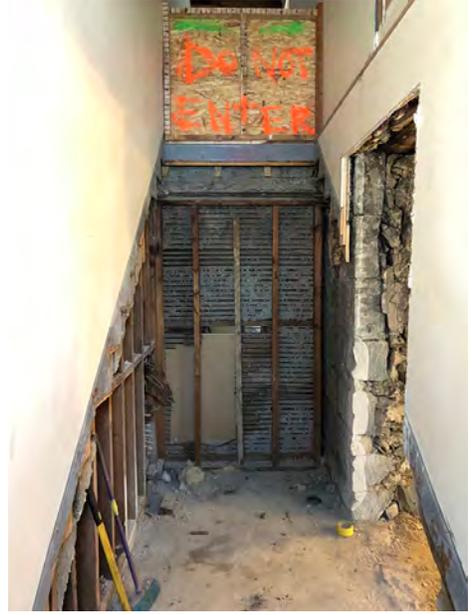
180103-IMG_7632.jpg

*Opening at Right for Second Entrance to Boiler Room
at Former Interior Stairway After Removal*

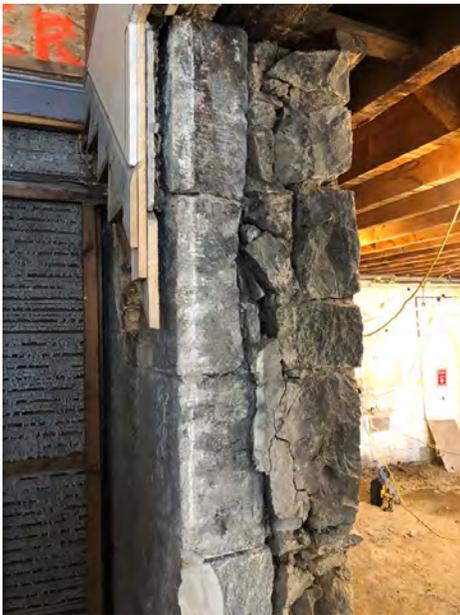
180103-IMG_7633.jpg

*Opening at Former Cellar Sash of Original Building;
Face Stones at Left & Rubble Backup at Right*

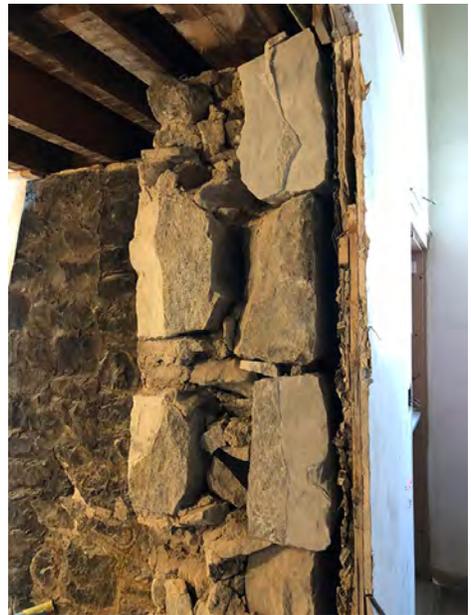
180103-IMG_7634.jpg

*Former Cellar Sash Repurposed for Entrance to Boiler Room
From Adjacent Exterior Door at NE Corner of Gym Beyond*

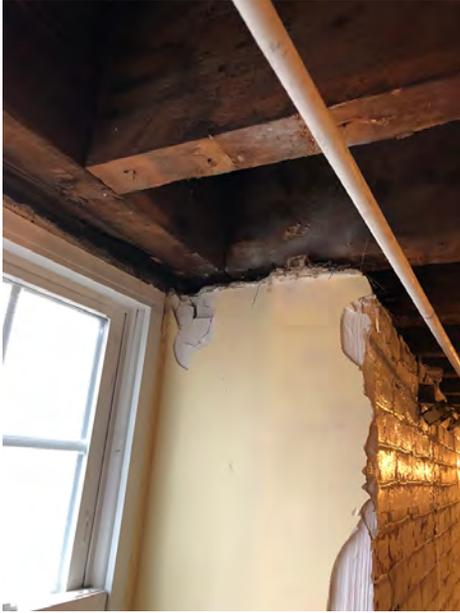
171206-IMG_7443.jpg

Detail of Former Men's Room Window Showing Plastered Interior Brick and Wood Framing Above

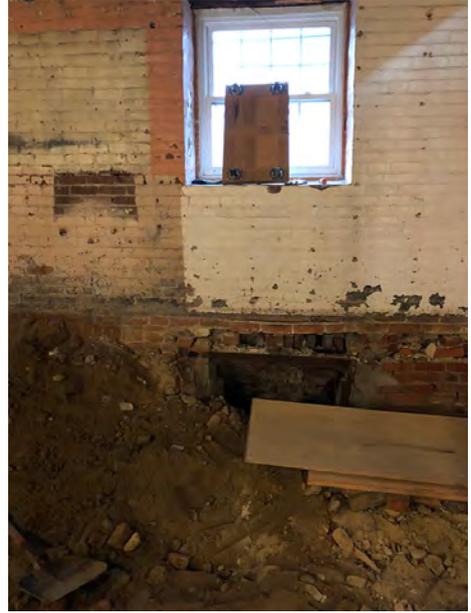
171206-IMG_7445.jpg

Interior Brick (Single Wythe) at Former Toilet Rooms Deteriorated Below Level of the Former Slab

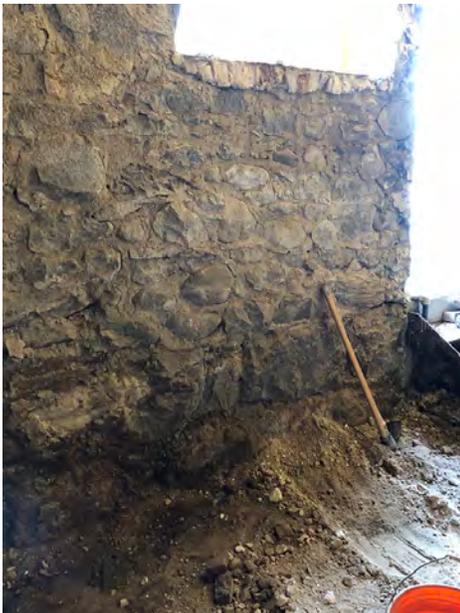
171213-IMG_7482.jpg

Interior Rubble Masonry Face After Removal of Interior Brick Finish at Former Toilet Rooms

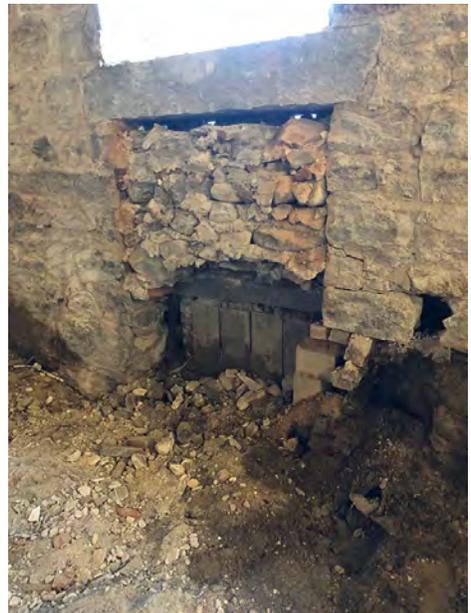
171213-IMG_7481.jpg

Previously Concealed Rubble Infill Below Granite Window Sill at Former Toilet Room with Blocked Opening Below

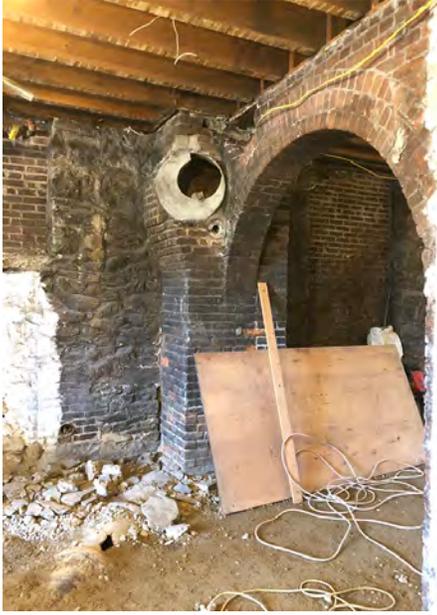
171213-IMG_7483.jpg

Brick Arch at Central Basement Wall Adjacent to Former Boiler Breaching into Flue at Back Wall

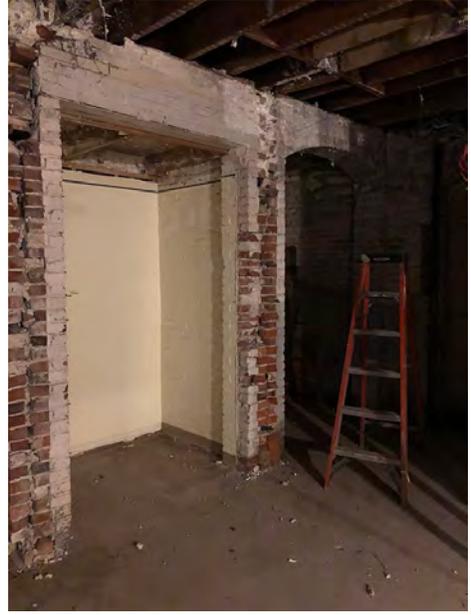
171206-IMG_7450.jpg

Alcove Below Front Entrance Area in Ground Floor Office

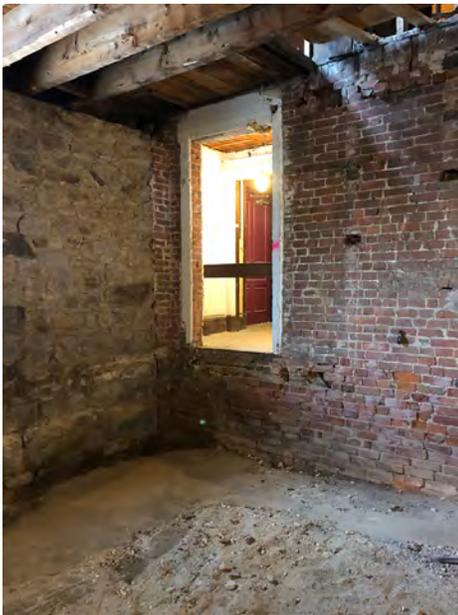
171213-IMG_7485.jpg

Former Women's Room Slab and Partitions Removed Adjacent to West Portico Entrance & Stair Beyond

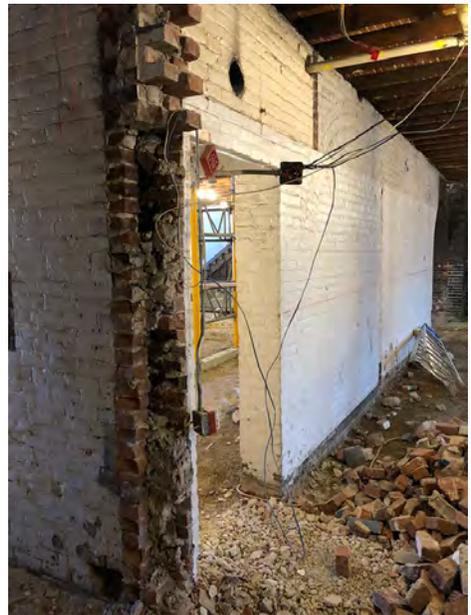
180103-IMG_7602.jpg

Central Brick Bearing Partition at Basement Level; Former Ground Floor Slab Removed

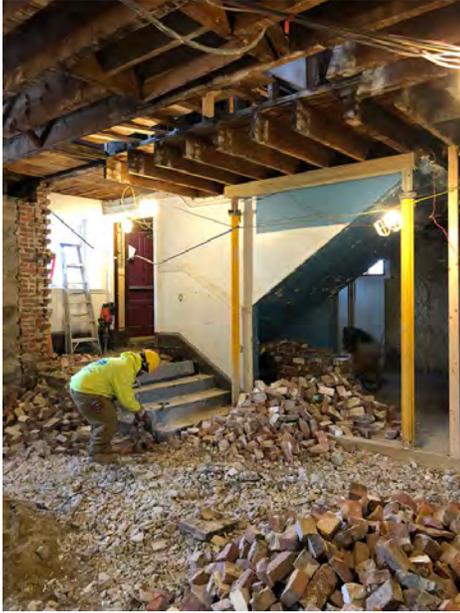
180103-IMG_7600.jpg

Demolition in Area of Elevator in Process

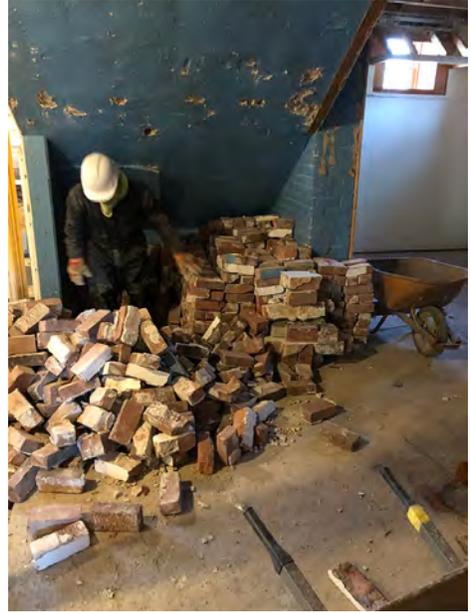
180103-IMG_7601.jpg

Stacking Salvaged Bricks Below West Stair for Use in Selective Reconstruction and Interior Infills

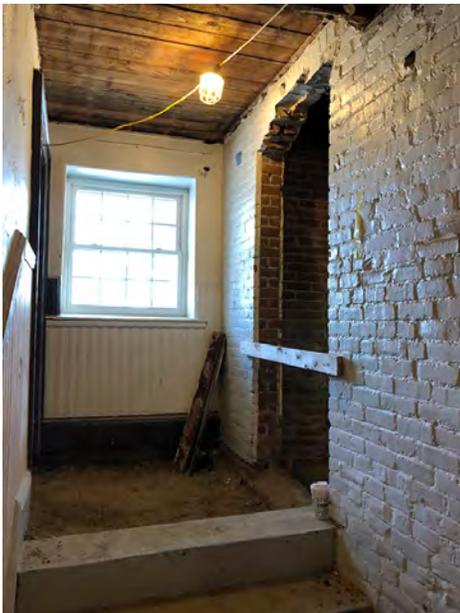
180103-IMG_7604.jpg

Slab Removed at East Portico Entrance Landing Adjacent to Former Men's Room

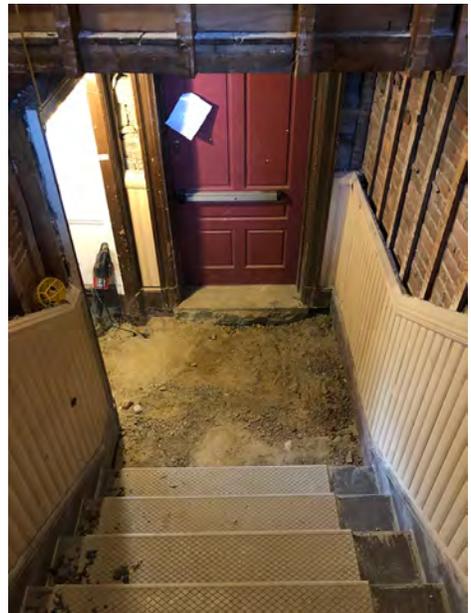
180103-IMG_7609.jpg

Looking Down West Stairs Toward Portico Entrance; Landing Slab Removed at Future Accessible Entry

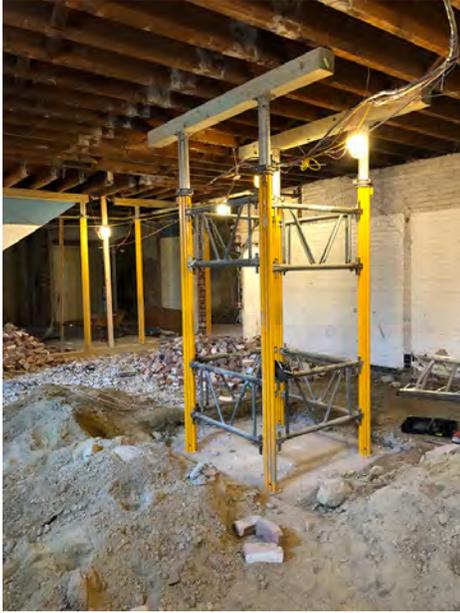
180103-IMG_7599.jpg

- 03.2 Temporary shoring for construction of the elevator hoistway and related structural work has been placed at the basement, first and second floors.

Shoring Tower Adjacent to Elevator Hoistway

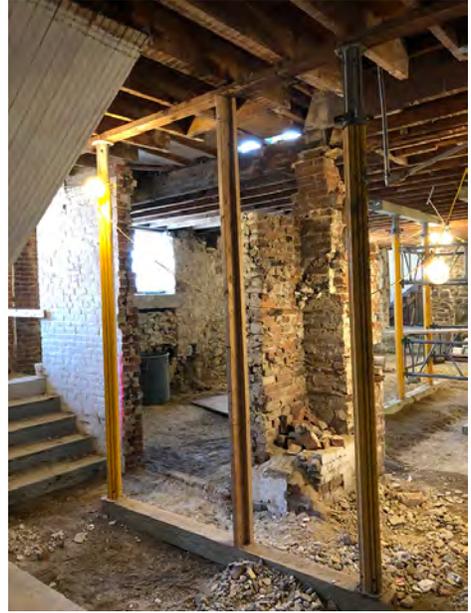
180103-IMG_7603.jpg

Shoring Adjacent to Former East Ventilation Shaft at Former Boiler Room Area in Basement

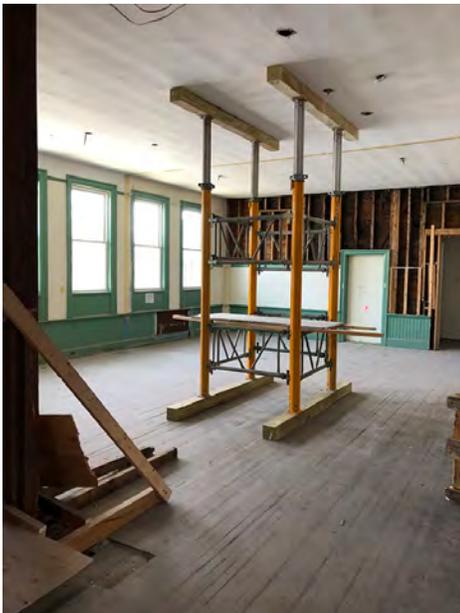
180103-IMG_7611.jpg

Shoring Tower in Avis Lounge at First Floor

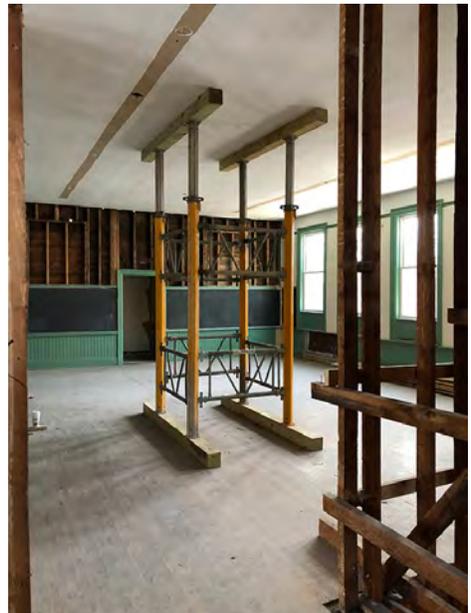
180103-IMG_7610.jpg

Shoring Tower in Classroom 2 at First Floor

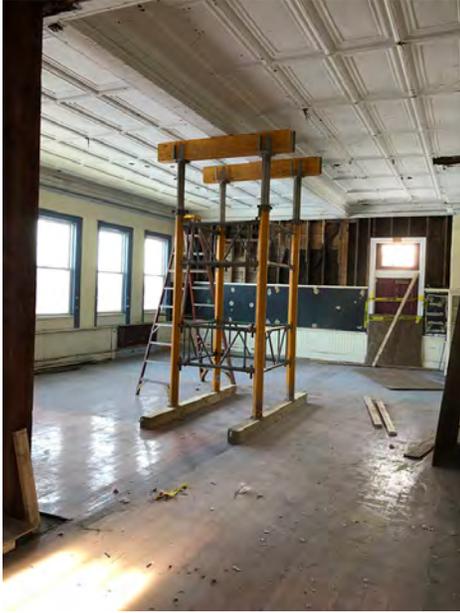
180103-IMG_7614.jpg

Shoring Tower Below Steel Beam at Classroom 3

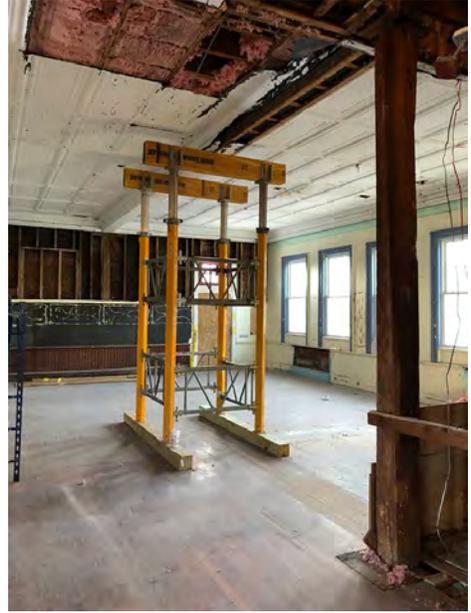
180103-IMG_7613.jpg

Shoring Tower Below Steel Beam at Classroom 4

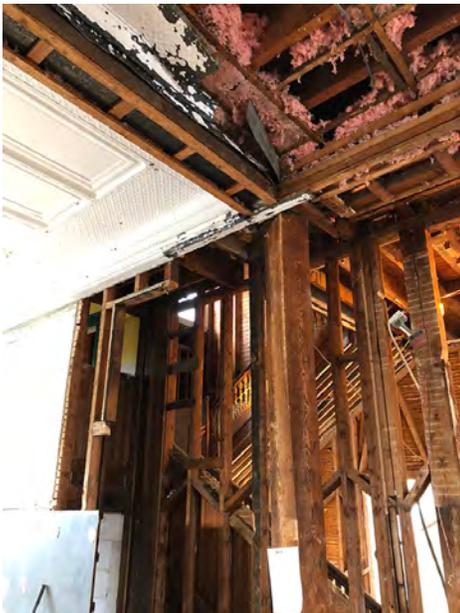
180103-IMG_7615.jpg

*Partial Removal of Tin Ceiling at Elevator Hoistway
Adjacent to Ventilation Shaft in Classroom 4*

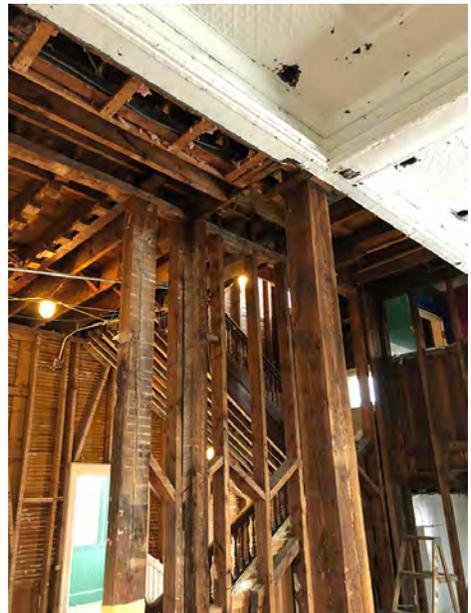
180103-IMG_7616.jpg

*Partial Removal of Tin Ceiling Above Accessible Toilet Room
Adjacent to Classroom 3*

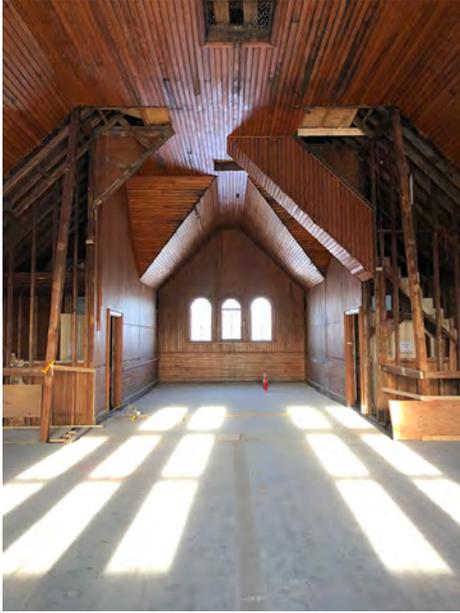
180103-IMG_7617.jpg

Looking North at Fourth Floor (Original Gym)

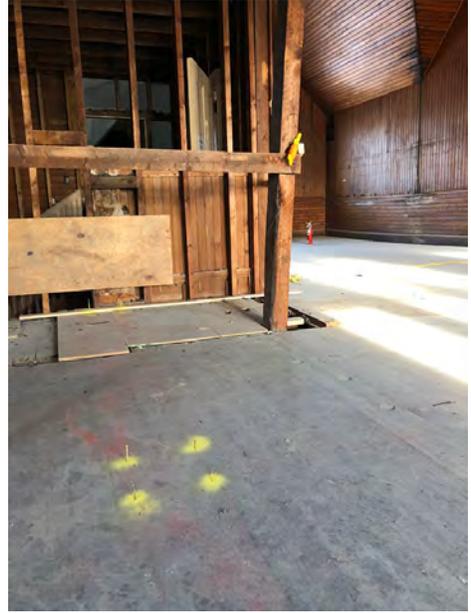
180103-IMG_7618.jpg

SW Corner of CMU Elevator Hoistway Marked on Fourth Floor

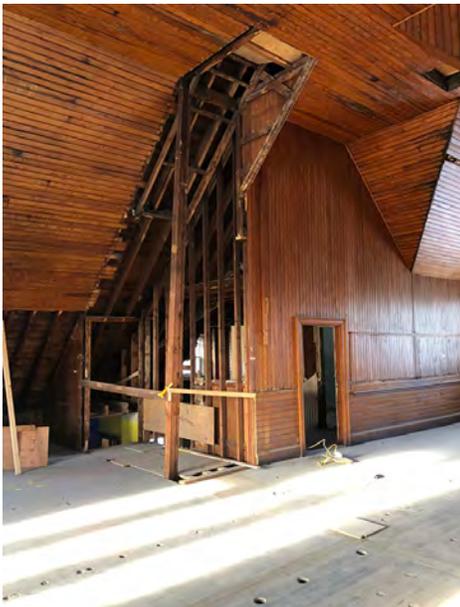
180103-IMG_7620.jpg

Area of Elevator Hoistway at Fourth Floor; Single Angled Post Part of Cupola Support

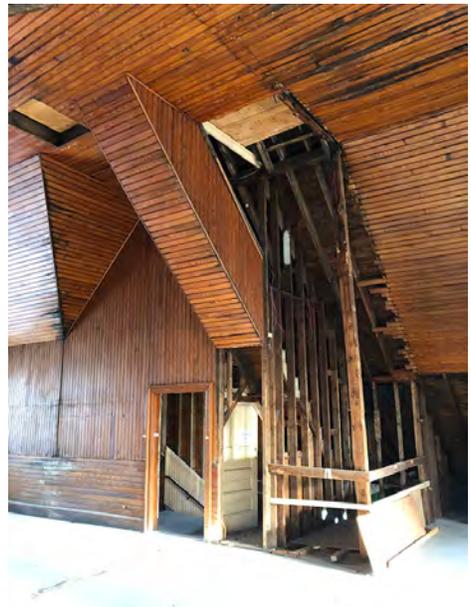
180103-IMG_7619.jpg

Area of Accessible Toilet Room at Fourth Floor; Angled Enclosure of Stairs to Cupola

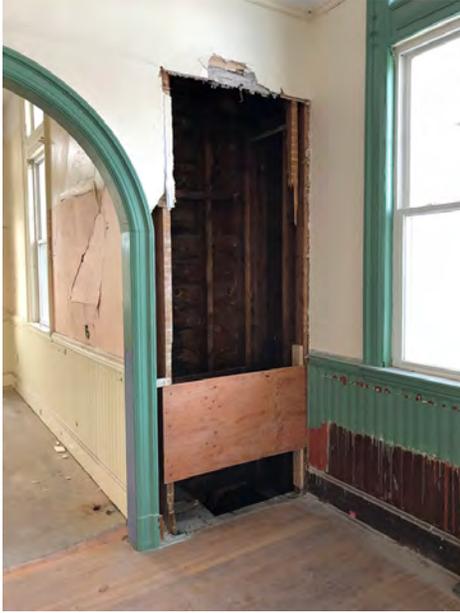
180103-IMG_7621.jpg

Opening into Former Shaft at NW Corner of Classroom 5

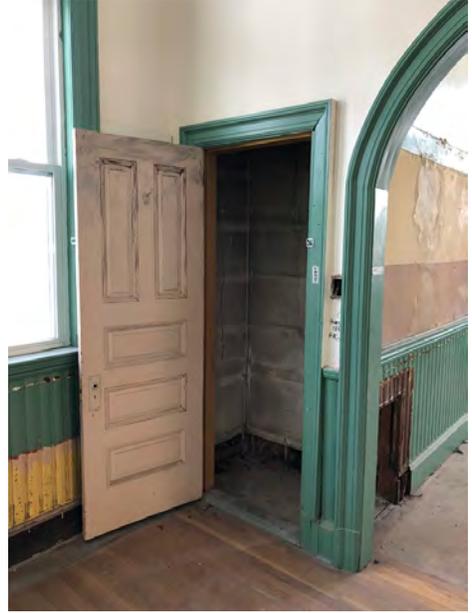
180103-IMG_7622.jpg

Former Ductwork Removed from Closet at NE Corner of Classroom 5 at Second Floor

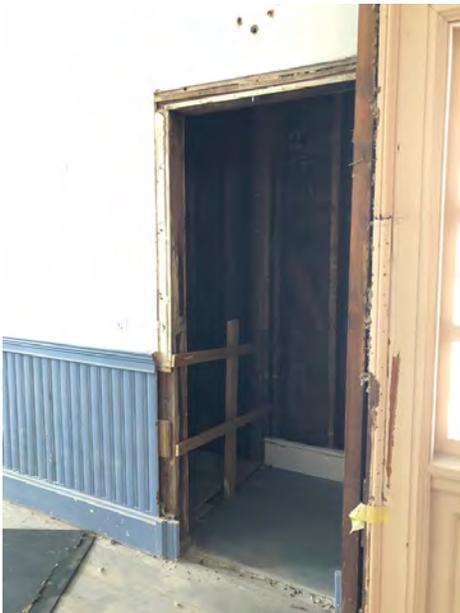
180103-IMG_7627.jpg

Former Shaft Opened in Closet of Receptionist at First Floor

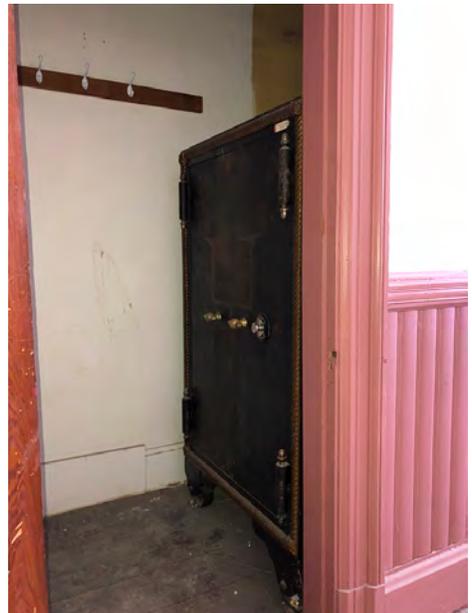
180103-IMG_7626.jpg

Freestanding Safe in Director's Office at First Floor

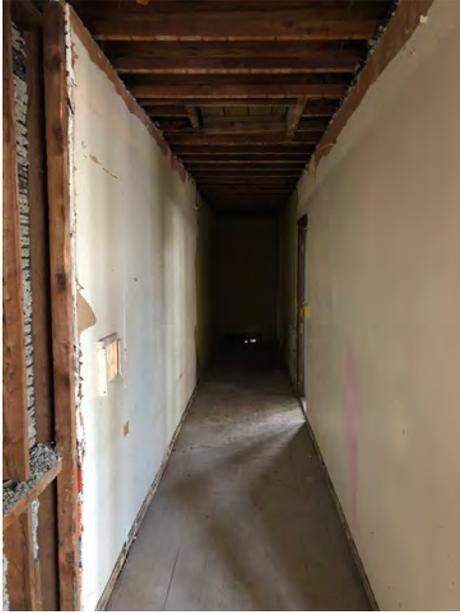
180103-IMG_7631.jpg

Storage Closet Area at Gym Addition Adjacent to Avis Lounge & Classroom 2 (Pair of Former Stairs)

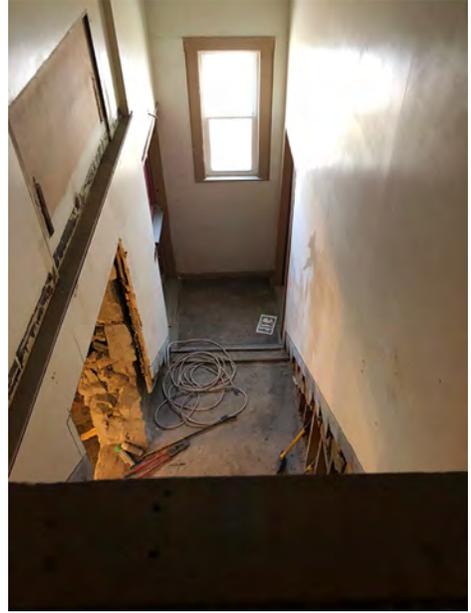
180103-IMG_7629.jpg

Looking East into Removed Stair at Gym Addition Adjacent to Avis Lounge; Floor to be Infilled

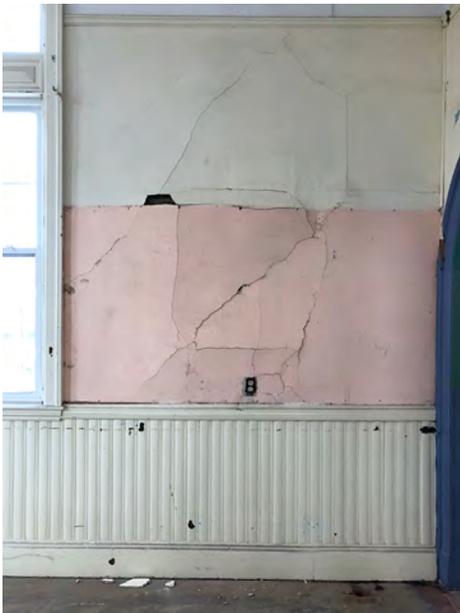
180103-IMG_7612.jpg

Plaster Cracked and Delaminated from Lath After Removal of Painted Homosote from North Wall of Kitchen

- 03.6 Existing plaster wall surfaces on the north wall of the Kitchen were severely damaged when the adhered painted homosote was removed. In lieu of repairing this plaster (see A-21, Elevations A.0 and A1), it should be removed and replaced with gypsum wallboard. A large portion of the wall will be covered with the exhaust hood that will be installed above the two ranges.

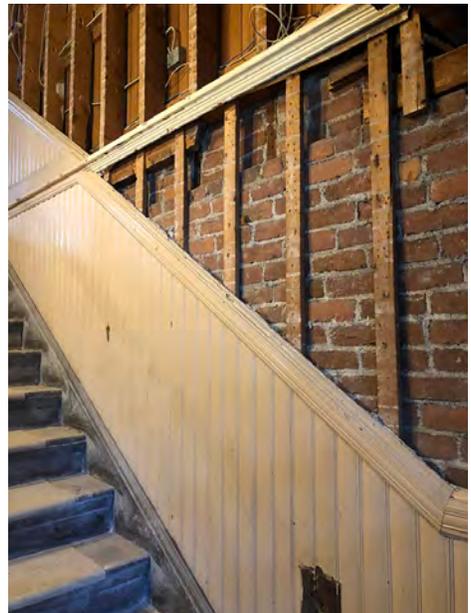
180103-IMG_7608.jpg

Wainscoting and Framing in Stairs Retained in Place Following Removal of Deteriorated Plaster & Lath
