FIELD REPORT No. 04

ROUDENBUSH COMMUNITY CENTER REHABILITATION

DATE/TIME: Jan 4, 2018 – Jan 31, 2018 (Project Meetings on Jan 10, 19, 24 & 31)
PURPOSE: Construction Progress Summary
PRESENT: Don Mills, Architect / Mills Whitaker Architects LLC
Ron Marsden, Architect's Site Rep (Clerk) / Delmont Construction Services
Bill Kennison, Owner's Project Manager / Town of Westford
Jeanne Roberts, Permanent Town Building Committee / Town of Westford (1/19; 1/31)
Steve Salemi, Project Manager / NELCO Worldwide
Stevan Gauthier, Project Superintendent / NELCO Worldwide
Alexander Castelluccio, Project Administrator / NELCO Worldwide (1/24)
Shawn Chamberlin, Safety Coordinator / NELCO Worldwide (1/24)

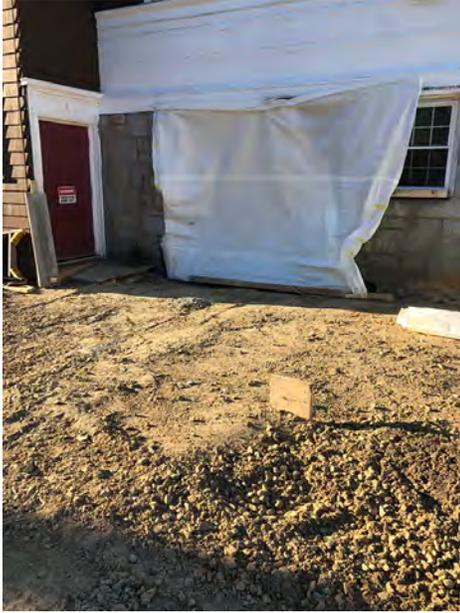
180131-IMG_7852.jpg

- 04.2 A temporary opening in the east exterior masonry wall was made at the former non-original boiler room door and the adjacent wood panel infill to the south. This opening is providing passage to the interior for excavating machinery to facilitate the interior foundations, footings and trenching for below-grade utilities.

*Protection Over Temporary Opening at East Facade;
Former Locations of Boiler Room Door & Wood Panel,
Both Non-Original Openings at This Location*

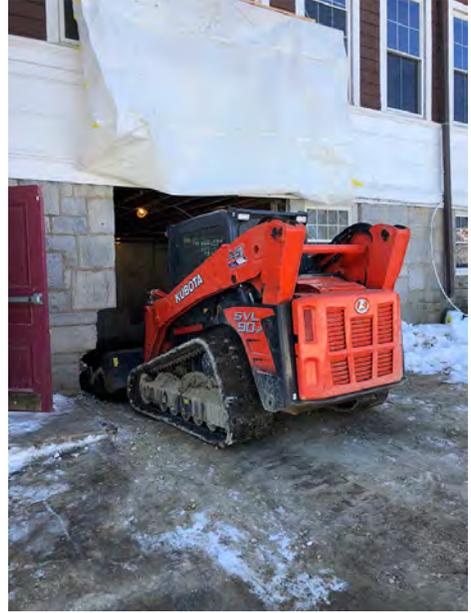
180110-IMG_7659.jpg

*Temporary Opening Used for Maneuvering Equipment into
Basement Level for Excavations and Earthwork*

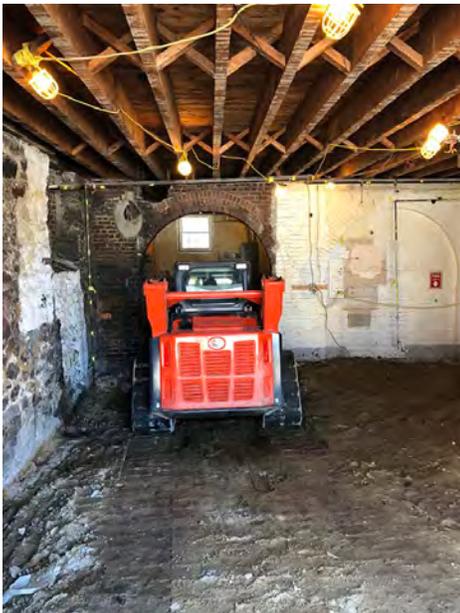
180110-IMG_7661.jpg

*Driving West Through Boiler Room Archway at
Central Brick Bearing Wall*

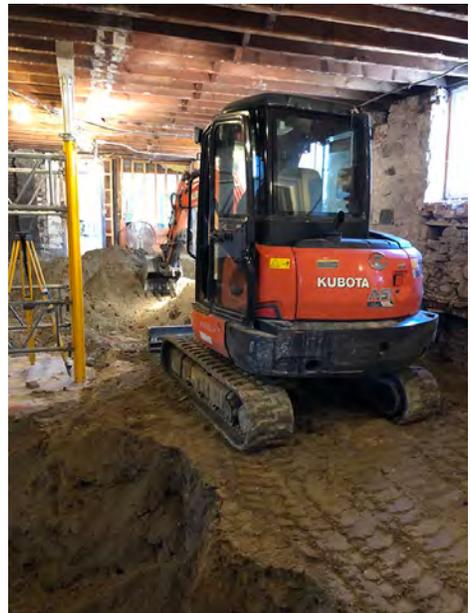
180110-IMG_7642.jpg

Small Backhoe Excavating Elevator Pit Area

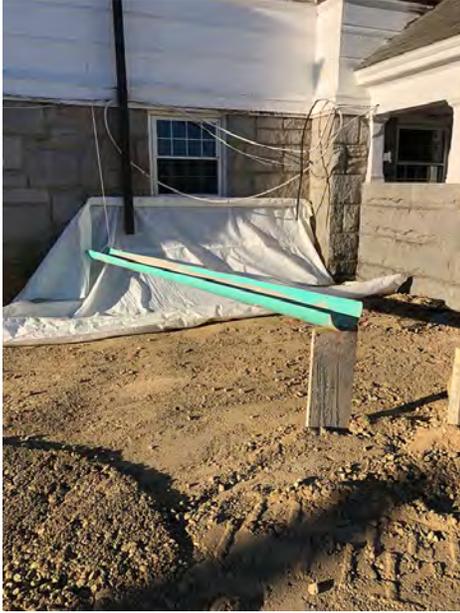
180131-IMG_7851.jpg

Protection Draped Over Temporary Excavation for Underground Electrical Conduits to Interior; Trough for Redirecting Water from Rain Leader

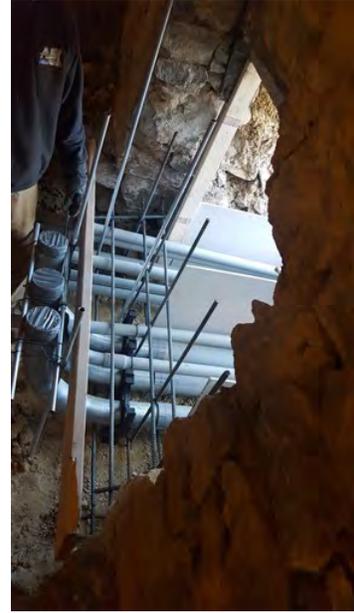
20180126_110225.jpg

Underground Main Ductbank for Electrical Service at Formerly Concealed Masonry Infill Area Below Window

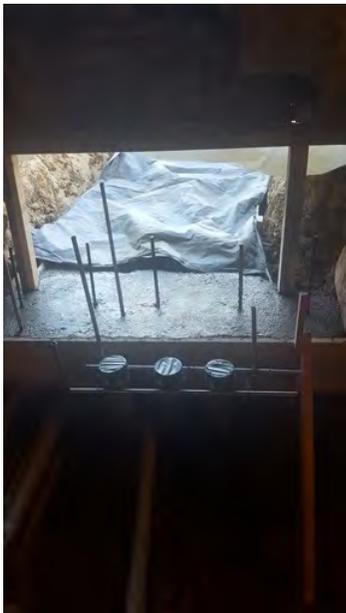
20180126_133146.jpg

Concrete Encasement at Foundation Wall for Protection of Underground Electrical Conduits Prior to Infill of Exterior Masonry Wall

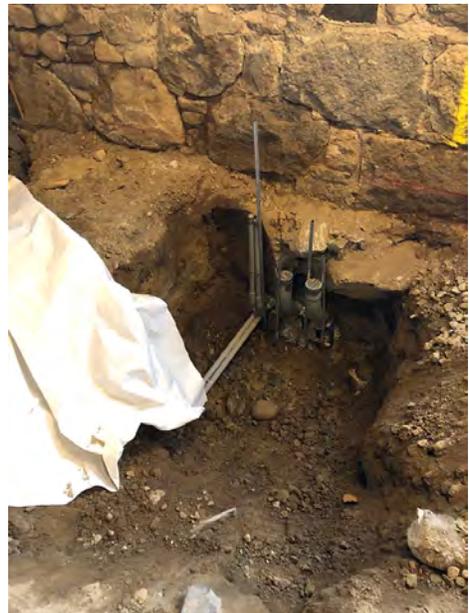
180131-IMG_7850.jpg

Underground Conduit to Emergency Panel and Automatic Transfer Switches at Electrical Room Below Intact Portion of Exterior Masonry Wall

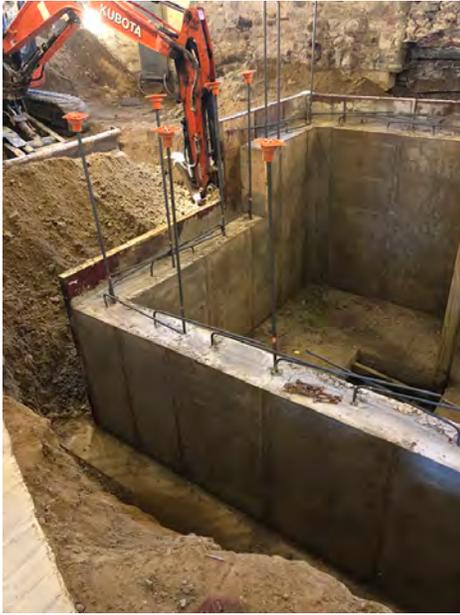
180131-IMG_7847.jpg

Southern Half of Elevator Pit From East

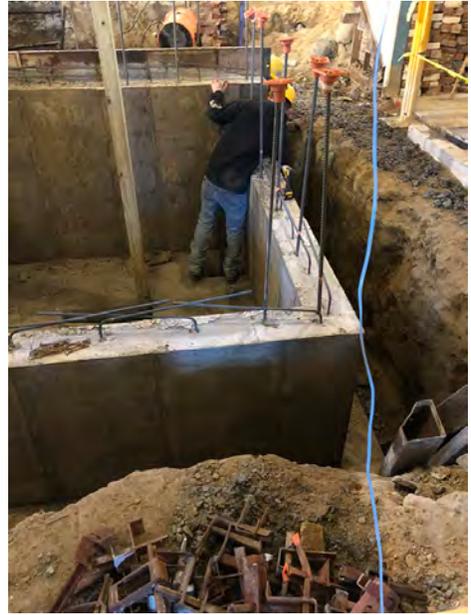
180131-IMG_7846.jpg

Northern Half of Elevator Pit from East

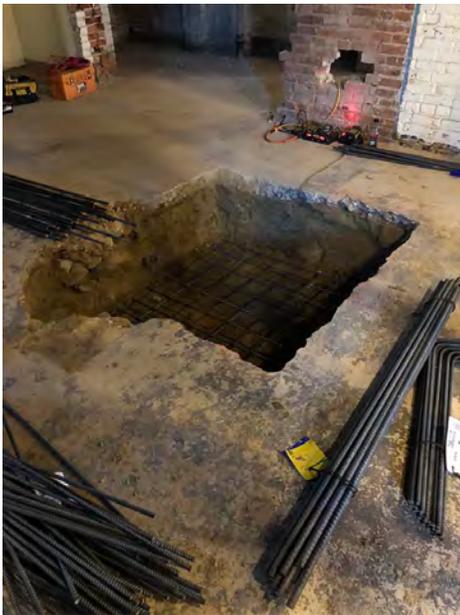
180110-IMG_7644.jpg

One of Two Footing Excavations in Office Areas

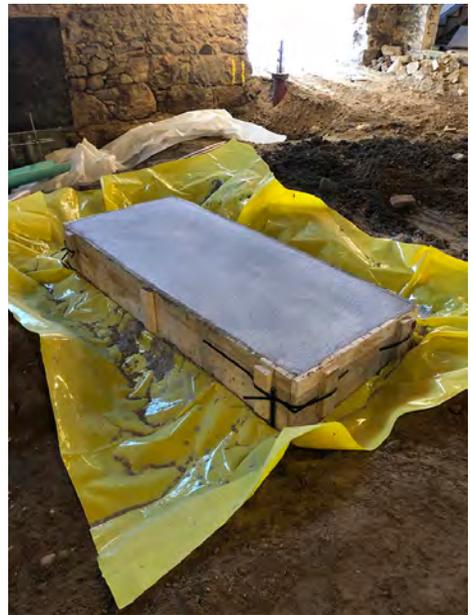
180131-IMG_7848.jpg

E/W Footing for Posts Up from Boiler Room Passageway

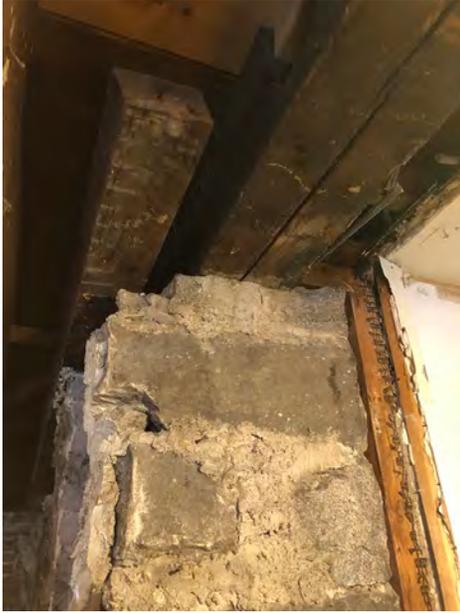
180110-IMG_7649.jpg

East End of Lower Lobby Opening to Gym at Top of Former Interior Ramp

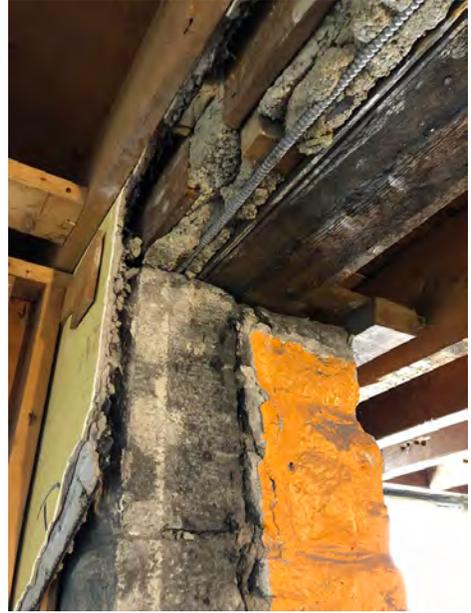
180110-IMG_7648.jpg

West End of Lower Lobby Opening at Former Exterior Granite Wall Prior to Gym Addition

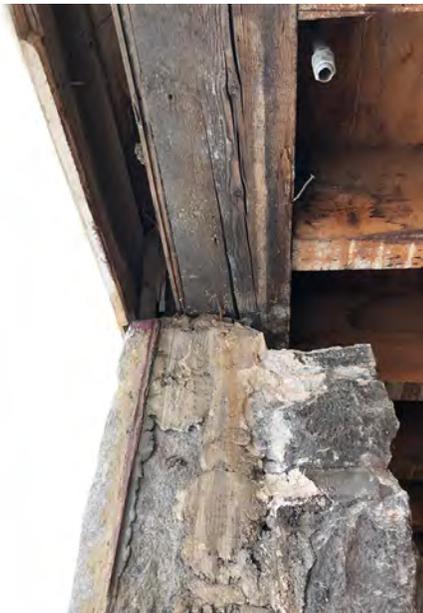
180131-IMG_7854.jpg

South End of Temporary Opening at East Facade; Joists Mortise into 8" x 11" Original Timber Sill

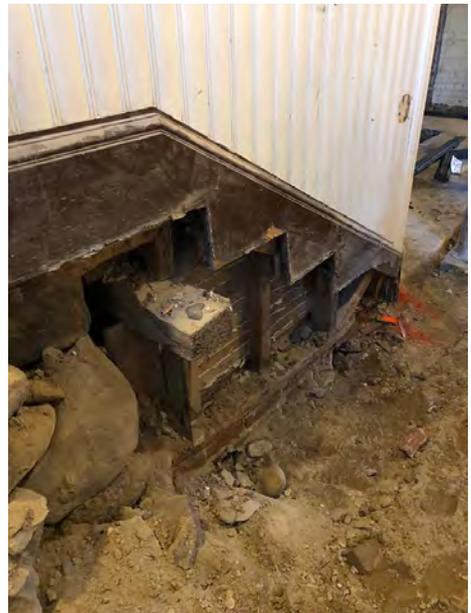
180110-IMG_7647.jpg

Former Granite Stairs Removed from West Entry to Basement Level Adjacent to West Stair

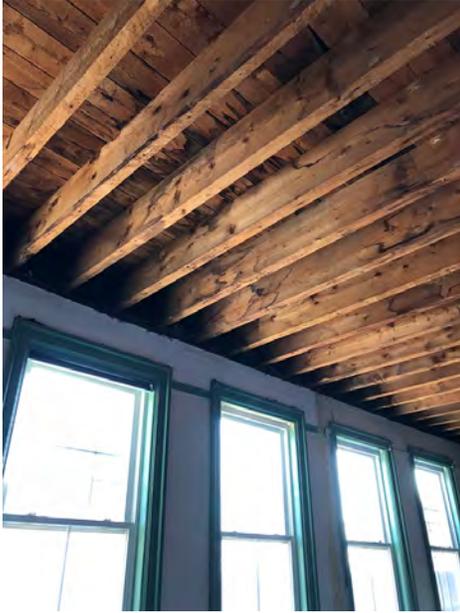
180131-IMG_7842.jpg

- 04.5 Plaster and lath below the second floor joists at the ceilings of the Avis Lounge and Classroom No. 2 were removed and sistering of joists began for reducing the amount of deflection in the second floor.

Plaster and Lath Removed from Avis Lounge Ceiling to Sister Second Floor Joists with LVLs

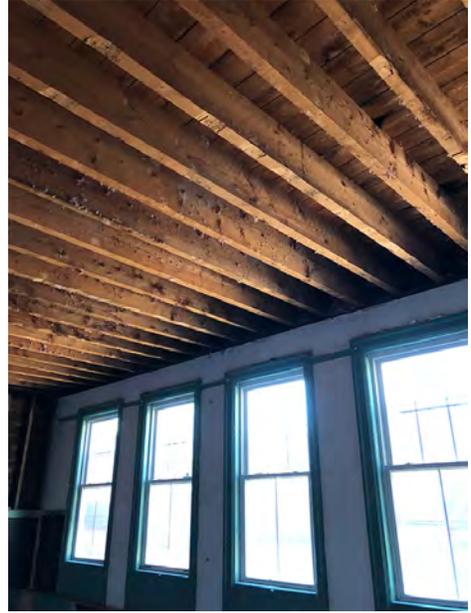
180131-IMG_7844.jpg

Plaster and Lath Removed from Classroom #2 Ceiling to Sister Second Floor Joists with LVLs

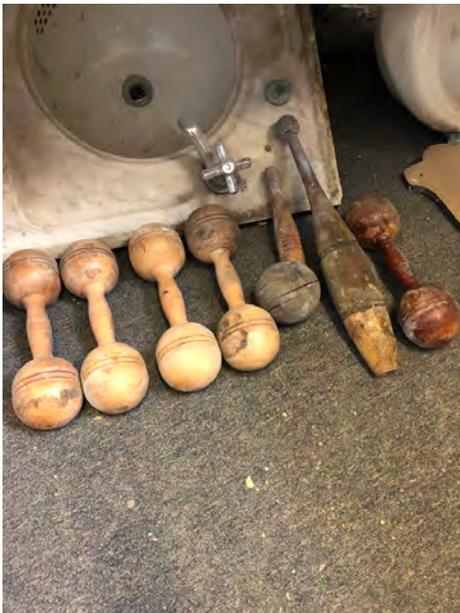
180131-IMG_7853.jpg

Wooden Items Found in Ceiling Above Avis Lounge; Marble Sink from Second Floor Stair Landing W.C.

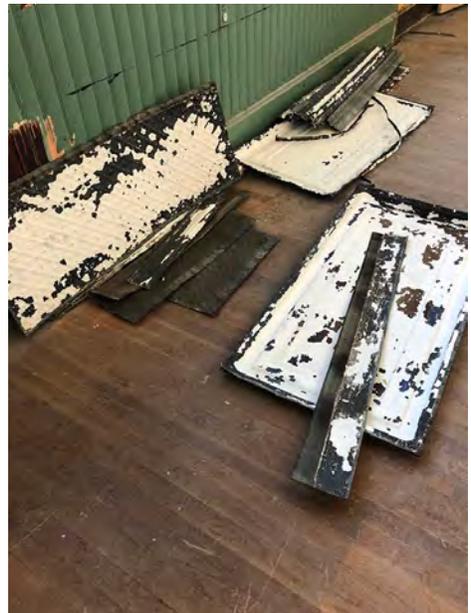
180110-IMG_7651.jpg

Selective Salvage of Embossed Metal Ceiling Components from Second Floor Elevator and Accessible Toilet Areas

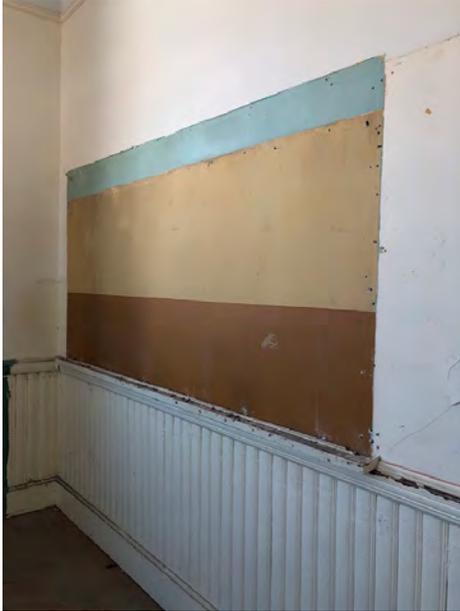
180110-IMG_7656.jpg

Homosote and Lockers Removed from South Wall of Classroom #5 Reveals Former Color Schemes

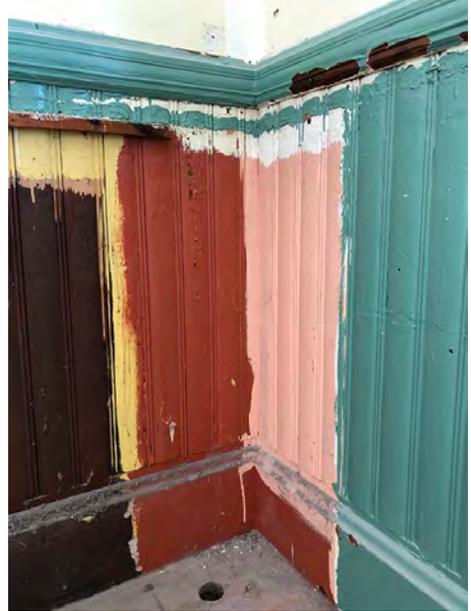
180110-IMG_7655.jpg

Former Color Schemes Behind Removed Radiator at NE Corner of Classroom #5

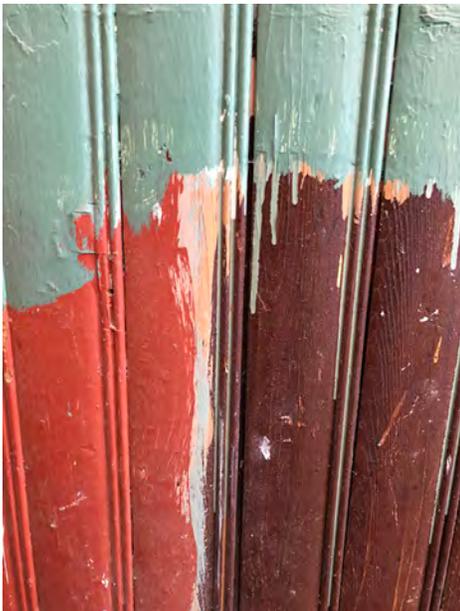
180110-IMG_7652.jpg

Detail of Former Colors Schemes in Classroom #5

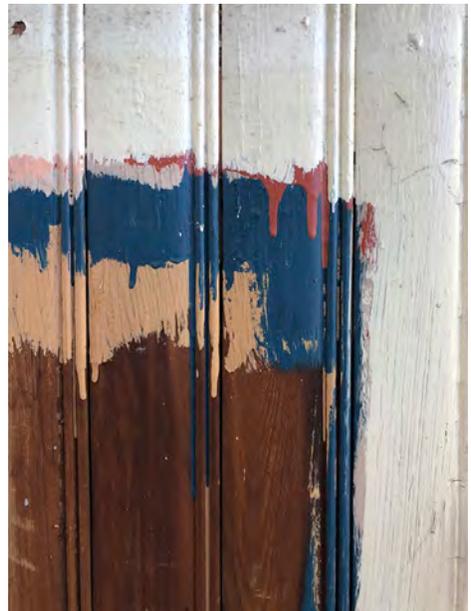
180110-IMG_7653.jpg

Detail of Former Colors Schemes in Classroom #5
