FIELD REPORT No. 05

ROUDENBUSH COMMUNITY CENTER REHABILITATION

DATE/TIME: Feb 1, 2018 – Feb 28, 2018 (Project Meetings on Feb 7, 14, 21 & 28)
PURPOSE: Construction Progress Summary
PRESENT: Don Mills, Architect / Mills Whitaker Architects LLC
Ron Marsden, Architect's Site Rep (Clerk) / Delmont Construction Services
Bill Kennison, Owner's Project Manager / Town of Westford
Jeanne Roberts, Permanent Town Building Committee / Town of Westford (2/7; 2/14; 2/28)
Steve Salemi, Project Manager / NELCO Worldwide
Stevan Gauthier, Project Superintendent / NELCO Worldwide
Alexander Castelluccio, Project Administrator / NELCO Worldwide (2/28)
Zachary Miliano, Project Manager / NELCO Worldwide (2/14)

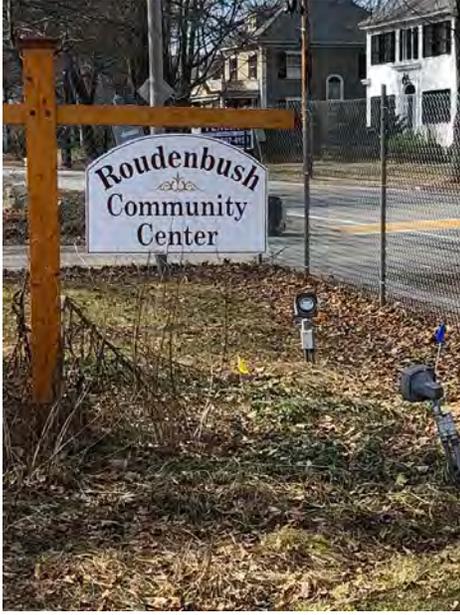
180228-IMG_7996.jpg

*Existing Freestanding Sign at Main Street;
Power to Light Fixtures Interrupted During Utility Trenching*

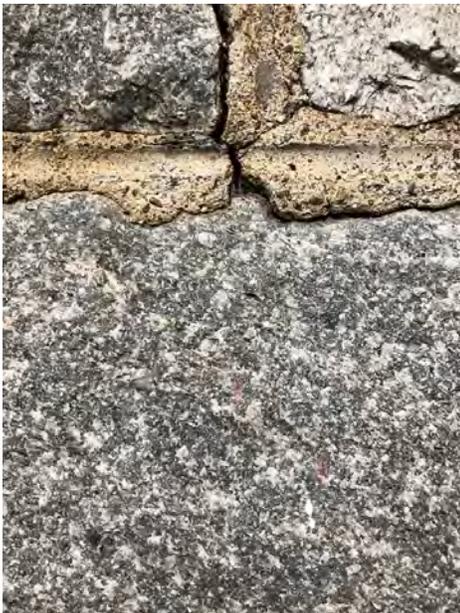
180221-IMG_7955.jpg

Existing Exterior Granite to be Repointed and Cleaned at Base of Original Building

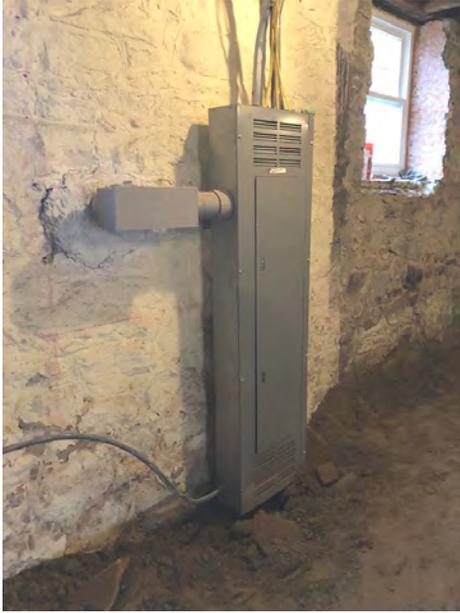
180214-IMG_7910.jpg

Former Electrical Service at West Wall in Use for Temporary Power During Construction

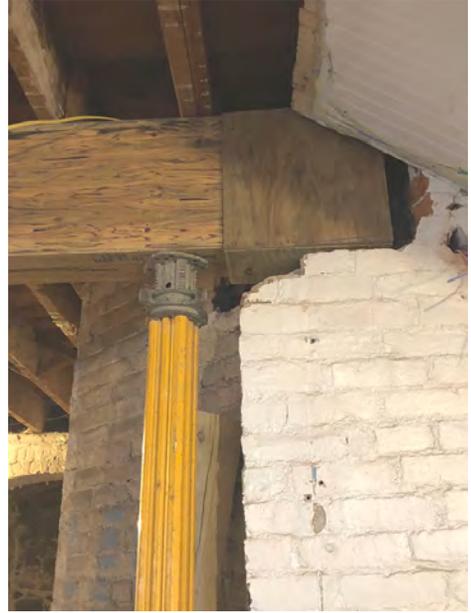
180228-IMG_7984.jpg

East End Bearing Condition at PSL Beam Showing Pressure-Treated Plywood Sheathing to Isolate PSL from Brick Masonry

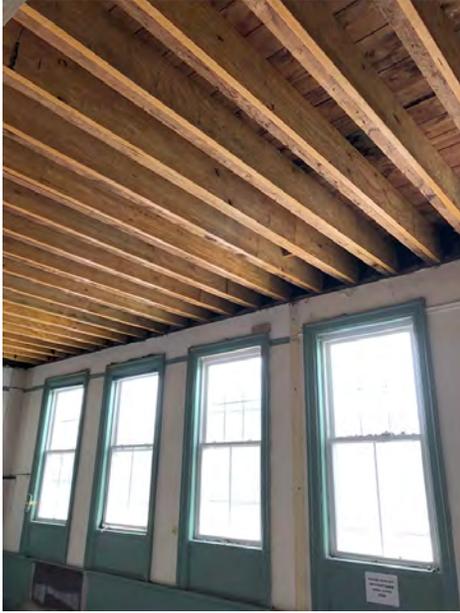
180207-IMG_7892.jpg

- 05.4 The placement of LVL and PSL beams at various levels of the building for structural reinforcement has made significant progress. Sistering of the second floor joists has been completed except in the area of the elevator hoistway, lobby and accessible restroom areas pending further construction.

Sistering of Second Floor Joists

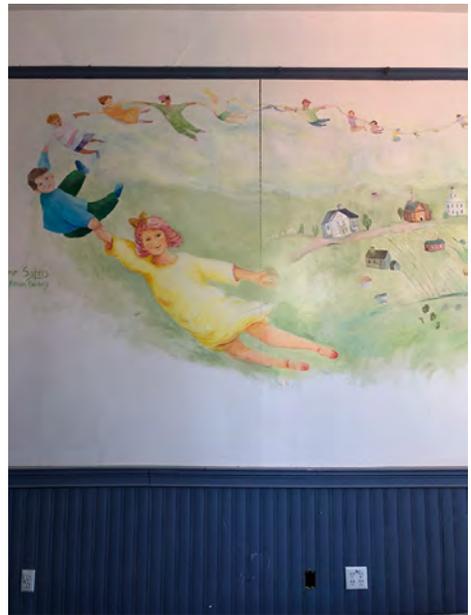
180214-IMG_7922.jpg

Vertical Crack Opened in South Partition of Reception
Area Due to Shoring and Beam Installation

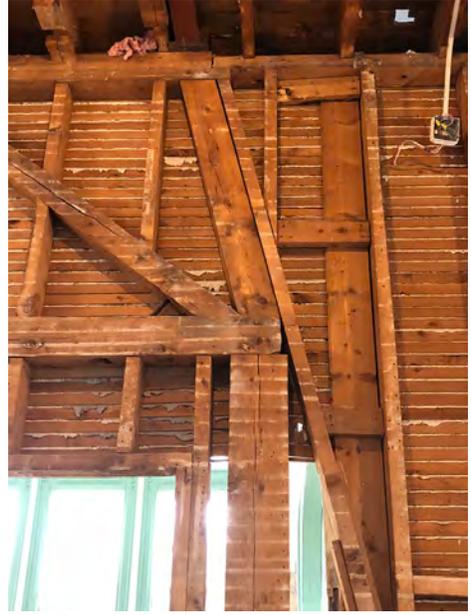
180214-IMG_7931.jpg

East End of "Truss"; Diagonal Member to Post Supports Cross Beam and Transfers Cupola Loads; Eastern Beam Shown (Western at Opposite Side)

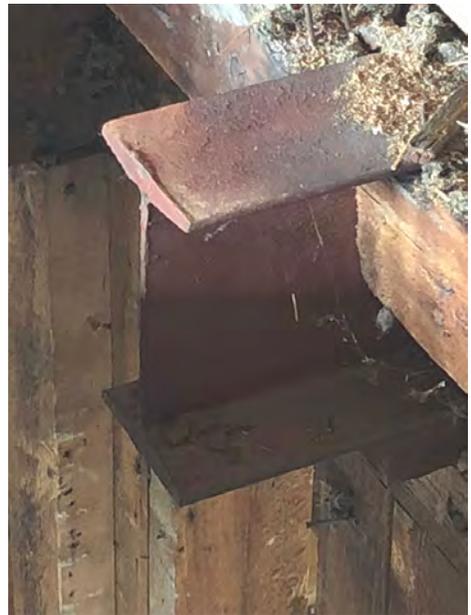
180228-IMG_7989.jpg

South End of Western Cross Beam to be Supported by Elevator Hoistway

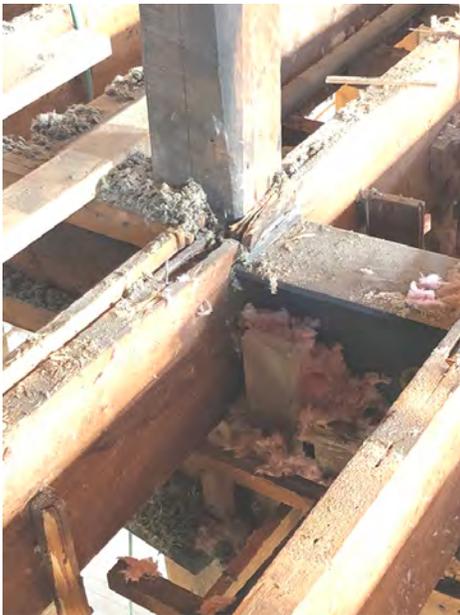
180228-IMG_7991.jpg

*Cupola Support Post on Steel Beam at Third Floor;
Post to be Shortened and Re-supported at Hoistway*

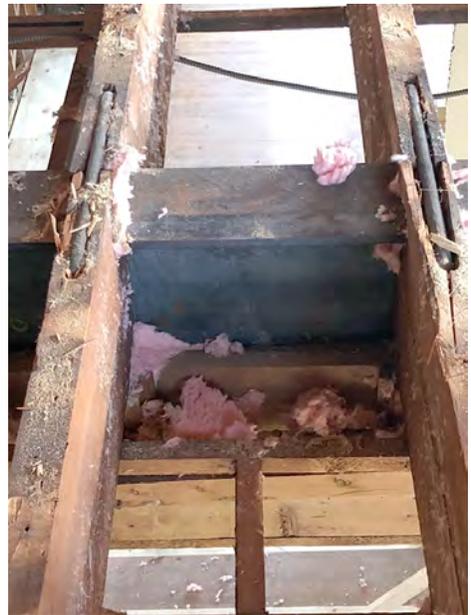
180228-IMG_7990.jpg

*Third Floor Joists at Beam Rest on Ledger at
Bottom Flange of Steel Beam; Tops of Joists
"Stapled" with Round Iron Rods*

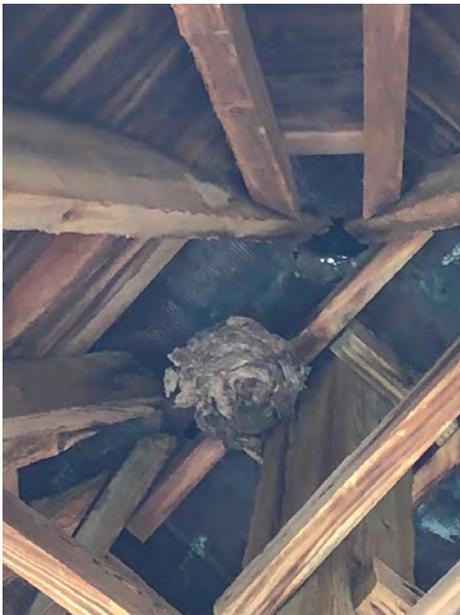
180228-IMG_7979.jpg

Wasp Nest Formerly Concealed in Cupola Framing; Pinholes in Copper Dome Visible From Below
