## FIELD REPORT No. 07

### ROUDENBUSH COMMUNITY CENTER REHABILITATION

**DATE/TIME:** Apr 5, 2018 – May 2, 2018 (Project Meetings on Apr 11, 18, 25 & May 2)  
**PURPOSE:** Construction Progress Summary  
**PRESENT:** Don Mills, Architect / Mills Whitaker Architects LLC  
Ron Marsden, Architect's Site Rep (Clerk) / Delmont Construction Services  
Bill Kenison, Owner's Project Manager / Town of Westford  
Jeanne Roberts, Permanent Town Building Committee / Town of Westford (all but 4/25)  
Steve Salemi, Project Manager / NELCO Worldwide  
Stevan Gauthier, Project Superintendent / NELCO Worldwide  
Alexander Castelluccio, Project Administrator / NELCO Worldwide (4/25 & 5/2)  
Greg Nowak, Structural Designer / Structures North Consulting (4/25)  
**LOCATION:** On Site

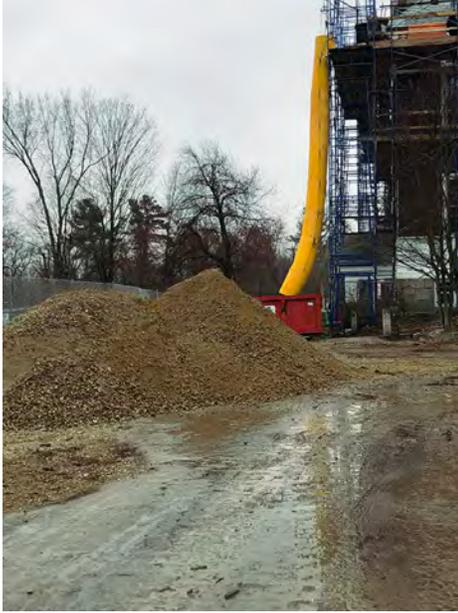
180425-IMG\_8377.jpg

*Scene at Exit Driveway During Excavation for Primary Conductors for Electrical Service and Roofing Demolition with Chute to Dumpster*

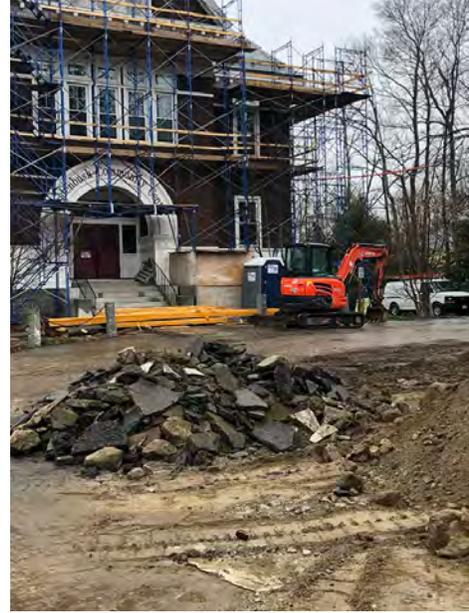
180425-IMG\_8378.jpg

*Broken Asphalt from Electrical Trench Excavation Sorted and Stacked for Removal and Recycling*

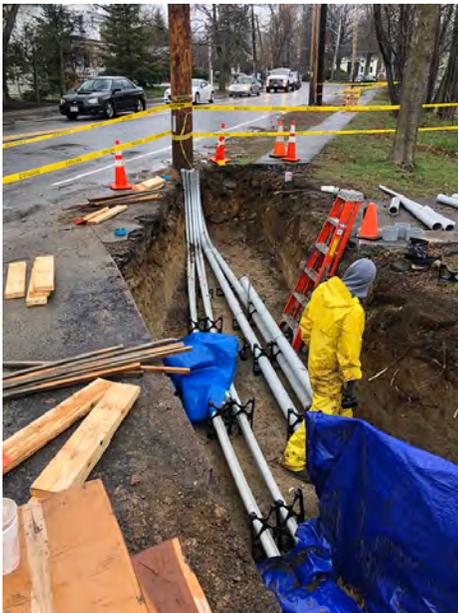
180425-IMG\_8374.jpg

*Underground Conduit Installation at Exit Drive to Utility Pole for Replacement of Electrical Service (Overhead Service at Entry Drive to be Removed)*

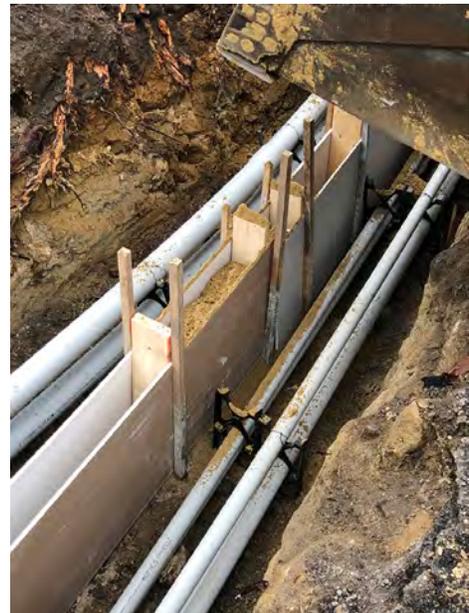
180425-IMG\_8376.jpg

*Detail of Underground Conduits with Separation Between Power and Communication Conduits*

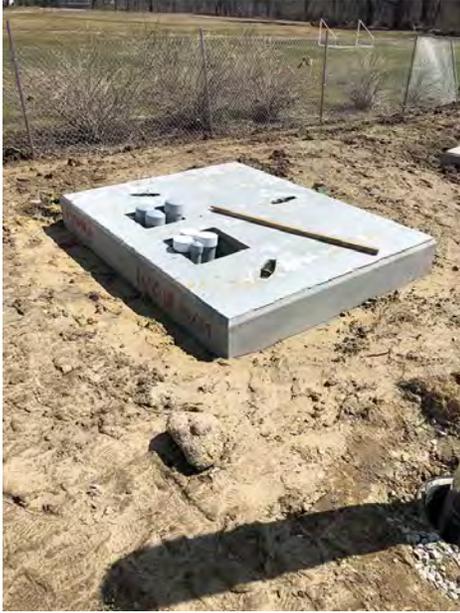
180411-IMG\_8311.jpg

- 07.3 Placement of underground conduits for the reconfigured electrical, phone and data cabling is nearing completion. Pads and bollards for the transformer and emergency generator are in place. Rough wiring at the interior of the building is underway and panel boxes are on site ready for installation.

*Pre-Cast Concrete Pad for Transformer in Place*

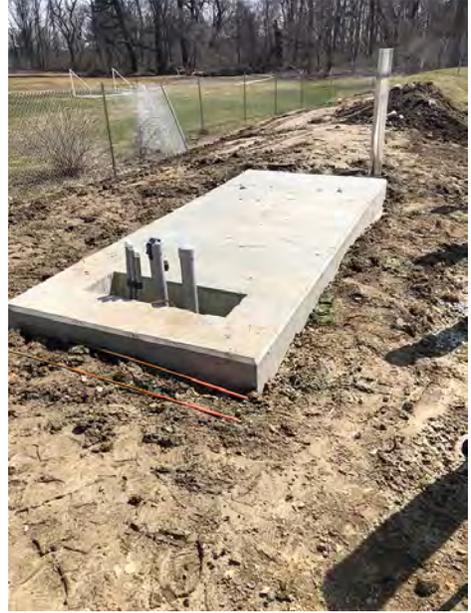
180411-IMG\_8312.jpg

*Cast-in-Place Concrete Pad for Generator in Place*

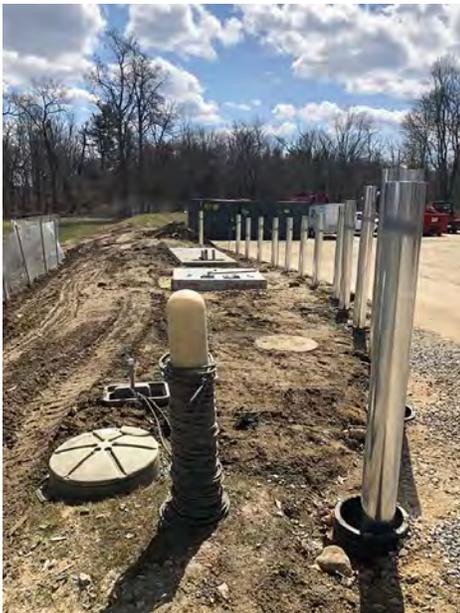
180411-IMG\_8310.jpg

*Bollards at Edge of Parking Lot to Protect Existing Grinder Pump Station (in Foreground) and Transformer and Emergency Generator Beyond*

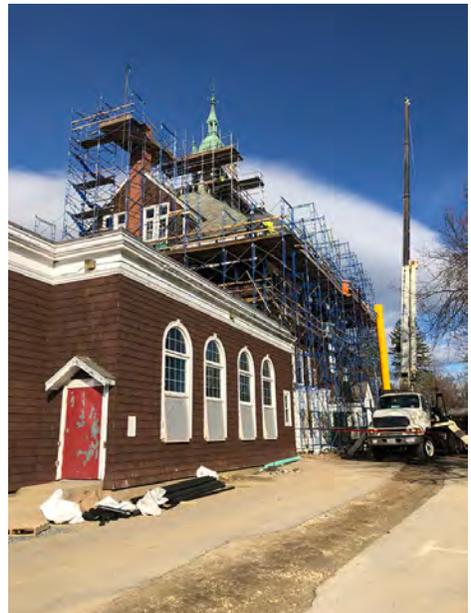
180418-IMG\_8333.jpg

*Scaffolding Installed at Facades of 1897 Building Including at Rear Gable for Brick Chimney Work*

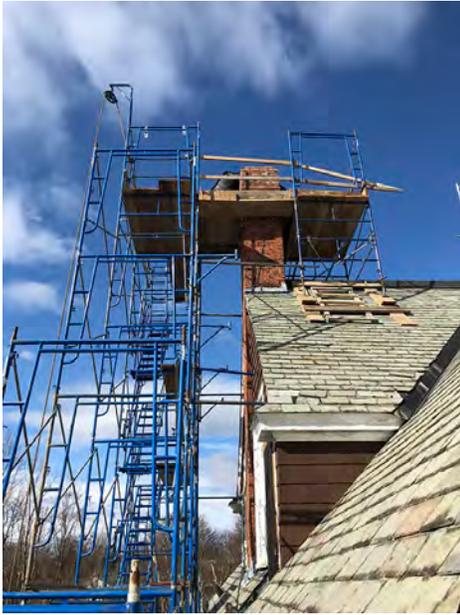
180418-IMG\_8348.jpg

*Scaffolding to Facilitate Brick Chimney Work for Reconstruction of Upper Portion and Full Repointing*

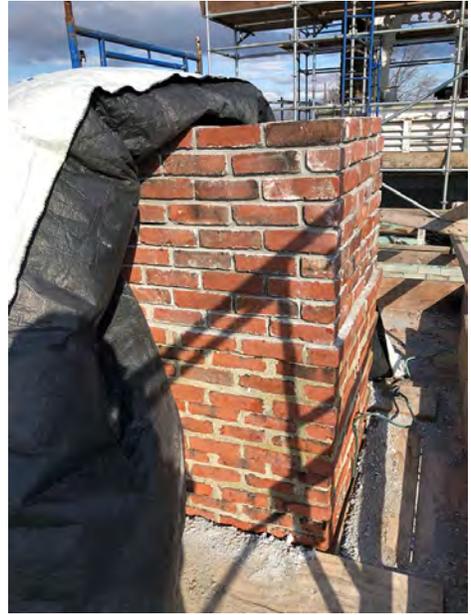
180418-IMG\_8339.jpg

*Upper Portion of Brick Chimney Reconstructed Using Sound Salvaged Existing Face Brick*

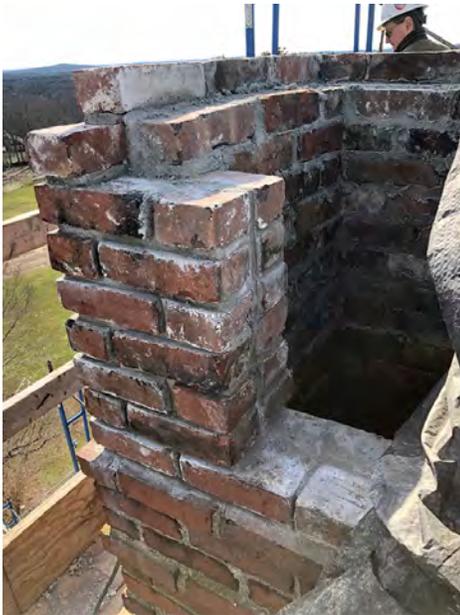
180418-IMG\_8344.jpg

*Detail at Blind Side of Chimney with Opening for Brick Vent Louver and Concrete Cap; Chimney Will No Longer Serve as Flue*

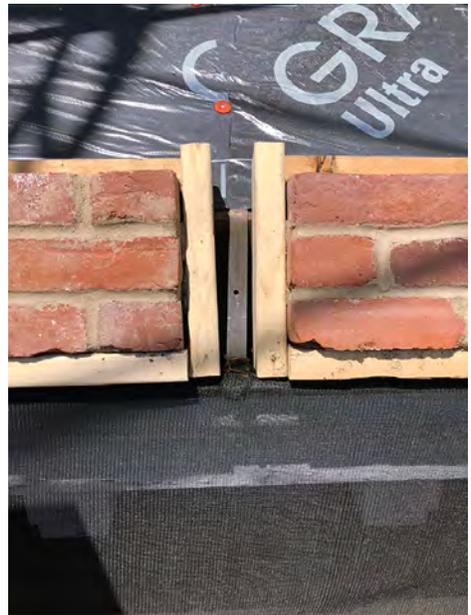
180502-IMG\_8436.jpg

*Two Brick Mortar Samples for Chimney Pointing; Sample at Left Approved for Color, Texture & Tooling; Awaiting Data Submittal of Mortar Prior to Release*

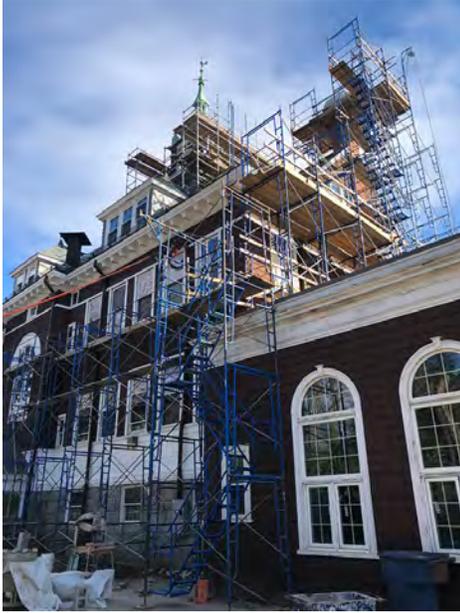
180418-IMG\_8331.jpg

- 07.5 Scaffolding for the exterior of the building is fully installed except for the area above the existing overhead electrical cables. When the new service is installed, the overhead wiring will be removed and the remaining portions of the west side scaffolding will be installed.

*View of Scaffolding on West Side of Building Along Entry Drive; Overhead Electrical Wiring Wrapped for Safety Prior to Removal When New Service is Activated*

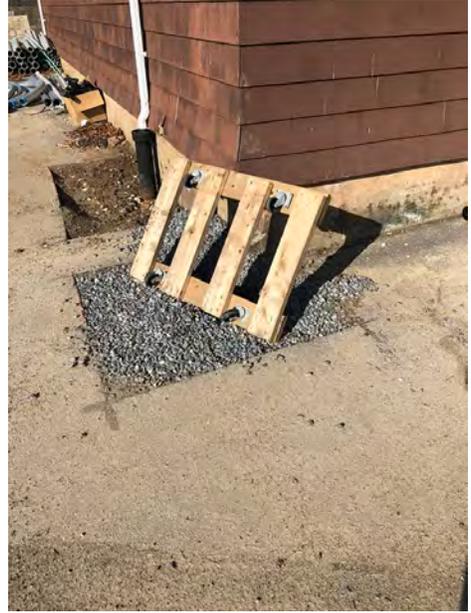
180418-IMG\_8334.jpg

*Saw-Cut Asphalt Paving for Bollard Placement at Outside Corners of Gymnasium*

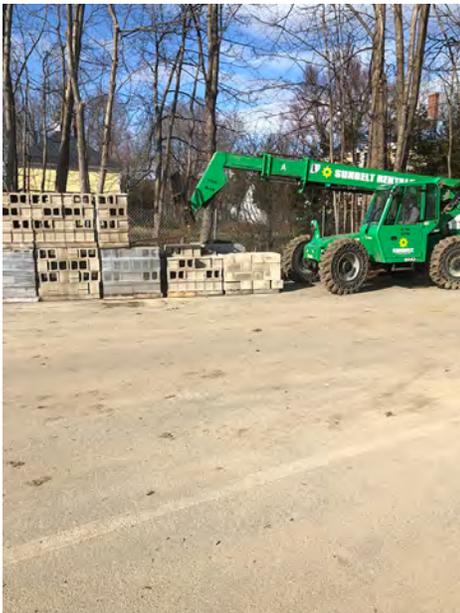
180418-IMG\_8336.jpg

*Concrete Masonry Units on Site for Construction of Elevator Hoistway*

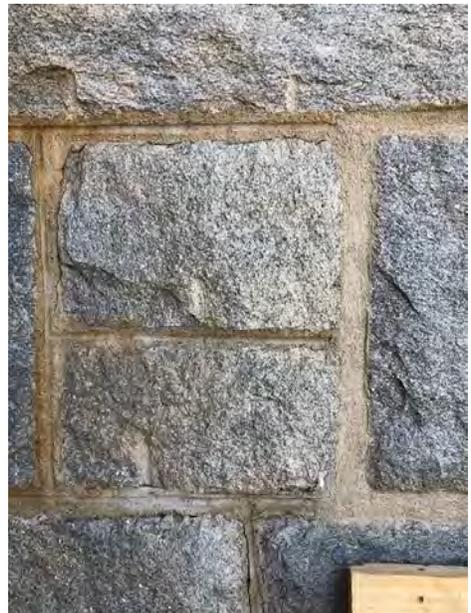
180502-IMG\_8435.jpg

*Repointing Sample of Mortar at Exterior Granite (Right); Color and Texture Approved, But Tooling Must Include Concave Center Groove to Match Original (Left); Awaiting Data Submittal of Mortar Prior to Release*

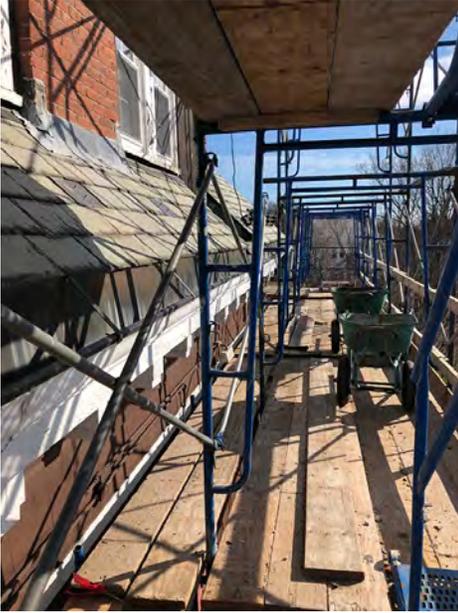
180418-IMG\_8346.jpg

*Scaffolding and Planking at South Eave of 1897 Building  
Adjacent to Rear Dormer at Third Floor*

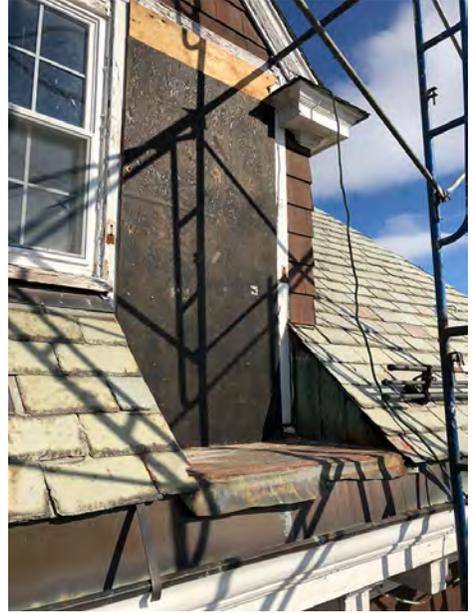
180418-IMG\_8347.jpg

*Former Third Floor Exit to Fire Escape;  
Roof Area & Missing Window to be Restored*

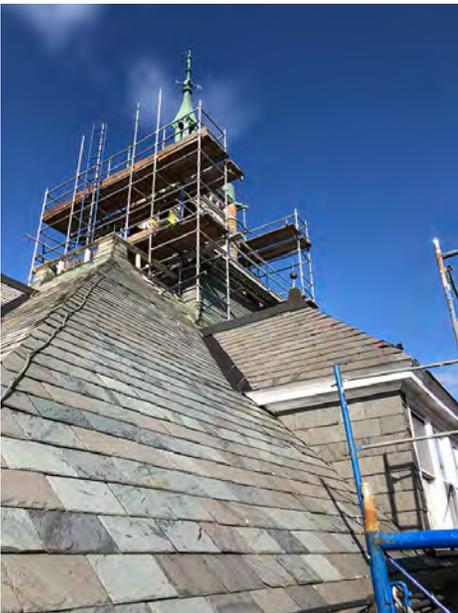
180418-IMG\_8349.jpg

*East Slope of Existing Slate Roof Prior to Removal;  
Note Slates at Side Walls of Dormers*

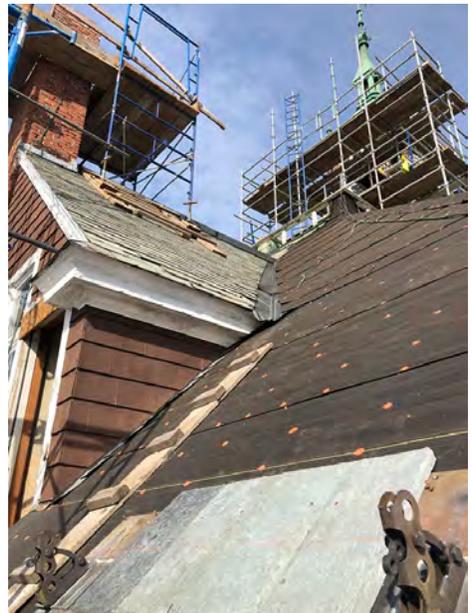
180502-IMG\_8403.jpg

*Slate Removal at South Slope; Wood Shingles at  
Rear Gable Side Walls to be Replaced with Slate*

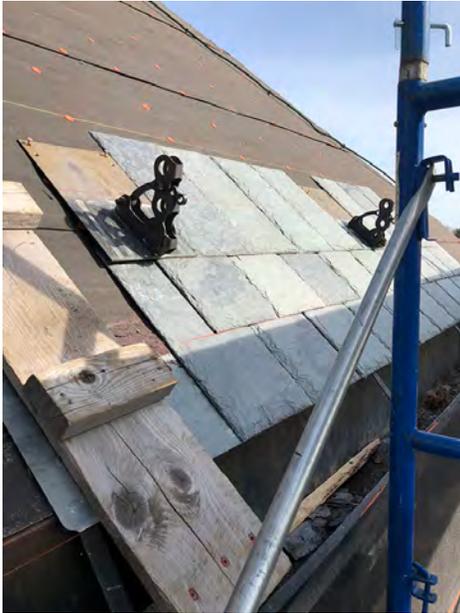
180502-IMG\_8399.jpg

- 07.6 Roofing work at the main 1897 portion of the building is in progress. A mock up for underlayment and slates was reviewed on site with the Architect. Slates will be fastened with smooth shank copper nails in lieu of the ring nails that were specified. This modification is based on the suggestion of the roofer because the smooth nails are stronger and provide more forgiveness for nail depth placement to hang the slates.

*Slate and Snow Guard Mockup at South Slope of Roof; 10" x 20" Slates with 8.5" Exposure and 3" Headlap*

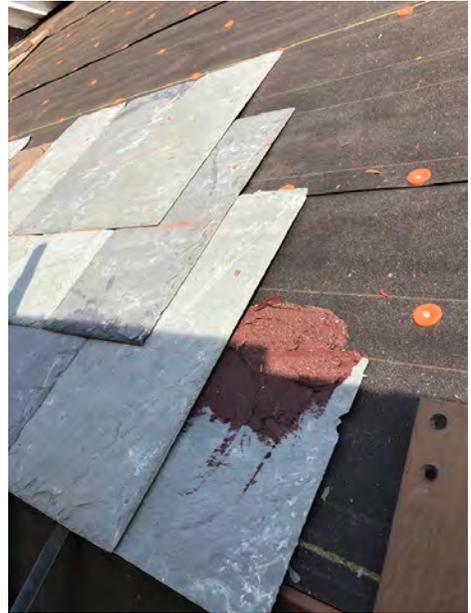
180502-IMG\_8400.jpg

*Bulldog Red Cement at Starter Course; Asphalt Paper (Roofing Felt) Placed Over Self-Adhered Membrane*

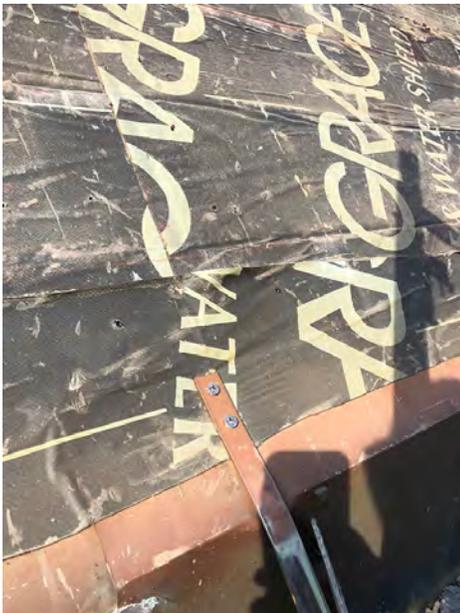
180502-IMG\_8402.jpg

*Self Adhering Membrane at Eaves for Added Protection; Existing Copper Gutter Straps (Dogs) Screwed into Sheathing*

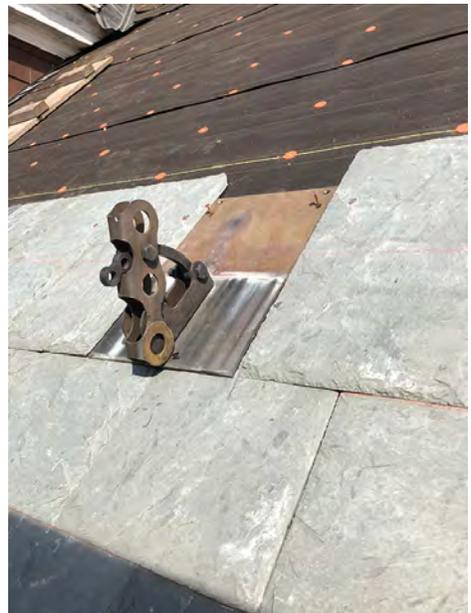
180502-IMG\_8401.jpg

*Salvaged Re-Use of Snow Guard Brackets; Copper Flashing to be Added to Provide Full Headlap; Plates to be Screwed into Sheathing (4 per); Smooth Shank Copper Nails to be Used for Slates*

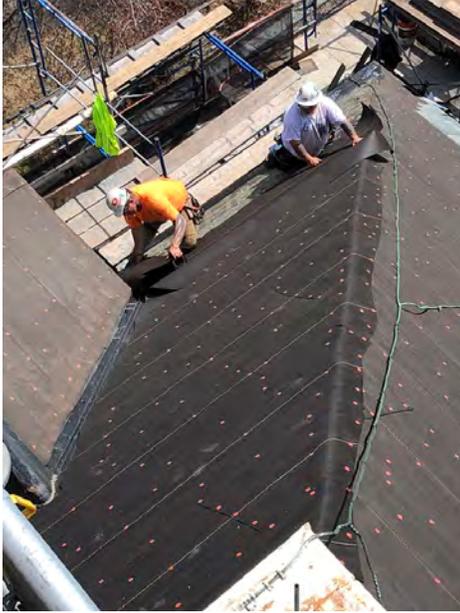
180502-IMG\_8422.jpg

*Roofing Felt Installation in Progress at Southeast Hip*

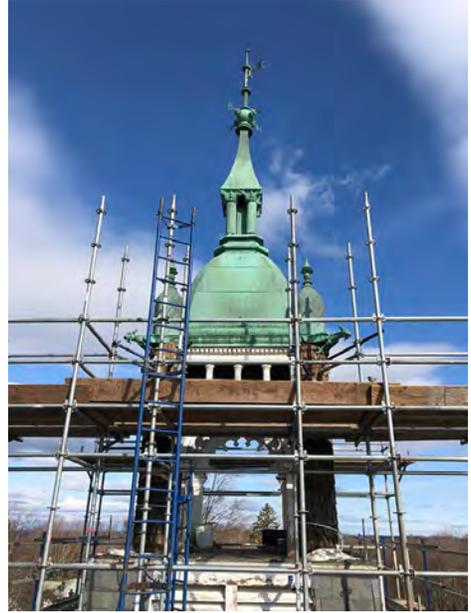
180418-IMG\_8342.jpg

*Scaffolding at Cupola*

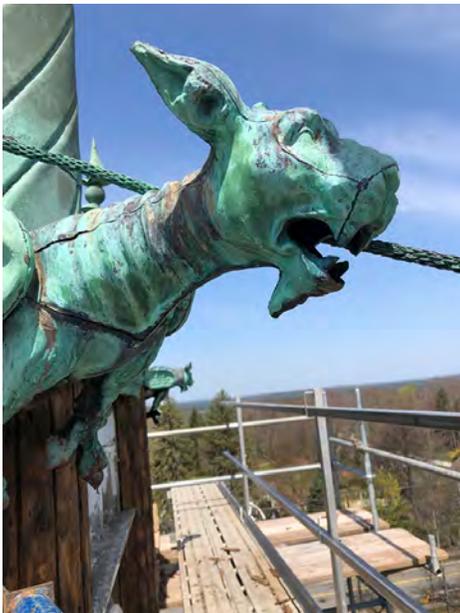
180502-IMG\_8414.jpg

*One of Four Grotesques at Cupola Corners*

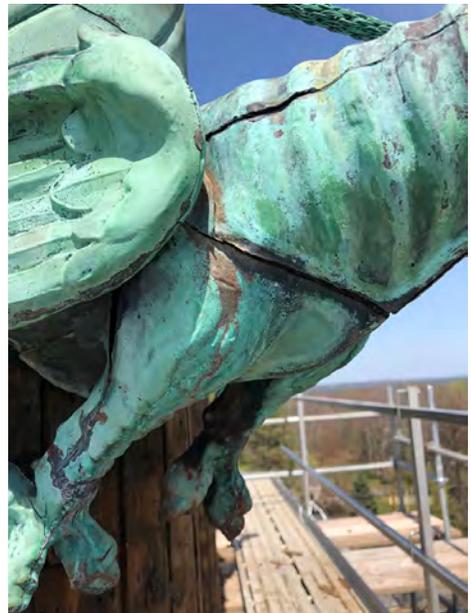
180502-IMG\_8415.jpg

*Open Seams Require Resoldering of Copper;  
Bird Debris Removal Required Inside of Grotesques;  
Copper Screening to be Provided as Bird Deterrent*

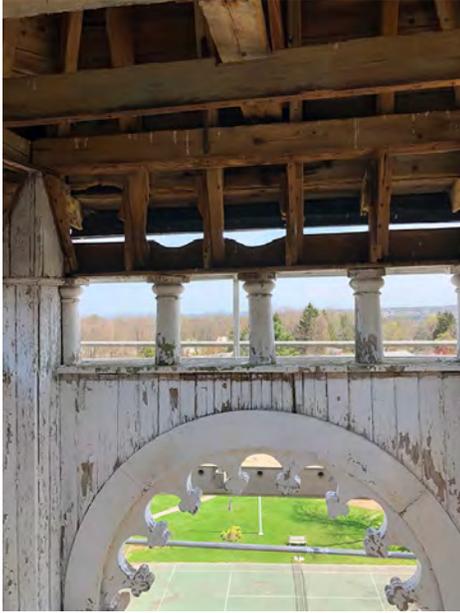
180502-IMG\_8421.jpg

- 07.7 Concealed damage at the cupola level has been revealed. The GC has noted that they do not have the right carpenters on their team to address the cupola appropriately. At the Owner's request, the Architect has contacted two steeplejack companies for a review of conditions as soon as possible.

*Removal of Interior Finishes at Ceiling of Cupola Revealed Concealed Damage to Soffit Framing & Fascias*

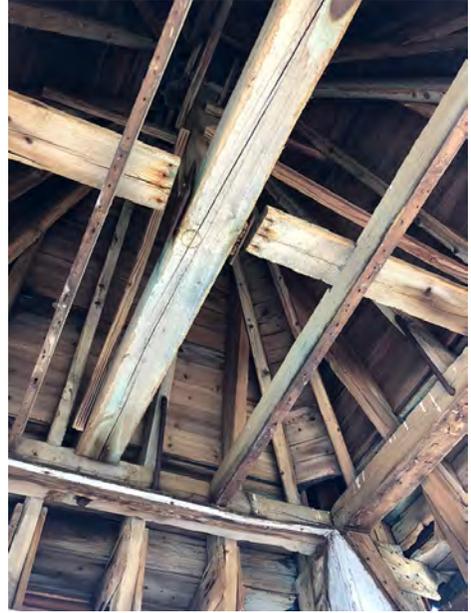
180502-IMG\_8424.jpg

*North-South Ceiling Tie at Cupola Ceiling; East-West Boards Separated from Main Tie*

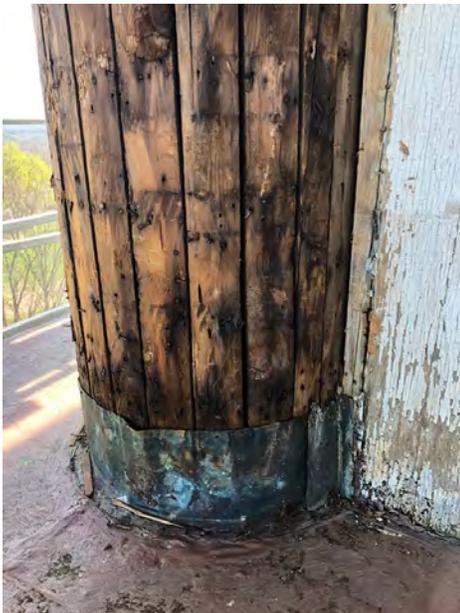
180502-IMG\_8423.jpg

*Sheathing and Flashing at Cupola Corners*

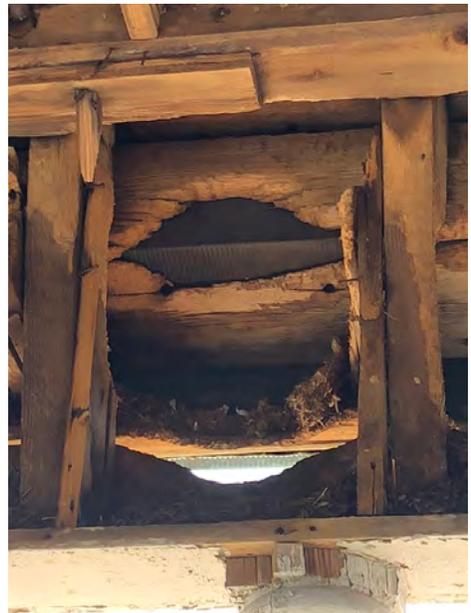
180502-IMG\_8425.jpg

*Damage to Wood Below Exterior Copper and Behind Interior Ceiling & Soffit Finishes*

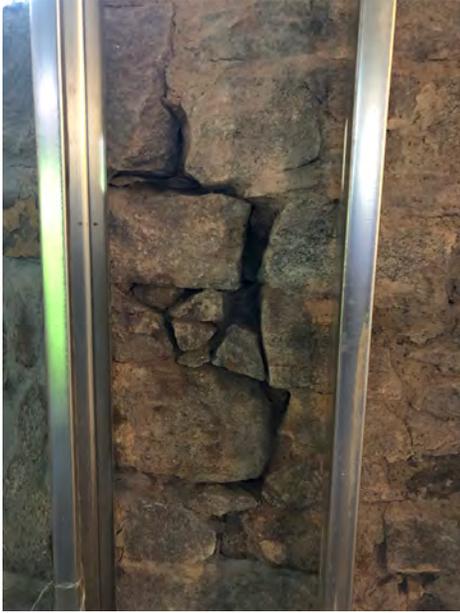
180502-IMG\_8432.jpg

*Open Void in Stone Wall at Electrical Room;  
Deep Repointing to Restore Integrity of Masonry*

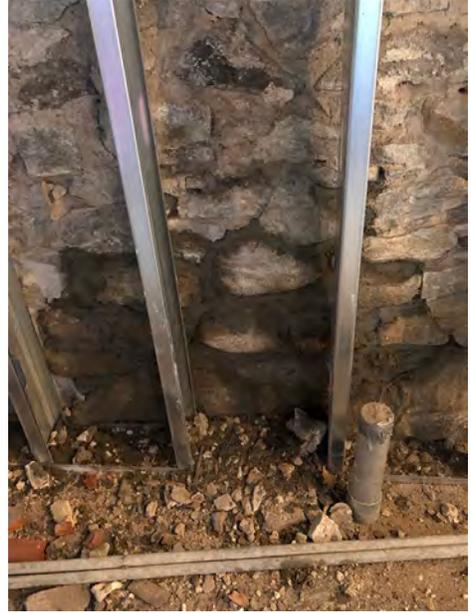
180502-IMG\_8434.jpg

*Selective Resetting of Loose Stones at Base of  
Wall in Electrical Room Prior to Concealment*

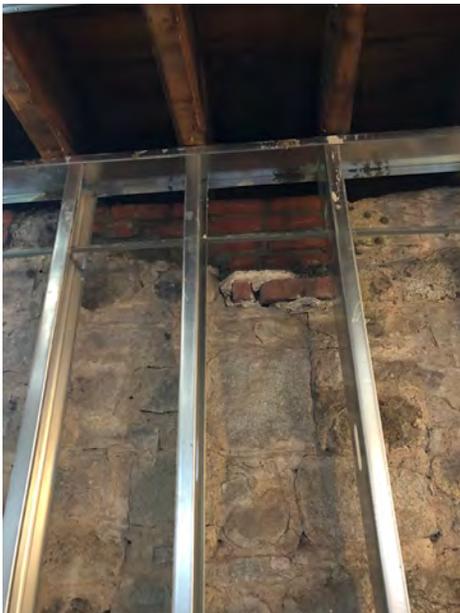
180502-IMG\_8433.jpg

*Brick Infill at Former Pocket at Top of Wall in  
Electrical Room Prior to Concealment*

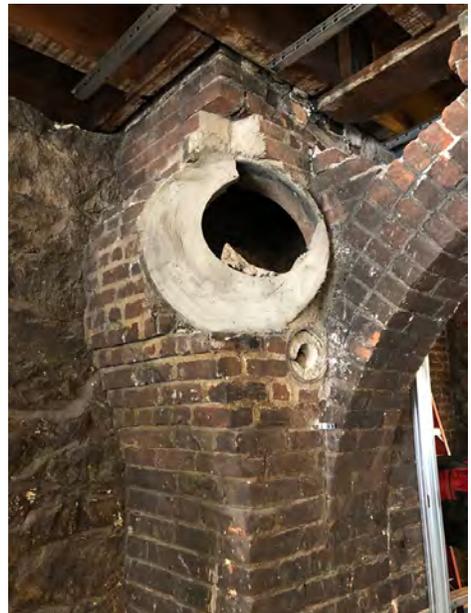
180418-IMG\_8363.jpg

*Former Breaching into Brick Chimney at Boiler Room;  
Flue No Longer Needed Due to High Efficiency  
Condensing Boiler & Hot Water Heater Installation*

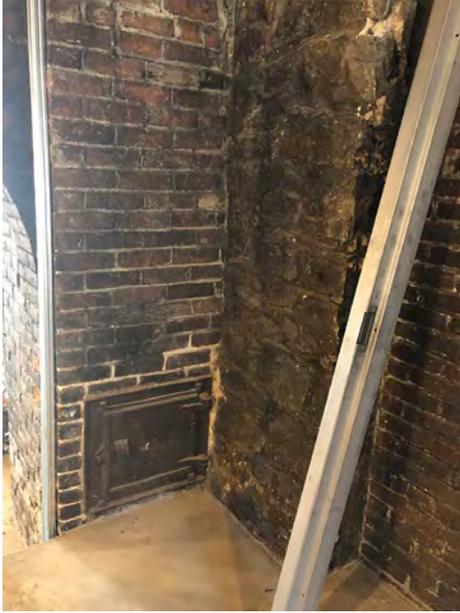
180411-IMG\_8300.jpg

*Former Ash Cleanout at Flue to be Left Visible in Lower Lobby Accessible Toilet Room*

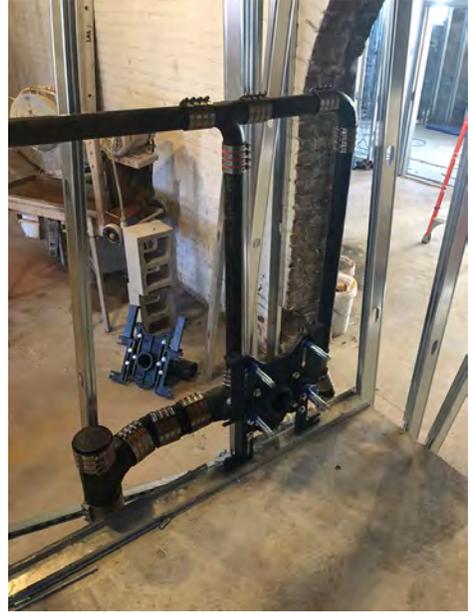
180411-IMG\_8299.jpg

*Rough Plumbing for Basement Toilet Rooms*

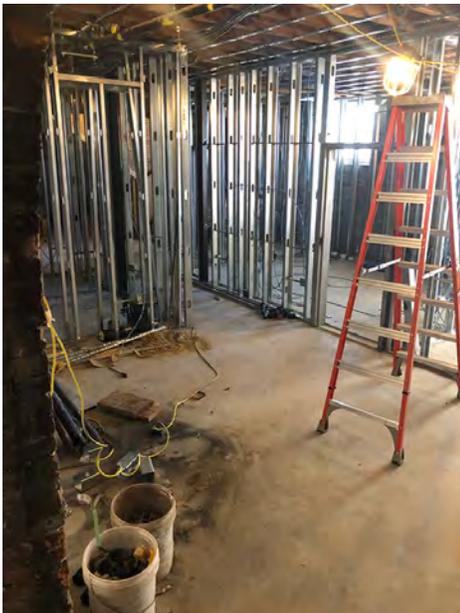
180411-IMG\_8302.jpg

*Boiler Room Looking NE Toward Electrical Room*

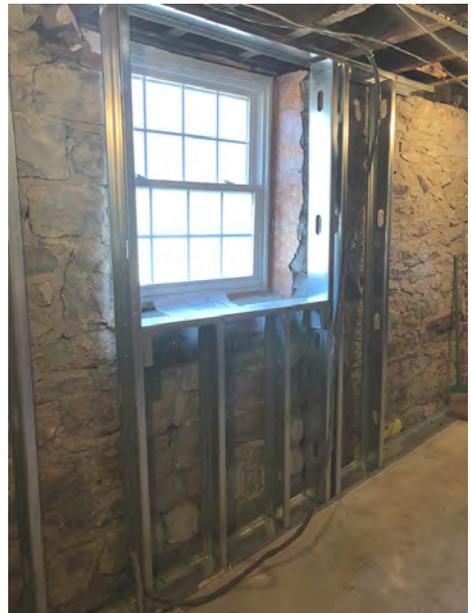
180411-IMG\_8297.jpg

*Metal Stud Framing at Lower Lobby Window in Former Women's Restroom; Vinyl Window & Translucent Glass to be Replaced with Wood Window & Clear Glass*

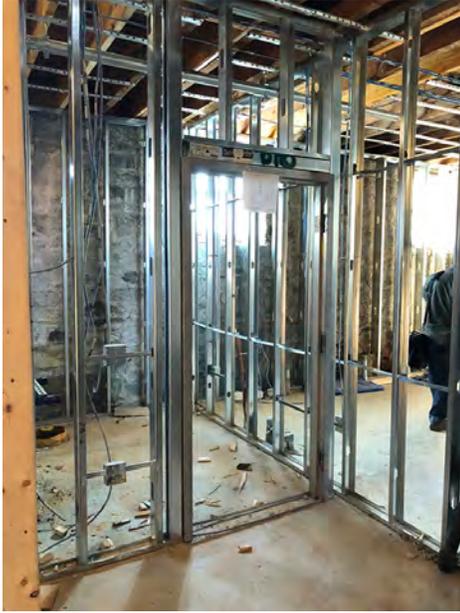
180418-IMG\_8360.jpg

*Stud Framing and Door Opening into Staff Accessible Toilet Room in Basement*

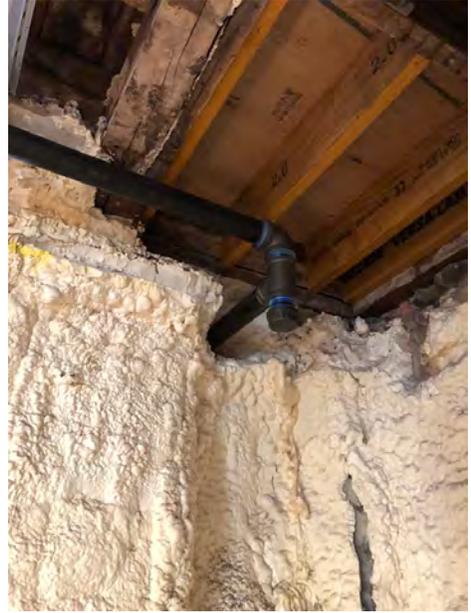
180418-IMG\_8359.jpg

*Existing Incoming Gas Piping at North Wall; Gas Piping to Boiler Room Replaced*

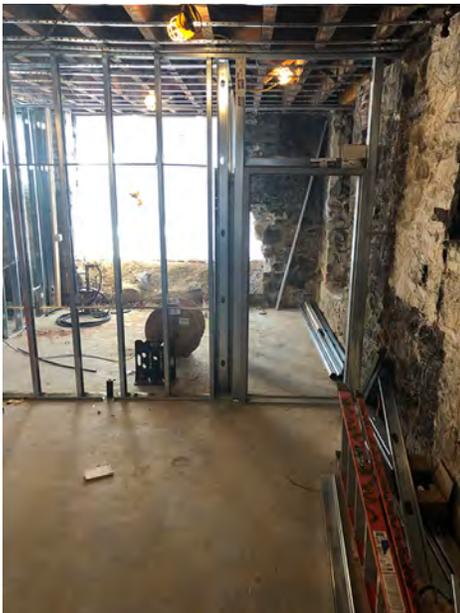
180411-IMG\_8301.jpg

*Stud Framing and Door Opening into Exit Passage from Boiler Room in Basement; Sprinkler Room at Left and Temporary Opening in Exterior Wall Beyond (for Excavation Work)*

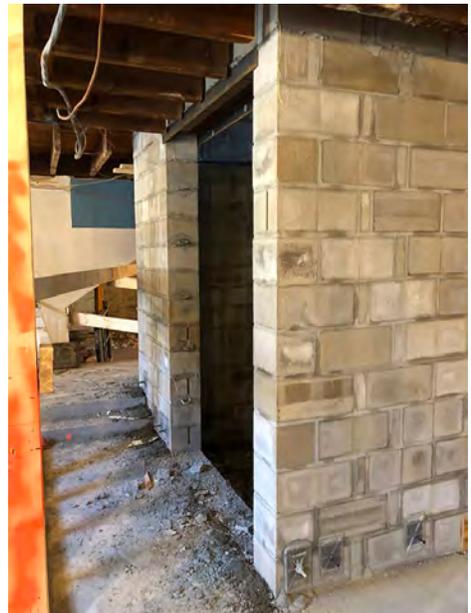
180418-IMG\_8357.jpg

*Lower Lobby Elevator Landing Level at CMU Hoistway Facing West; Original Joists Trimmed & Sistered to Provide Adequate Clearance for Required Door Height*

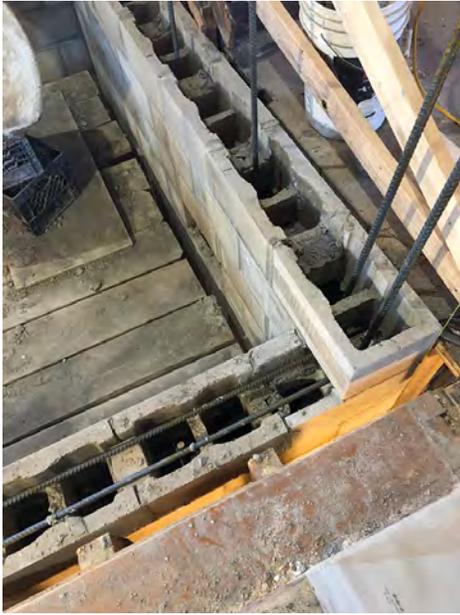
180411-IMG\_8284.jpg

*Open Cells with Reinforcement Prior to Grouting at Typical Bond Beam Level of Elevator Hoistway*

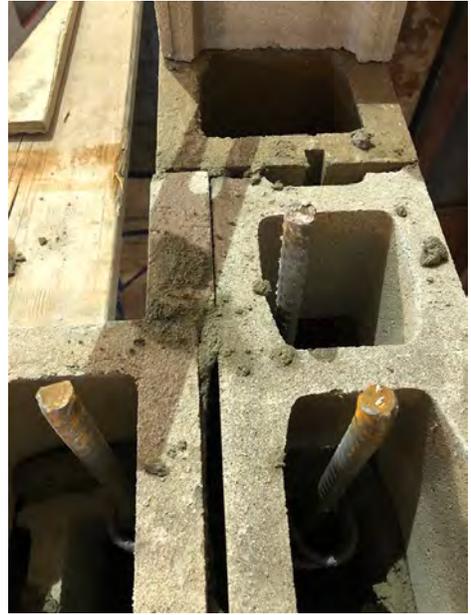
180418-IMG\_8352.jpg

*Detail of Corner CMU Showing 8" Block Abutting 10" Block with Interior 2" Soap*

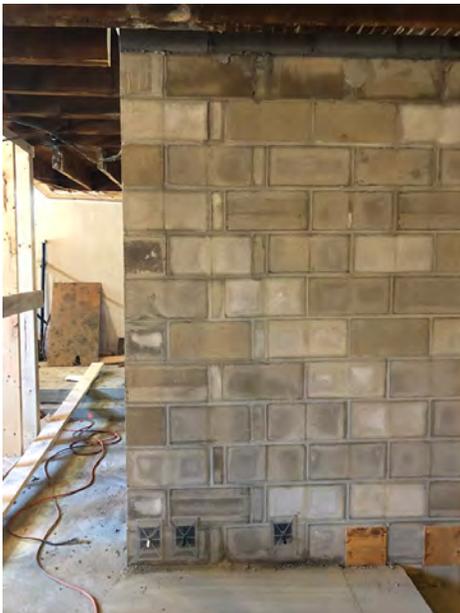
180411-IMG\_8308.jpg

*South Elevation of Shaft at SW Corner of Basement Level; Lower Lobby Landing Level at Left Side (West)*

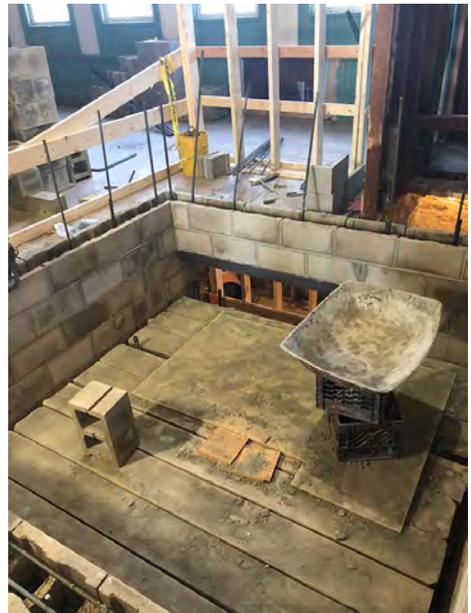
180411-IMG\_8287.jpg

*Hoistway Construction at First Floor Level; Lintels at Lower Lobby Landing Opening Visible Below*

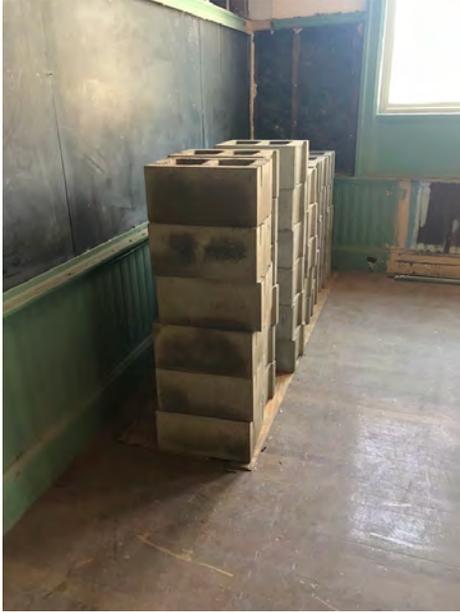
180411-IMG\_8290.jpg

*CMU Stored at Edges of First Floor Classroom #2  
Close to Bearing Locations for Load Distribution*

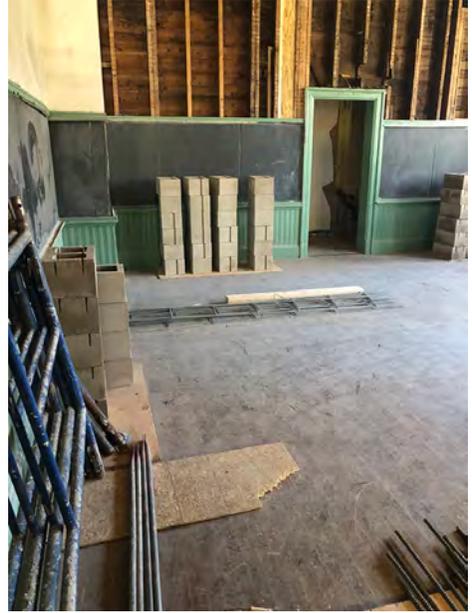
180411-IMG\_8289.jpg

*CMU Stored at Edges of First Floor Classroom #2  
Close to Bearing Locations for Load Distribution*

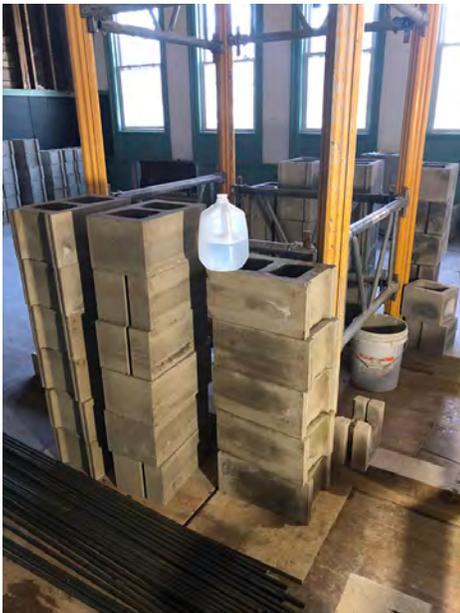
180411-IMG\_8288.jpg

*CMU Stored at First Floor Classroom #2  
Adjacent to Shoring by Shaft for Load Distribution*

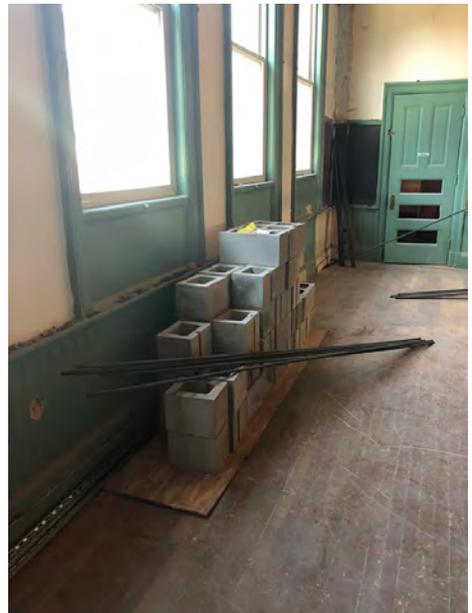
180411-IMG\_8291.jpg

*CMU Stored at Edges of First Floor Classroom #2  
Close to Bearing Locations for Load Distribution*

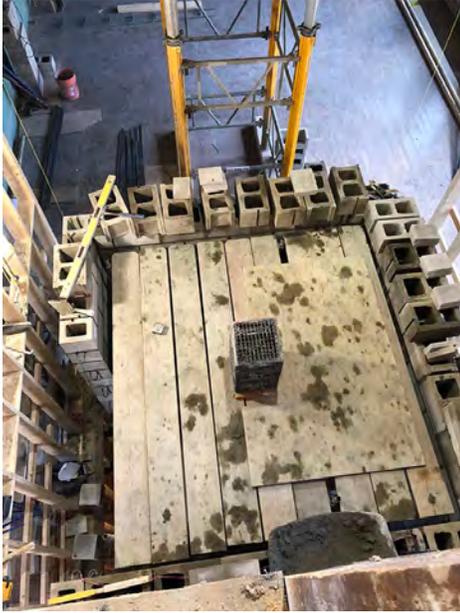
180418-IMG\_8353.jpg

*View Down Hoistway Opening to Elevator Shaft Construction*

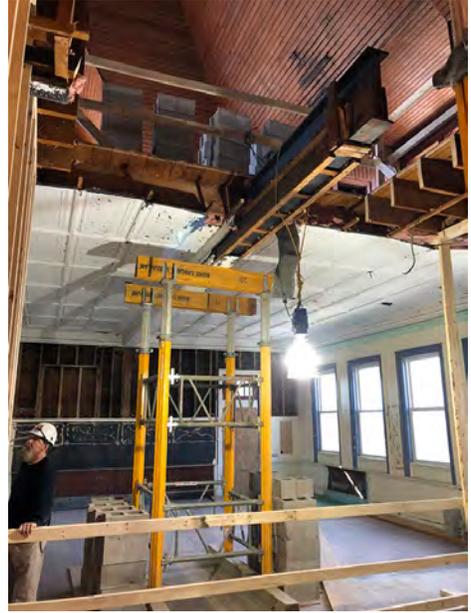
180418-IMG\_8354.jpg

*Original Steel Beam at Ceiling of Second Floor Prior to Cutting and Resupport at Elevator Hoistway*

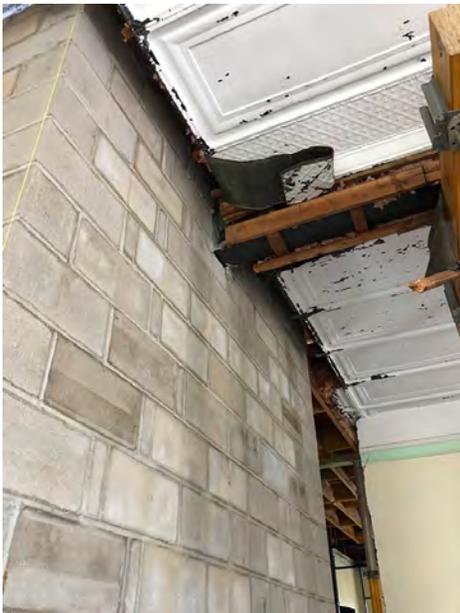
180502-IMG\_8412.jpg

- 07.1 The reinforced CMU elevator hoistway was constructed during the month of April, complete with grouting, bond beams and reinforcing. The provision of bolted ledgers for wood joist connection to the shaft is nearing completion. Existing steel beams that were interrupted by the shaft have been cut and supported with plates at the bond beams as planned. The steel hoistway beam has been installed at the top of shaft.

*Steel Beam Resupported at Elevator Hoistway*

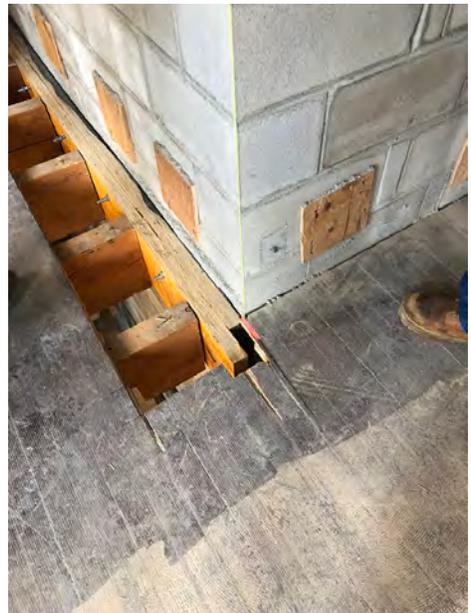
180502-IMG\_8411.jpg

*Grouting Ports in CMU Walls Covered with Plywood; LVL Ledger Bolted into Grouted CMU for Support of Adjacent Original Floor Joists at Second Floor*

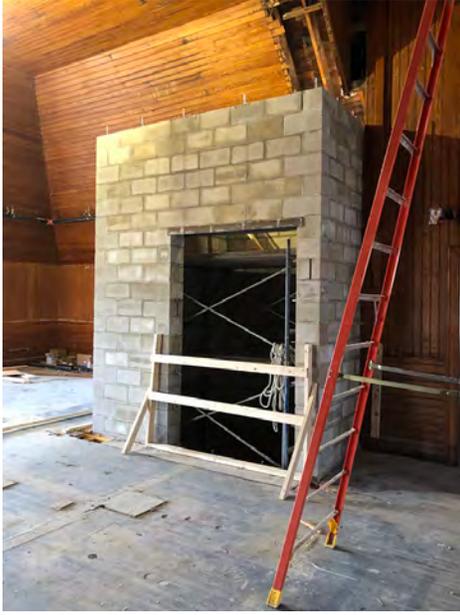
180502-IMG\_8426.jpg

*Third Floor Landing Opening at CMU Hoistway*

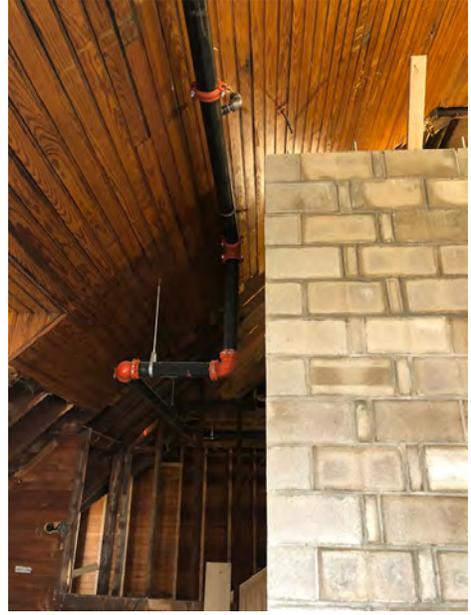
180502-IMG\_8427.jpg

*Southwest Corner of Hoistway at Third Floor*

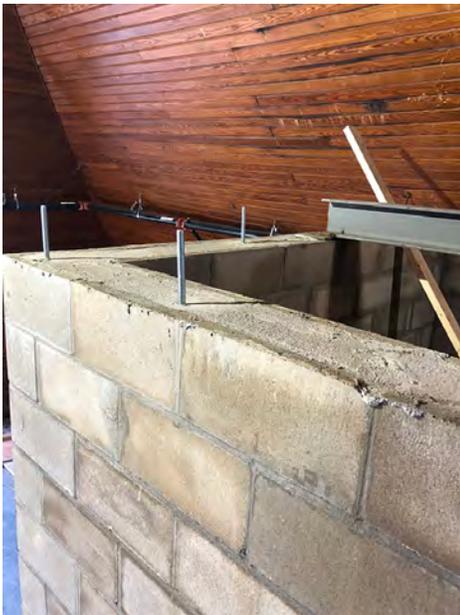
180502-IMG\_8429.jpg

*SE Corner at Top of Hoistway Showing Anchor Bolts for Cap Framing and Hoistway Beam for Use by Elevator Installers during Construction*

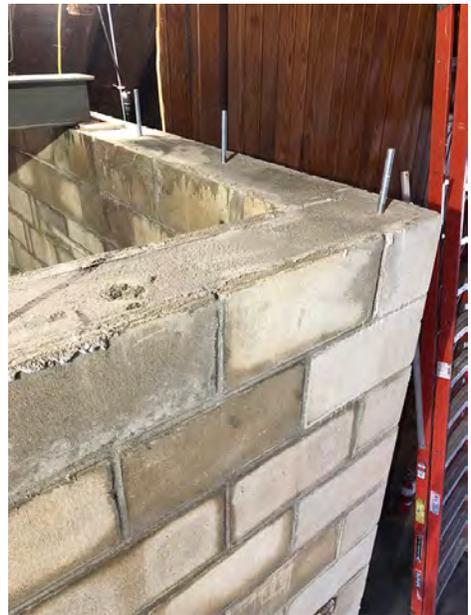
180502-IMG\_8430.jpg

*NE Corner at Top of Hoistway Showing Anchor Bolts for Cap Framing and Hoistway Beam for Use by Elevator Installers during Construction*

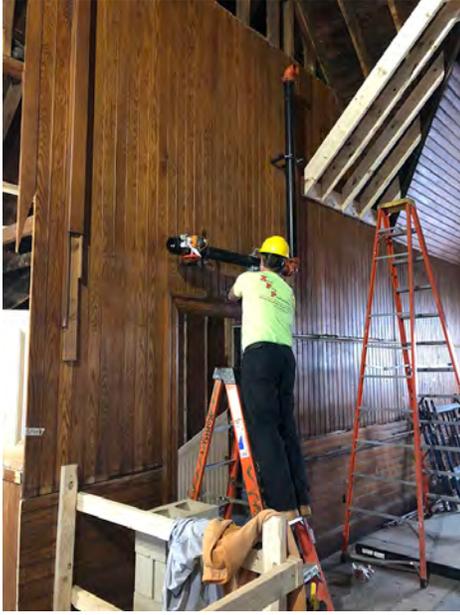
180425-IMG\_8371.jpg

- 07.4 Sprinkler piping has started at the third floor and basement levels. The existing double check valve has been moved from its former location to the sprinkler room.

*Sprinkler Piping Installation in Progress at Third Floor*

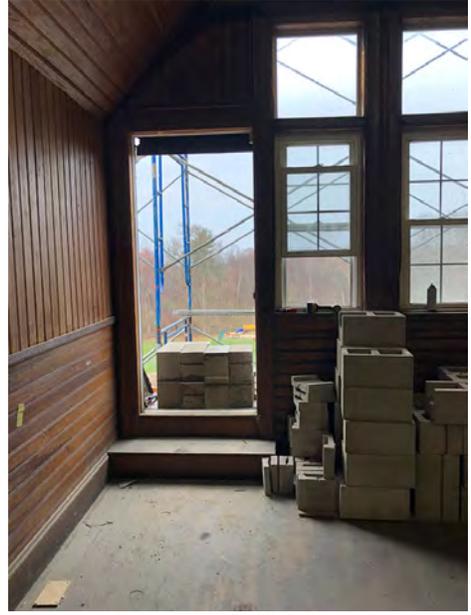
180425-IMG\_8368.jpg

*Former Exit Door from Third Floor to Fire Escape; Original Wall & Missing Window to be Restored*

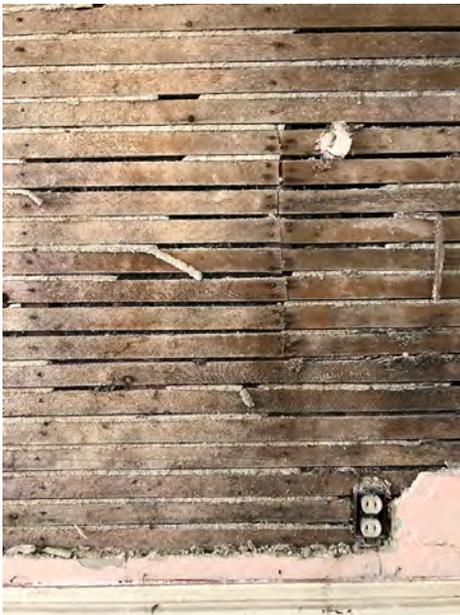
180418-IMG\_8355.jpg

*Intact Plaster Lath at North Wall of Second Floor Kitchen; Plaster Removal Required Due to Concealed Damage Behind the Formerly Adhered Homosote Covering*

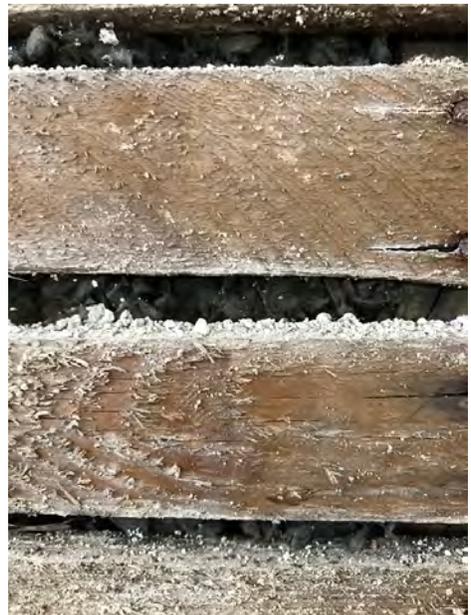
180418-IMG\_8356.jpg

*Detail of Lath at Kitchen with Loose Fill Insulation in Wall; Retain Lath in Place to Preserve Insulation; Refasten and Provide Thinner Drywall to Replicate Former Plane*

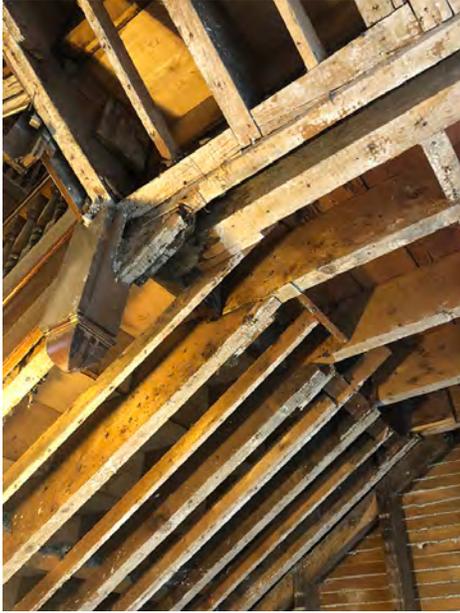
180425-IMG\_8379.jpg

*Exposed Framing of West Stair Landing at Level 1.5  
Looking South at Newel & Lower Landing;  
Framing Reinforcement Strategy Under Consideration*

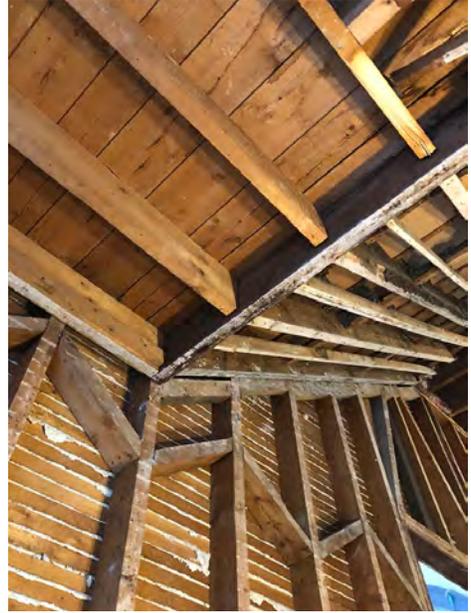
180425-IMG\_8382.jpg

*Exposed Framing of West Stair Landing at Level 1.5  
Looking Northeast at Upper Intermediate Landing;  
Framing Reinforcement Strategy Under Consideration*

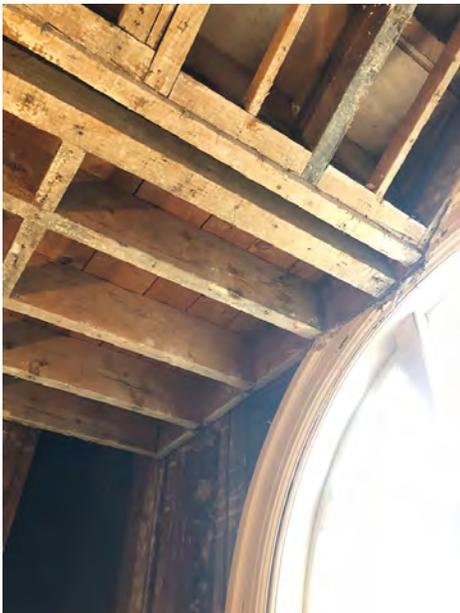
180425-IMG\_8381.jpg

*Exposed Framing of West Stair Landing at Level 1.5  
Looking Southwest at Lower Intermediate Landing;  
Framing Reinforcement Strategy Under Consideration*

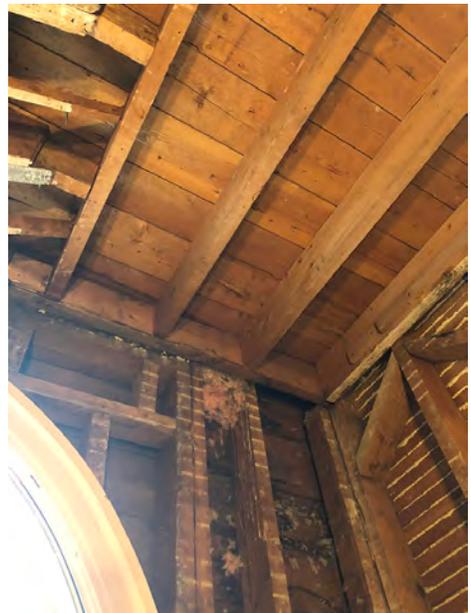
180425-IMG\_8380.jpg

*Exposed Framing of West Stair Landing at Level 1.5  
Looking Northwest at Upper Intermediate Landing;  
Framing Reinforcement Strategy Under Consideration*
