FIELD REPORT No. 08

ROUDENBUSH COMMUNITY CENTER REHABILITATION

DATE/TIME: May 3 – June 6, 2018 (Project Meetings on May 9, 16, 23, 30, June 6) (Other Visits 5/18 + 6/4)

PURPOSE: Construction Progress Summary

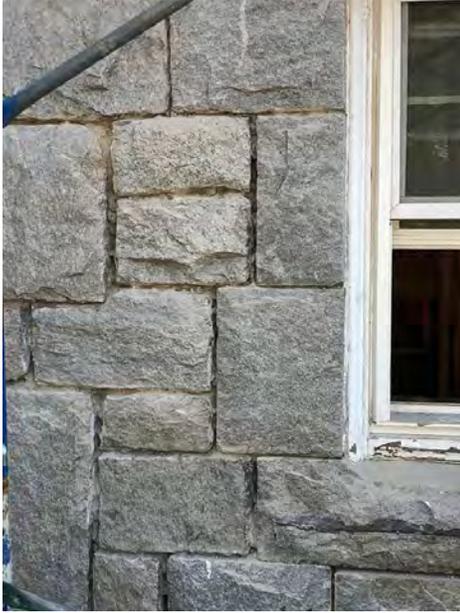
180509-IMG_8464.jpg

Mortar Joints Cut Out at Exterior Granite in Preparation for Repointing of Exterior

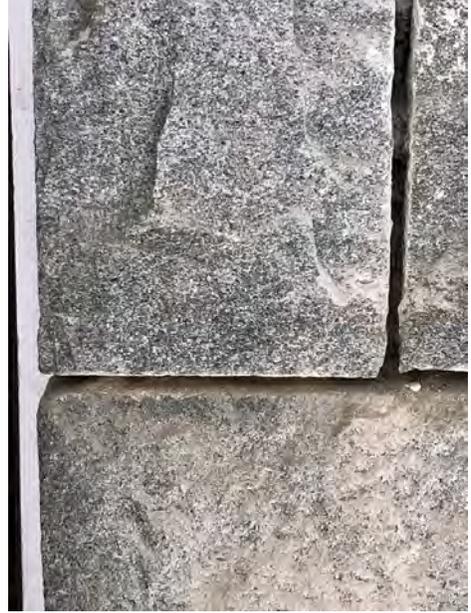
180523-IMG_8514.jpg

Detail of Pointing Mortar Removal at Granite Exterior in Preparation for Repointing

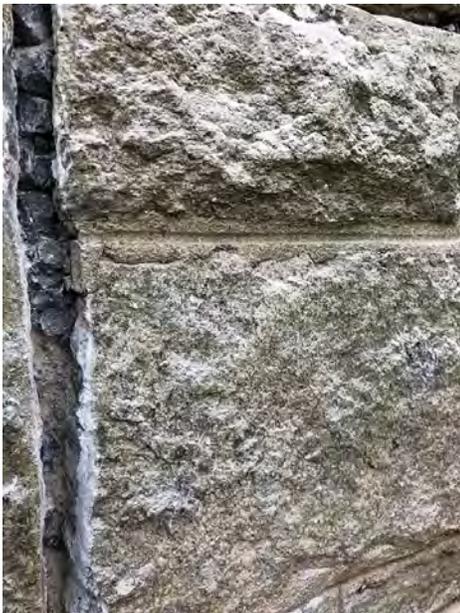
180523-IMG_8527.jpg

Detail of Original Pointing with Concave Half Round Tooling in Middle of Mortar Joint

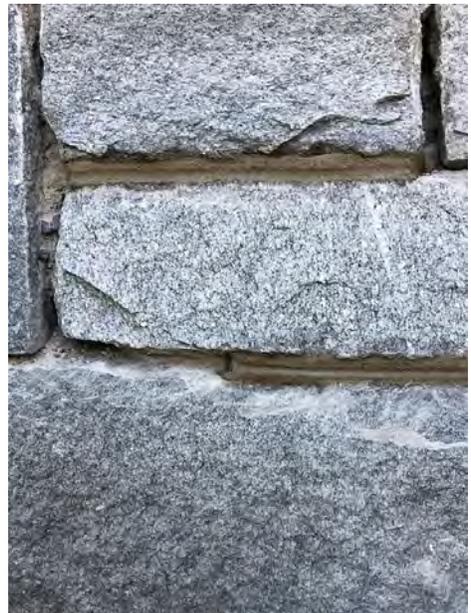
180523-IMG_8526.jpg

Two Samples with Two Sizes of Half Round Tooling; Upper Sample is Larger than the Original; Lower Sample is the Approved Match

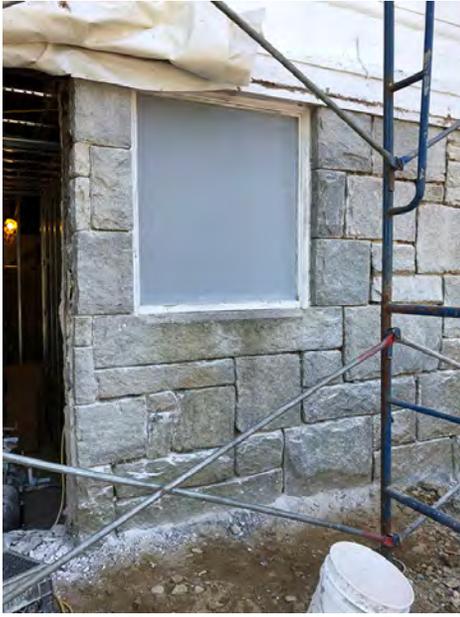
180523-IMG_8525.jpg

Solid Painted Plywood Set Into Original Frame to Retain Original Opening at Former Men's Room; Vinyl Window Removed for Electrical Room Within

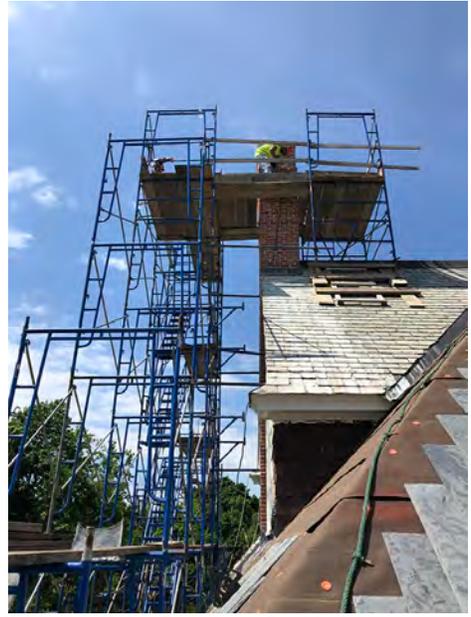
180530-IMG_8581.jpg

Scaffolding at Rear Facade to Enable Reconstruction of Upper Portion of Brick Chimney and Repointing of Full Height of Chimney

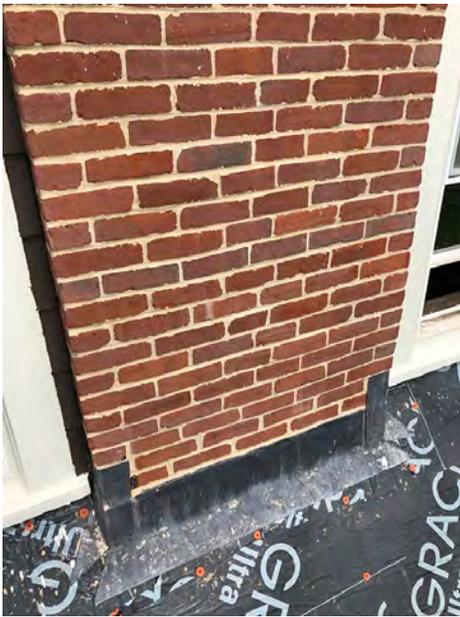
180530-IMG_8568.jpg

Detail of Replacement Flashing and Repointing at Base of Existing Brick Chimney at South Facade

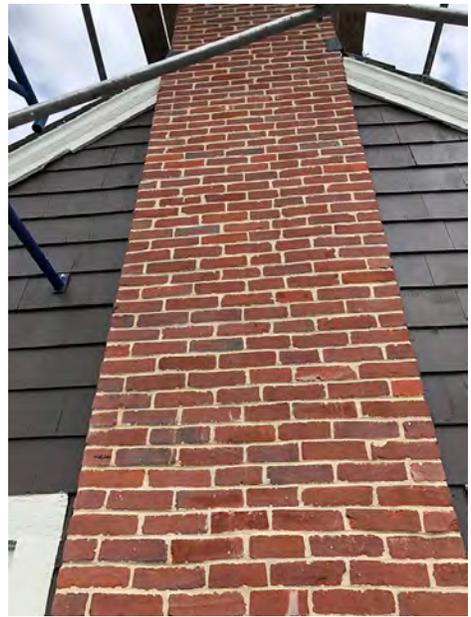
180530-IMG_8569.jpg

Detail of Repointing of Existing Brick Chimney

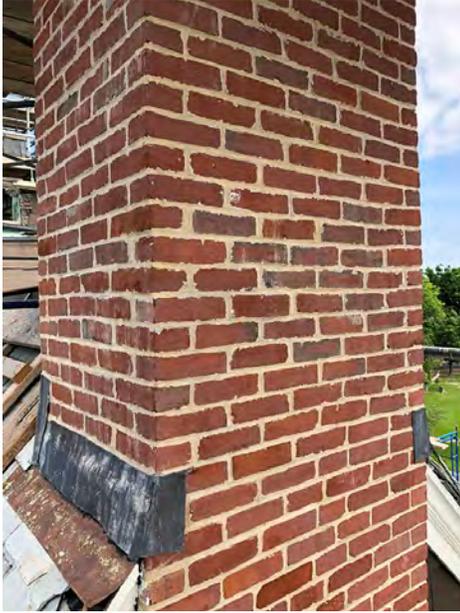
180530-IMG_8574.jpg

*Chimney Repointed and Washed;
Flashings at Rear Gable Roof Replaced*

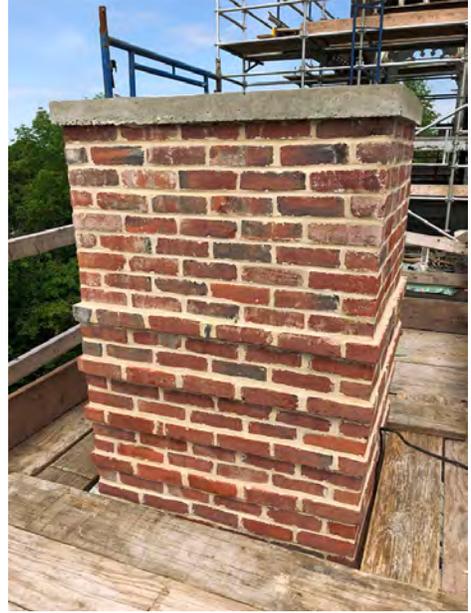
180530-IMG_8575.jpg

*Upper Coursing of Chimney Reconstructed with
Salvaged Brickwork from Existing Chimney*

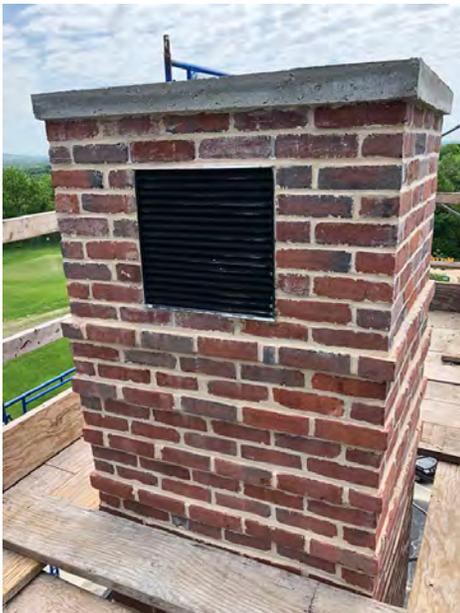
180530-IMG_8576.jpg

*Blind Side of Chimney Fitted with Brick Vent Louver;
Chimney Capped with Concrete Matching the
Original Cap (But With Full Coverage)*

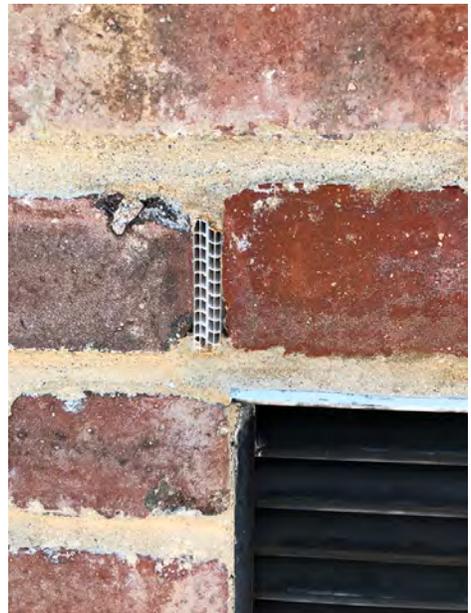
180523-IMG_8499.jpg

*Detail of One of the Pair of Weeps at Head Lintel of
Brick Louver; Chimney No Longer Venting the Boiler;
Louver Vent is for Relief of Interior Condensation*

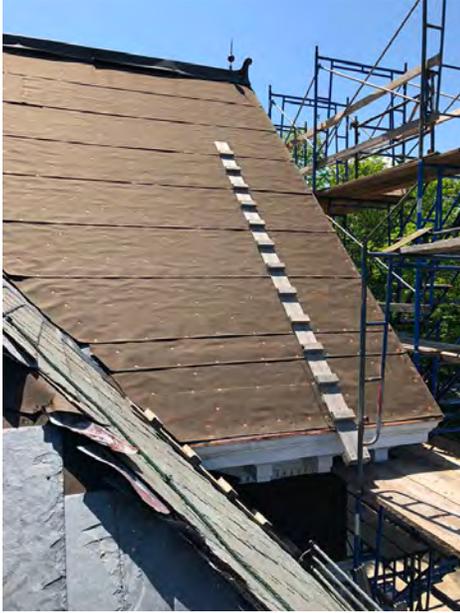
180523-IMG_8501.jpg

East Slope of Front Gable of Slate Roof; Roofing Felt Paper Over Slope with Ice/Water Shield (Now Concealed) at Eave, Valley, Rake

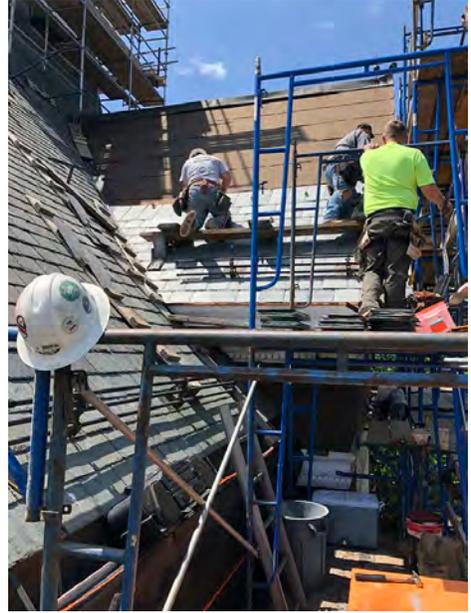
180530-IMG_8582.jpg

Installation of Slate Shingles at East Slope of Front Gable; Provision of Snow Rails & Pads to Replicate Former Pattern

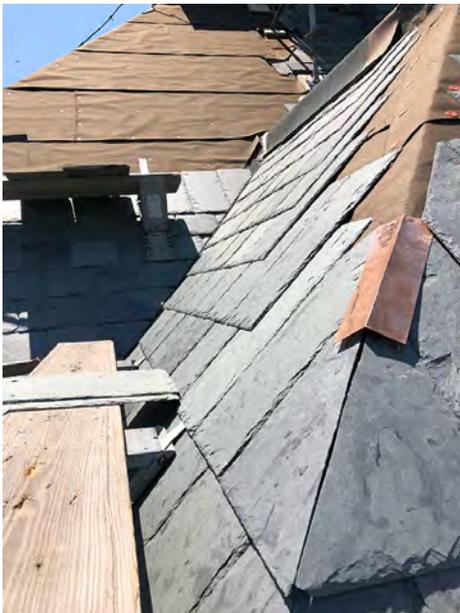
180523-IMG_8506.jpg

Hip Detail at Dormer Showing Incremental Concealed Copper Flashing to Cover Open Hip Joint

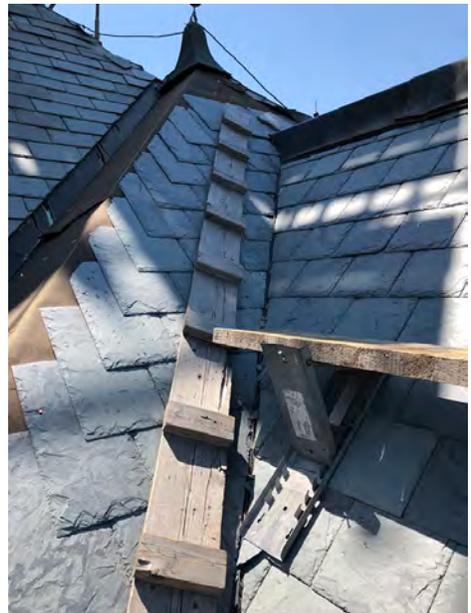
180523-IMG_8505.jpg

Revised Slate Shingle Detail at Closed Valleys; Former Open Valleys Allowed for Ice Wedging

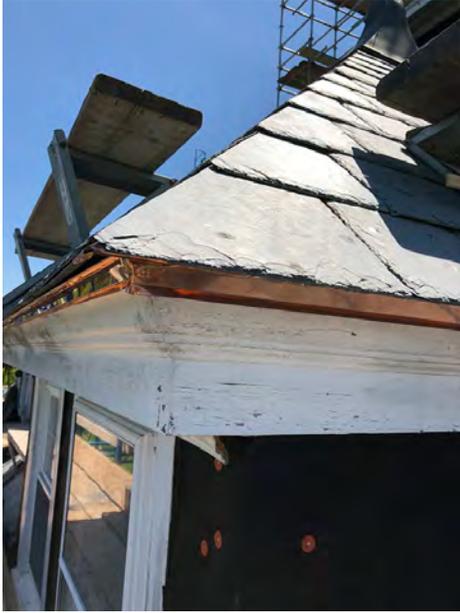
180523-IMG_8503.jpg

Copper Drip Detail at Eave

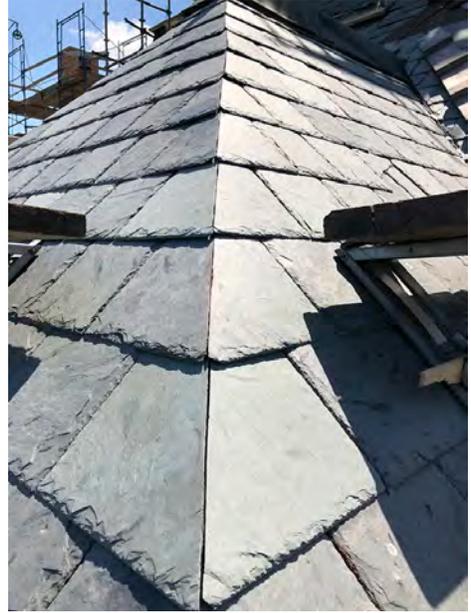
180523-IMG_8504.jpg

Detail of Hip Miter at Slate Shingles

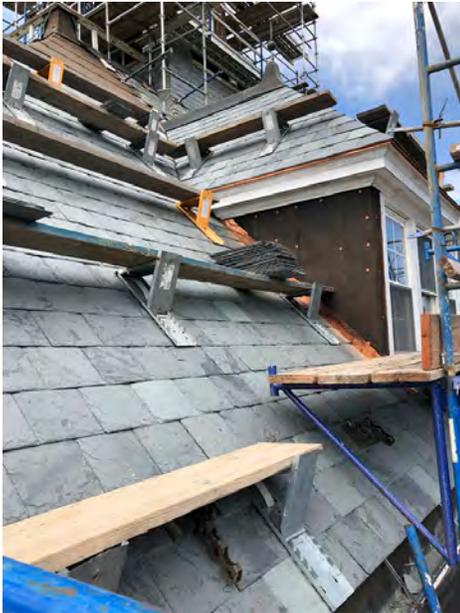
180530-IMG_8573.jpg

*East Facade Roofing at Main Slope and Hip Dormer;
Embedded Dormer to Receive Slates at Side Walls*

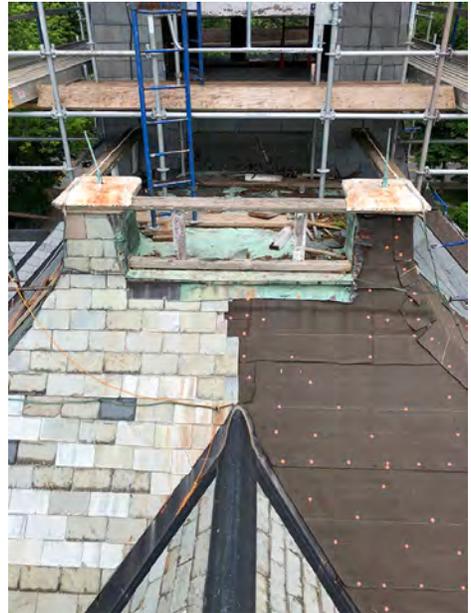
180530-IMG_8578.jpg

*Rear Slope of Main Room Below Cupola at South Gable;
This Slope Contained Older Shingles Than Other 3 Exposures;
East Side of Rear Gable Prepped for Replacement Slates;
Slates at West Side of Rear Gable Not Yet Removed*

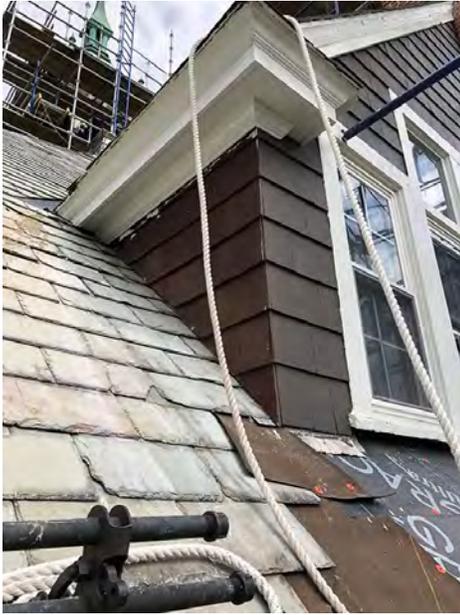
180530-IMG_8570.jpg

Southwest Corner of Rear Gable with Painted Wood Shingles Side Walls; Slates in View Not Yet Removed; Snow Rail in Foreground to Be Salvaged and Reinstalled

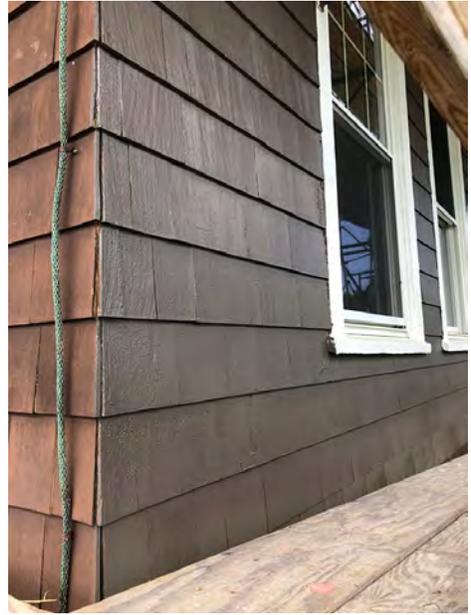
180530-IMG_8567.jpg

East Facade at Southeast Corner Repainted; South Facade at Left Not Yet Repainted

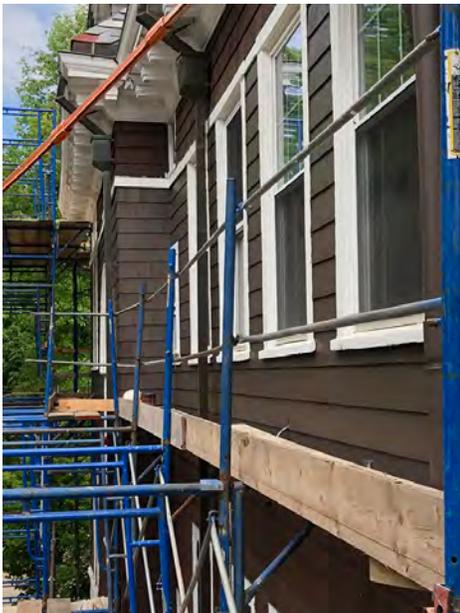
180530-IMG_8566.jpg

Scaffolding for Roofing and Painting at West Side Awaiting Removal of Overhead Power Lines for Full Access; Power Lines Wrapped in Orange Protective Covering

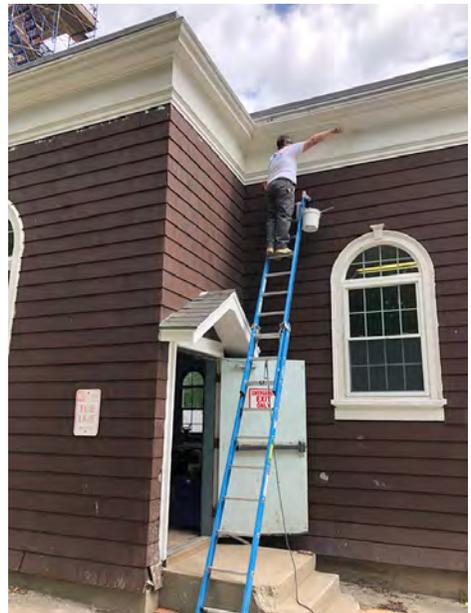
180530-IMG_8565.jpg

Repainting of Upper Trim at Gymnasium in Progress

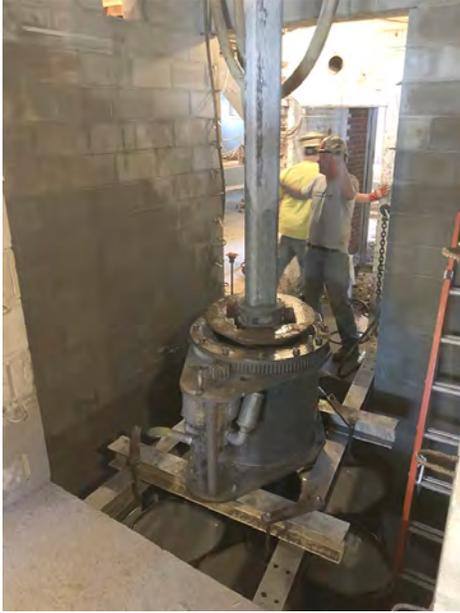
180509-IMG_8462.jpg

Drilling of Hole for Piston at Base of Elevator Shaft

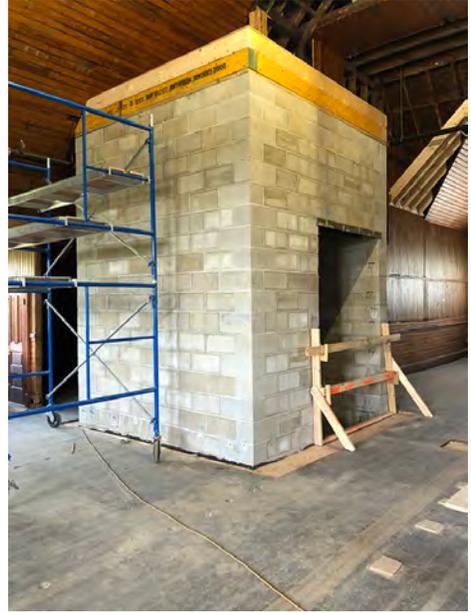
180530-IMG_8592.jpg

Completed Elevator Shaft at Third Floor

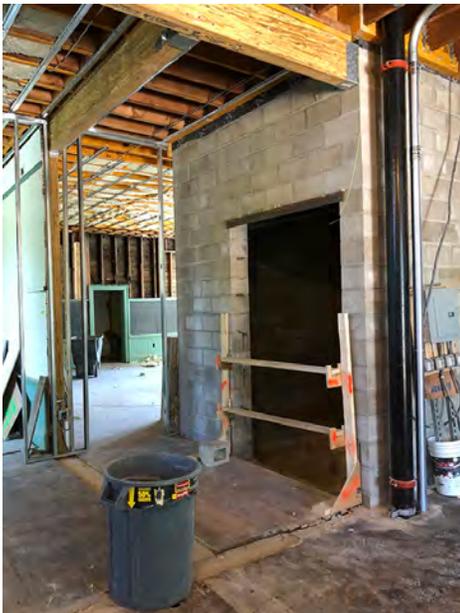
180523-IMG_8516.jpg

Framing and Fire Suppression Piping Adjacent to Elevator Shaft at First Floor Lobby Area

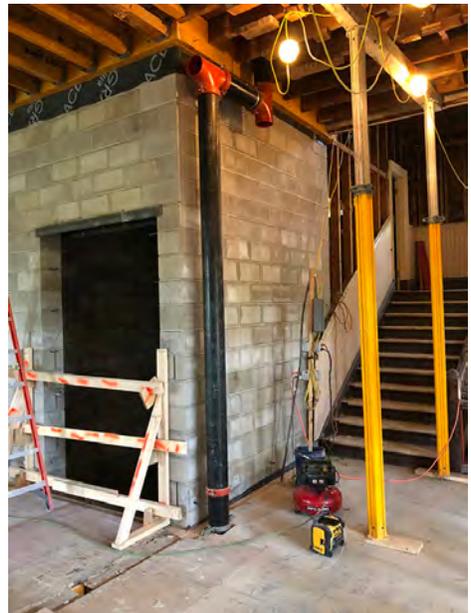
180516-IMG_8489.jpg

Elevator Shaft and Fire Suppression Piping at Lobby of Second Floor

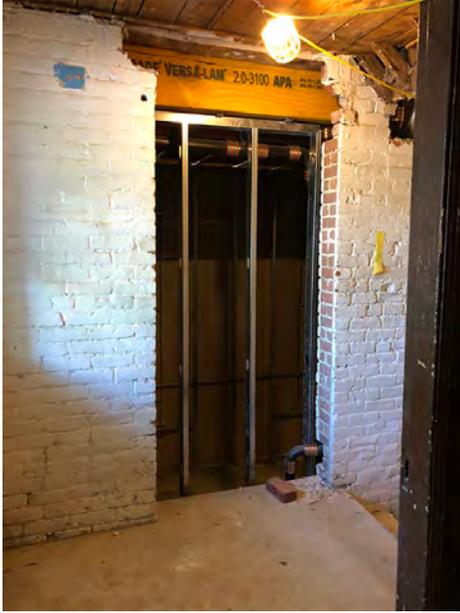
180523-IMG_8524.jpg

East Stair Landing at Former Door Opening in Painted Brick Wall to Men's Room in Basement; Brick Wall Infill to Follow; Staff HCAP Toilet Beyond

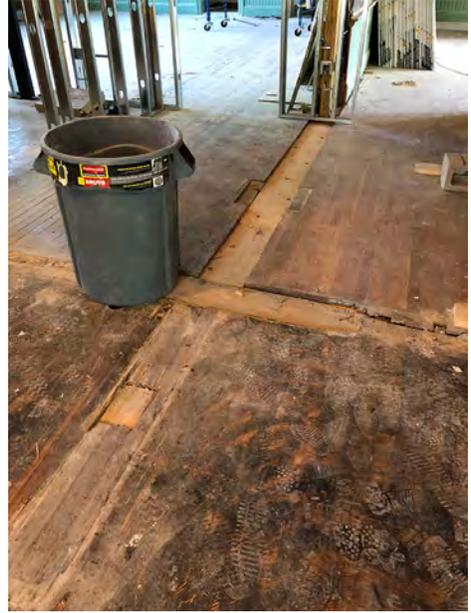
180523-IMG_8523.jpg

Flooring Voids at Former Stair and Classroom Wall Plates at First Floor in Reconfigured Areas

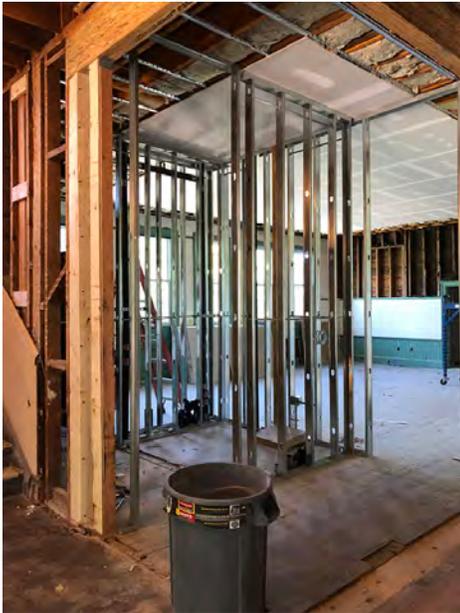
180523-IMG_8515.jpg

Lobby and Accessible Toilet Framing at First Floor

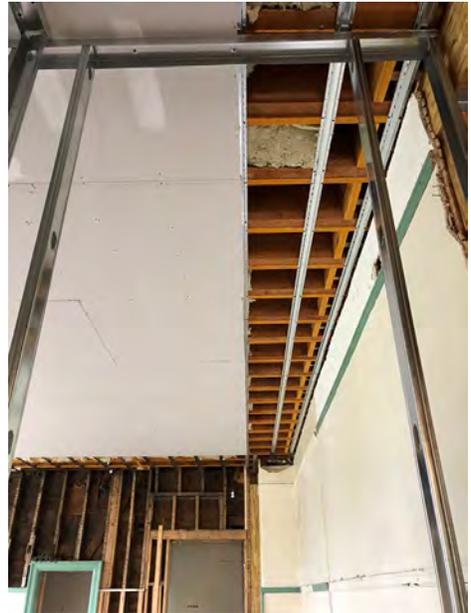
180516-IMG_8493.jpg

First Floor Ceiling at Avis Lounge; Sistered Joists and Mineral Wool Insulation Visible Behind Fire-Taped Gypsum

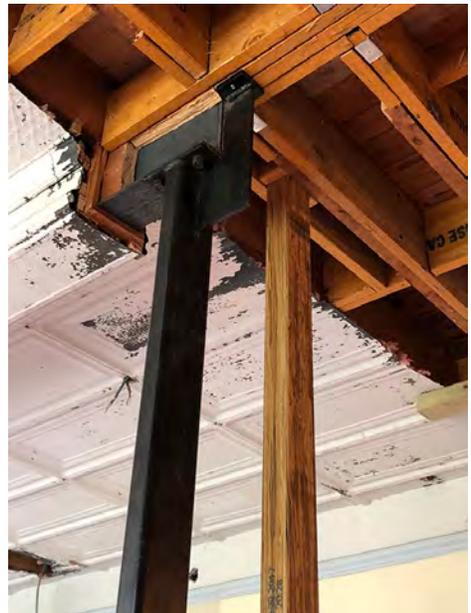
180516-IMG_8488.jpg

Detail of Steel and Wood Framing at Ceiling of Second Floor; Original Painted Tin Ceiling Beyond

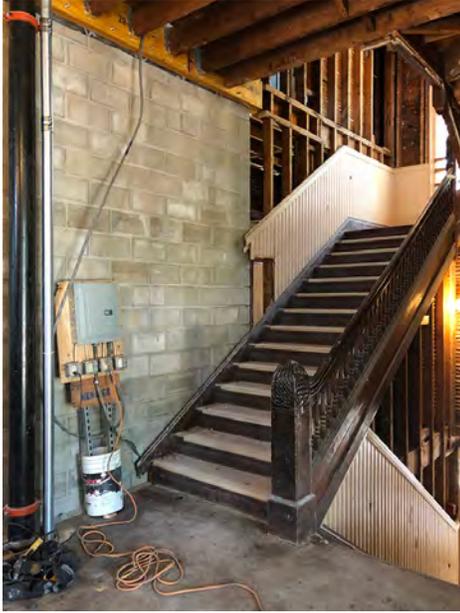
180530-IMG_8587.jpg

Elevator Hoistway Adjacent to West Stair at First Floor Lobby; Note Hand-Carved Newel Post

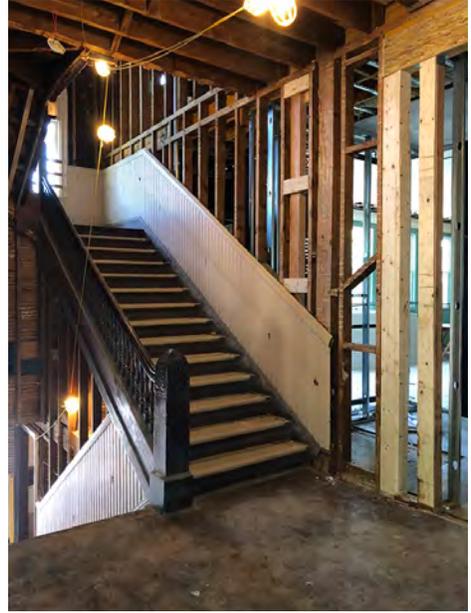
180530-IMG_8588.jpg

East Stairs at First Floor Lobby with Original Wainscoting and Hand-Carved Newel; Cracked Flat Plaster to be Replaced with Drywall

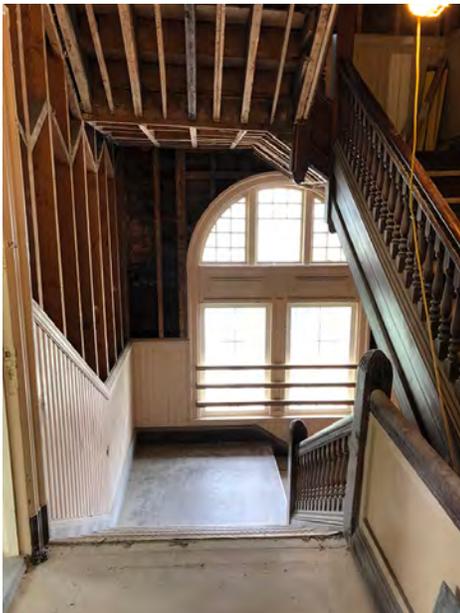
180516-IMG_8492.jpg

View from Second Floor Down East Stair Toward Arched Window; Landing Above at Level 2.5 to be Reinforced with Concealed Steel

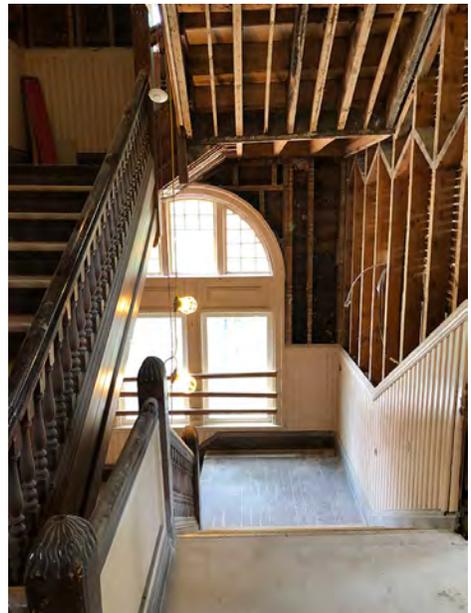
180516-IMG_8491.jpg

View from Second Floor Down West Stair Toward Arched Window; Landing Above at Level 2.5 to be Reinforced with Concealed Steel

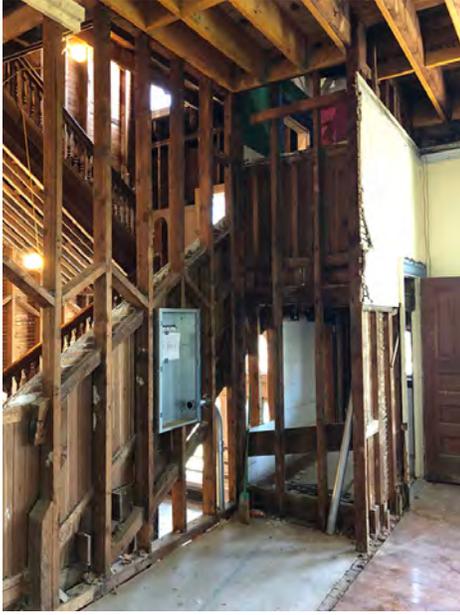
180509-IMG_8465.jpg

Electrical Panel Installed at Second Floor Storage Room Adjacent to Classroom #3

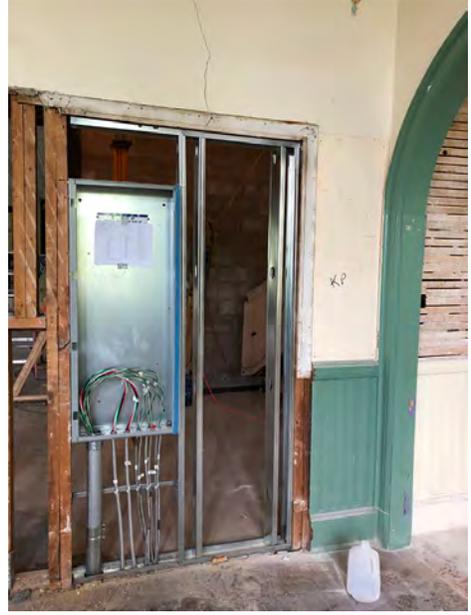
180516-IMG_8490.jpg

Electrical Panel Installed in Wall of Classroom #5; Kitchen at Right and Lobby Beyond

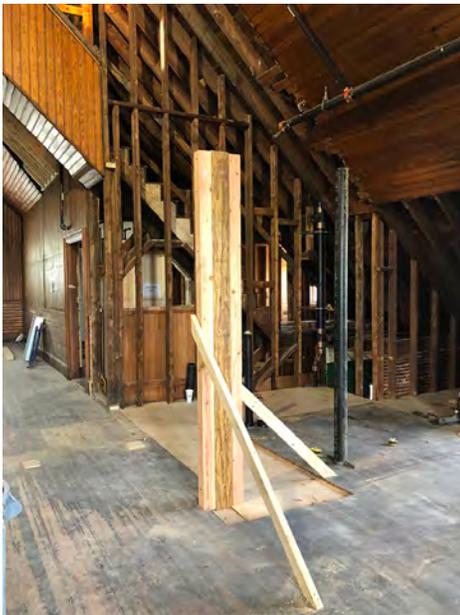
180530-IMG_8591.jpg

Post for Support of Transfer Beam at Third Floor Installed at Wall Between Academy Loft and Accessible Toilet Room

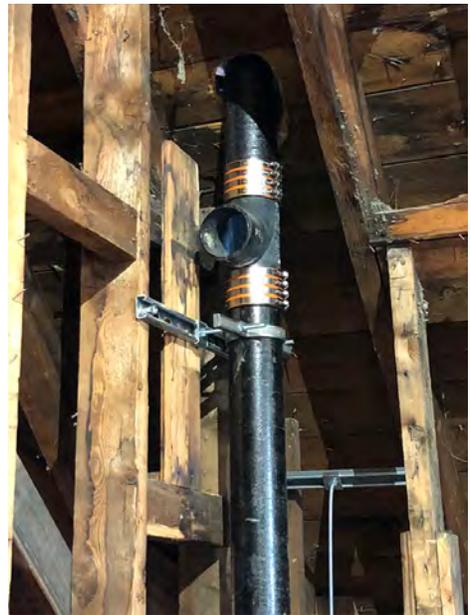
180530-IMG_8593.jpg

Replacement Plumbing Vent at Third Floor with Connection for Accessible Toilet Room
