## FIELD REPORT No. 09

### ROUDENBUSH COMMUNITY CENTER REHABILITATION

**DATE/TIME:** June 7 – July 5, 2018 (Project Meetings on June 13, 20, 27) (Other Visit on July 5)  
**PURPOSE:** Construction Progress Summary  
**PRESENT:** Don Mills, Architect / Mills Whitaker Architects LLC  
Ron Marsden, Architect's Site Rep (Clerk) / Delmont Construction Services (6/13)  
John Lyons, Clerk Superintendent / Delmont Construction Services (6/20)  
Bill Kenison, Owner's Project Manager / Town of Westford  
Jim Zegowitz, PTBC Temp Sub for Jeanne Roberts / Town of Westford (6/20 & 6/27)  
Steve Salemi, Project Manager / NELCO Worldwide  
Aaron Falardeau, Assistant to Project Manager / NELCO Worldwide (6/13 & 6/27)  
Stevan Gauthier, Project Superintendent / NELCO Worldwide  
Alexander Castelluccio, Project Administrator / NELCO Worldwide (6/20 & 6/27)  
Shawn Chamberlin, Safety Officer / NELCO Worldwide (6/20)  
Luis Fernandez, Fire Suppression Engineer / Fernandez & Associates (7/5)

## FIELD OBSERVATION REPORT

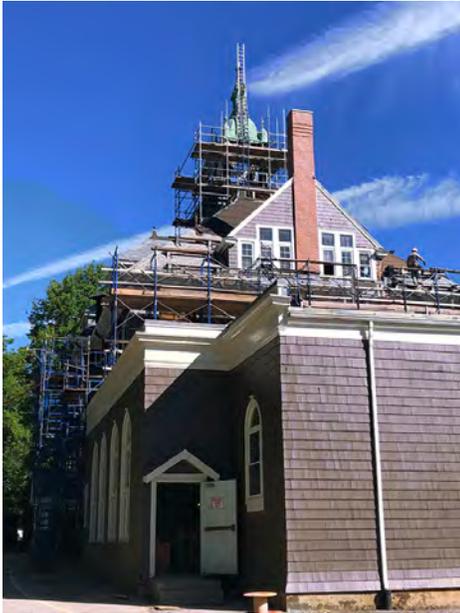
180620-IMG\_8668.jpg

*View of Scaffolding from Rear Parking Lot;  
Upper Portion at Rear Dormer & Chimney Removed*

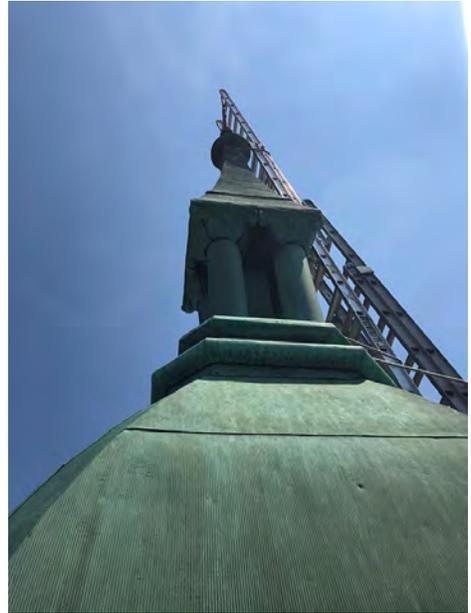
180705-IMG\_8741.jpg

*Pair of Extension Ladders Attached to Cupola;  
Weather Vane Removed for Repairs*

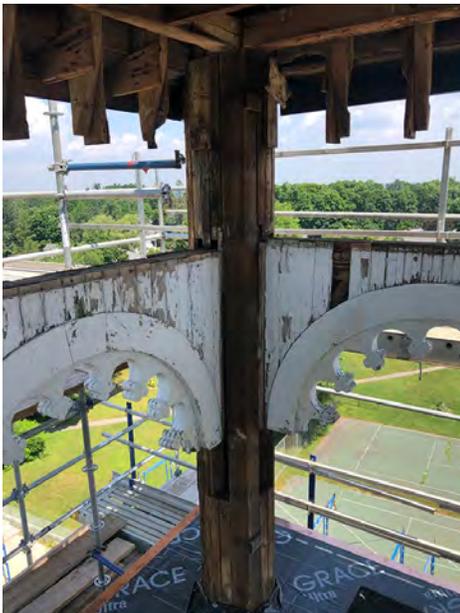
180705-IMG\_8742.jpg

*Transom Columns & Ledge Removed from Cupola;  
Fascia & Soffit Boards Also Removed*

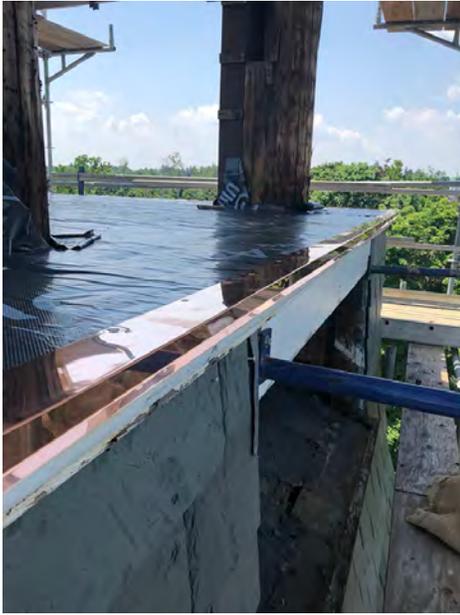
180705-IMG\_8739.jpg

*Belfry Deck Copper Work in Progress;  
Copper Drip Edging & Self-Adhering Membrane in Place*

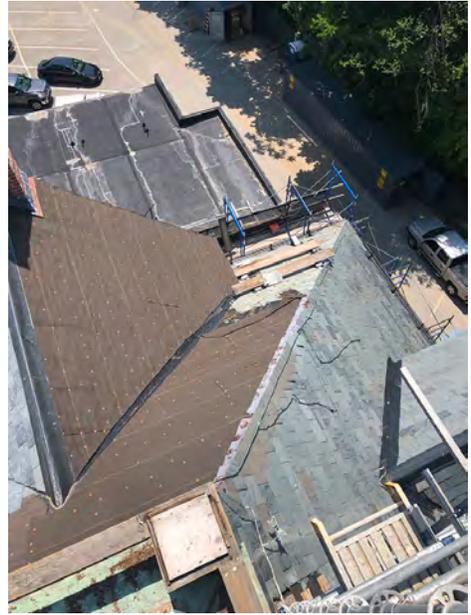
180705-IMG\_8745.jpg

*Existing Slates Removed in Portion of SW Roof Area*

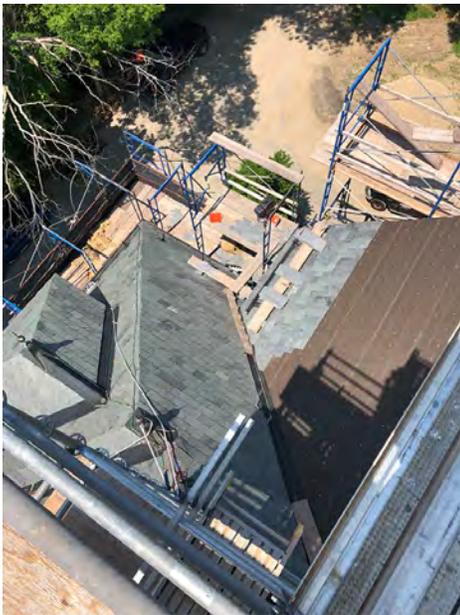
180705-IMG\_8747.jpg

*Slate Replacement Started at West Side of North Gable;  
West Side of Valley (at left) Not Yet Replaced*

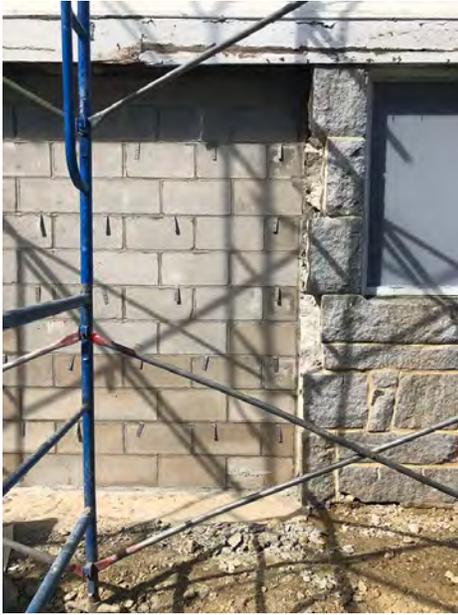
180613-IMG\_8631.jpg

*CMU Infill at East Facade to Restore Original Masonry Opening After Removal of More Recent Boiler Room Entry*

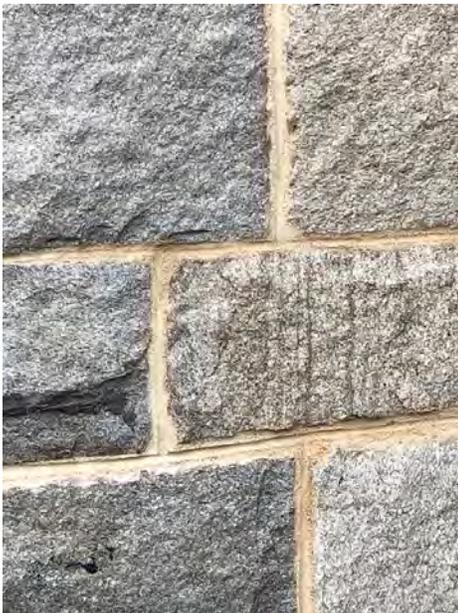
180627-IMG\_8704.jpg

*Repointed Granite Facing; Stone is Streaked After Mortar Washdown; Full Cleaning Not Yet Completed*

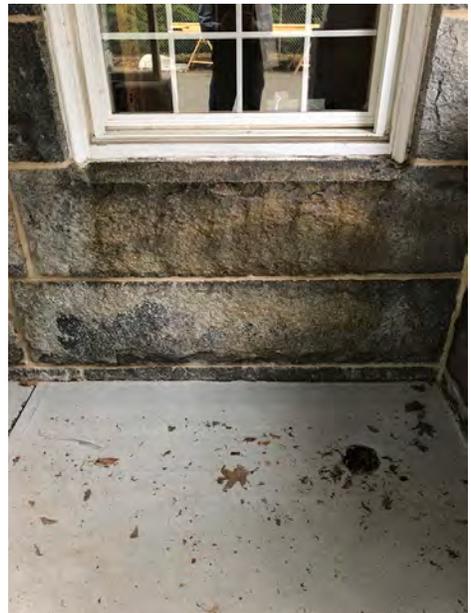
180627-IMG\_8705.jpg

*Granite Not Yet Cleaned as Seen in West Portico Entrance Area with Stained & Streaked Stones*

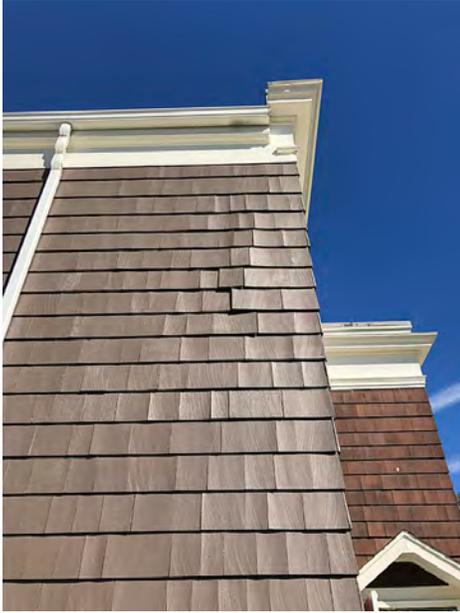
180620-IMG\_8679.jpg

*Loose Existing Shingle Cladding on South Facade of Gym*

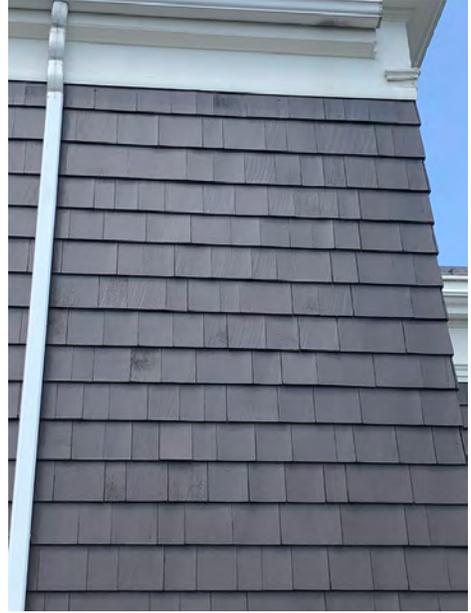
180705-IMG\_8751.jpg

*Existing Shingle Cladding Re-Nailed at South Facade of Gym*

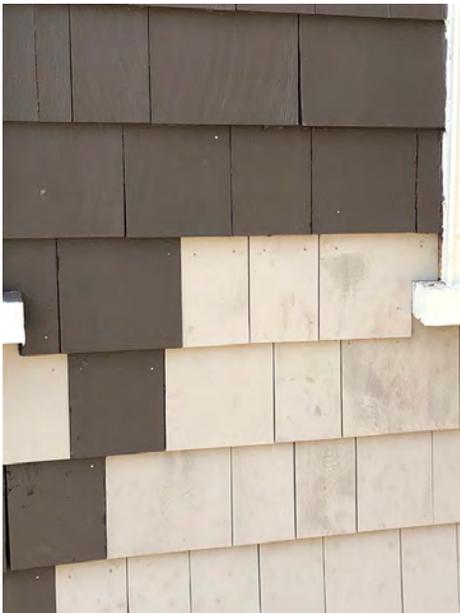
180705-IMG\_8752.jpg

*Cladding Repairs with Primed White Cedar Shingles*

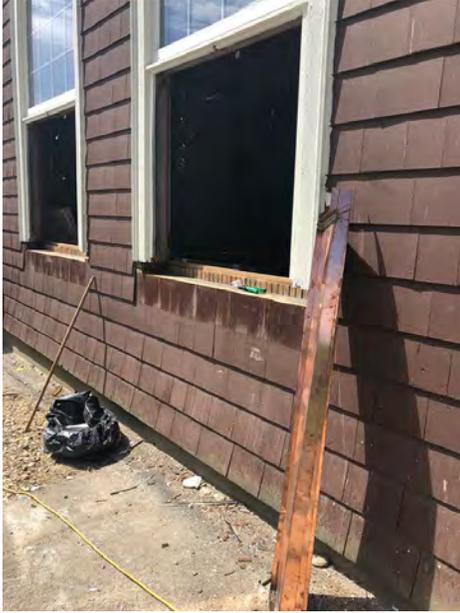
180613-IMG\_8640.jpg

*Copper Pan Flashing Installation at East Facade of Gym for Replacement of Exterior Window Sills*

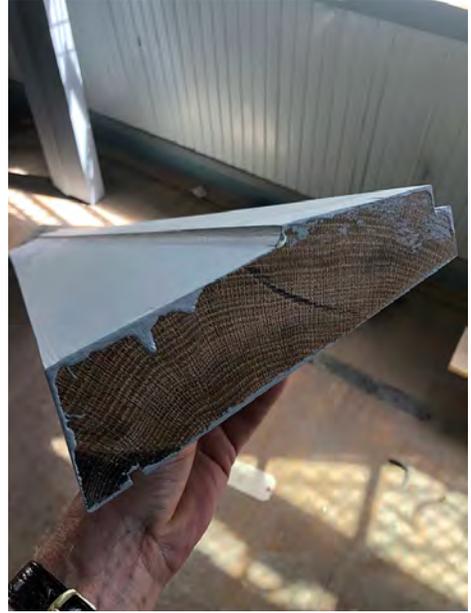
180613-IMG\_8641.jpg

*Mahogany Sill Replacement for Gym Windows at East Facade*

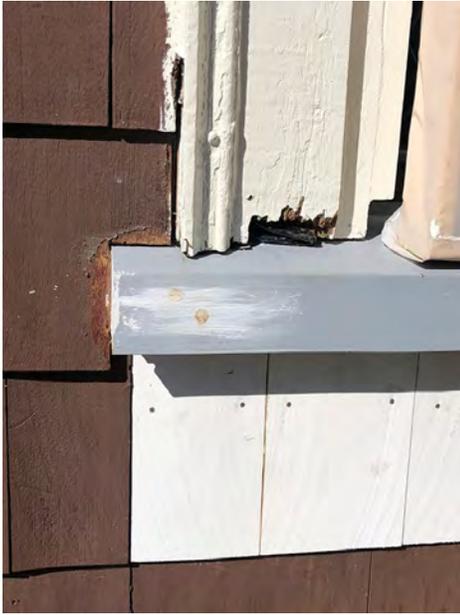
180620-IMG\_8674.jpg

*Detail of Replacement Sill and Deteriorated Casings in Need of Epoxy Repairs as Specified*

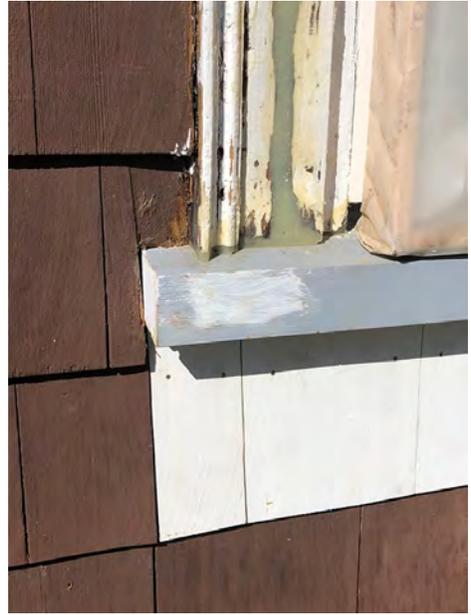
180620-IMG\_8673.jpg

*Detail of Replacement Sill and Epoxy Repairs to Exterior Casings*

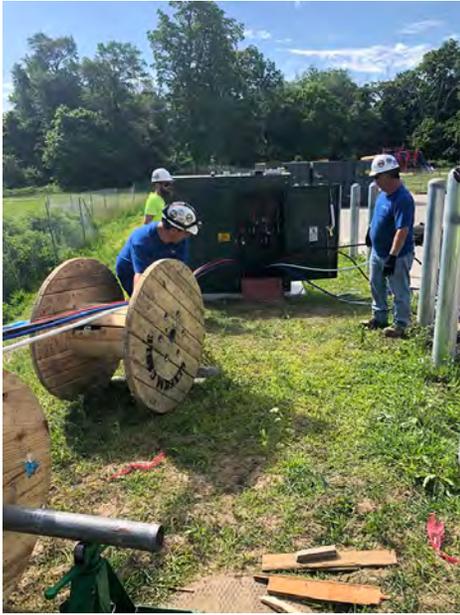
180613-IMG\_8630.jpg

*Installation of Conductors to Transformer in Preparation of New Electrical Service*

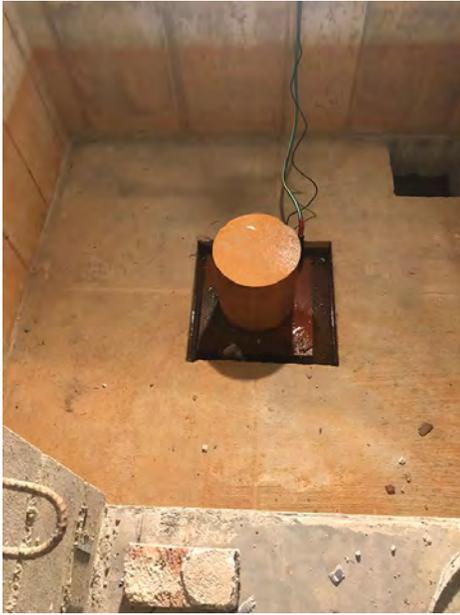
180613-IMG\_8638.jpg

*Elevator Pit Prior to Installation of Waterproofing*

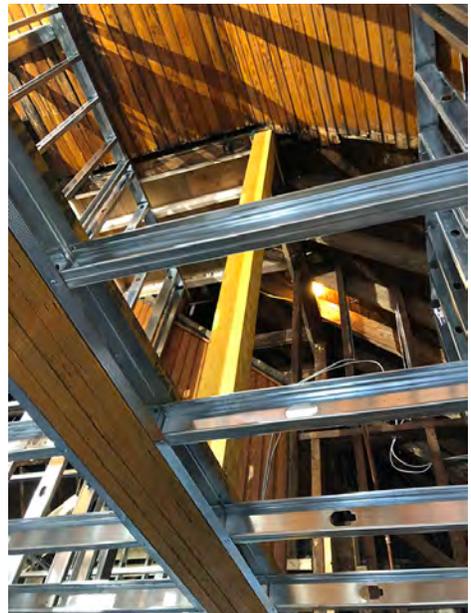
180705-IMG\_8715.jpg

- 09.1 Progress on remaining portions of interior framing modifications is still underway. The Architect issued a request for reinforcement of two stair landings on June 8 and received a cost proposal on July 9. A cupola post support at the Third Floor above the HCAP toilet room was in place as of July 5.

*Post & Transfer Beam at Third Floor at Ceiling of Accessible Toilet Room to Cupola Framing Support*

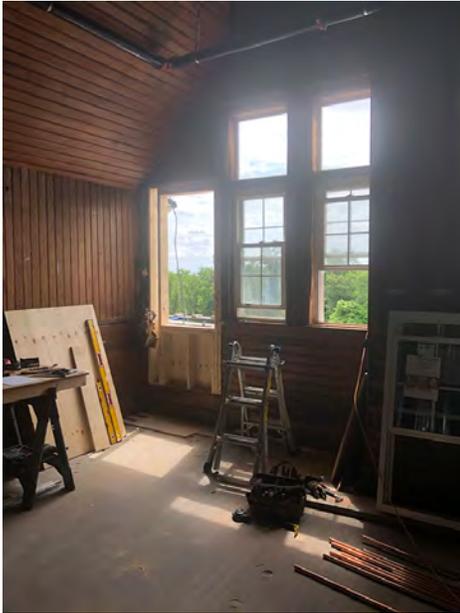
180613-IMG\_8652.jpg

West Side of Existing Third Floor Dormer at Former Fire Escape Exit Door Framed for Missing Window

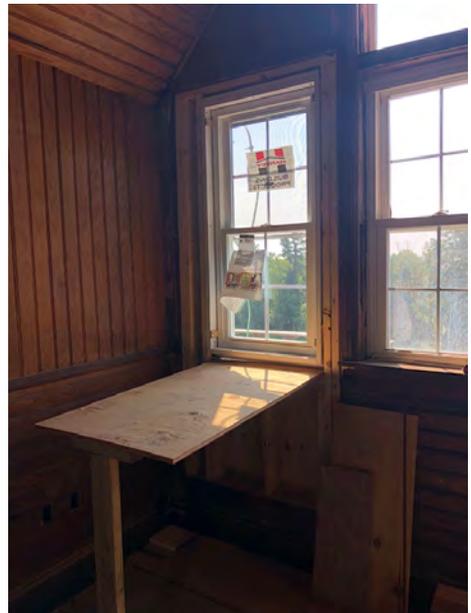
180705-IMG\_8717.jpg

- 09.2 Interior work has included installation of metal stud framing, metal doorframes and framed openings for wood door frames at all levels. Restored window sash at the Third Floor front façade have been replaced into their respective openings, and the missing window at the rear façade (former fire escape) is in place.

Window Installed at Former Fire Escape Exit Door; Temporary Plywood "Plans Table" in Foreground

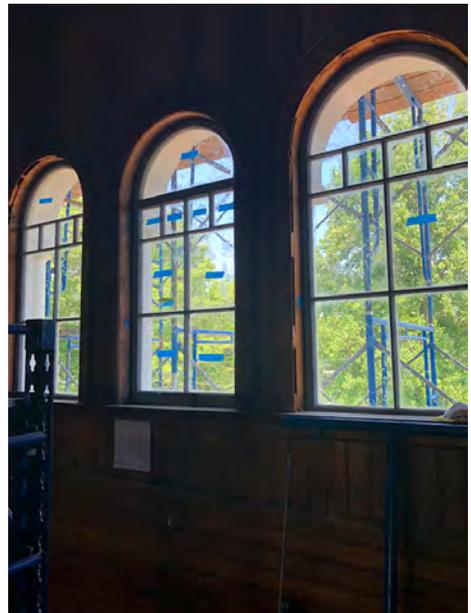
180705-IMG\_8719.jpg

*Windows on Front Facade of Third Floor Re-Installed*

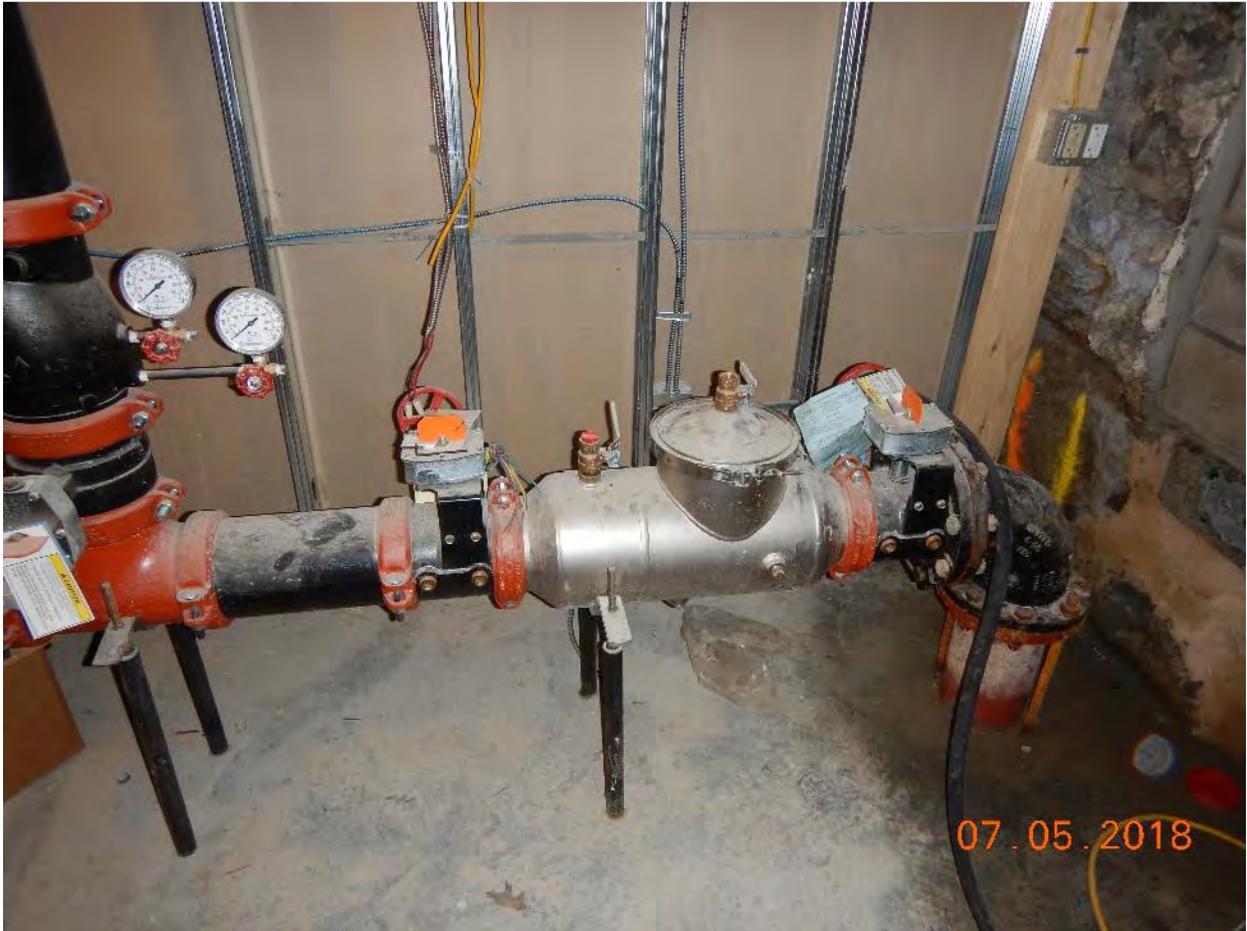
<ol style="list-style-type: none"><li>1. Incoming service, backflow preventer and wet-pipe valve installed.</li><li>2. Mains and branch lines have been installed on levels 1, 2 and 3.</li><li>3. Standpipe/FP risers installed.</li></ol>
---

Lower Level – Sprinkler Room Incoming Service

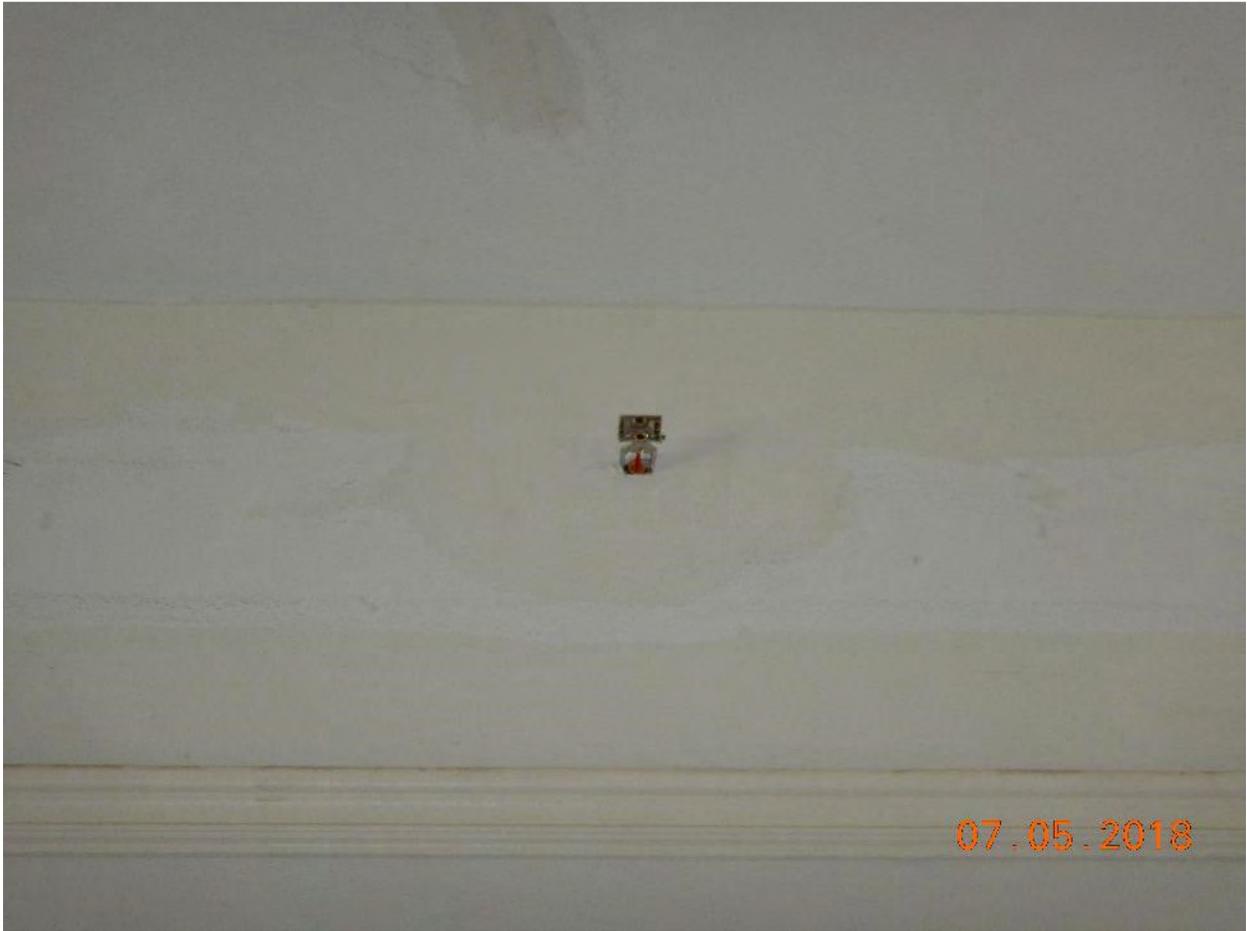
<ol style="list-style-type: none"><li>1. Installation proceeding in a professional manner.</li><li>2. On the 2<sup>nd</sup> Floor there is a sprinkler branch line under copper piping will trap some of the system. It appears that there is enough room to go above the copper pipe and avoid trapping water.</li><li>3. On the 2<sup>nd</sup> Floor there are two sidewall sprinkler heads covered in plaster.</li></ol>
---

Second Floor – Sidewall sprinkler covered in plaster.

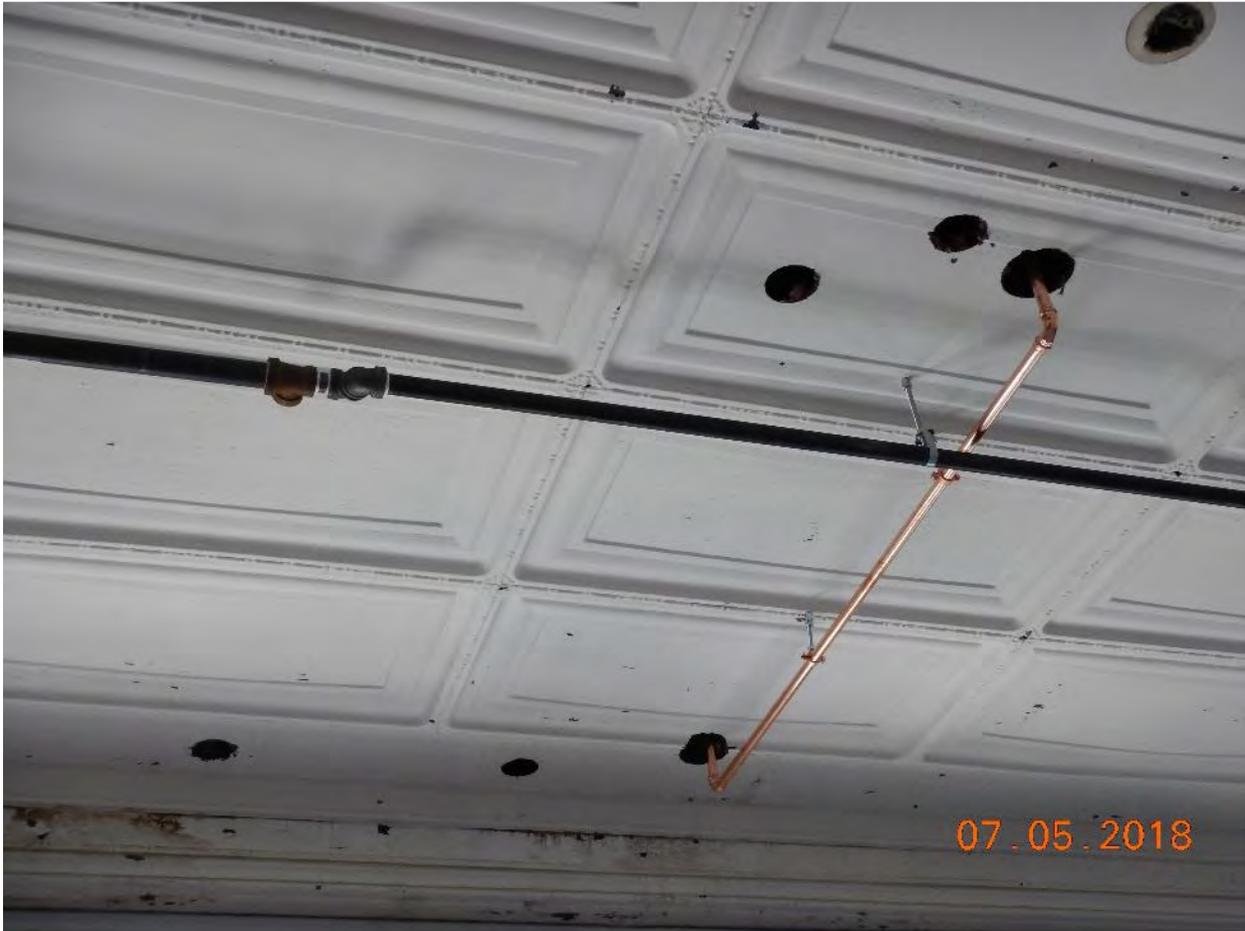
Second Floor – Sprinkler branch line under copper pipe.
