June 23, 2011

RE: **REPORT OF OBSERVATIONS AND RECOMMENDATIONS FROM THE
VISUAL STRUCTURAL CONDITION EVALUATION OF THE
WESTFORD TOWN FARM BUILDING**

35 Town Farm Road - Westford, Massachusetts 01886
Ipswich River Engineering, Inc. Project No.: IR-0387

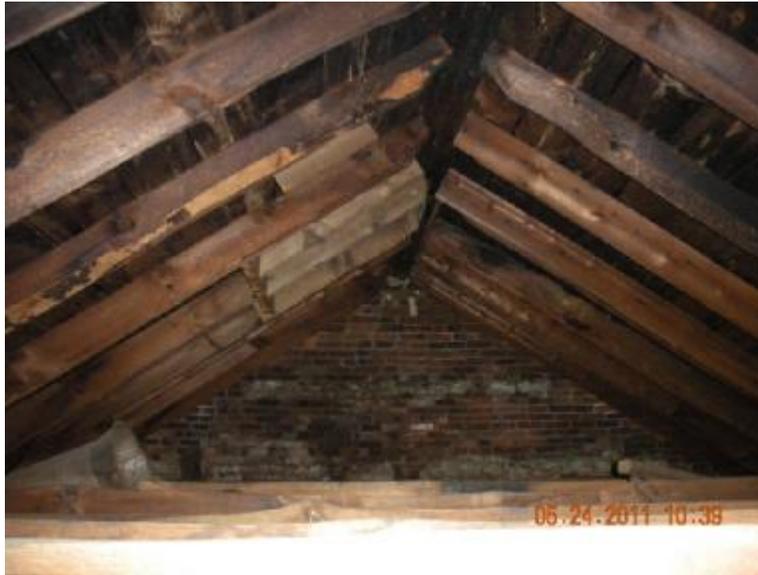
- The gable roof structure of the *Farmhouse* was observed to be framed with rough hewn timber rafters that appear to be framed into the sides of a rough hewn timber ridge board by means of mortise and tenon joints – refer to **Appendix A - Figure 1**. IREI anticipates that the bottom ends of these gable roof rafters bear on and are supported by the top of the brick masonry sidewall bearing walls along the left and right sidewalls of the *Farmhouse*. However, the bottom ends of these rafters could not be directly viewed because of the interior timber framed knee walls at the Third Floor level. IREI did observe a significant amount of damage and water staining to the interior plates finish at the underside of both the sloped and flat portion of the Third Floor level ceilings – refer to **Appendix A - Figure 2** and **Figure 3**. The observed plaster damage is significant and indicates apparent substantial amount of water leaking through the roof shingles. IREI is not sure whether the leak is currently leaking or whether this water damage occurred at some time in the past. IREI's concern is that there could be a significant potential of structural damage to the timber roof framing elements in these areas from long term water leakage and decay. IREI recommends that the *Town* have all of the existing damaged plaster finishes removed from all the walls and ceiling surfaces (both flat and sloped portions of the ceilings) at the Third Floor level so that the underlying timber roof structure can be closely reviewed and inspected for timber damage and determine whether the roof framing must be repaired and reinforced.

Figure 1 – *Farmhouse* - Main Roof Framing & Ridge Board

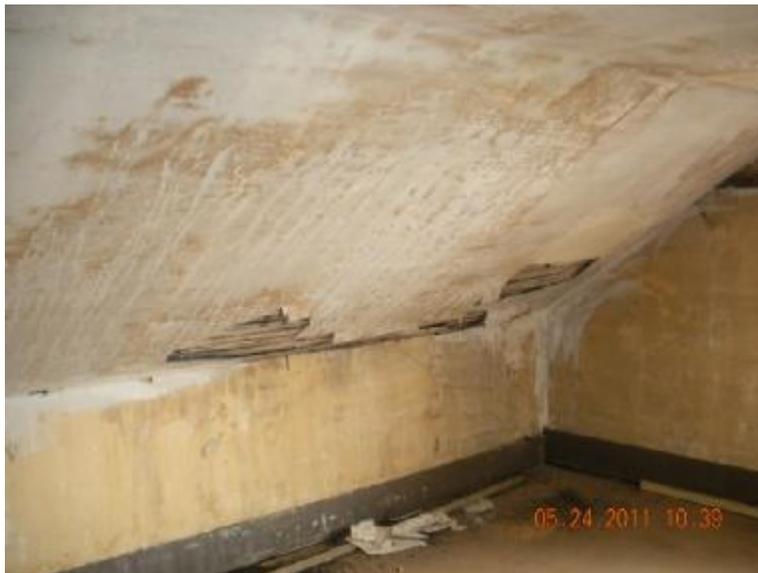
Figure 2 – *Farmhouse* - Damaged Ceiling Finishes

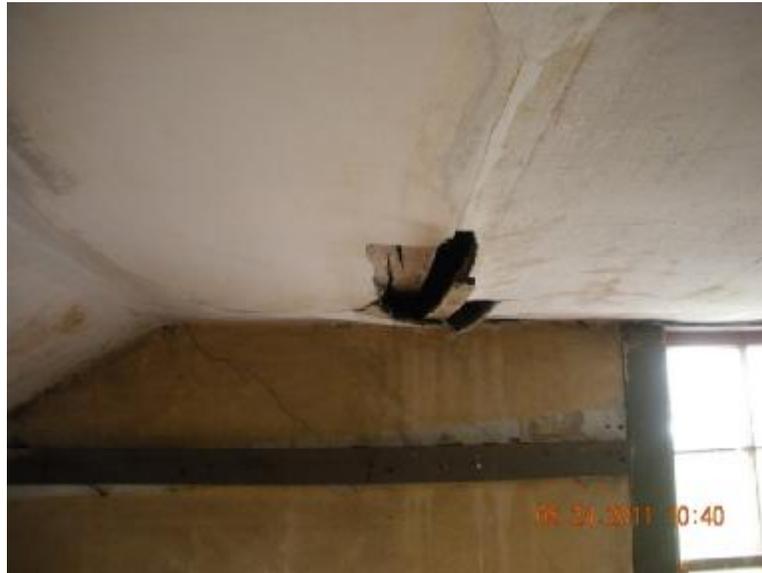
Figure 3 - *Farmhouse* - Damaged Ceiling Finishes

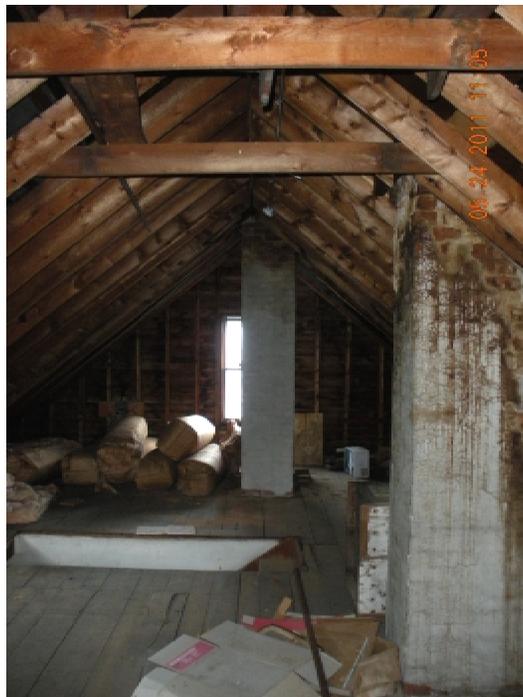
- IREI observed that the existing gable roof framing of the *Late 1800's Addition* appeared to be full 2 inch by 7 inch sloped gable rafters spaced at approximately 2'-0" on center in general - refer to **Appendix A – Figures 4 and 5**. Numerically, the existing gable roof rafters at the observed size and spacing in the *Late 1800's Addition* roof system is structurally insufficient to support the current code required snow loads and the actual snow load magnitudes based on current timber design standards and criteria (i.e. within allowable stress levels for the timber). However, this existing gable roof system appears to have functioned satisfactorily for over 100 years in its current configuration. In fact, this past winter, and the recent winter of 1995-1996, saw near record snowfalls in the area and this existing gable roof system appears to have supported the roof snow loads without collapsing. However, number wise IREI cannot back this up performance within allowable timber stress levels. What this indicates is that under snow loading this existing

roof structure and the various timber connections are well into the factors of safety for the allowable member strength and stress levels. Therefore, from a structural engineering analysis point of view (i.e. numerically) IREI cannot confirm or certify that the existing gable roof framing of the *Late 1800's Addition* is structurally capable of supporting either the code required snow loads or the actual likely snow load magnitudes in its current configuration without reinforcement or modifications.

Figure 4 - *First Addition* - Roof Framing

- IREI observed that only a few of the rafters had existing Collar Ties between the top ends of these roof rafters within the top third of the rafter span. At a minimum, IREI would recommend installing new 2x8 *Spruce-Pine-Fir No. 2 or Better* grade timber Collar Ties within the top third of the rafter span to tie the top ends of the rafters together to increase the structural continuity of the roof framing system.

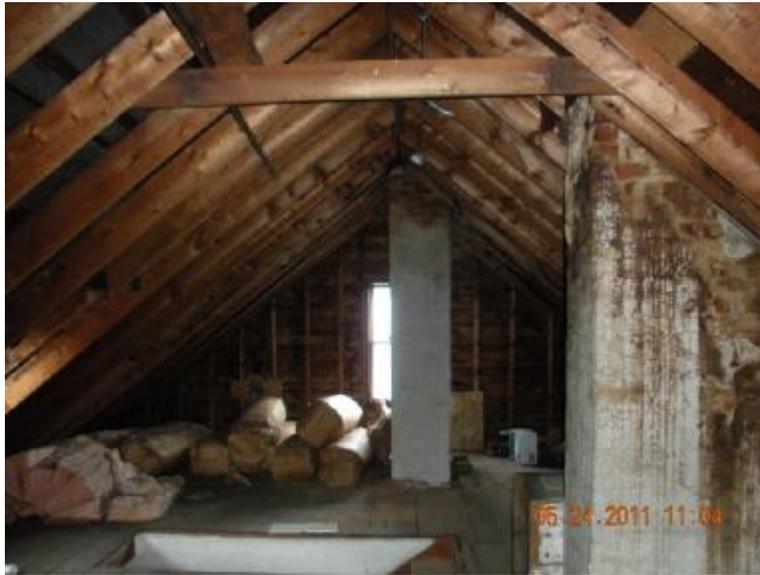
Figure 5 – *First Addition* - Roof Framing

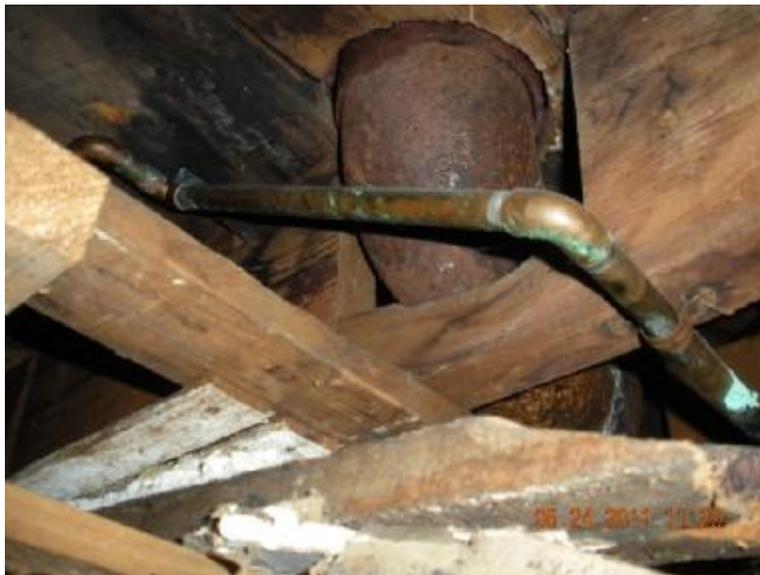
- IREI observed that at the existing Second Floor framing directly below the Second Floor Bathroom the plumbing contractor that installed the waste line for the toilet saw cut and removed large portions of the timber floor joists in this section of the floor system to install the waste line. This has resulted in significant structural damage and weakening of several floor joists in this portion of the floor structure in this area of the floor – refer to **Appendix A – Figure 6**. **This**

Figure 6 – *First Addition* – Damaged 2nd Floor Framing by Plumbing

framing condition is structurally unacceptable and should be shored up as required immediately to prevent a localized structural collapse of the floor system – the shoring should remain in place until this section of the floor framing has been repaired/corrected.

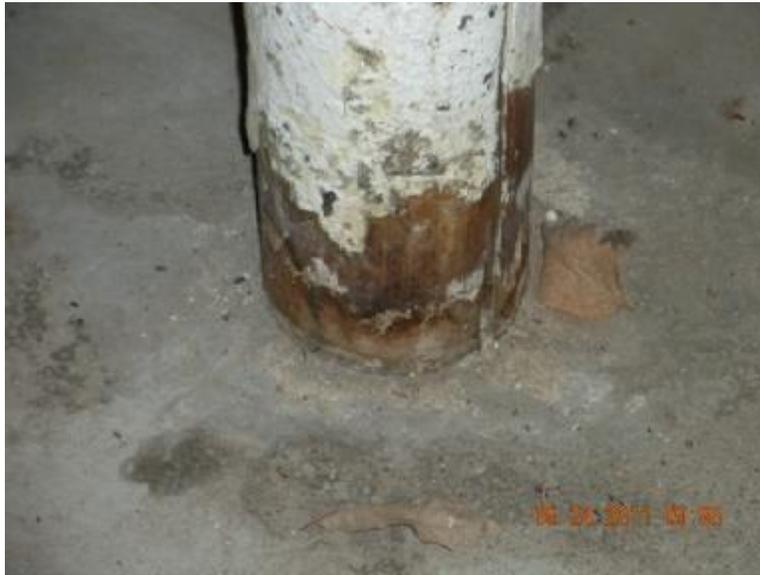
- IREI observed several locations where the base of the non-preservative treated timber posts that support the timber First Floor level floor beams bear directly on the top of the concrete Basement Floor slab (refer to **Appendix A - Figure 7**) without any steel or iron bearing plates to isolate the timber from the concrete. The bases of these timber posts appeared to have deteriorated and punky from being in contact with the concrete slab and the moisture from the slab wicking up the posts over time. These damaged posts should be removed and replaced with either new preservative treated timber posts set on steel bearing plates or steel pipe or tube columns. However, prior to installing the replacement posts the existing footings (if any are present) must be investigated and replaced if not found to be sufficient to support the post loads. In addition, at several locations the timber floor beams that these posts support show significant signs of structural distress and need to be repaired, replaced, or reinforced. This work will require analysis of the existing structure to determine the post/footing loads.

Figure 7 – Farmhouse – Timber Damage at Base of Basement Post

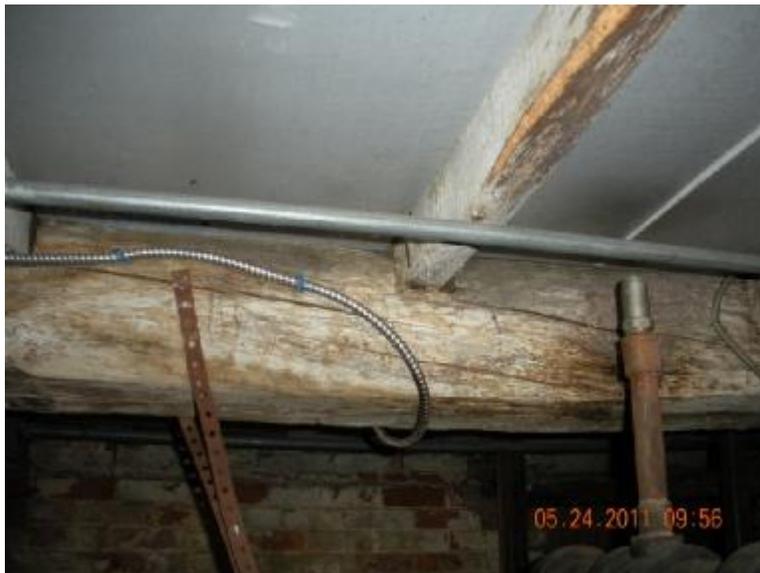
- **IREI observed numerous locations along the various timber First Floor beams in the Farmhouse where horizontal and sloping shear cracks (see Appendix A – Figure 8 and Figure 10) have developed. It is IREI’s professional opinion that these damaged floor beams with the shear cracks are in a state of structural failure and must be repaired, reinforced or replaced. IREI strongly recommends that the Town install continuous temporary shoring lines parallel and below these damaged floor beams and the tenoned ends of the floor joists immediately. These temporary shoring lines must support the bottom of the failed floor beams as well as supporting the tenoned ends of the floor joists on each side of the floor beams to eliminate the loading on the tenoned ends. It is IREI’s professional opinion that these lines of temporary shoring should be installed immediately to prevent a complete structural failure and collapse of the floor system. This temporary shoring should remain in place until these insufficient floor joist connections and damaged floor beams have been repaired, corrected, or replaced.**

Figure 8 – Farmhouse - Apparent Shear Cracks in 1st Floor Timber Beam

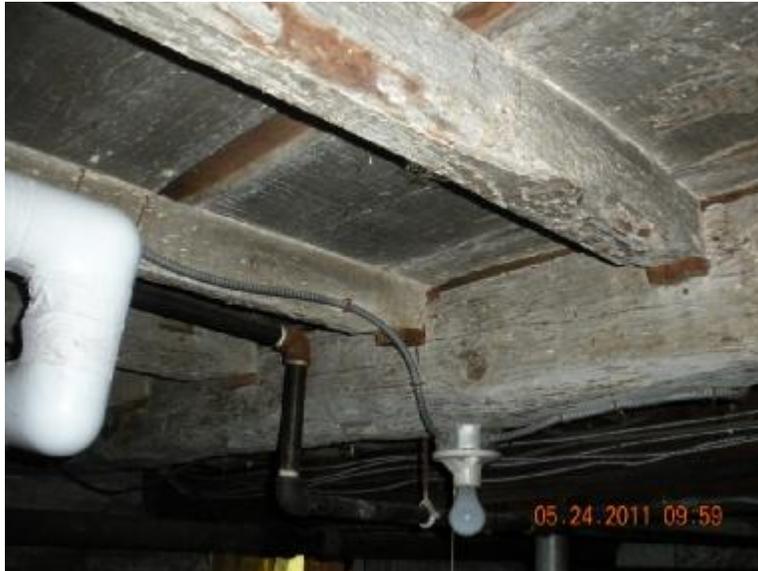
- IREI observed that in general the majority of the existing First Floor level floor framing of the *Farmhouse* appeared to have been constructed with full size 3 inch wide by 4 inch depth timber floor joists spaced at approximately 20 to 24 inches on center – refer to **Appendix A - Figures 8, 9 and 10**. IREI observed these floor joists are flush framed into the sides of various sized timber floor beams that are supported on a combination of stone columns and timber posts. Some of the timber posts appeared to have been added at some time in the past and were likely not part of the original floor framing. These existing flush framed joist-to-beam connections are achieved by mortise and tenon type framing connections. The ends of these joists are notched at the bottom edge resulting in an approximately two (2) inch depth tenon that extend into rectangular mortises cut into the sides of the timber floor beams. The notched tenon ends of these floor joists at the face of the floor beam reduce the structural shear capacity of the joists by approximately 50% from the shear capacity of the joist if the joist ends were full depth. This shear strength reduction is the result of the concentration of tension and shear stresses in the joist occurring at the reentrant corner of the notch at the end of the joist. These mortise and tenon type timber framing connections were a very common framing connection in timber framed structures of this type and age. However, based on IREI's experience these mortise and tenon connections between the floor joists and beams are often problematic and are not capable of transferring the floor loads (for office and corridor occupancies) to the supporting beams. In general, numerically, the existing First Floor framing at this section of the *Farmhouse* appears to be structurally insufficient to support the current office and Corridor use code required floor live loading based on current timber design standards and criteria (i.e. within allowable stress levels for the timber). What this indicates is that under the current floor loading this existing floor structure and the various timber connections are likely well into the factors of safety for the allowable member strength and stress levels. Therefore, from a structural engineering analysis point of view (i.e. numerically) IREI cannot confirm or certify that this portion of the existing First Floor framing in the *Farmhouse* is structurally capable of supporting the code required floor live load for the current use of the space.

Figure 9 – Farmhouse – Excessive Deflection in Timber 1st Floor Beam

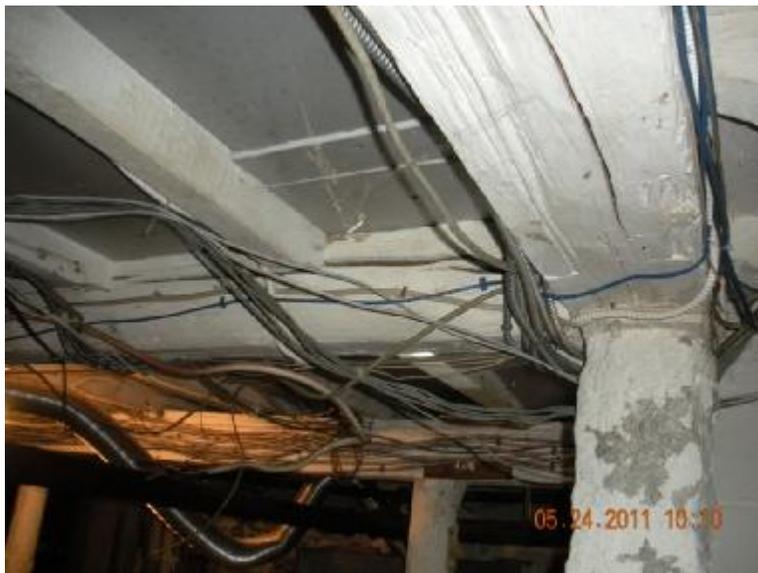
Figure 10 – Farmhouse – Shear Cracks at Bottom of Beam Mortise Cuts

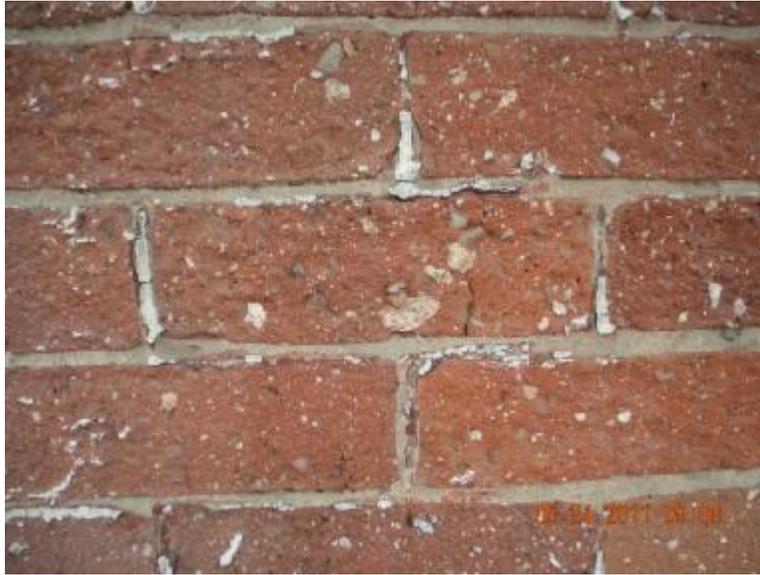
- IREI observed that it appears that the exterior faces of the brick surfaces of the *Farmhouse* exterior walls have been sandblasted at sometime in the past (refer to **Appendix A – Figure 11**). In general, it appears that this sandblasting has removed the protective finish surface on the brick that prevents moisture from migrating into the exposed interior portion of the brick. IREI recommends that the *Town* retain a qualified Architect or masonry/restoration specialist as soon as possible to visit the *Farmhouse*, view the sandblasted brick surfaces, and provide the *Town* with their professional recommendations for the repairing the mortar joints (i.e. tuckpointing) in the brick and options for applying some type of suitable masonry sealer material to seal the exterior of the brick to reduce moisture penetrating the brick. Sealing the exterior face of the brick appears to be in need to be applied to minimize the potential for additional and future damage due to ice riving from freeze-thaw cycles of water in any open or cracked mortar joints and the brick elements themselves. This is preventative maintenance which is money well spent by the *Town* to reduce the potential for future significant structural damage to these exterior brick walls.

Figure 11 - *Farmhouse* - Sandblasted Brick Surface

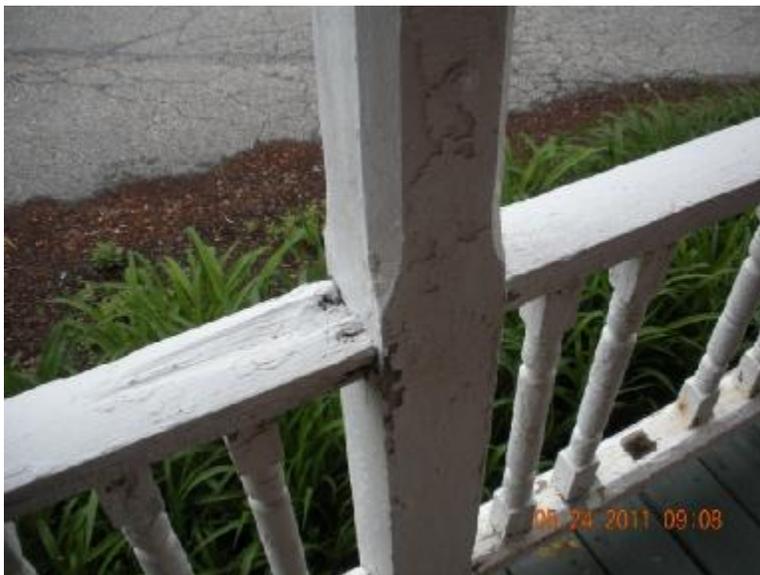
- IREI observed that the timber railings/guards (see **Appendix A – Figure 12 and Figure 13**) along the First and Second Floor levels of the Porch and the stairways at the First and Second Floor levels have numerous missing vertical members and areas of timber damage. This existing railing/guard systems in their current condition and configuration do not appear to be structurally sufficient to support the code required horizontal railing/guard loads. IREI recommends that these railings/guards be replaced with new railing/guard systems capable of meeting the structural and architectural requirements of the building code immediately because of the potential for someone leaning against these railings/guards causing a failure of the rail/guard resulting in personal injury or worse. IREI recommends that these flights of timber framed stairs be replaced with new railing/guard systems capable of meeting the structural loading (gravity and horizontal loads) and architectural requirements of the building code immediately because of the potential for someone being hurt by a structural failure of the existing stairways. IREI recommends that the *Town* retain an Architect as soon as possible to review the egress issues of the *Farmhouse*, these Porches/stairways and the Town Farm building in general, determine whether these existing Porches and Porch stairways at the front of the *Farmhouse* are means of egress for the current *Town* use and whether the porches and stairways meet the

Figure 12 - *Farmhouse* - Damaged Front Timber Railings

dimensional requirements for the Porches, stairways, and means of egress, and provide the *Town* with their professional opinion on those issues.

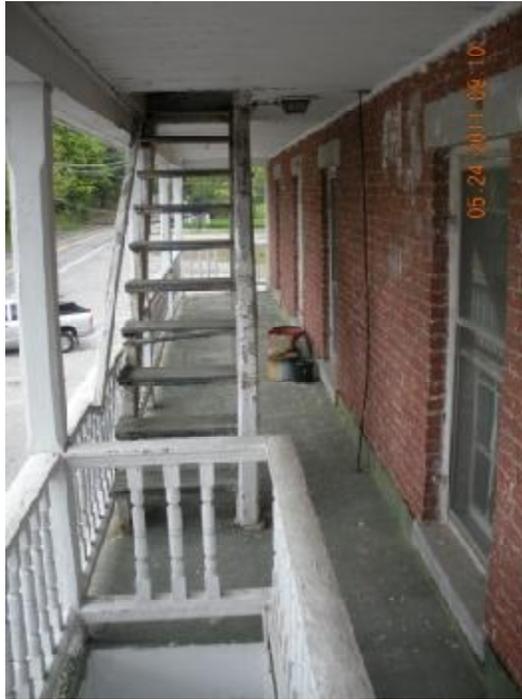
Figure 13 - *Farmhouse* - Structurally Deficient Exterior Stairway

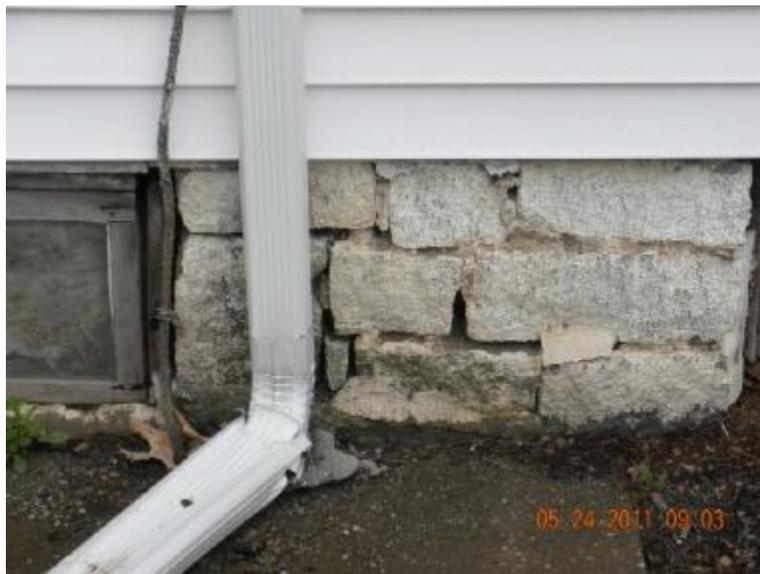
- IREI observed numerous locations on the exposed portions of the existing stone foundation walls along exterior perimeter of the *Town Farm Building* where the mortar joints have deteriorated leaving wide open joints between the stones – refer to **Appendix A – Figure 14**. IREI recommends that all open and deteriorated mortar joints in the stone foundation walls be cleaned, prepared and repaired as soon as possible to prevent continued and further structural damage from ice riving of the joints by water freezing during the winter months. The continued repeated freeze-thaw cycles will likely cause structural damage to the stone work that will end up causing major damage that will be expensive to repair. Simple repair of the mortar joints now will likely be money well spent and should significantly reduce the potential for further decay and damage of these foundation walls.

Figure 14 - *Late 1800's Addition* - Open Mortar Joints in Foundation Wall
