WESTFORD TOWN FARM - ADAPTIVE REUSE CONSIDERATIONS

35 Town Farm Road

Westford MA

22 October 2019

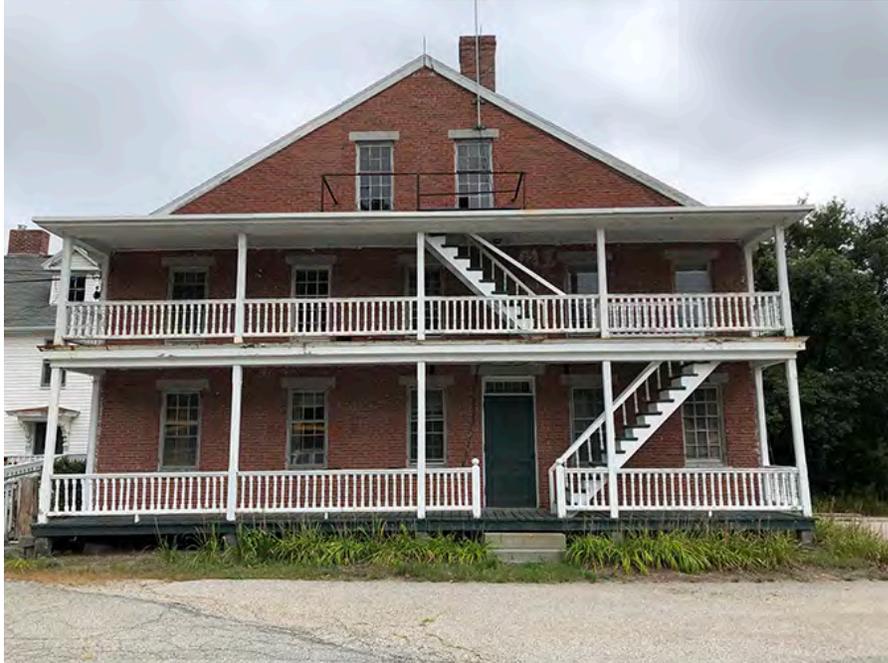
190910-IMG_3073.JPG

*Front Facade of Town Farm with Added (c 1900)
Fire Escape Balcony Porches at First & Second Floors*

The fire escape balconies on the front façade of the 1837 portion date from 1900, so they have gained historic significance even though they are not original. Their preservation or removal should be determined as part of the Preservation Restriction. Since they date from the same era as the 1900 Ell, it seems that preservation of that time period would be of more merit than restoration to an earlier period. They could be properly maintained without being used for egress, especially since their configurations are unsafe due to low railing heights, open risers and the tentative third floor hatch access. If they were to be removed, earlier conditions of the exterior brick would be revealed under the wood.

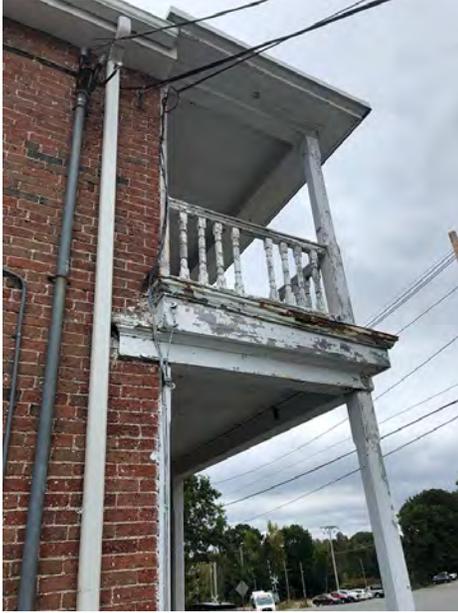
191003-IMG_3899.JPG

*Railing with Missing Baluster at North End of
Second Floor Fire Escape Balcony*

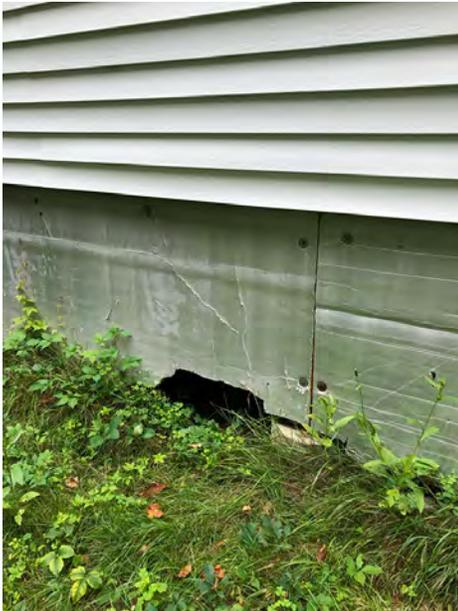
190910-IMG_3055.JPG

Deteriorating Enclosure of Crawl Space at East Addition

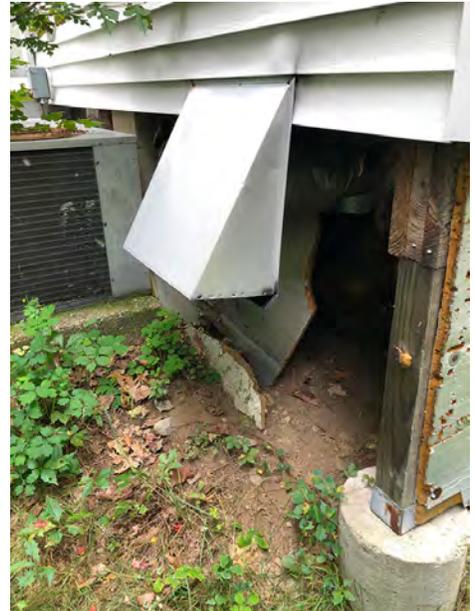
190910-IMG_3063.JPG

*Vent Hood and Missing Crawl Space Enclosure at
Southeast Corner of Contemporary Addition;
Concrete Sonotube Foundation Piers*

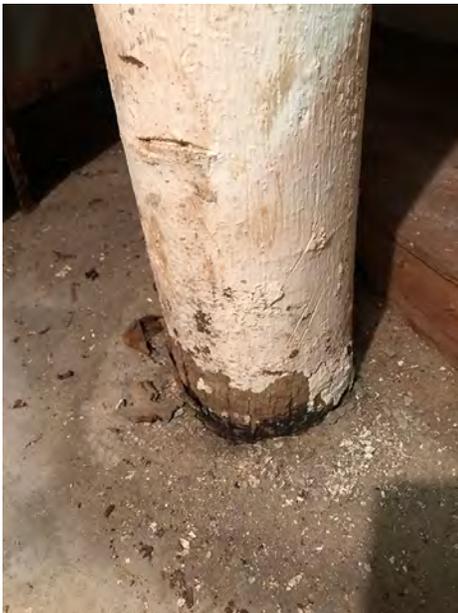
190910-IMG_2938.JPG

*Base of Painted Log Post on Basement Slab;
Moisture Wicking into Lower Fibers Evident*

2 Support columns for the first floor framing, in some cases, bear directly on concrete slabs and as a result have absorbed water and become punky. Posts should be replaced with new pressure treated posts on concrete foundations raised above the floor with steel separating plates.

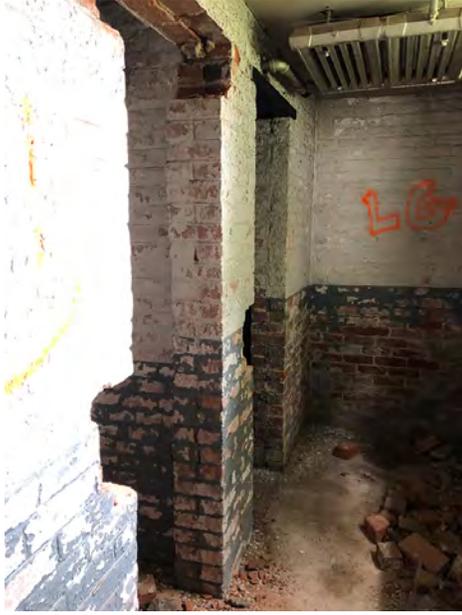
190910-IMG_2799.JPG

Two Jail Cells with Missing Cell Doors

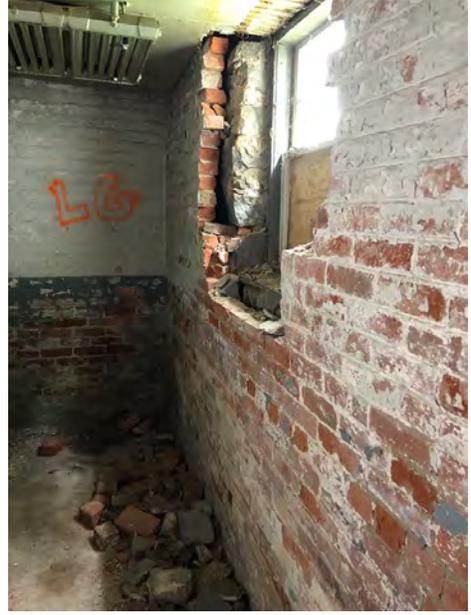
190910-IMG_2801.JPG

*Missing Bars at Basement Window
for Natural Light to Jail Cells*

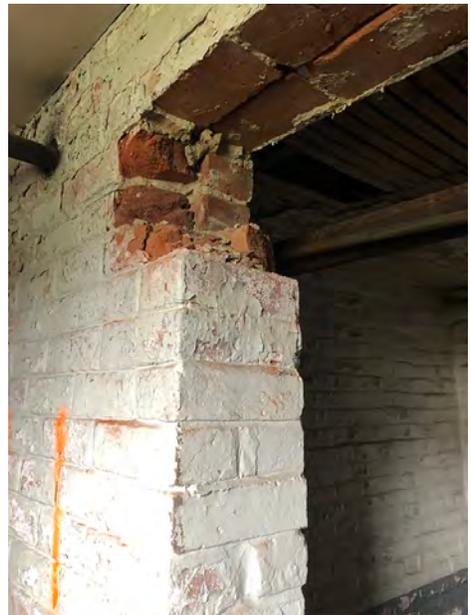
190910-IMG_2803.JPG

*Missing Brick at Former Cell Door
in Embedded Hinge Locations*

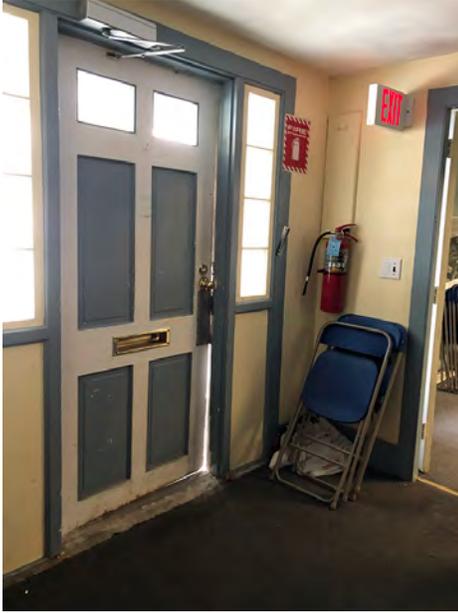
190910-IMG_2887.JPG

Entrance Door at North Facade in Original Opening but Replacement Components

Contemporary replacement doors at the entrances to the 1837 and 1900 buildings should be replaced with replicas of the original doors. Photographic evidence should be reviewed and the original door on the front façade of the 1837 portion should be preserved.

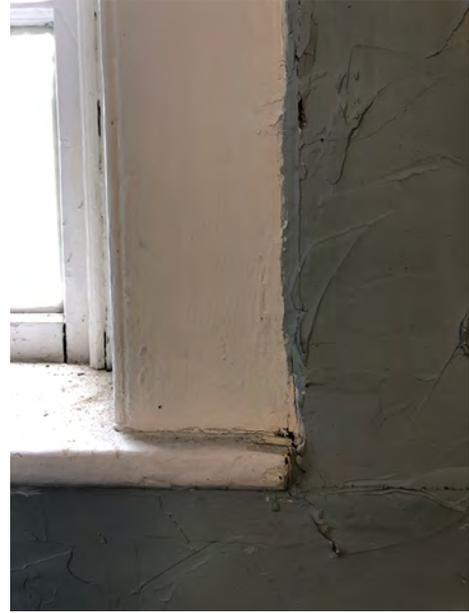
191003-IMG_3932.JPG

*Wall Repairs Added Thickness to Interior,
Bringing Surface Flush with Window Casings*

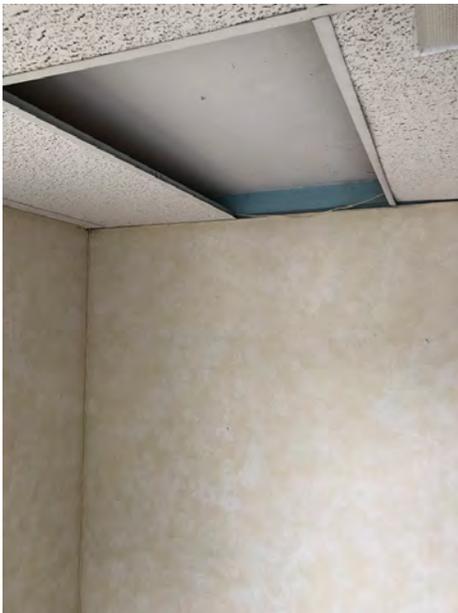
190910-IMG_2830.JPG

*2' x 4' Fissured Acoustical Panels Placed in
Ceiling Grid Slightly Below Flat Plaster Ceiling*

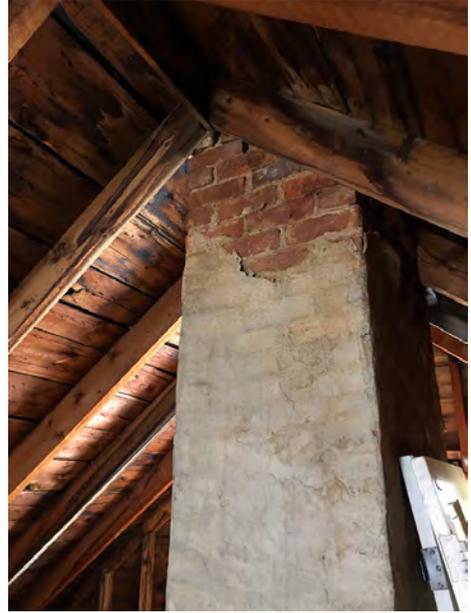
190910-IMG_2858.JPG

*Plastered Brick Chimney in Attic with Some Missing
Plaster Most Likely Due to Past Water Damage*

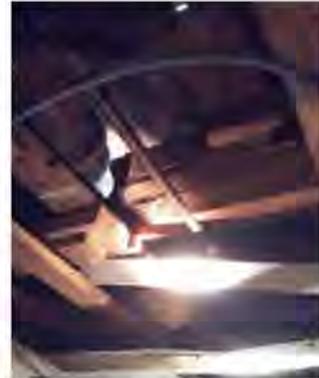
The sizes of roof members indicate that the structure is over over-stressed particularly at time of heavy snow loading. There is visual evidence of sagging roof members. Similarly the attic floor joists appear to be undersized. A full analysis of the roof framing should be performed and the structure reinforced to meet current code required roof loading.

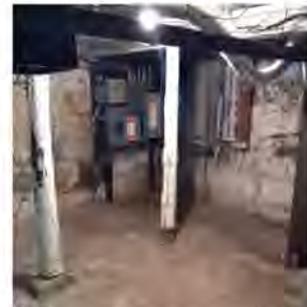
2 Floor connections to the posts have been over-stressed and, following structural analysis, will require hangers, reinforcement, additional support or replacement.

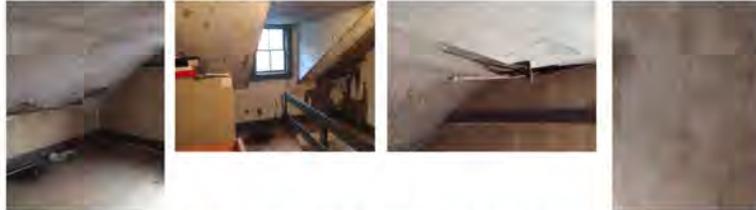
sections although deteriorated should be considered for retention as a historic record) and re-finishing all surfaces. The following photos indicate areas of plaster damage at sloped ceilings; low guardrail at top of stairs and unfinished walls; ceiling damage; typical plaster crazing.

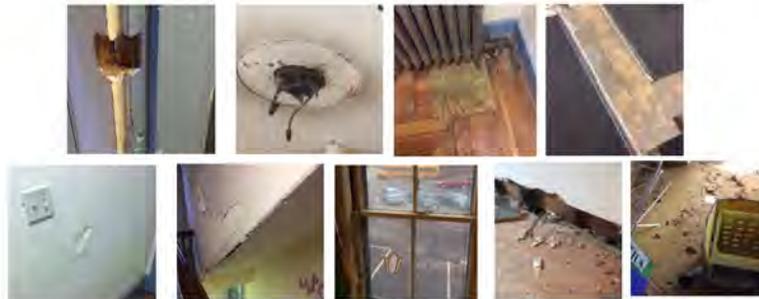
Damaged door frame; exposed ceiling wiring; patched and damaged floor at radiator;; partitions removed but carpeting not repaired; make-shift wall repairs; damaged stair enclosure; broken window sash cords; baseboards missing (from fire); and exposed carpet padding.

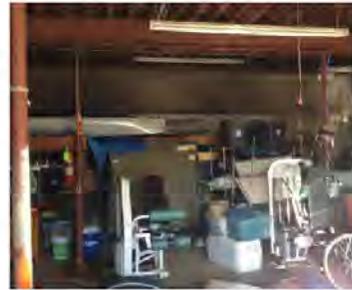
3 The first floor steel beams need to be stabilized to resist rotation, especially at post locations. This would entail cutting the steel beams at post locations, installing new structural steel posts, and reconnecting the steel beams to the steel posts. The column bases exhibit excessive corrosion due to water. Replacement of the columns, base plates, and anchors needs to be a priority.

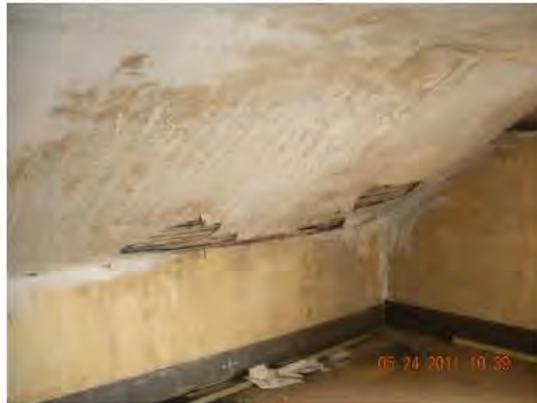
Figure 2 - *Farmhouse* - Damaged Ceiling Finishes

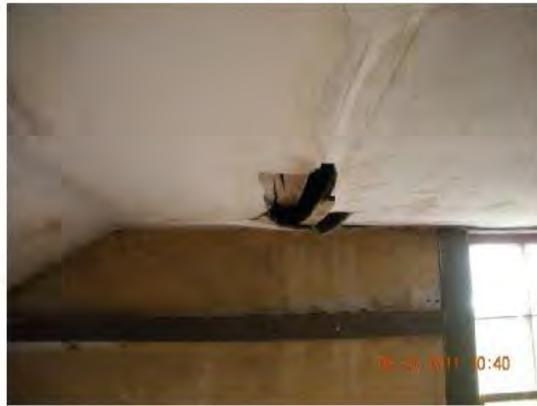
Figure 3 – Farmhouse - Damaged Ceiling Finishes

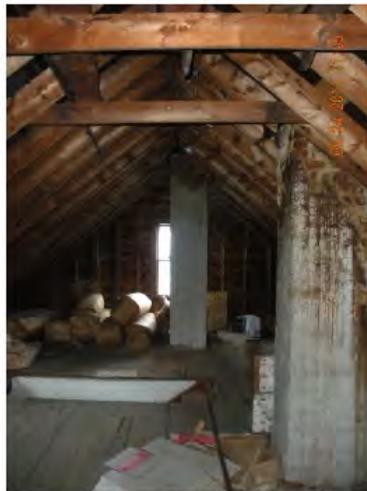
Figure 4 – First Addition - Roof Framing

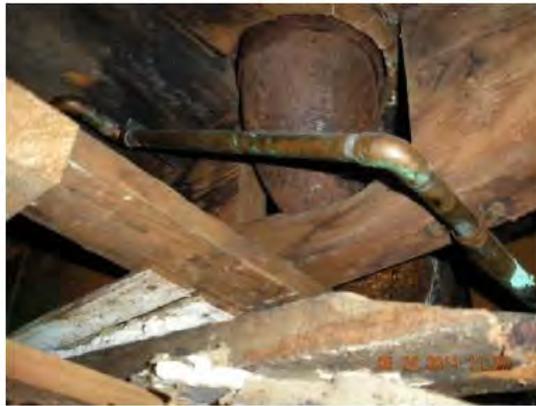
2 Second floor framing in the late 1800's addition has been cut to accommodate new plumbing. The work done is structurally un-sound and it is recommended that shoring be added to support the floor framing until framing repairs can be achieved.

Figure 6 - *First Addition* - Damaged 2nd Floor Framing by Plumbing

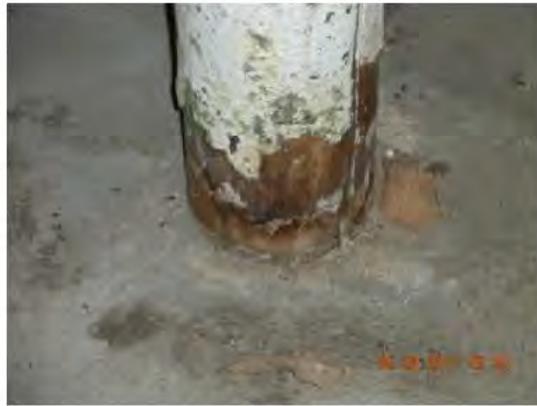
Figure 7 - *Farmhouse* - Timber Damage at Base of Basement Post

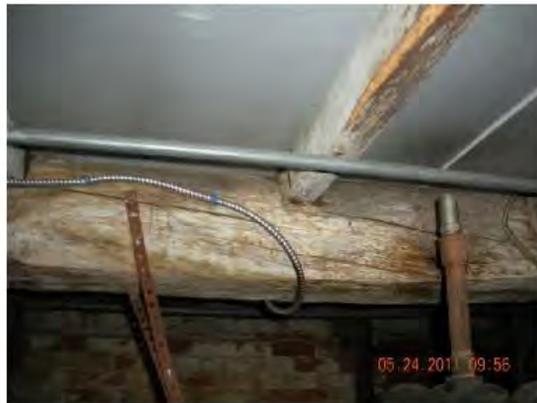
Figure 8 - *Farmhouse* - Apparent Shear Cracks in 1st Floor Timber Beam

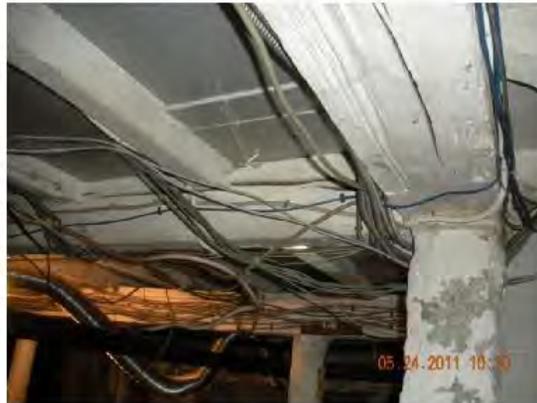
Figure 10 - *Farmhouse* - Shear Cracks at Bottom of Beam Mortise Cuts

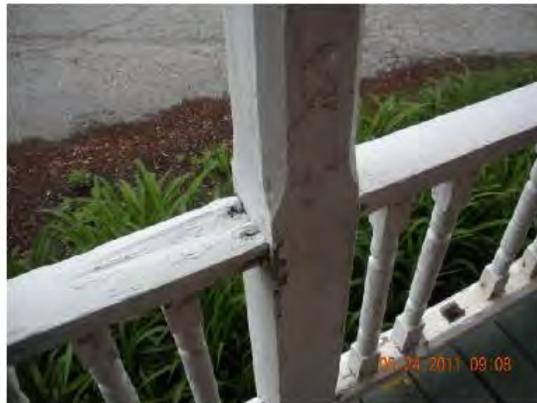
Figure 12 - *Farmhouse* - Damaged Front Timber Railings

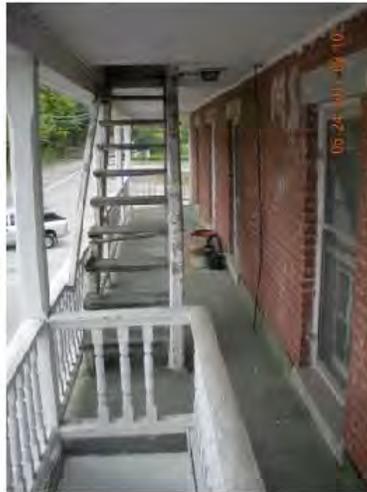
Figure 13 - *Farmhouse* - Structurally Deficient Exterior Stairway

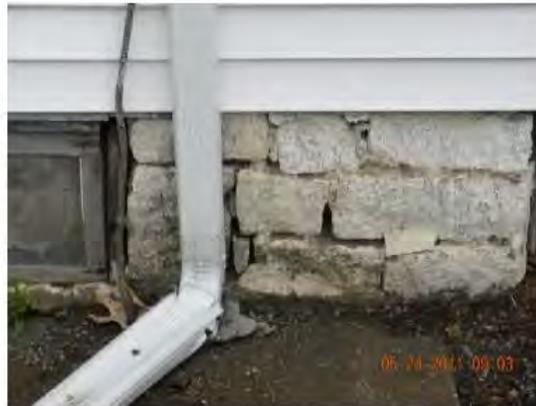
Figure 14 - *Late 1800's Addition* - Open Mortar Joints in Foundation Wall
