ABBOT SCHOOL

25 Depot Street

Year Constructed: 1955
Year of Renovation/Addition: 2005 and Unknown
Building Type: E
Construction Type: IIIB
Fire sprinklers: No
Total Floor Area: 56,816 SF
Floors: Basement, First and Second.
Assessor Lot # 026 0086 0000

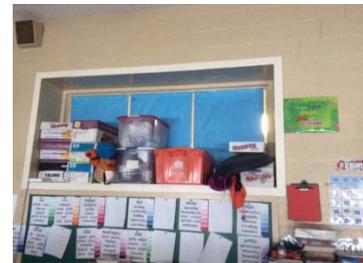
4 Typical, borrowed lights with wired glass are located in the hallway walls of most class rooms are all covered to reduce visibility into classrooms. Remove for security reasons and infill wall areas.

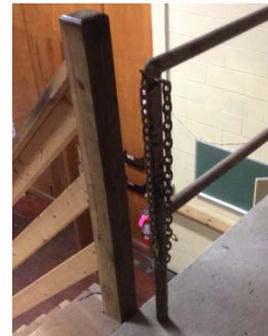
2 Guardrail at Mezzanine at Stage is not OSHA compliant. Make rail 42" high and add 4" high toe kick at floor.

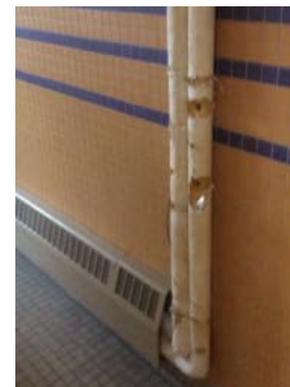
- Pump Room - 200 linear feet assumed to be Asbestos. Repair or remove as recommended by 2012 AHERA Report.
- Gymnasium - 25 linear feet assumed to be Asbestos. No Action Required as recommended by 2012 AHERA Report.

1 We recommend that all asbestos containing pipe insulation in occupied areas be removed and replaced. In areas such as the restroom the pipe insulation has been damaged and should be replaced and wrapped with plastic sheathing.

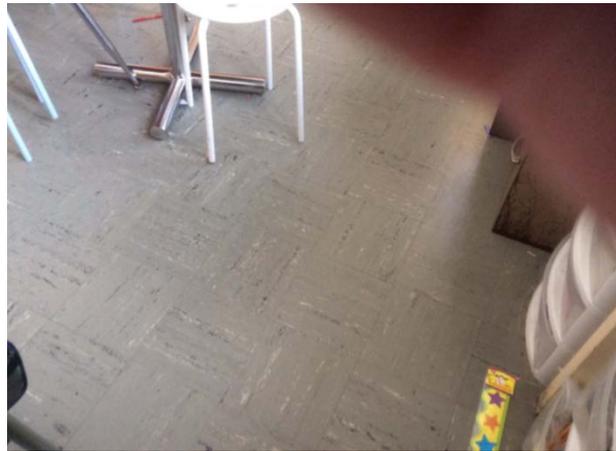
- Office Area - 100 square feet assumed to be Asbestos.
- Stage Areas - 250 square feet assumed to be Asbestos.

No Action Required as recommended by 2012 AHERA Report.

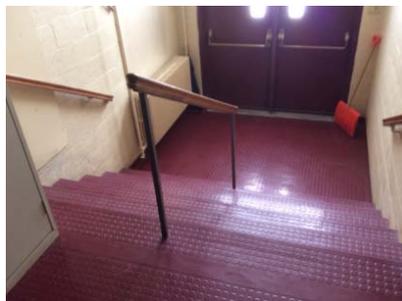
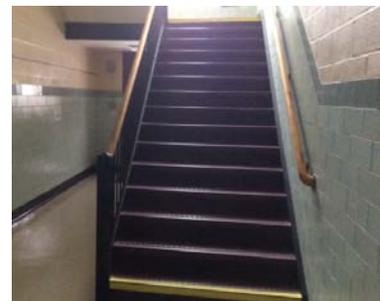
3 Main stairs not ADA compliant, low guardrail, no handrail, no handrail extensions and nosing's exist on the treads. Similarly, stairs in halls to Stage are not ADA compliant. Increase height of guardrail, add continuous handrail with top and bottom extensions in accordance with ADA. Infill area beneath

projecting nosings and vinyl treads and risers.

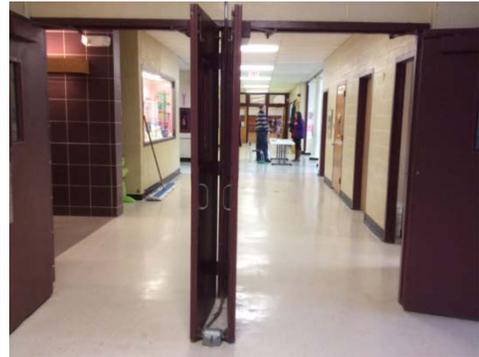
- 3 Corridor doors at stairs are too narrow similarly halls to and from stage have narrow doors. Replace with new asymmetrical pairs of doors with one leaf 36" wide. It was noted that a number of corridor doors are kept open with magnetic hold-open devices which provides accessibility during normal day to day operations, but these door will close during a fire alarm creating a barrier to persons with disabilities.

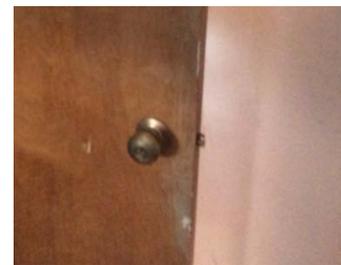
- 3 All Classrooms doors to adjoining rooms have knob set hardware. Similarly the follow doors have knob set hardware: Staff room, Copy room (4 doors), Storage room and Workshop off Stage. Remove knob sets and install lever hardware.

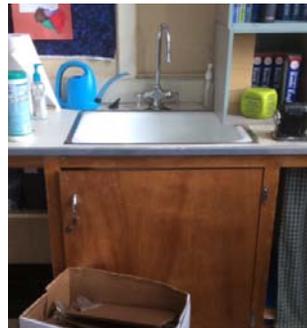
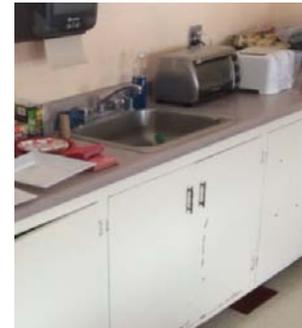
- 3 Staff Room, and rooms 6 and 7 sinks are not ADA accessible. Replace with accessible sinks and cabinets.

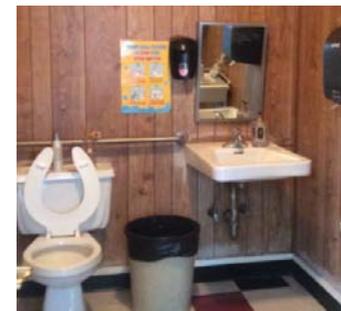
- 3 Nurses suite restroom needs to have insulation on the pipes below the sink.

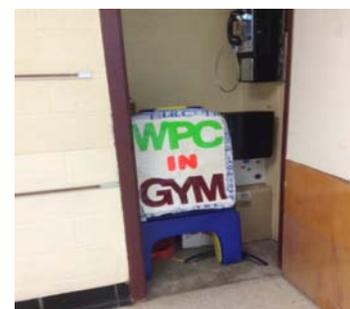
- Narrow door with knob set to Phone booth. Pay phone too high, not ADA accessible. We assume the phone booth is abandoned and do not recommend any action.

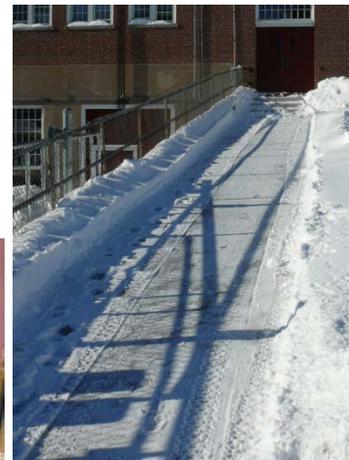
Rear ramp should be provided with handrails.

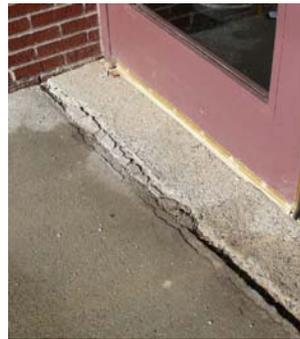
Joint in slabs at exterior south door needs to be cleaned out, concrete patching applied to create a straight joint and sealant added.

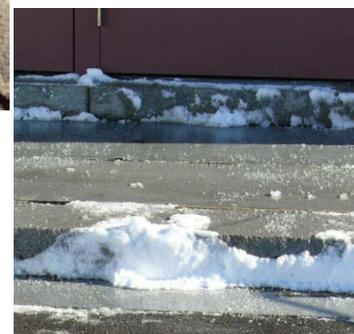
Exterior paving at west entrances has missing or loose mortar. Rake out joints and re-point. Similarly, re-point granite steps where mortar is loose or missing.

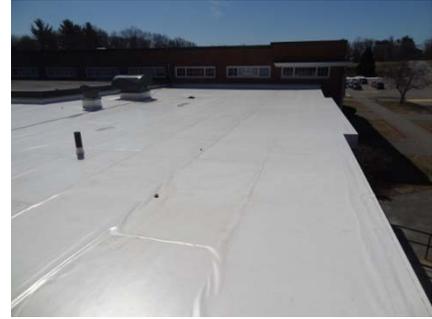
- 4 PVC roof has raised sections that follow the lines of joints in the insulation below. Normally this could be caused by internal air pressure but this is unlikely in a school. We recommend that under the warranty the manufacturer be requested to send someone out to rectify the problem.

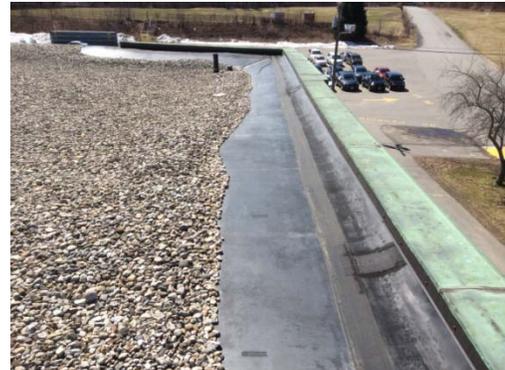
- 1 The higher south roof has a ballasted Carlisle EPDM membrane. Wind has blown smaller stones on to the lower roof but of most concern is the west end of the roof where wind has been lifting the roof membrane and has moved stone away from the perimeter of the roof. In the right wind condition this could cause a catastrophic failure of the roof as the membrane is not attached. As a minimum the stone should be redistributed over the loose membrane, but preferable ASTM D448 size 2 (2.5" dia.) stone should be installed for the first four feet of roof at 13 pounds per square foot.

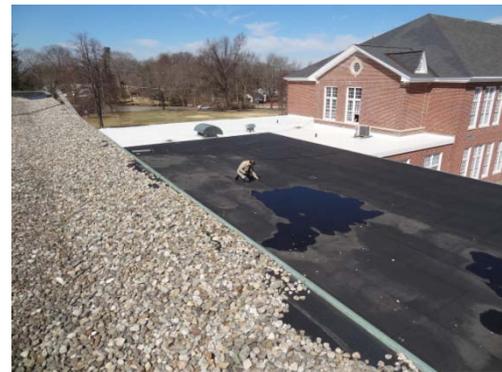
- 3 Stone appears to have been blown off the south roof onto the lower roof. We believe this is caused by the gravel stop being too low. Replace north gravel stop with a higher type to retain stone.

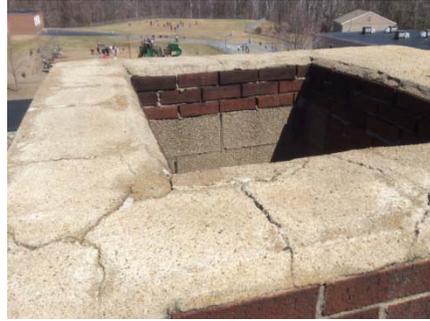
- 3 Chimney needs to have top three courses re-pointed inside the flue and the cement wash replaced with a metal cap.

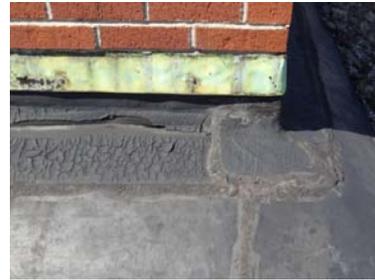
- 3 Base flashing around chimney needs to be replaced.

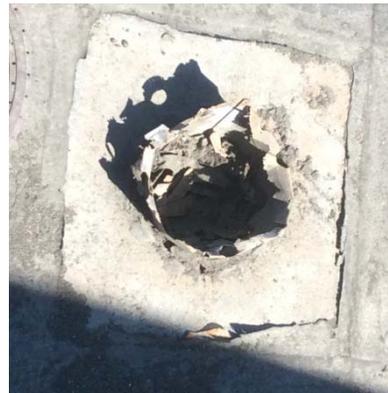
- 2 Roof drains on southern fully adhered section of EPDM roof are old type with sheet metal baskets that are damaged and need to be replaced with cast iron drains.

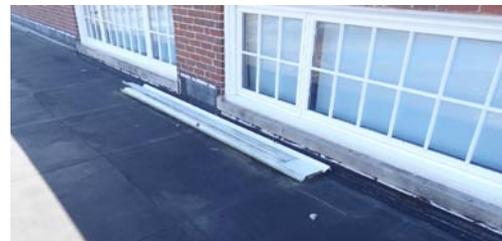
- 4 Wall flashing at the lower north end EPDM roof has only a termination bar at the top of the membrane. Add a cap flashing that is cut into the wall and sealed to prevent reliance on a soft joint to keep the flashing from leaking.

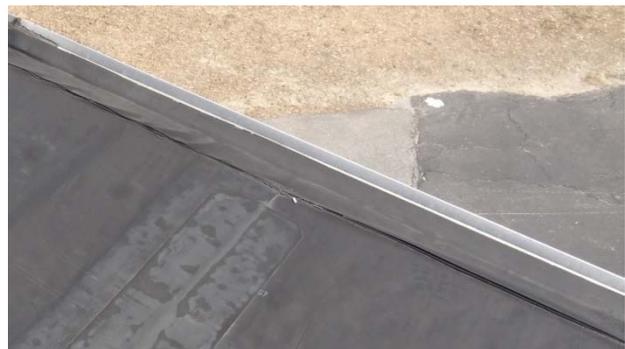
- 3 Edges of seams in membrane (north roof) are starting to lift. The membrane appears to be in good condition. Seams should be redone to extend the life of the roof.

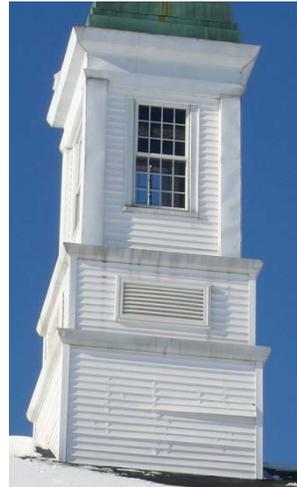
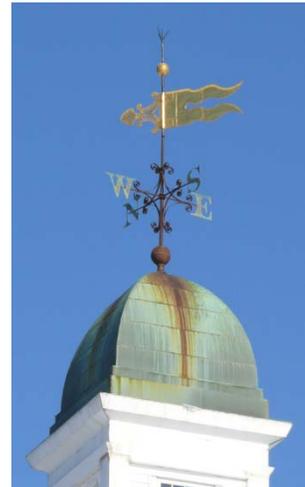
- 3 Leaks are reported at the cupola. Visual inspection from the ground suggests this may be caused by loose siding on the cupola. Repair or replace siding to ensure a secure installation. Further investigation should be made during this work to determine if other factors are causing the leaks and appropriate repairs made.

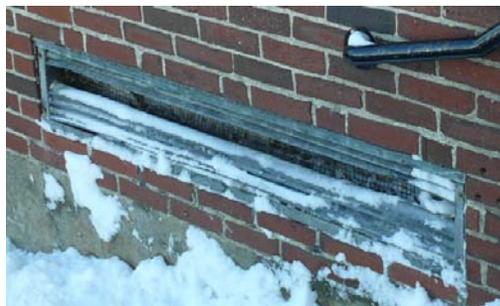
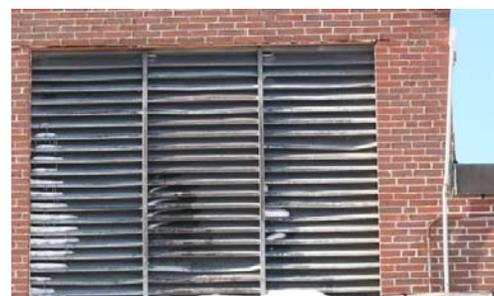
- 4 There are a number of louvers that are damaged and need sealant at the perimeter. Replace severely damaged units, rake out perimeter joint and apply new sealant and backer rod. Most unit ventilator louvers need replacement.

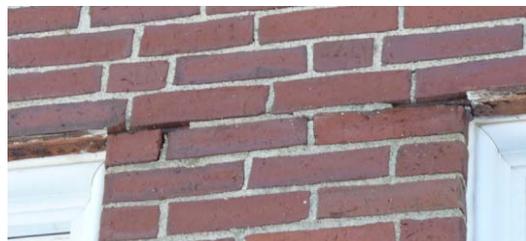
- 2 Brick and mortar is damaged at the steel lintels at various locations around the building but most uniformly on the north addition. The steel lintels in the exterior facade should be cleaned with a wire brush and painted to resist further corrosion. Repointing of the masonry joints and replacement of select bricks is required at all loose or deteriorated masonry locations.

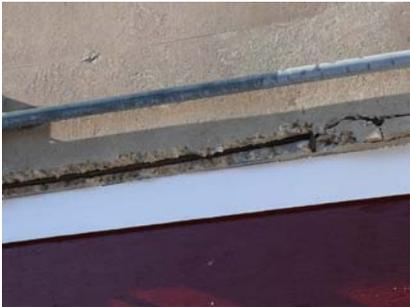
3 At the concrete foundation walls remove any loose material, clean and prepare the existing surface with a bonding agent, and replace spalled areas with concrete.
We would recommend that shrinkage cracks in the foundation walls be repaired with caulking to resist water infiltration.

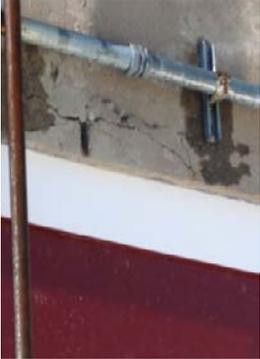
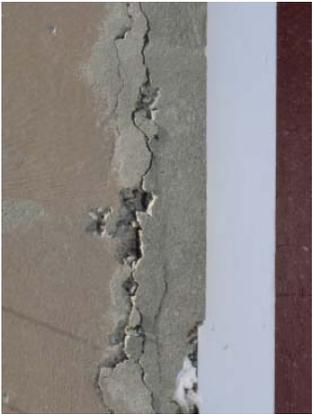
3 At the two retaining walls adjacent to the loading dock, clean any exposed and corroding reinforcing bars with a wire brush and patch the concrete with a bonding agent and cementitious material to resist further water infiltration and deterioration to the wall structure. A similar repair should be applied at any spalled concrete and exposed reinforcing in the building façade in the location of the boiler room.

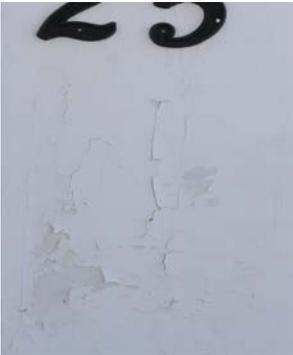
4 West facing entrance surrounds are peeling. Scrape and re-paint entrances.

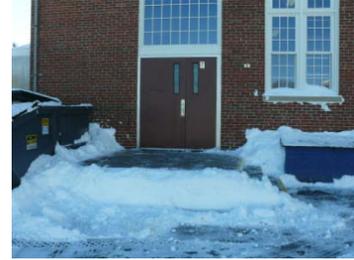
- 2 Loading dock area should have a removable railing and handrails on steps.

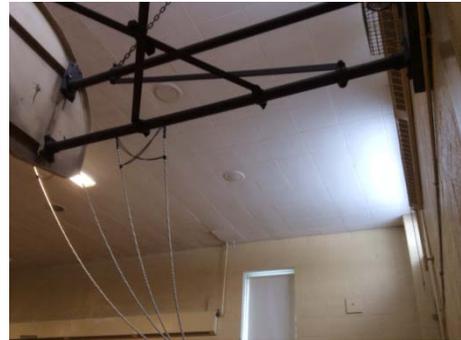
- 4 There are large areas of the building that have 12x12 or 24 x 24 adhered ceiling panels. Panel adhesive may contain asbestos. These should all be replaced with suspended acoustical panels. Spaces include: Closets off of Main Office (80SF), Rm M5, Custodial room (50SF), Gymnasium, Stage including a portion of Mezzanine, Cafeteria, two Practice rooms (290 SF), Storage room (150 SF), Workshop (off stage).

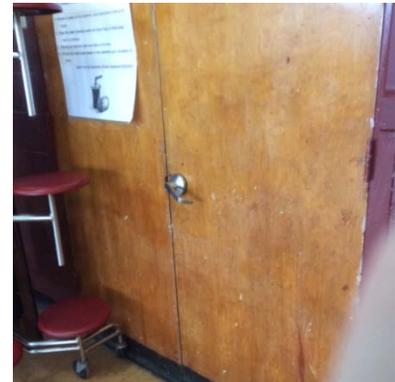
- 4 Typical all Classrooms, doors are not lockable except from the outside and no clearance on jamb side. A "refrigerator magnet" is removed from between the door and jamb to quickly lock doors. A more permanent solution would be to replace the locksets (see next item).

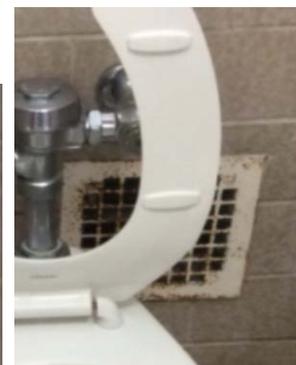
- 4 Exhaust grilles behind toilets are corroded and need to be re-painted.
- 4 There are various holes on glazed block walls that need to be sealed.

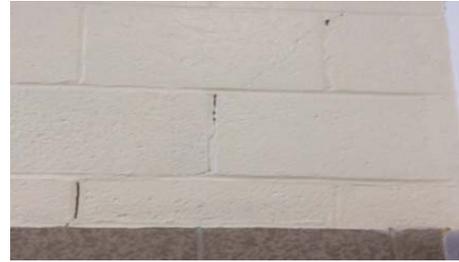
- 4 There are a few cracks in the walls that need to be caulked.

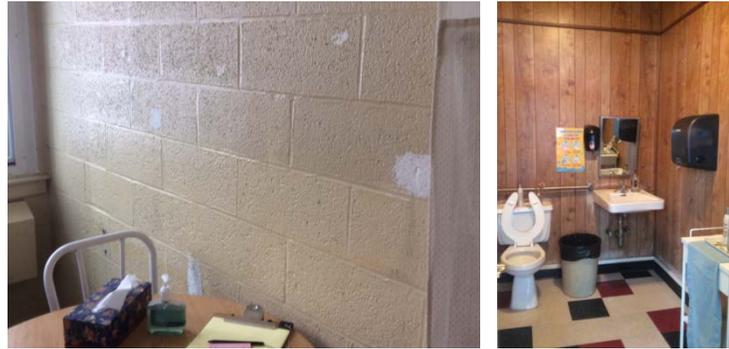
- 4 Walls need to be painted in Nurses suite.

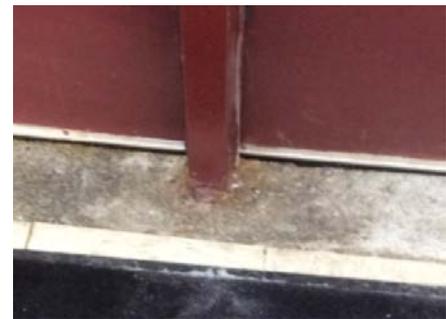
- 4 Threshold at main entrance doors has been damaged by salts. Patch concrete threshold.

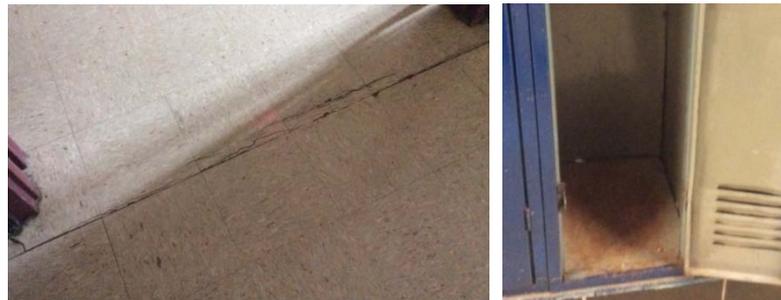
- 4 At stair well, a 6 foot section of floor tiles are cracked at corridor doors and need to be replaced cracked at doors. Prior to replacement the slab edges should be ground down.

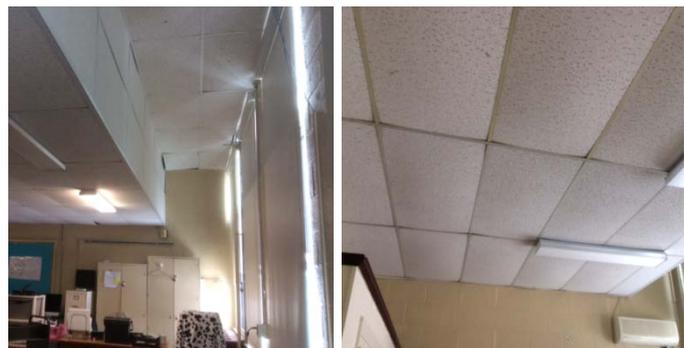
- 4 Throughout the school there are areas of acoustical 2x4 ceiling panels that are dirty, sagging or the grid has become loose. Repair damaged grid, replace badly sagging tiles and re-finish aged 2x4 ceilings.

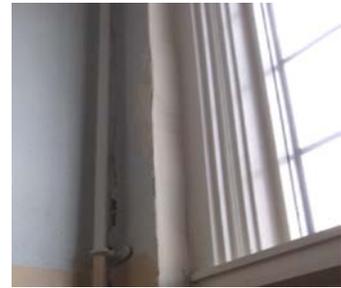
3 Where interior partitions meet the east side exterior walls cracks have developed. This has also occurred in the delivery area. Repair cracks with caulking and re-paint.

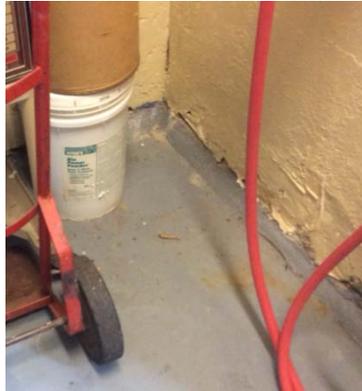
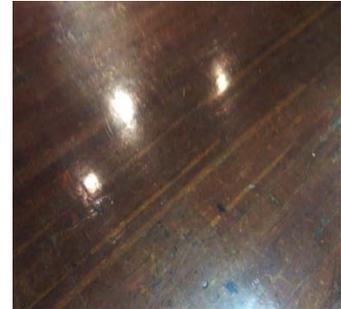
3 Lobby in kitchen area by the freezer has about 20SF of wall (at floor) that needs to be repaired and repainted.

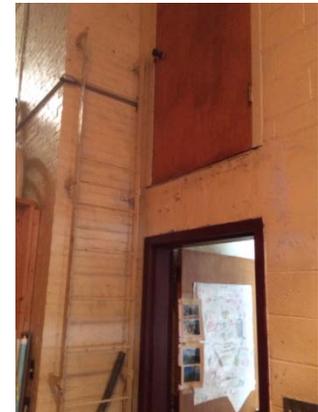
4 Fiberboard panels over Mezzanine stair need to be repaired and re-painted.

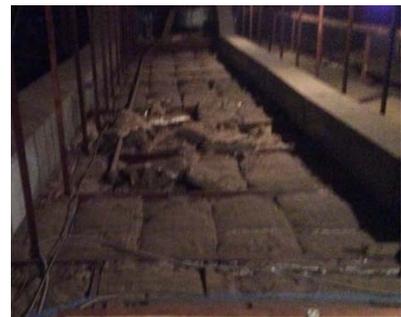
4 Insulation in Attic is in good condition but disturbed in a couple of areas. Verify and repair disturbed areas to form a tight thermal barrier to the spaces below. (Also see exterior notes).

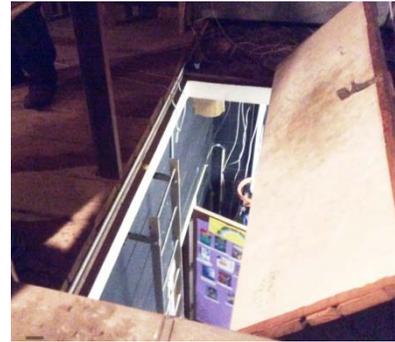
4 In the attic, we would recommend installing hardware (Simpson Strong-Tie) to reinforce the connections (especially at toe-nailed locations) to resist uplift due to wind loads.
