BLANCHARD MIDDLE SCHOOL

14 West Street

Year Constructed: 1992
Year of Renovation/Addition: 1998
Building Type: E
Construction Type: IIB
Fire sprinklers: Yes
Total Floor Area: 109,556 SF
Floors: First.
Assessor Lot # 029 0002 0000

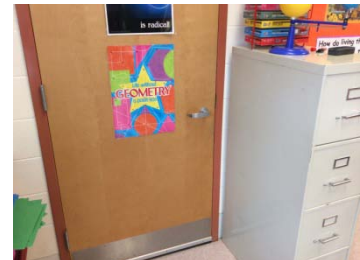
2 Doors between classrooms are secured with passage sets only. For security there needs to be a restriction on the number of classrooms that can be accessed. Add lockset with thumb turn to each door. The two doors in each room shall have thumb turns or alternately locks, which will allow free access to three classrooms maximum. Review with Police Chief.

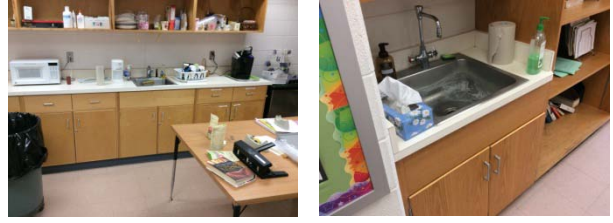
3 Rooms 39, 33, Art room, Teachers Dining room, Library circulation workroom, staff room/workroom, and storage/roof access room sinks are not ADA compliant. Replace cabinets to allow for knee space.

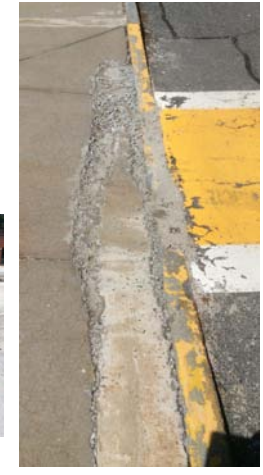
2 Ramp at sidewalk/crosswalk in front of main entrance is badly deteriorated. Remove all loose concrete material and patch concrete. Re-paint curb.

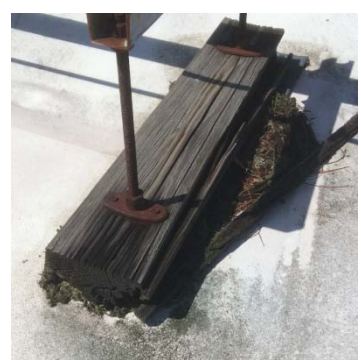
2 Pressure treated wood blocking below some pipe supports has rotted and should be replaced.

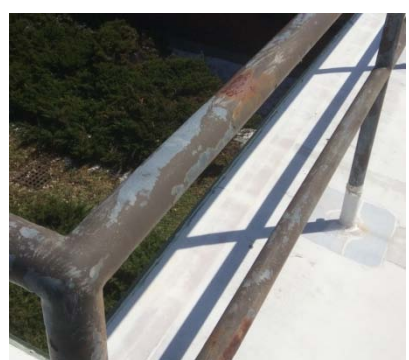
3 Galvanized guardrails around courtyard are starting to rust. Remove rust to bare metal and prime with a zinc rich primer. Paint all railings two coats.

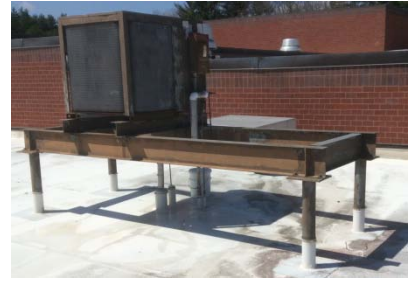
3 Similarly, dunnage steel is starting to rust and should be treated the same as for guardrails.

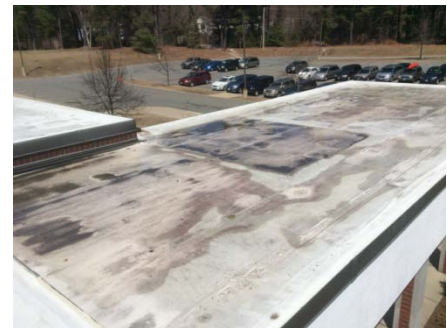
3 The main entrance canopy appear to have little slope and is drained by one scupper. The roof is extremely dirty suggesting that ponding may be a problem. It is recommended that this area be considered for replacement with tapered insulation added to improve run-off.

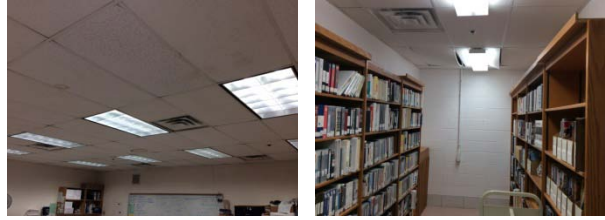
4 Ceilings have some staining and areas where panels are sagging. These include: Computer laboratory A has stained and sagging panels. Replaced stained panels. Computer laboratory B has a ceiling grid that is sagging plus tiles are also sagging. Remove and reinstall ceiling replacing sagging panels with no-sag panels.

Room 53 has a few stained ceiling panels that require replacement. Corridors have a few stained ceiling panels and panels are lightly sagging. Replace stained panels. Replace ceiling panels in Storage room off of Library. Room 39 has stained ceiling panels.

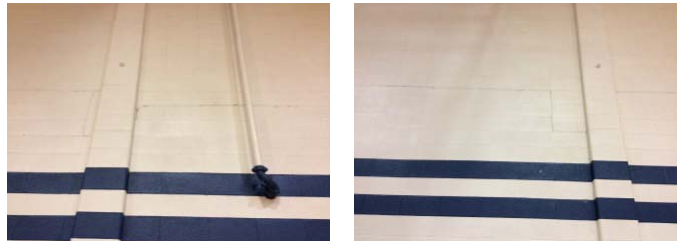
- 4 There are horizontal cracks in CMU walls in the gymnasium. Caulk cracks.
