JOHN A. CRISAFULLI SCHOOL

33 Robinson Road

Year Constructed: 2002
Year of Renovation/Addition: 1998
Building Type: E
Construction Type: II B
Fire sprinklers: Yes
Total Floor Area: 79,220 SF
Floors: First, Second and Third
Assessor Lot # 020 0102 0000

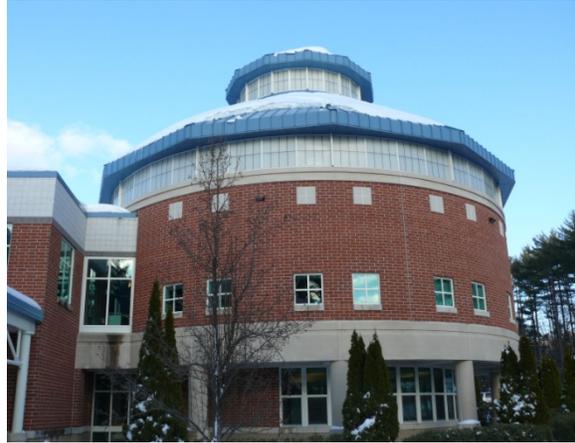
The building generally is in good condition. Fire protection and plumbing have the greatest number of high priority items along with the need for adding snow guards around the library roof (shown above). Although not reviewed for OSHA compliance it was noted that the roof hatches do not have guardrails around them to protect the opening. To be assured of compliance guardrails and a gate should be added, however, these could be omitted if the roof hatch is kept closed while anyone is on the roof. This requires a maintenance policy and signage at the hatch to ensure the hatch is kept closed. Further review of OSHA requirements for this issue should be undertaken.

1 Add snow guards around library roof as snow slides directly onto sidewalk.

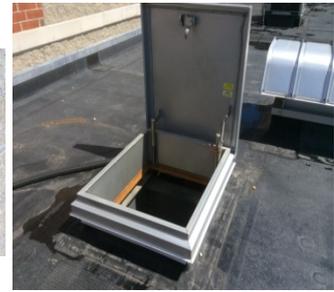
2 Roof hatches (3) do not have guardrails. Add railings, signs and gates.

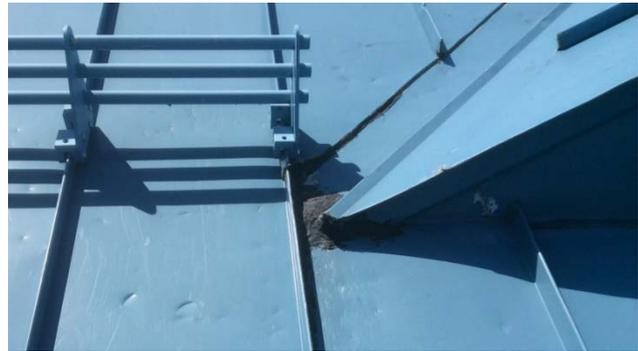
2 The valleys in the metal roofing discharge adjacent to a standing seam that allows water to penetrate the seam. It is recommended that the seam at the valley be eliminated and that a wide matching sheet of metal be used from the valley to the edge of the roof. This metal will need to be locked to the two standing seam "pans" above and locked into the side standing seams.

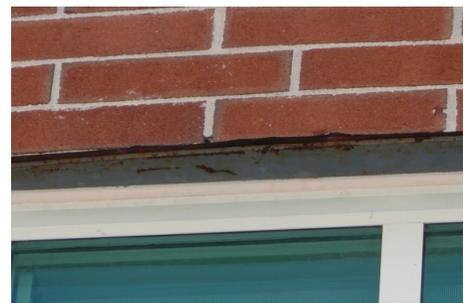
3 Edges of lintels are starting to rust. remove rust and re-paint.

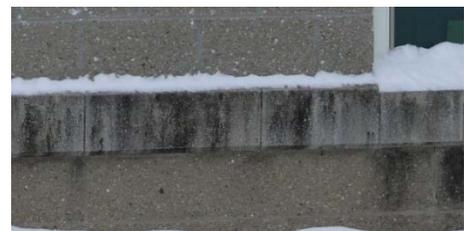
4 Ledges and other projections have stained the face of the building. Clean areas of building to remove black staining.

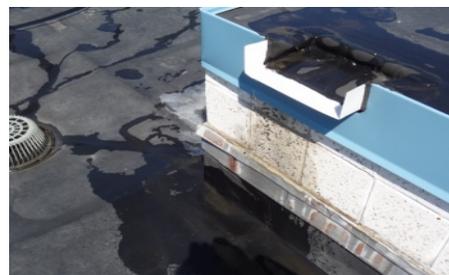
- 3 Elevator roof scuppers allow water to run on face of wall. Add an extension at a 45 degree angle to direct water away from wall.

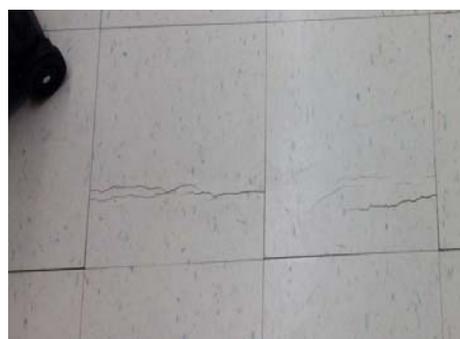
- 3 Vinyl tiles running through room 107 across building through room 108 are installed over a construction joint in the concrete floors. Remove and replace cracked tiles.

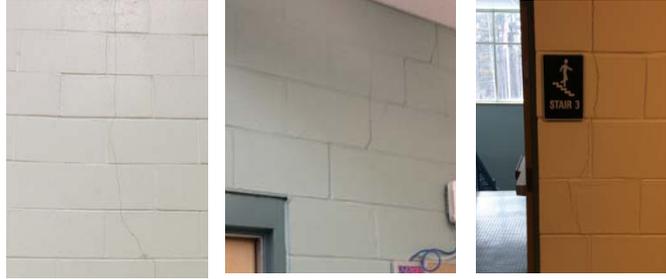
- 4 There are vertical cracks in the walls of the gymnasium, one above the right hand bleacher and the other to the left of the entrance door. Also cracks exist over door to music 119, behind the mop sink in Jan 1B, at the kitchen joint by the door and at the wall adjacent to the door at the top of Stair 3. Cracks need to be filled with caulking and re-painted.

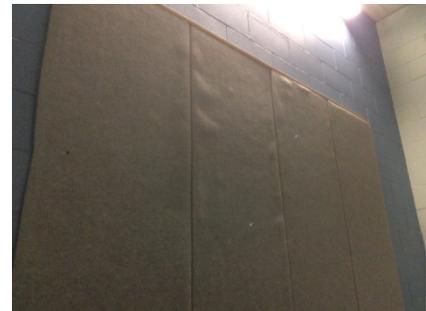
- 3 The fabric wrapping on the acoustical panels in the main stair has come loose. Remove panels and re-install fabric stretching tightly over substrate prior to re-installation.
