NORMAN DAY ELEMENTARY SCHOOL

75 East Prescott Street

Year Constructed: 1965
Year of Renovation/Addition: 1998
Building Type: E
Construction Type: IIB
Fire sprinklers: No
Total Floor Area: 60,456 SF
Floors: First and Second
Assessor Lot # 024 0005 0000

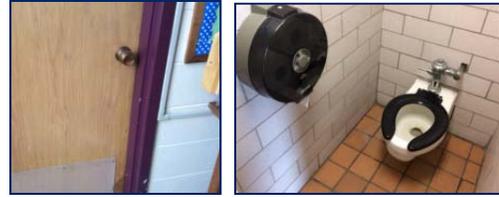
- 3 Clinic Room A-107 restroom is not ADA accessible, knobs on doors to restroom and 2 closets. Replace with lever hardware.

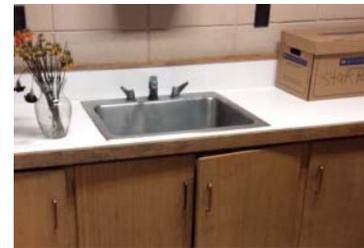
- 3 Sink in Staff Restroom is not ADA compliant. Replace sink and cabinet with compliant unit.

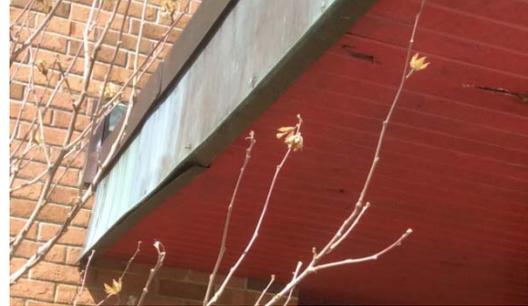
Wood soffit under canopy has some small holes that need to be filled and re-painted.

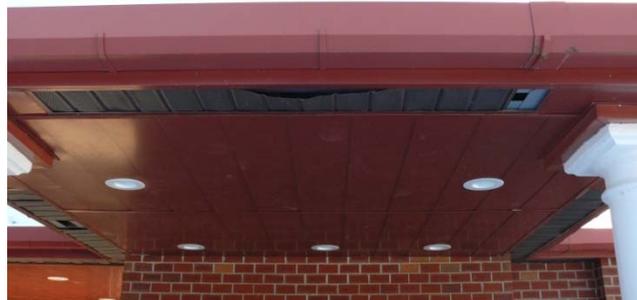
Joints between gutters at the new wing are leaking. Seal joints in gutters.

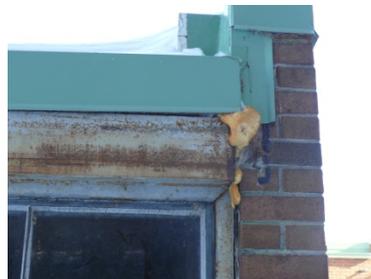
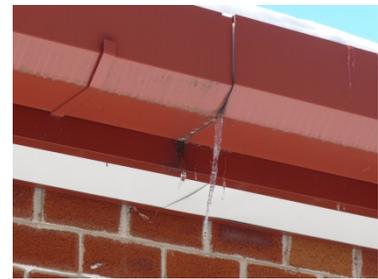
Paint fascia on rear wing and seal against brickwork at ends.

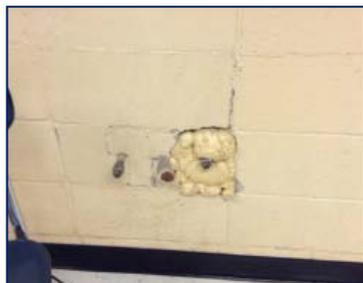
- 3 Room 100, CMU block wall has cracked, spray foam is exposed and dry wall needs to be repaired. Replace damaged CMU and paint CMU block and drywall.
