MILLENNIUM SCHOOL

23 Depot Street

Year Constructed: 1999
(Modular Building)
Year of Renovation/Addition: NONE
Building Type: E
Construction Type: VB
Fire sprinklers: Yes
Total Floor Area: 32,000 SF
Floors: First
Assessor Lot # 026 0086 0000

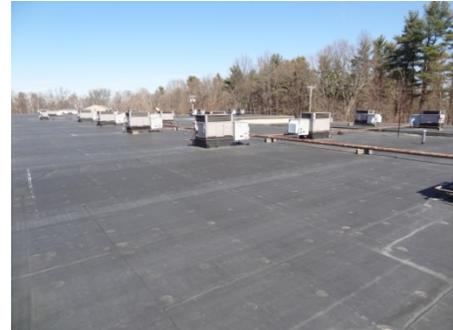
3 Roof is .060 EPDM, fully adhered. There has been some leaks in the roof but they appear to be mostly seam related. Some seams are open on sides and some have slight bubbling. It appears that sealant used on areas of the roof may not be compatible with the membrane. There is also about 20 SF of roof that has puckered but is otherwise sound. All open seams need to be recovered which should extend roof life by at least ten years.

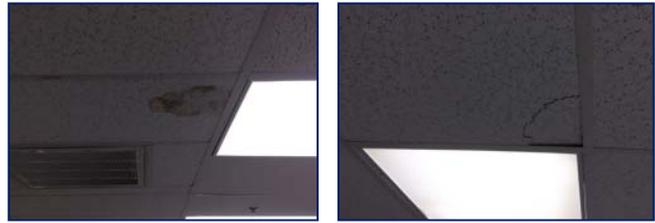
- 3 Broken or stained tiles in Rooms 3, 4, 7, 12, 14B, 15, 16, 17, 19, Teachers Room, Corridors and many other rooms.

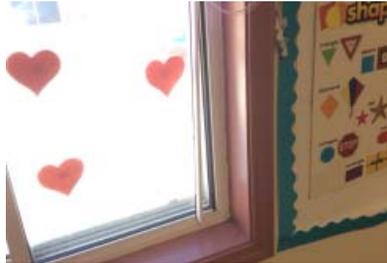
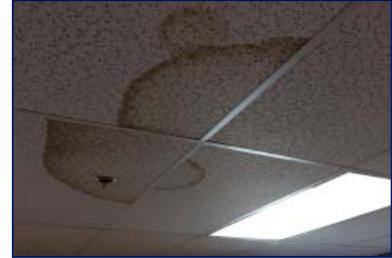
- 3 Past roof leak and broken window frame in Rooms 1 and 19. Repair Broken Window Frame. and replace Tiles
