RITA MILLER SCHOOL

1 Mitchell Way

Year Constructed: 2002
Year of Renovation/Addition: 1996
Building Type: E
Construction Type: II B
Fire sprinklers: Yes
Total Floor Area: 90,463 SF
Floors: First Second
Assessor Lot # 048 0011 0232

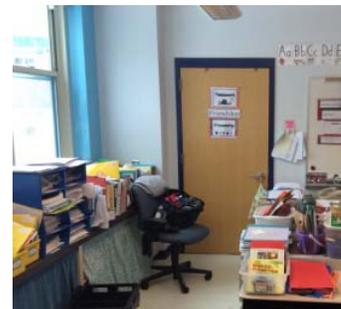
- 2 Doors between classrooms are secured with passage sets only. For security there needs to be a restriction on the number of classrooms that can be accessed. Add lockset with thumb turn to each door. The two doors in each room shall have thumb turns or alternately locks, which will allow free access to three classrooms maximum. Review with Police Chief.

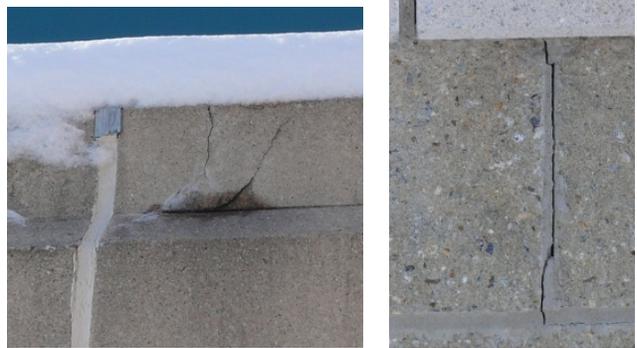
3 There is some minor cracking below the windows in the courtyard that should be caulked.

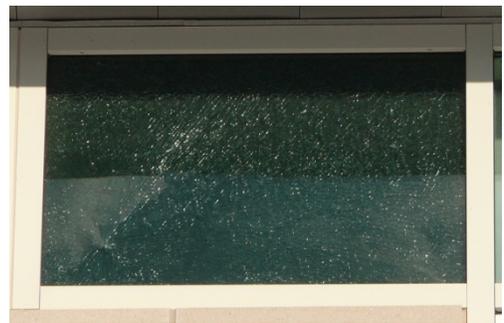
3 Minor cracking at the entrance canopy pre-cast concrete will probably result in loss of material. Remove loose areas and re-attach with epoxy, or apply and epoxy patch.

3 Replace broken glass panel.

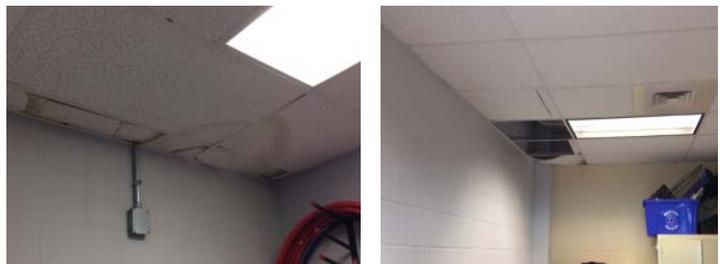
3 Ceilings have some staining and areas where panels are sagging:

Storage 2B has stained, damaged and missing panels. Gymnasium storage has four stained panels. Tutorial 2 has approximately ten stained panels. Stair 3 has approximately six stained panels. Stair 3 has six stained panels. Room 120 has three missing panels.

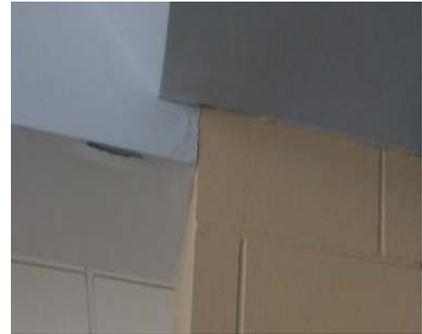
There have been a number of roof leaks along the corridor outside the gymnasium where the metal roofing meets the gymnasium wall. This has resulted in wallboard damage and damage to ceiling panels.

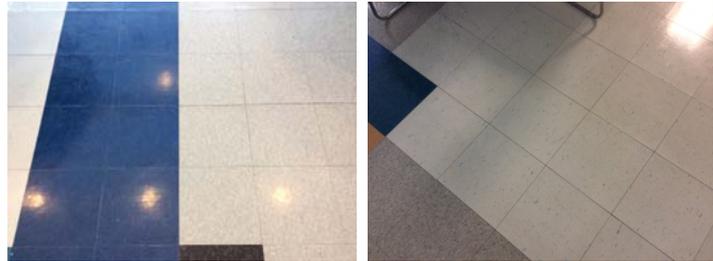
Vinyl composition tiles (VCT) are curling and lifting in various areas of the building requiring replacement of tiles by maintenance staff.

Unfortunately, the tiles used do not always match the original. Replacement will need to be an on-going activity as tiles continue to lift.

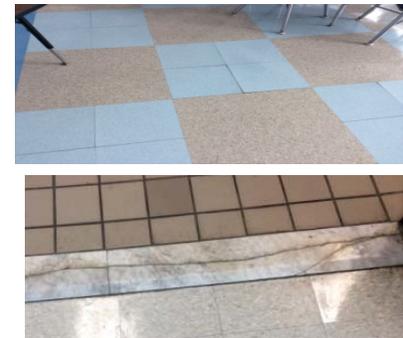
Marble threshold between VCT and quarry tiles in Cafeteria/ Servery is badly cracked. The location may be directly over a construction joint in the concrete floor beneath. To avoid a similar occurrence replace the threshold with a metal threshold that can "float" between the two finishes.

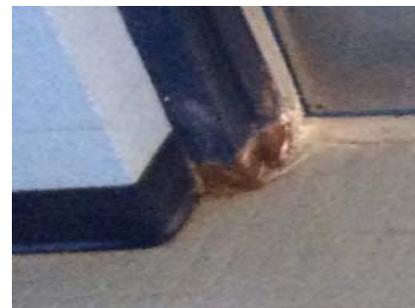
The bottom of the exterior door frames 3, and 4 are rusting badly. These should be cleaned of rust to the bare metal and re-finished.

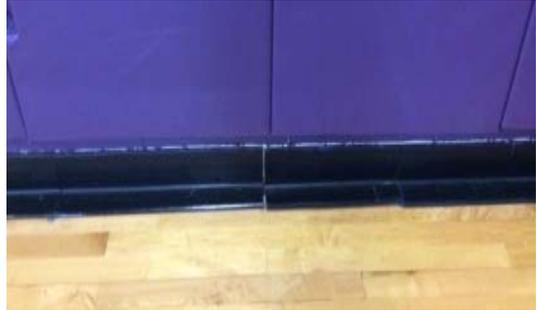
- 3 Gymnasium wall padding and baseboard are loose in a number of locations and need to be re-secured.
