NABNASSET SCHOOL

99 Plain Road

Year Constructed: 1960
Year of Renovation/Addition: 1996
Building Type: E
Construction Type: II or III
Fire sprinklers: Yes
Total Floor Area: 58,766 SF
Floors: First.
Assessor Lot # 069 0253 0000

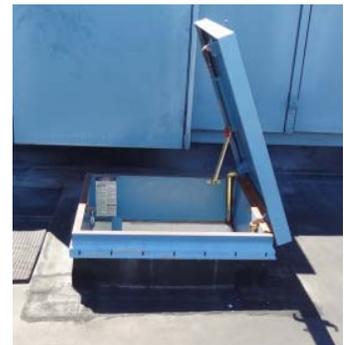
- 3 Doors between classrooms are secured with passage sets only. For security there needs to be a restriction on the number of classrooms that can be accessed. Add lockset with thumb turn to each door. The two doors in each room shall have thumb turns or alternately locks, which will allow free access to three classrooms maximum. Police input recommended.
- 2 The two roof hatches need railings around roof opening and should have an extendable handrail for ladder to provide safe access to the roof. Alternatively signage requiring hatches to be kept closed when people are on the roof should be added.

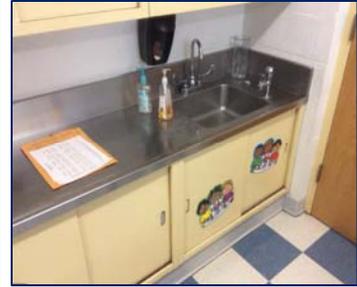
Rooms 1 and 11 have sink mounted bubblers that exceed 3.5 inches from the front of the cabinet. There is also no knee space under the sink. Due to the stainless steel counters and the provision of bubblers in the hallways no change is suggested.

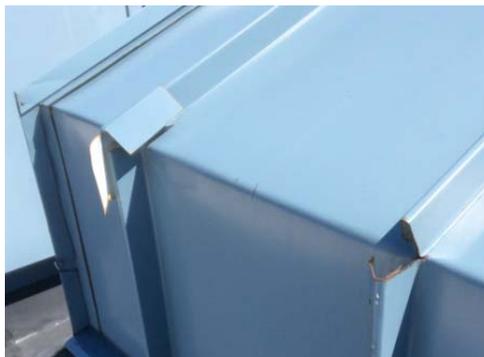
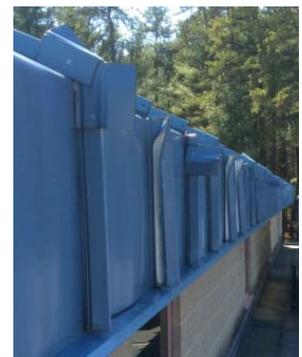
Vertical corner covers for standing seams have been dislodged by snow and ice. Most are damaged but some are missing. Replace all corner covers.

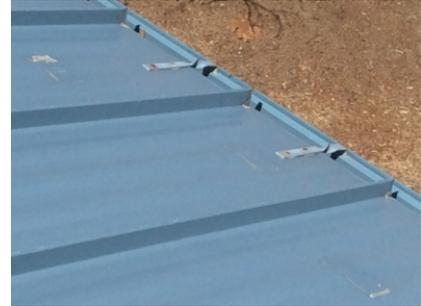
- 2 Walkway canopies have lost their snow guard. Replace guards with type that clamp to standing seams.

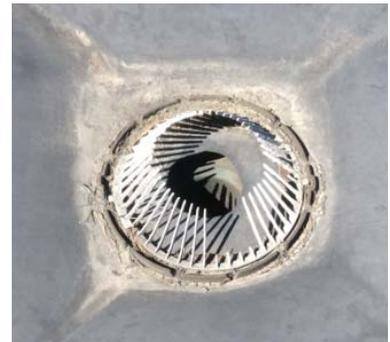
- 3 All roof drains have plastic covers that are badly deteriorated and some have blown away with the wind. They should be replaced with cast iron covers

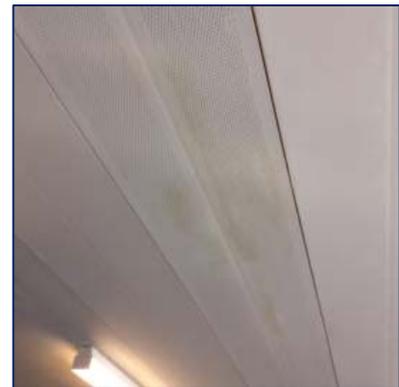
- 3 Ceiling panels throughout building are sagging from humidity. Replace ceiling panels with non-sag panels in rooms 8, 9, and 40% of room 15.

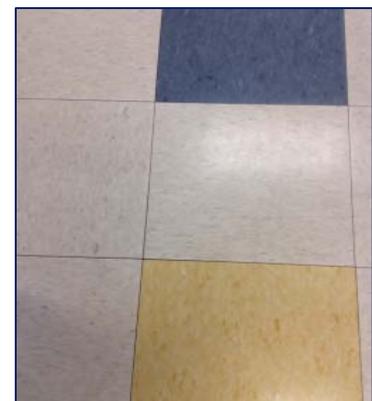
- 3 Floor tiles lifting in places. Also joints between tiles have opened up in rooms 1, 9, 10, 13, 14, and 15. Open joints are not critical but will collect dirt overtime and will allow stripper to get under tiles. Replace areas of floor with lifting tiles. This will be an on-going item as tiles continue to lift in the building.

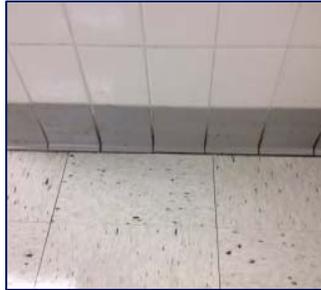
3 Tile floors have grout that is dirty. Similarly, in hallways tile base has grout that has turned black from dirt. Floor tile and tile base grout should be cleaned in all restrooms and hallways respectively.

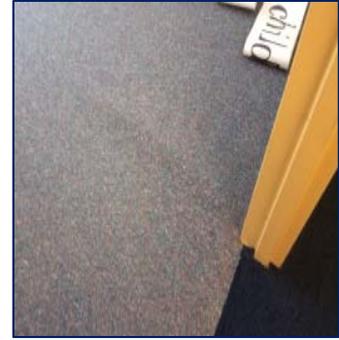
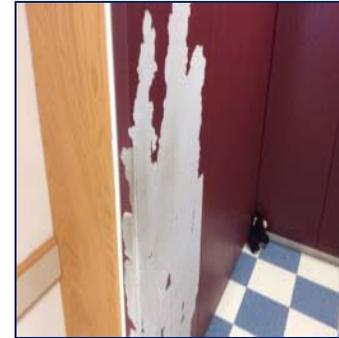
3 In Special Education room 14, wall padding in time-out room is damaged and needs to be replaced.

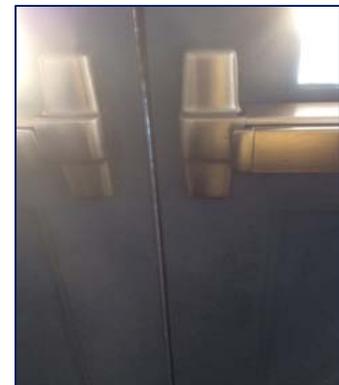
3 Entrance vestibule weather-stripping needs to be adjusted or replaced on exterior doors.
