# COLONEL JOHN ROBINSON SCHOOL

60 Concord Road

Year Constructed: 1970  
Year of Renovation/Addition: None  
Building Type: E  
Construction Type: II B  
Fire sprinklers: No  
Total Floor Area: 55,836 SF  
Floors: First.  
Assessor Lot # 020 0102 0000

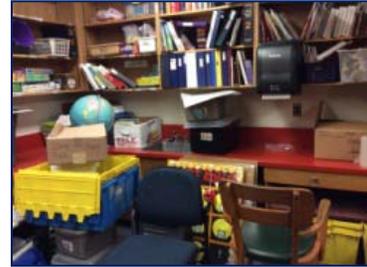
3 Storage rooms have knobsets that need to be replaced with lever hardware. Also clearances with rooms are not sufficient for wheelchair access.

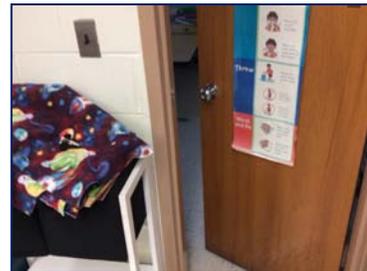
3 Sinks and restroom in Health Clinic are not ADA accessible. Knobs on doors need to be replaced with lever type hardware.

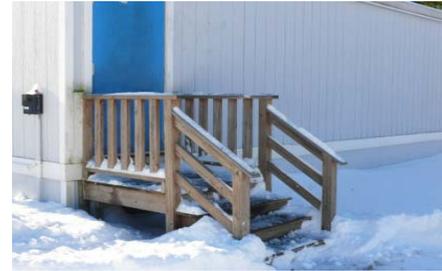
3 At the steps from the portables handrails are not ADA compliant. Replace railing to comply with ADA.

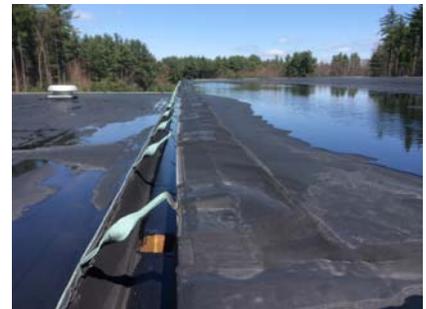
3 Roofs have areas of significant ponding and seams are starting to open. As the roof is approaching 30 years old we recommend full replacement which will also have the added advantage of being able to increase the roof insulation for the building.

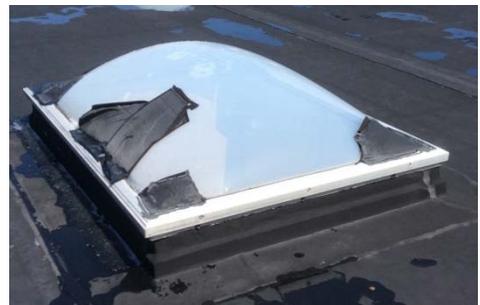
A number of skylights are damaged on roof. Replace four 4'x6' and two 4'x4' skylights as part of re-roofing project.

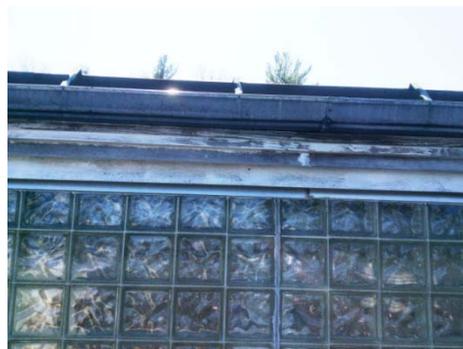
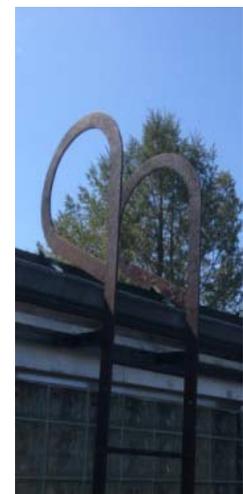
3 Roof ladder needs to be re-painted.

3 Clean and re-paint wood fascias under gutters that are deteriorating.

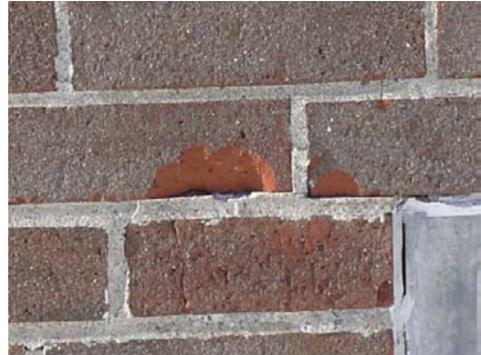
There are approximately 40 damage brick units that need to be cut out and replaced.

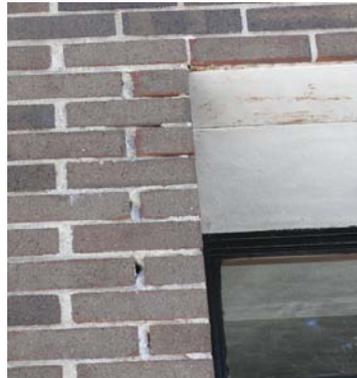
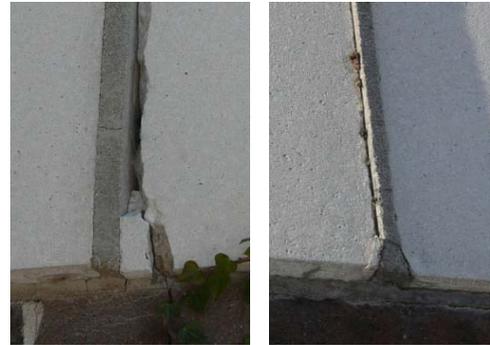
Even though there are no expansion joints in the brick walls there is very little damage. Re-point approximately 150 SF of brickwork and pre-cast concrete panels. Some edges of pre-cast are damage but can be covered when re-pointing occurs.

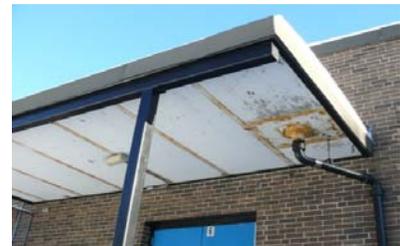
Clean and repaint exterior canopy at delivery dock.

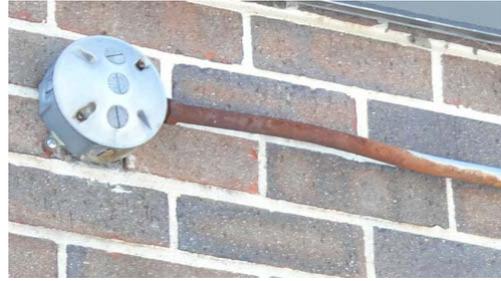
3 Exterior conduits on face of building are rusted and need to be scraped, cleaned and repainted or replaced.

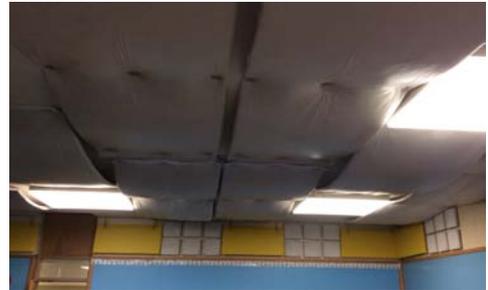
4 Draped acoustical batts have been installed over plaster ceilings throughout classrooms. These require annual cleaning to remove dust that collects on the upper surface. These should be removed and replaced with 2'x2' suspended acoustical tile ceilings.

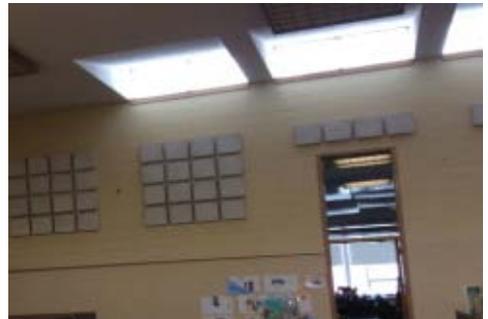
3 Acoustical wall panels are worn and dirty and should be removed. Panels are probably secured to wall with adhesive. The adhesive needs to be checked for hazardous materials.

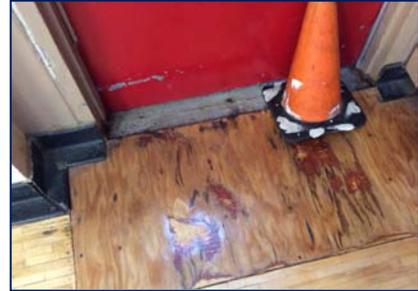
- 2 Floor at exterior door number 5 in Gymnasium is damaged and patched with plywood causing a possible trip hazard. Remove plywood and repair floor properly.

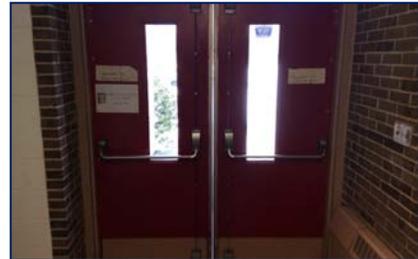
- 3 Exterior Double doors number 2 have a gap between doors and allow light and exterior conditions to penetrate interior. Install weather stripping to eliminate gap.
