BEACON STREET SCHOOL MAINTENANCE FACILITY

28 Beacon Street

Year Constructed: 1963
Year of Renovation/Addition: NONE
Building Type: S-2
Construction Type: III B
Fire sprinklers: No
Total Floor Area: 10,735 SF
Floors: First
Assessor Lot # 030 0045 0000

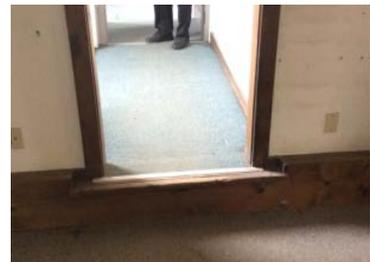
4 There is a ramp in the office area that has a step. Ramp needs to be replaced to eliminate step. Include railings. (Space currently un-used but reportedly used in the summer).

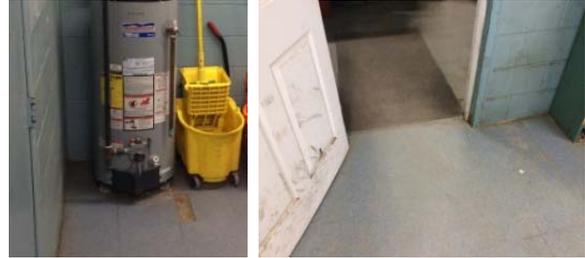
- 3 Vinyl floor tile in office, lounge, parts room and toilet is worn and needs to be replaced. Floor tile is also missing at the water heater and needs to be replaced.

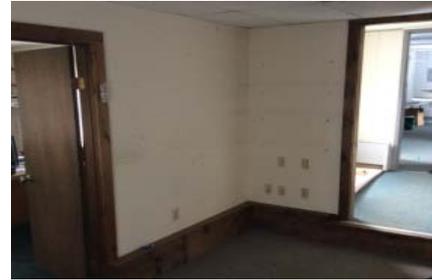
- 3 Paint all office space walls.

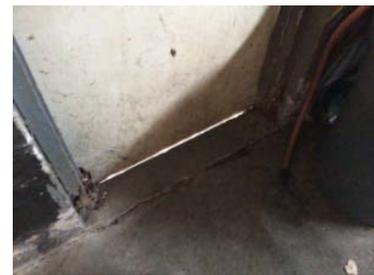
- 3 Door at main entry rusted at bottom of door and door frame in end bay is badly rusted and needs to be replaced.

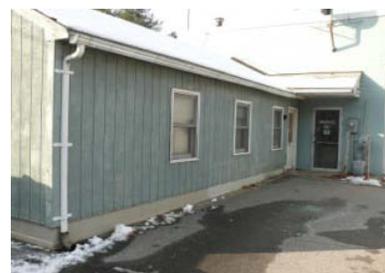
- 3 All windows are single glazed steel framed. Either add storm panels to interior or replace entire window. Include Low-E insulating glass.
