STONY BROOK SCHOOL

9 Farmers Way

Year Constructed: 2003
Year of Renovation/Addition: None
Building Type: E
Construction Type: II B
Fire sprinklers: Yes
Total Floor Area: 119,130 SF
Floors: First, Second and Third
Assessor Lot # 035 0108 0000

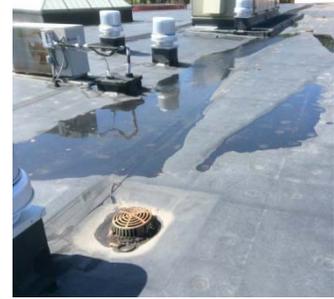
- 3 Tapered insulation around roof drains has become slightly higher than the adjacent insulation resulting in some large ponded water areas. Insulation around drains should be cut down to allow free flow of water and the roof membrane repaired.

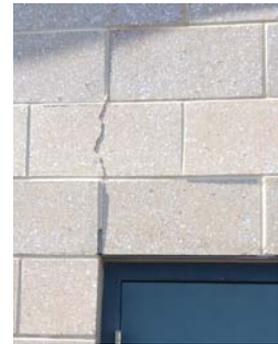
- 3 A section of masonry has become dislodged above the lintel to a roof door. Masonry needs to be removed and reconstructed with a vertical control joint formed in line with the door jamb.

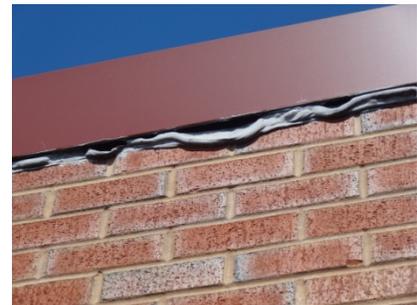
- 3 It appears that the metal fascia on the upper roof (adjacent to the ladder) did not completely cover the masonry wall below. The gap had been filled with sealant which has become dislodged. Apply an extension to the fascia, tucked behind the existing, with a continuous cleat to cover the wide joint.

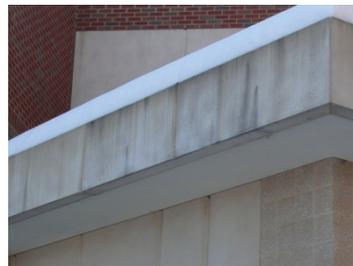
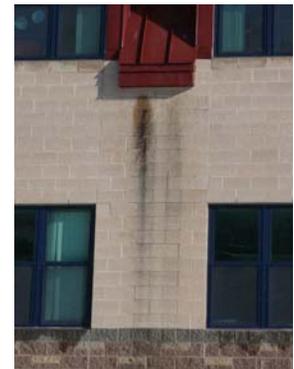
- 3 Masonry including pre-cast concrete around the building has become stained from run-off from metal roofs, or from ledges where dirt has collected. Selective cleaning of the building is recommended.

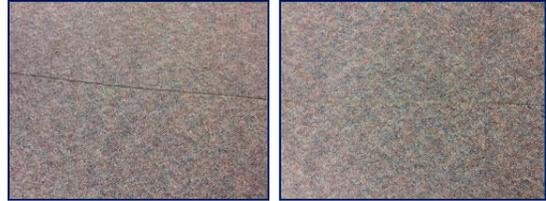
- 3 Carpet pulling apart at seams in 4 locations in Room B215 (Computer Room), Library and Large Group Room. Verify if warrantee is still active.

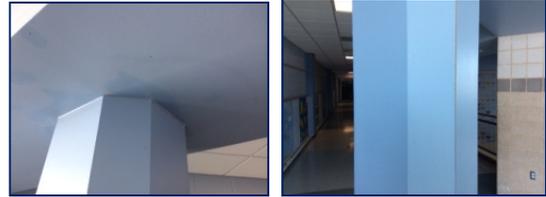
- 3 Crack at column head and down the seam of column at the second floor atrium area. Re-tape, spackle and paint cracked areas.

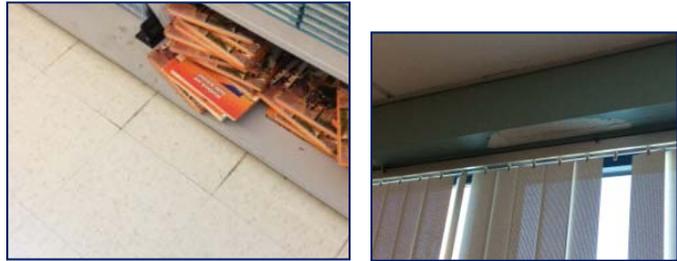
- 3 Cracks in wall at window head in. Patch sheetrock and re-paint.
