MUSEUM COTTAGE

4 Boston Road

Year Constructed: 1900
Year of Renovation/Addition: Unknown
Building Type: B
Construction Type: VB
Fire sprinklers: No
Total Floor Area: 2,200 SF
Floors: Basement, First and Second.

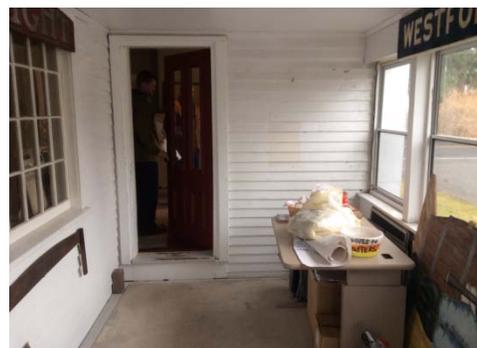
- 3 The building is not handicapped accessible. Construct a new ramp to the porch level and a separate ramp, within the porch, to the first floor. Increase the door widths to and from the porch to 36 inches.

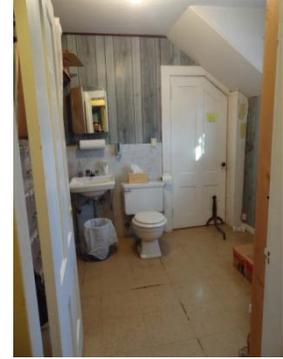
The only restroom is on the second floor and is not accessible. Construct a new handicapped accessible restroom on the first floor.

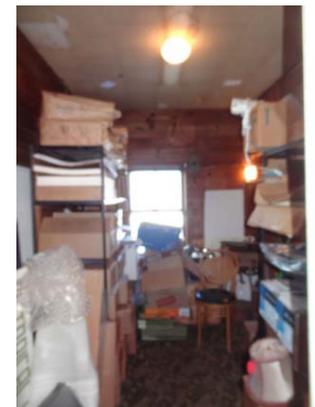
2 To resist lateral loads which are causing deformation of the structure, reinforcing the exterior wall is required. Upon analysis, this will include infilling a few of the windows at the side entrance with a plywood sheathed wood stud shear wall.

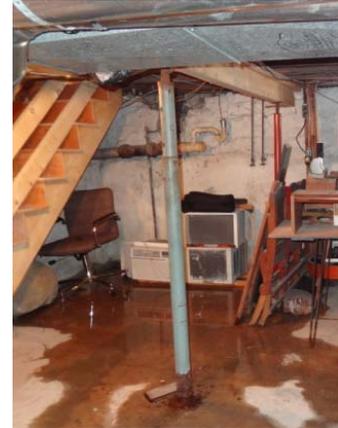
- 2 There is a significant slope in the first floor. In the basement, temporary shoring needs to be replaced with permanent engineered framing; concrete filled lally columns, and spread footings. Work is also required to remove floor framing from the chimney structure and to add appropriate supports. Chimney will need to be patched.

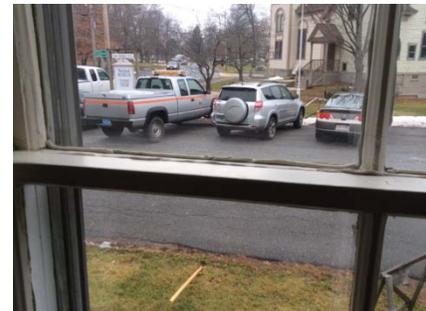
- 3 Many windows have no window hardware at meeting rails and, due to the amount of air leakage, sealant has been added between the sash. Remove sash and install weather-stripping to all windows. Provide new meeting rail latches.
