# NABNASSET FIRE STATION

14 Oakhill Road

Year Constructed: 1963  
Year of Renovation/Addition:  
Building Type: B/S-2/R-2  
Construction Type: VB  
Fire sprinklers: No  
Total Floor Area: 2,232 SF  
Floors: First.

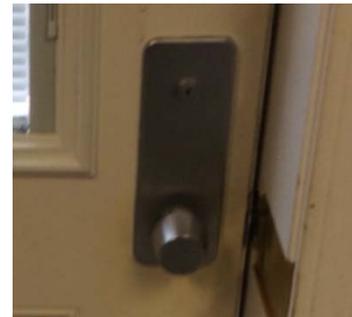
3 Doors have knob-sets and need to be changed to lever hardware.

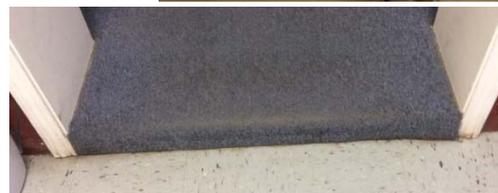
3 There is a step up into the dorm room addition. A ramp needs to be added to overcome the floor change.

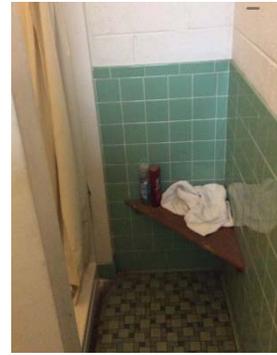
- 3 Shower is not accessible. Provide showers for both men and women.

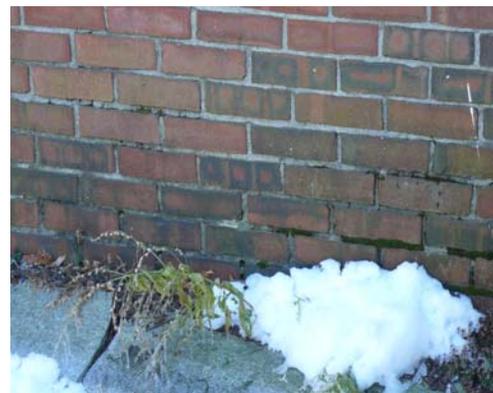
- 2 Stone drip around building causes rainwater to splash against brick resulting in staining and some brick failures. Clean lower 18 inches of wall and re-point bricks. Replace stone with either pea-stone or slope away from building to deflect rainwater away from building.

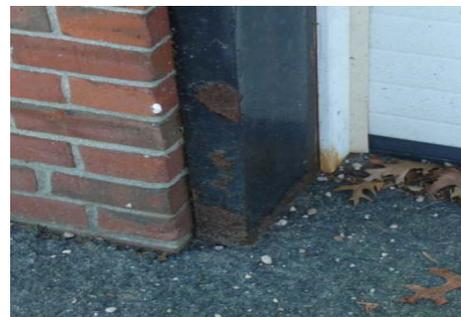
- 3 Steel channel frames at overhead doors need to be scraped and re-painted.

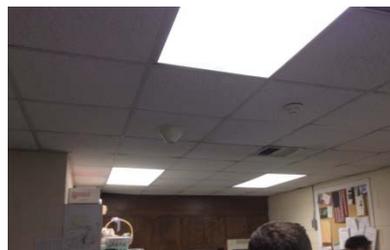
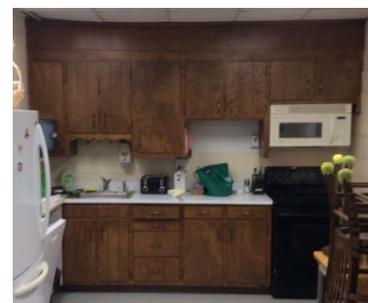
- 4 Kitchen cabinets are in poor condition and should be refinished or replaced.

- 4 Walls and ceiling need to be repainted in Dayroom.

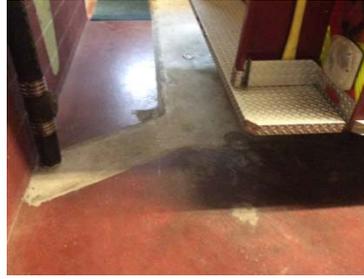
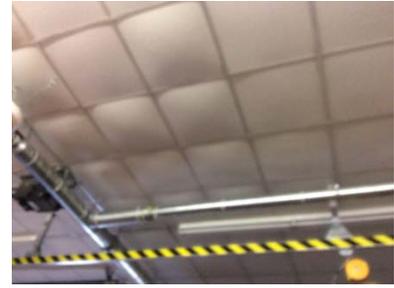
Ceiling panels in bays are sagging and need to be replaced with non-sag panels.

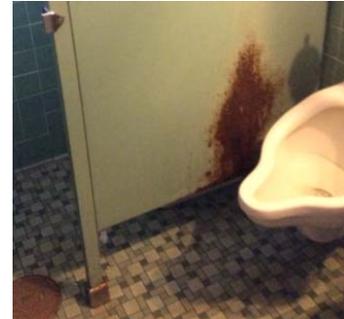
Toilet room stall partition is badly rusted. No action required as it will be removed when toilet room is upgraded.

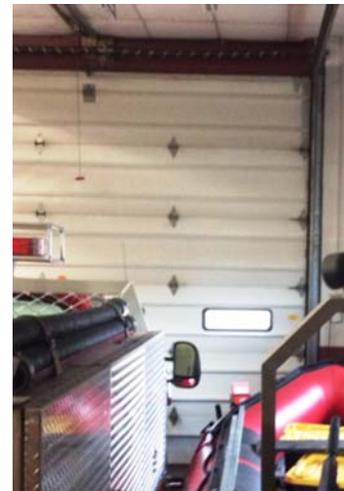
The three overhead doors are un-insulated and do not have weather-stripping. Replace doors with insulated doors with weather-stripping.
