# PERCHLORATE TREATMENT BUILDING

19 Nutting Road

Year Constructed: 2011  
Year of Renovation/Addition: NONE  
Building Type: F-2  
Construction Type: V B  
Fire sprinklers: No  
Total Floor Area: 1,400 SF  
Floors: First  
Assessor Lot # 068 0001 0000

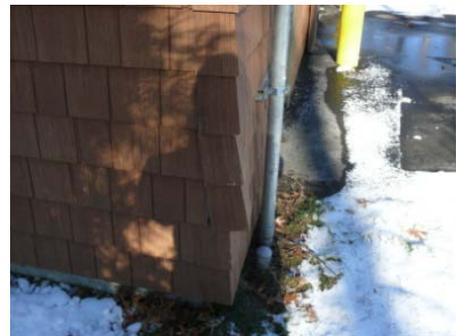
3 One section of corner trim has become loose and needs to be re-installed.

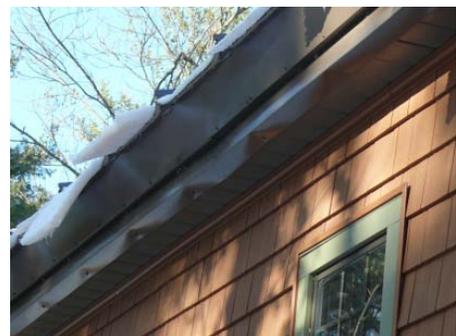
3 Metal soffit/fascia trim has been secured with nails that are not allowing expansion/contraction of the metal resulting in oil-canning. Metal should be re-secured using screws with washers through oversized holes in the metal trim.
