NUTTING ROAD TREATMENT PLANT

17 Nutting Road

Year Constructed: 2010
Year of Renovation/Addition: NONE
Building Type: F-2
Construction Type: V B
Fire sprinklers: No
Total Floor Area: 6,000 SF
Floors: First
Assessor Lot # 068 0001 0000

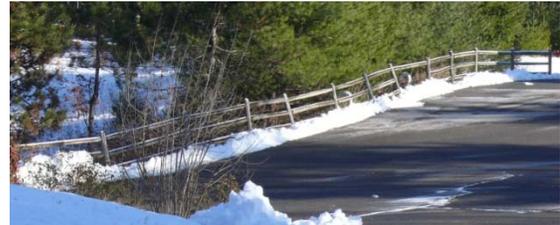
- 3 Fence along driveway is leaning and one rail is missing. Straighten fence and replace rail.

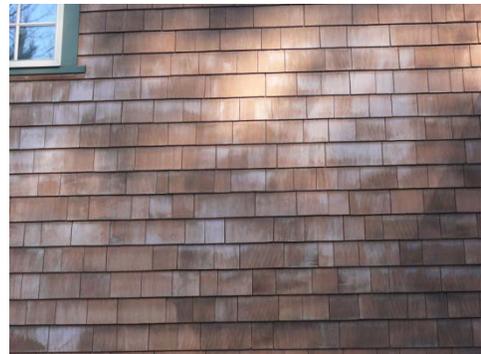
- 3 The cedar shingles are exhibiting a white bloom on the surface, similar to efflorescence on brickwork. This is a result of high salts in the building materials, typically attributed to poor storage directly on the ground, instead of being raised up on pallets, during the process of manufacture or installation. We recommend that the condition be monitored and, if detrimental to the appearance of the building, the wall be lightly power washed with an application of very dilute muriatic acid. Small areas of the wall should be tested to ensure that the solution used will not cause damage.

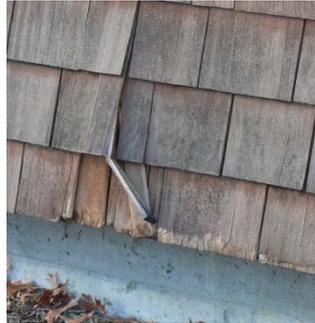
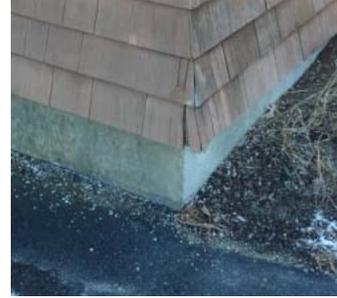
There is some minor damage to shingles adjacent to the loading dock driveway and on the street side of the building (possibly cause by an animal). Replacement of about twenty shingles is required.

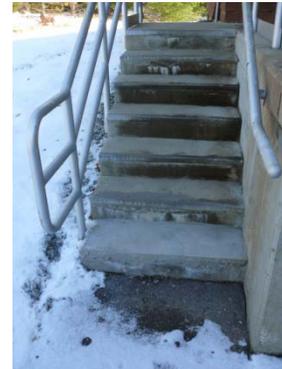
Some repairs have been made to the steps by the loading dock but the deterioration of the concrete continues, probably from rusting rebar. Front of steps will need to be removed along with nosings, rebar replaced with epoxy coated bar, and concrete replaced with a patching material.
