PARKERVILLE SCHOOLHOUSE

110 Carlisle Road

Year Constructed: 1880
Year of Renovation: 1989
Building Type: A-3
Construction Type: VB
Fire sprinklers: No
Total Floor Area: 2,335 SF
Floors: Basement and First.
Assessor Lot # 012 0101 0000

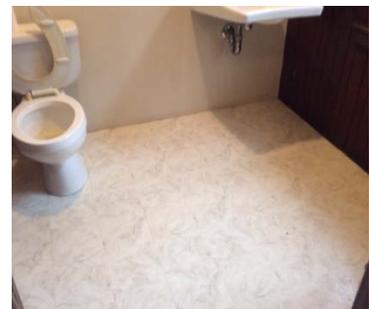
- Accessibility is limited by the historic nature of the building. It appears that reasonable accommodations have been made for access to the building. We advise that a variance be obtained from MAAB to obtain their approval of the current conditions.
- 3 ADA accessible rest room has not grab bars installed. Recommend installing grab bars per ADA code.

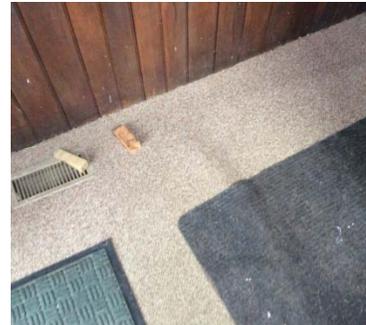
- 2 Remove loose carpeting from entrance lobby that could be a tripping hazard. It is loose and buckled and should be removed from the floor or be better secured to eliminate tripping.

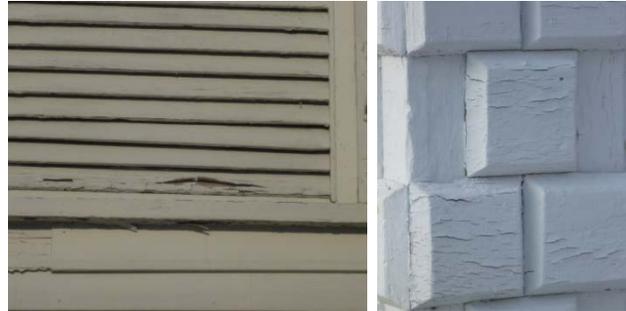
- 3 Exterior paint cracking, peeling and chipping, recommend scraping and painting all exterior wood finishes.

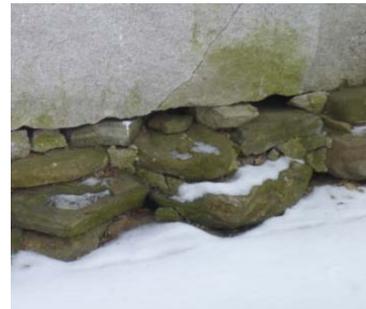
- 2 Pointing the rubble foundation and granite blocks on both the interior and exterior should be done to strengthen the foundation walls and resist further movement. Cracks in the granite blocks should also be pointed to resist water infiltration and freeze-thaw cycles.

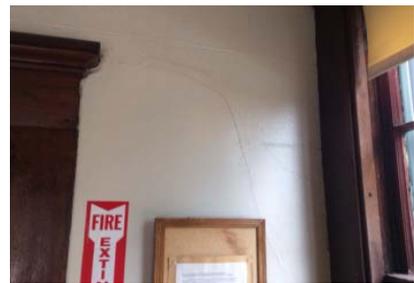
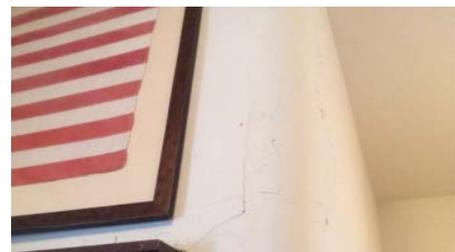
- 3 The plaster, that has been scored to look like stone is damaged and has some cracks. Entry Vestibule, Restroom and Classroom walls no longer shows the lines of the scoring. Following investigation of the paint color history, paint should be stripped to better show the scoring and where plaster is repaired scoring should be duplicated. There is also a crack approximately four feet long that needs to be repaired. As described above paint should be stripped prior to repair and re-applied in the original color after completion of the plaster work.

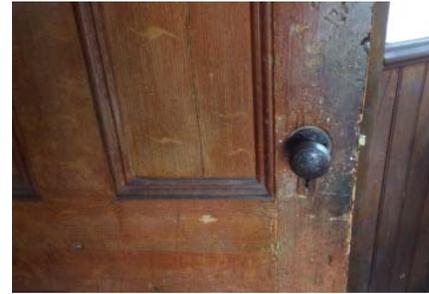
3 Historic door knobs should be tightened if possible.

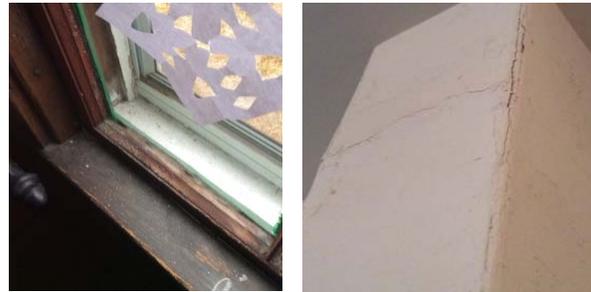
3 Windows need to be stripped and repainted to maintain integrity.

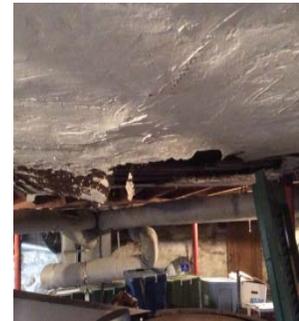
3 There is approximately 140 SF of plaster ceiling in the Basement that needs to be removed.

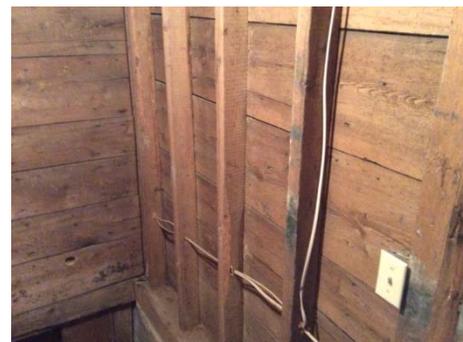
3 Blocking should be installed between all rafter and joist bays at bearing points in the attic and the first floor framing. These locations should also receive hardware (Simpson Strong-Tie) to reinforce the framing connections, stabilize the wood rafters and joists and resist wind uplift. The column cap plates in the basement should be anchored to the underside of the heavy timber girder.

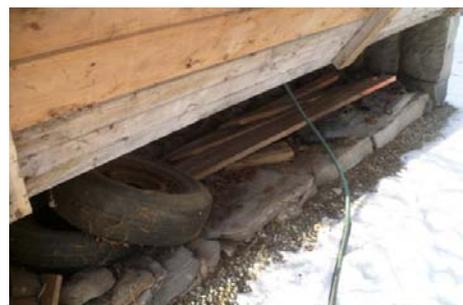
3 A concealed enclosure with insulation should be added to the underside of the outhouse to protect against the weather.

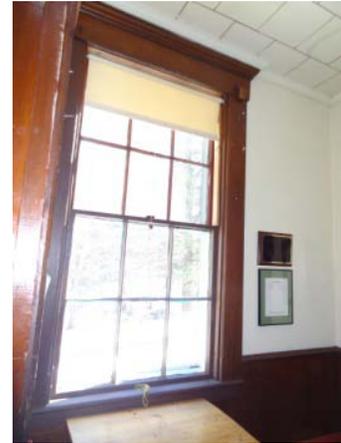
- 3 Windows do not appear to be weather-stripped. Add concealed weather-stripping to windows.
- 3 It is assumed that the exterior walls are without insulation. Insulate exterior walls.
- Replace furnace to a high efficiency type. See note below
