POLICE STATION

53 Main Street

Year Constructed: 1999
Year of Renovation/Addition: None
Building Type: B
Construction Type: IIC
Fire sprinklers: Yes
Total Floor Area: 30,875 SF
Floors: First, and Second.

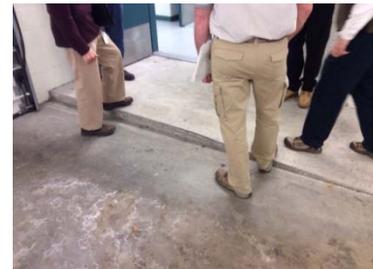
- 2 The ramp in the sally port, Slope was not verified but if the slope exceeds 1 in 12 handrails will need to be added. Step at edge can be difficult when escorting suspects into the cell area so a slope should be added to that side.

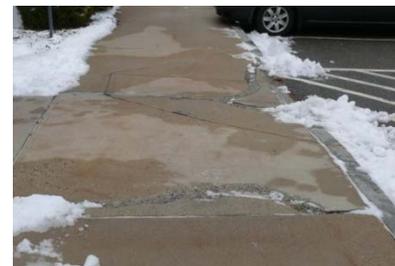
- 2 Areas of surrounding sidewalks have deteriorated, been patched, and are in need of repairs again. It is recommended that the damaged areas be cut out, retaining the re-bar, such as to prevent a tapered edge to the patch, and a bonding agent be applied to the existing concrete prior to patching.

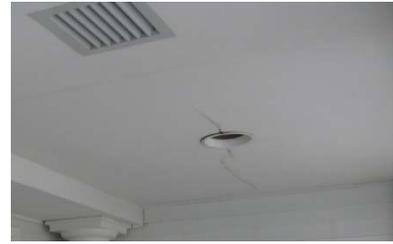
2 Flat roof drain connects to downspout and as a result leaks above the canopy ceiling. Replace roof drainage system above ceiling and to points of connection to underground system in four locations. Replace ceiling.

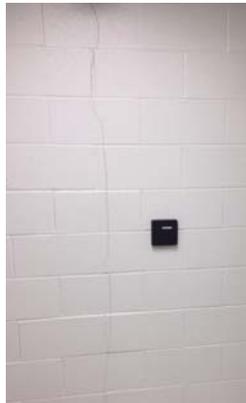
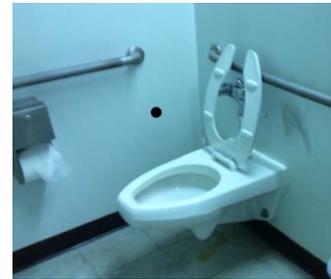
4 The vertical cracks in the CMU in the Sally port and gun range should be repaired with caulking for aesthetics and to resist water infiltration through exterior walls.

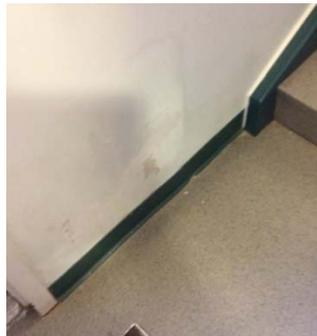
3 At Stair 11 drywall is damaged at the exterior door and the door frame has started to rust. Repair wall and re-finish door frame.

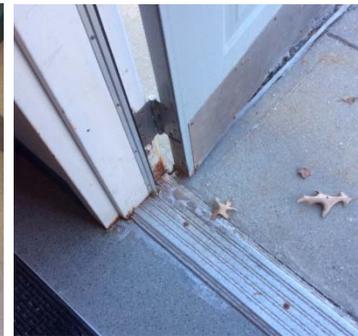
3 At Stair 12 exterior door and frame have started to rust and the door sticks when cold. Refinish door and frame and adjusted to prevent sticking.
