# ROGERS FIRE STATION

39 Town Farm Road

Year Constructed: 2000  
Year of Renovation/Addition: None  
Building Type: B/S-2/R-2  
Construction Type: IIIA  
Fire sprinklers: Yes  
Total Floor Area: 9,912 SF  
Floors: Basement, First and Mezzanine.

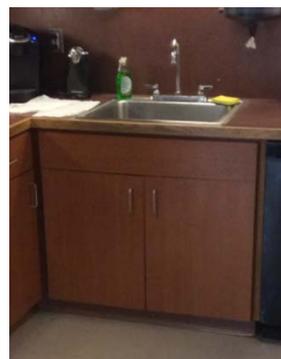
- 3 Water cooler is flush to wall and is not ADA compliant. Replace unit with dual height water cooler.
- 3 Sink in kitchen area of Dayroom does not have required knee space. Replace cabinet and sink to achieve ADA compliance.

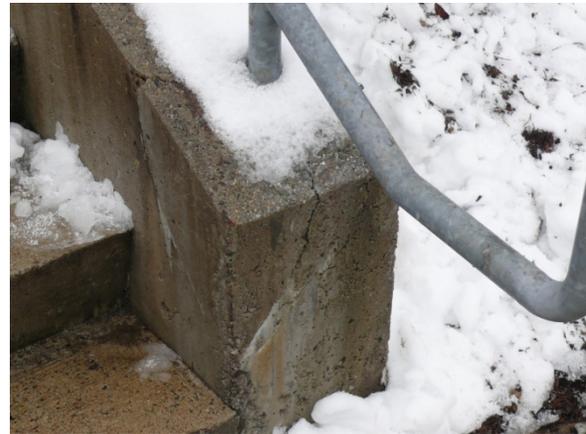
- 4 Concrete cheek wall at stair are cracking probably due to lack of expansion space around stair railings. Remove railing and enlarge holes, reset handrail with compressible material and sealant. Concrete to be repaired by reattaching section with epoxy or by patching entire area of loose material.

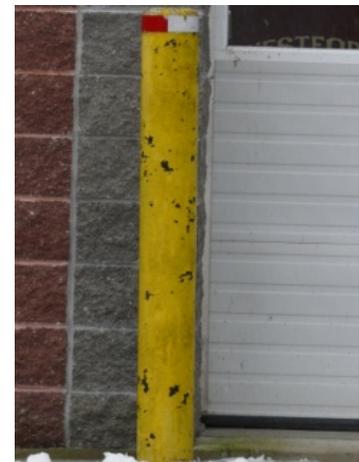
- 4 Bollards at garage door are starting to corrode and need to be re-painted.

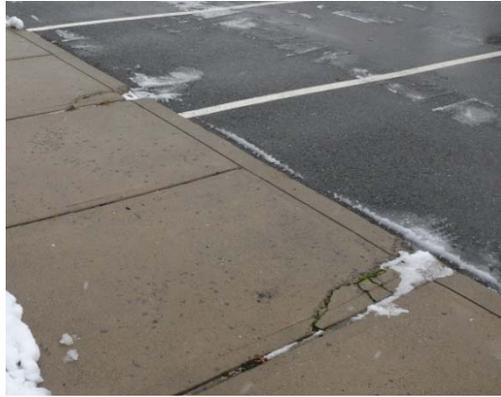
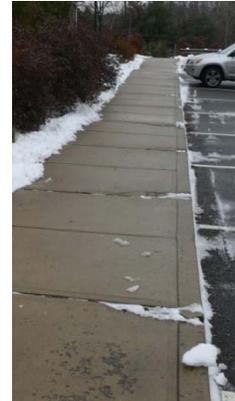
Concrete sidewalks between building and parking area on upper level are failing consistently along length of sidewalk. Remove loose material to sound concrete. Saw cut joint and patch concrete.

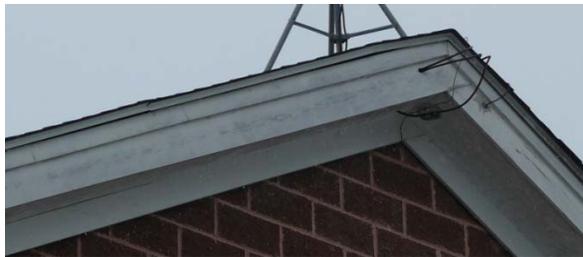
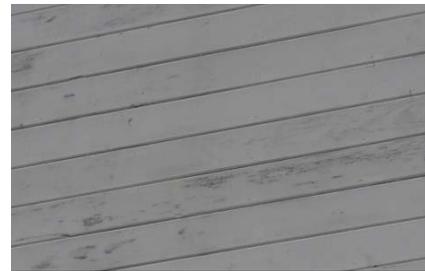
Siding and building trim is stained with mildew and paint is worn. Wash siding and trim and re-paint.

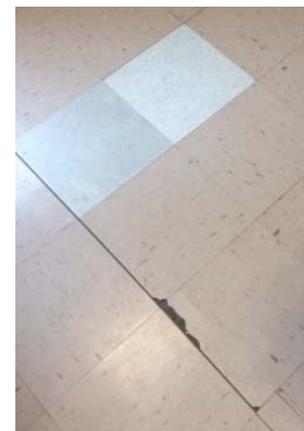
Vinyl composition tile is cupping. This can be exacerbated each time the floor is stripped. The floor may require replacement or replacement of isolated tiles. It is recommended that tiles matching the floors be purchased to facilitate replacement as needed.

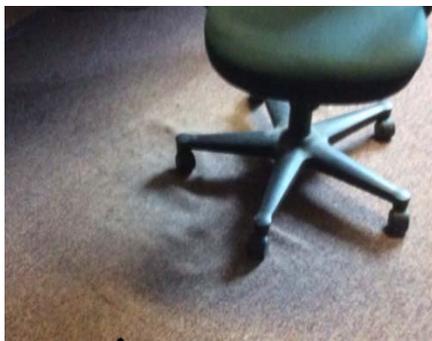
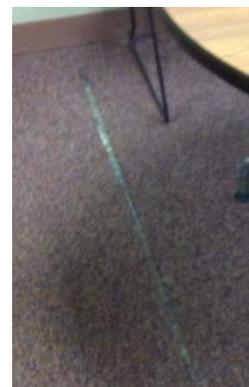
- 3 Carpet under chairs is worn and should be replaced. It is also recommended that plastic carpet protectors be provided for each chair. Also carpet in Training room has failed and needs to be replaced.

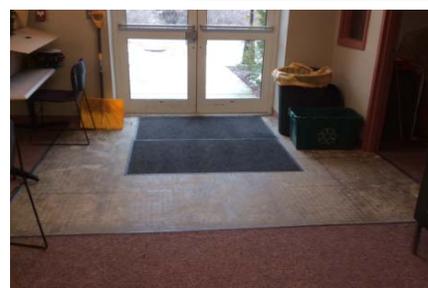
- 3 Walk-off mat (8'x10') in Training room is missing and needs to be replaced.

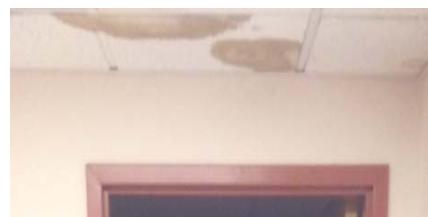
- 4 Replace stained ceiling panels in Training room.
