ROGER'S FIRE STATION STORAGE BARN

39 Town Farm Road

Year Constructed: 1920
Year of Renovation/Addition: None
Building Type: S-2
Construction Type: IV
Fire sprinklers: No
Total Floor Area: 3,500 SF
Floors: First.
Assessor Lot # 024 0022 0000

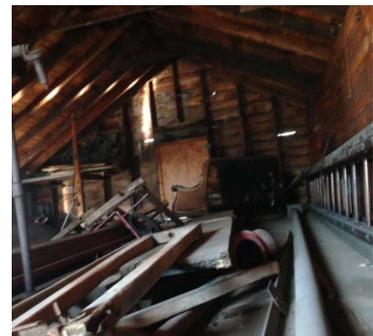
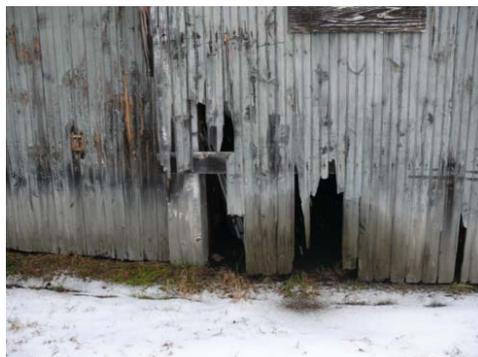
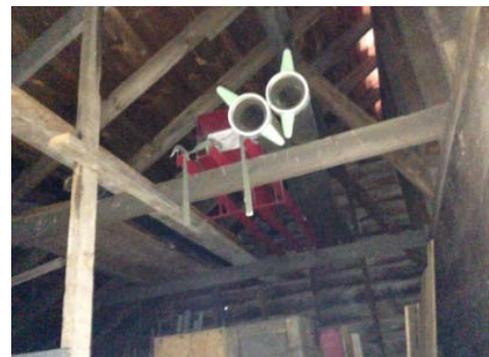
2 The building is in a state of disrepair. The exterior cladding and roofing need to be replaced, along with other efforts to enclose the building. The windows, gutters and downspouts should be replaced. A concrete slab on grade should be placed at the first floor to resist pest infestation and water infiltration.

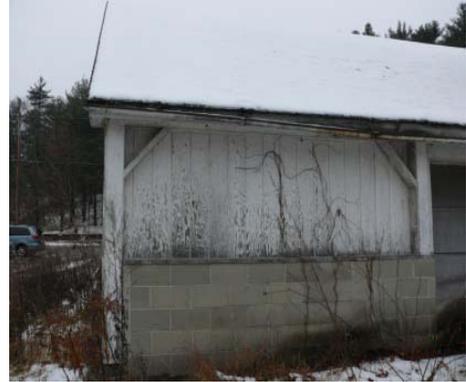
The voids in the CMU wall at the rear of the building need to be repaired and provided with positive attachment to the wood structure. This needs to include tie downs and bolts. Further investigation would be required to determine if the CMU is reinforced.

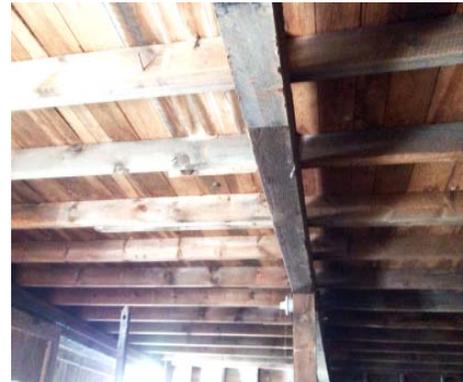
The unsupported joist in the attic framing should be sistered. Blocking needs to be installed between the joists to provide stability to the framing. The wood framing connections should be reinforced with metal plates (Simpson Strong-Tie) and anchored well to the foundation. The existing wood posts should be replaced with concrete filled steel lally posts that probably need new foundations. Further investigation is required to determine the condition of the foundations, which were not exposed to view at the time of this assessment.

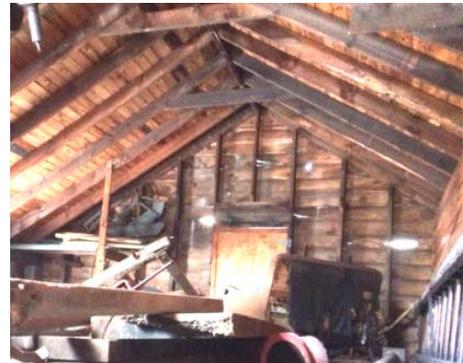
The roof needs to be reinforced, including structural ridge beams, transfer beams, new concrete filled steel lally posts (see above) and spread footings.
