# RECREATION AND SCHOOL STORAGE BARN

39 Town Farm Road

Year Constructed:  
Year of Renovation/Addition:  
Building Type: S-2  
Construction Type: VB  
Fire sprinklers: No  
Total Floor Area: 3,500 SF  
Floors: Main, Basement/Garage .  
Assessor Lot # 024 0022 0000

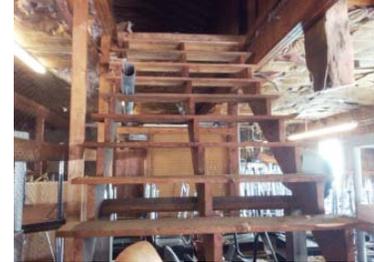
- 2 Low headroom extends over the stair to the attic. Similarly, the overhead door track extends over the stair creating a headroom problem. Both of these situations are dangerous. The wide stair should be replaced with a narrow stair to avoid the low headroom areas.

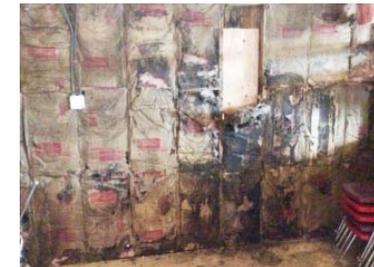
- 2 Wall and ceiling insulation is badly deteriorated and could be unhealthy. In its exposed condition is may be infested with rodents. Further investigation is required. If discovered insulation will need to be removed and walls sanitized. Also see "Energy and Water Conservation" below.

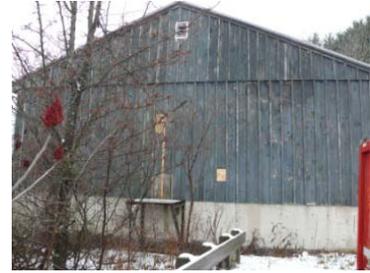
2 The board and batten siding is split and damaged in locations and exposed unfinished wood is evident throughout. Replaced damaged and patched boards, battens, fill missing knots and repaint building. Also repaint soffits and fascia.

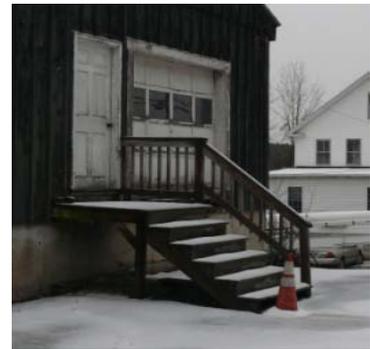
2 Stair to first floor has only one handrail/guardrail. Add new railing with handrails on both sides. Add inverted clapboards to stair risers to eliminate projecting nosings and re-paint stair.

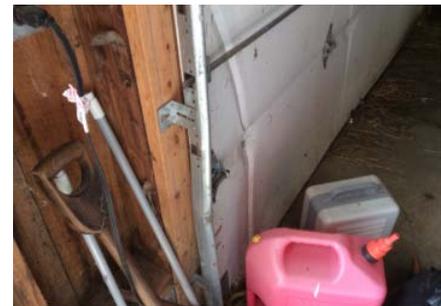
3 Dented overhead door and track on lower level. Replace damage sections of track and door panels.

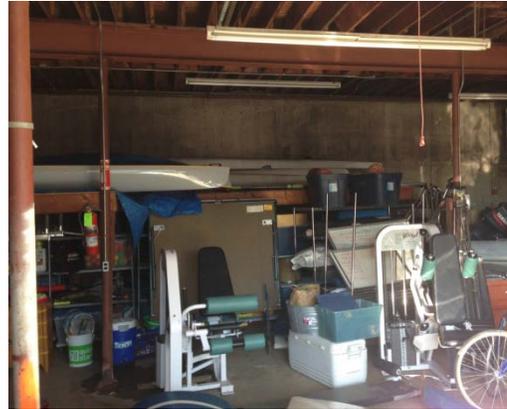
3 The first floor steel beams need to be stabilized to resist rotation, especially at post locations. This would entail cutting the steel beams at post locations, installing new structural steel posts, and reconnecting the steel beams to the steel posts. The column bases exhibit excessive corrosion due to water. Replacement of the columns, base plates, and anchors needs to be a priority.

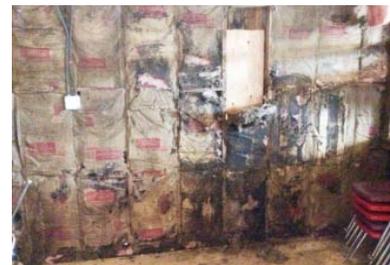
Wall insulation is exposed and badly deteriorated. Insulation should be also be inspected for mice. Insulation should be replaced with spray-foam insulation to achieve a minimum R=20. Refer to Health section above.

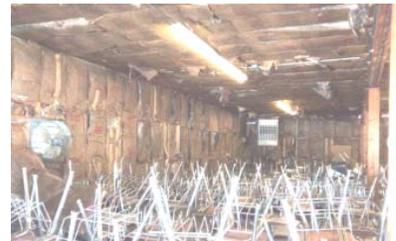
3 Roof is un-insulated. Add spray-foam insulation to rafter space to achieve a minimum of R=38. Note that attic floor is insulated but attic space is open to the first floor below. We recommend that the attic floor insulation be removed.

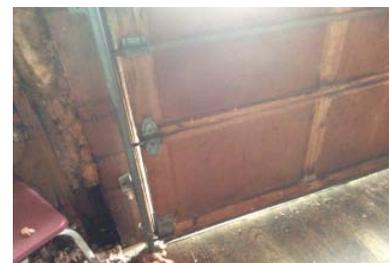
Add weather-stripping at overhead doors.
