# TOWN HALL

55 Main Street

Year Constructed: 1850  
Year of Renovation/Addition: 2010  
Building Type: B  
Construction Type: VB  
Fire sprinklers: Yes  
Total Floor Area: 12,000 SF  
Floors: Basement, First and Second

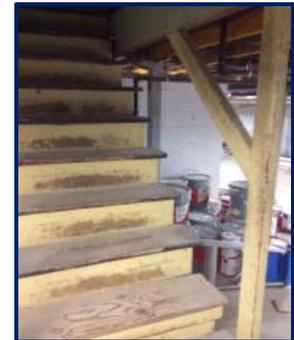
- 2 There are no guardrails on stair from Basement. only handrails. Add guardrails and handrails to stair.

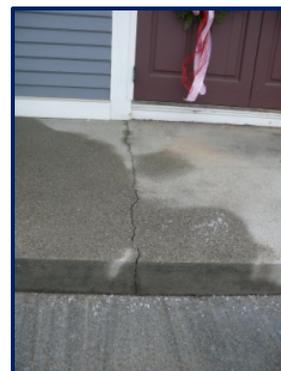
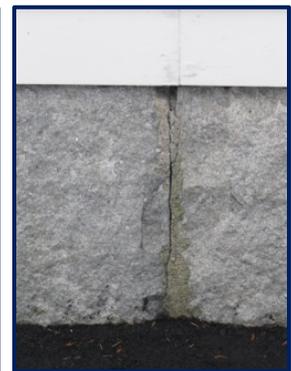
- 3 Hairline cracks are present in some of the granite foundation mortar joints and mortar has started to deteriorate. Remove damaged joints and add sealant with backer rod.

- 3 Slab in front of front entrance is cracked. Cut out crack in a straight line and add sealant joint.
