WATER DEPARTMENT GARAGE

63 Forge Village Road

Year Constructed: 1975
Year of Renovation/Addition: NONE
Building Type: S-2
Construction Type: II B
Fire sprinklers: No
Total Floor Area: 7,426 SF
Floors: First
Assessor Lot # 025 0010 0000

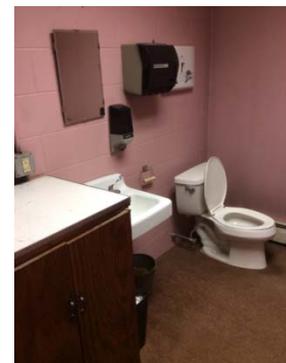
- 2 Restroom is carpeted that needs to be replaced with a hard surface floor such as vinyl tile.

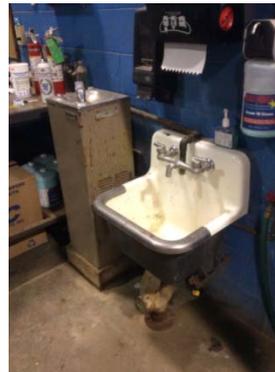
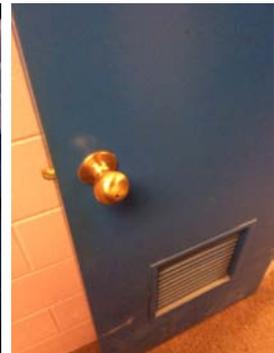
3 Restroom is not ADA compliant and should be reconstructed to meet accessibility standards.

3 Doors have knobset hardware that needs to be changed to lever type hardware.

3 Some doors are too narrow and should be replaced with 3'-0" wide doors.

2 The water cooler is not accessible and should be replaced and relocated. New unit should be a dual height electric water cooler.

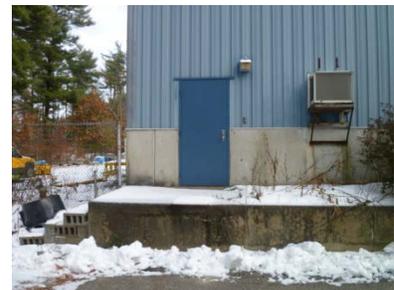
3 Guardrail needs to be added at raised platform on south side of building. New permanent steps need to be constructed to replace the stacked blocks. Handrails need to be added to the new steps.

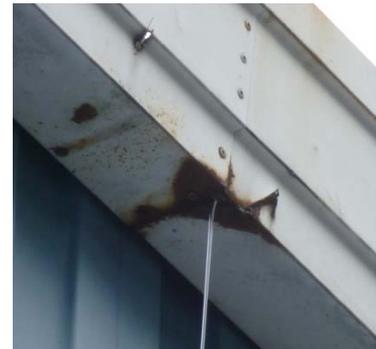
3 Seams between gutter sections are rusting and leaking. Clean gutters, remove rust and repaint at joints. Add mastic to joints to prevent further leaks. Gutters are also missing downspouts that splash water down the face of the building and need to be replaced.

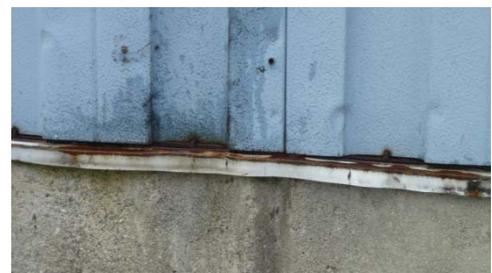
3 Metal drip between siding and foundation has been damaged and is rusting. Remove rust, and repaint.

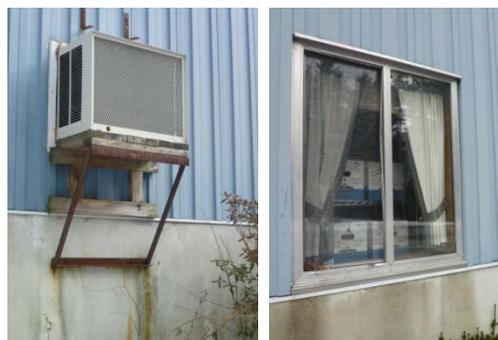
3 Windows are single glazed and should be replaced with low-E insulated glass windows.

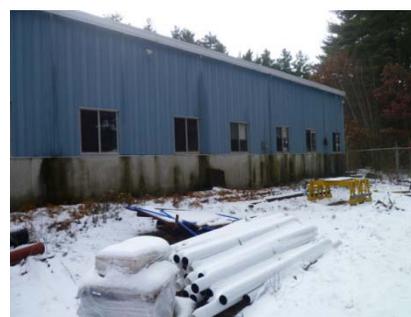
3 Through wall A/C unit needs to have support frame cleaned of rust and re-painted.

3 Foundation wall is badly stained with moss where gutters missing. Once downspouts are added, power wash foundation wall.

3 Vertical cracking in various areas of the perimeter foundation wall require caulking to prevent water infiltration.

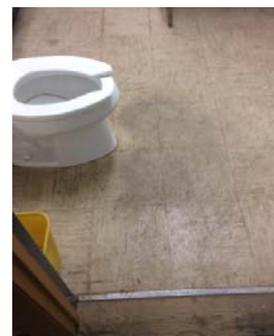
3 Carpet is present in the meter room. This is an inappropriate material for the use of the room and should be replaced with a vinyl tile floor.

3 The floor to the toilet room on the Mezzanine needs to be replaced.

3 We would recommend anchoring the railing to the mezzanine structure in lieu of the roof structure.
