CAMERON SENIOR CENTER

20 Pleasant Street

Year Constructed: 1872
Year of Renovation/Addition: 2010
Building Type: A-3
Construction Type: VA
Fire sprinklers: Yes
Total Floor Area: 15,288 SF
Floors: Basement, First and Second

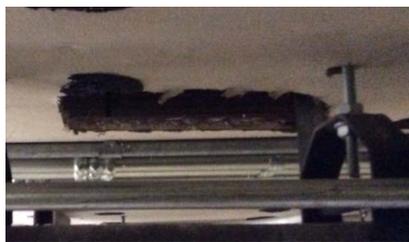
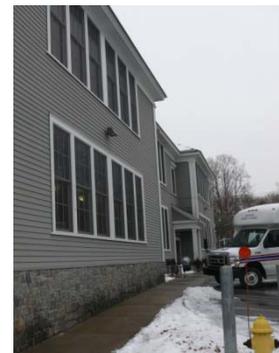
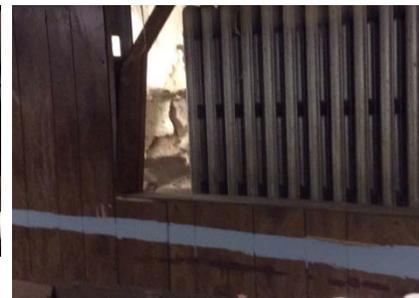
2 Holes in basement ceiling need to be patched to cover wood framing to prevent potential fire in concealed space.

3 Chase walls at perimeter of basement is not fully enclosed with drywall but does have metal studs. Complete enclosure of walls.

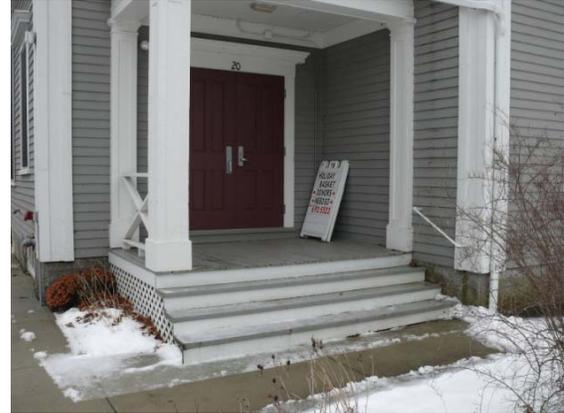
- 3 Egress steps (2 sets) at front of building do not have ADA compliant handrails on both sides. These need to be added.

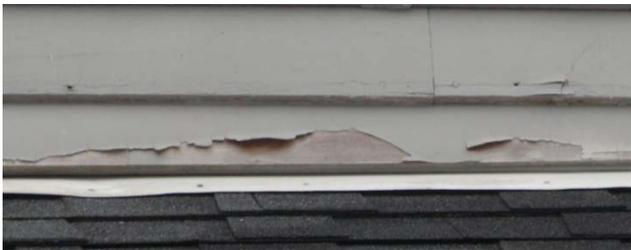
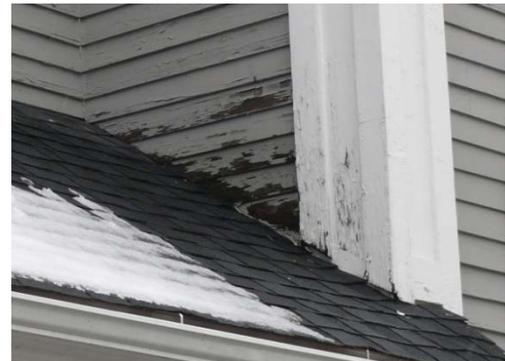
- 3 Small pitched roofs at first floor are causing deterioration of adjacent siding on slope. Remove paint down to bare wood and add consolidant to wood before re-painting.

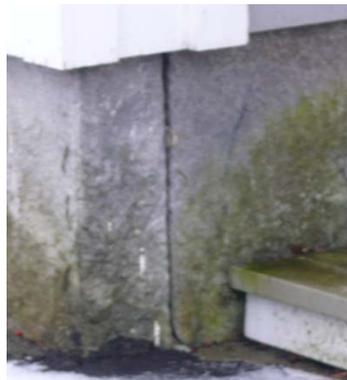
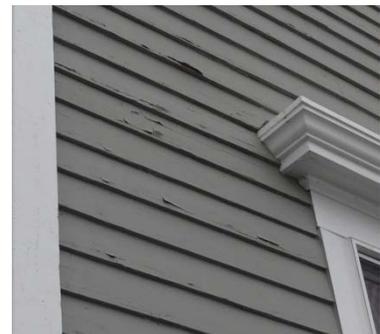
- 3 Some areas of siding are starting to peel. Scrape and re-paint these isolated areas.

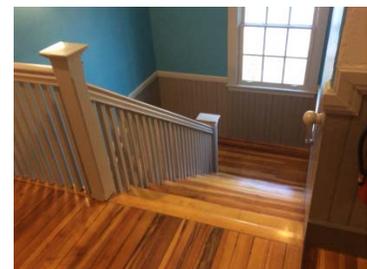
- 4 On the top landing at north stair the floor is not properly secured. Re-attach floor.
