CENTER FIRE STATION

51 Main Street

Year Constructed: 1974
Year of Renovation/Addition: None
Building Type: B/S-2(R-2)
Construction Type: VB
Fire sprinklers: No
Total Floor Area: 6,825 SF
Floors: First, and Second.

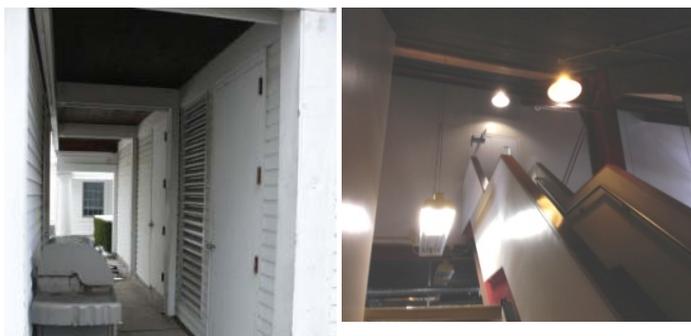
- 1 Open exit stairs are used from the dorm rooms on the second floor and discharge into the equipment bays in violation of the code. To overcome these life safety concerns the south stair needs to be enclosed with one hour fire rated construction to fully separate it from the equipment bays. The stair enclosure should extend to the

exterior door. Any exposed wood covered with sheetrock. The wood ceiling in the exterior hall should be covered with exterior sheetrock and construction of the passageway upgraded to provide a 1 hour fire rating.. Any structure (steel beams, columns and rod hangers and braces) supporting the stair need to be fire-rated to 1 hour. Without fire sprinklers an area of refuge is required.

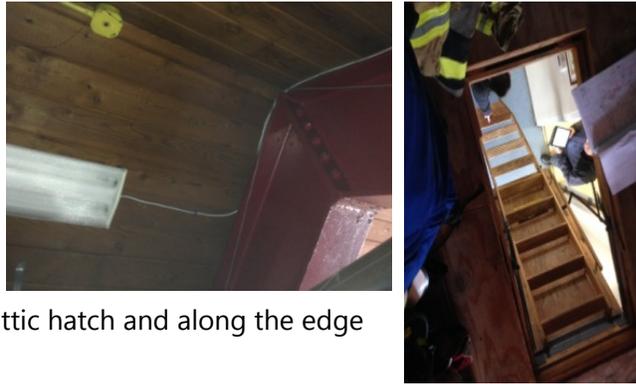
- 2 Wood ceilings exist throughout the equipment bays. These should be replaced with gypsum wallboard as the space is used as an exit route from other parts of the building and should therefore have a Class "B" finish.

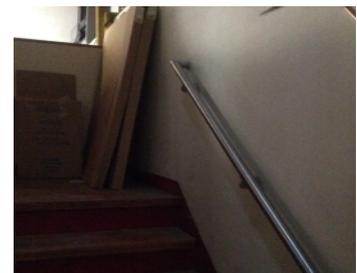
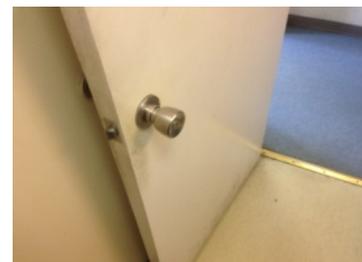
- 3 Stairs do not have ADA compliant handrails which need to be added.
- 3 Stairs have projecting nosings. Wood fillers need to be added to provide a smooth transition between the riser and the tread.
- 3 Doors throughout building have knobsets that need to be changed to lever style hardware.

3 Doors have insufficient clearance on the pull side of the door that needs to extend over the wall surface adjacent to the strike. Entrance should be reconstructed to achieve clearances but to correct the remainder of doors would be "technically infeasible" without re-constructing many of the doors and walls.

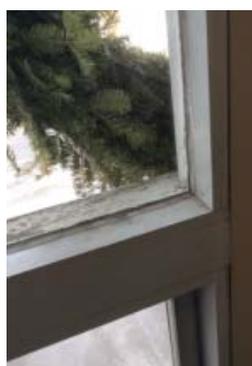
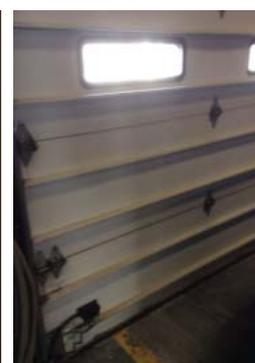
- 3 Overhead doors are un-insulated. Replace with new insulated doors.

- 3 Windows are single glazed and should be replaced with new insulated, low-E glass windows.
