HIGHWAY FACILITY

28 North Street

Year Constructed: 2006
Year of Renovation/Addition: None
Building Type: B/S-1
Construction Type: IIB
Fire sprinklers: Yes
Total Floor Area: 71,000 SF
Floors: First and Second.

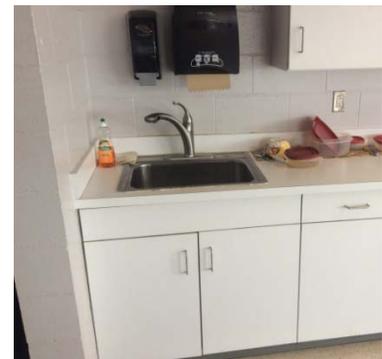
3 Kitchen and second floor lunch room sink not ADA compliant. Change sink and cabinet to meet ADA.

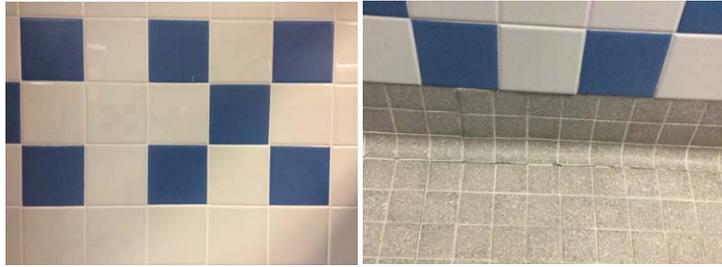
- 3 The wall behind urinal and floor tile in main floor men's room is cracked. Crack tiles should be removed and new tiles installed.

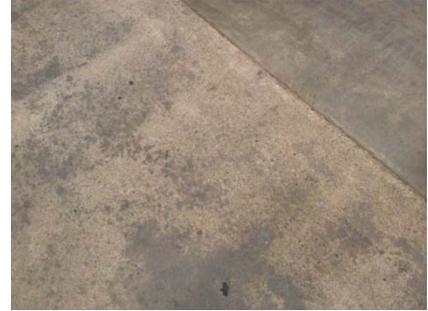
- 2 We observed moderate damage to the surface of the concrete slab on grade within the middle driving lane. This damage is due to wear and tear in combination with water and salts from the trucks. It appears that the damage was accelerated by heavy vehicle rear axles skidding across the surface. The damaged areas of concrete slab on grade should be repaired by cleaning any loose material, roughening the concrete, and adding cement material patch. It would be advisable to protect the wearing surface of the slab with a protective epoxy coating.

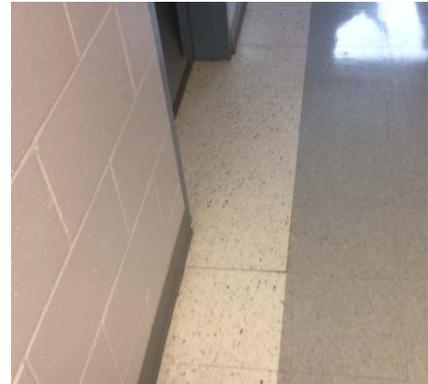
- 3 Second floor, floor tile adhesive is failing allowing tiles to lift. Replace affected areas with new tile.
