J. V. FLETCHER LIBRARY

50 Main Street

Year Constructed: 1895
Year of Renovation/Addition: 1963,1969,
1988
Building Type: A-3
Construction Type: III B
Fire sprinklers: No
Gross Floor Area: 22,456 SF
Floors: Ground, First and Second plus
attic.
Assessor Lot # 059 0018 0000

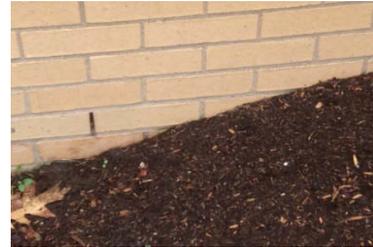
- 3 Rain leaders, in general, have been damaged where they enter the ground. Connector needs to be hammered out so as to not restrict the water flow.

- 4 It appears that mulch may be covering weep holes around the front of the building. Move mulch away from building to allow cavity wall to drain.

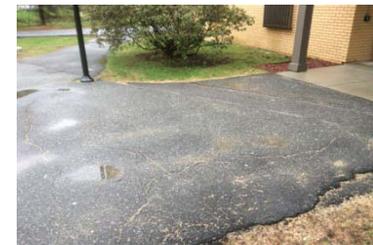
- 3 Bituminous walks adjacent to building are cracked and need crack filler added.

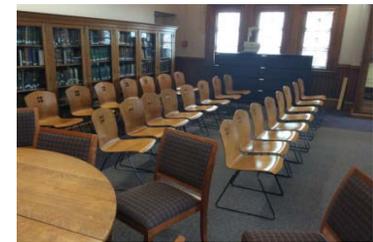
- 2 The floor of the third floor vibrates in one location. We were unable to observe the third floor framing at the time of the visit. Further investigation is required to understand and mitigate the unusual vibration due to footfall noted in the third floor. (Apparently, a supporting wall was removed in 1969)

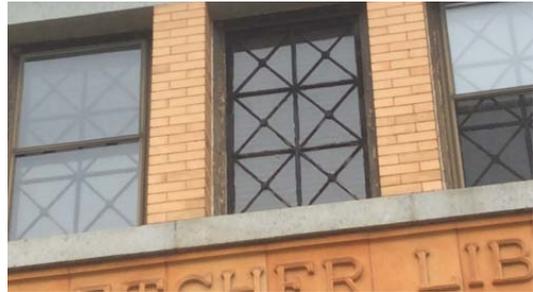
- 3 North Entrance does not have a vestibule allowing cold air deep into the building. A vestibule should be added.
- 3 Original build's windows are single glazed but only some have storm panels. Storm panels were missing and should be replaced
