Proj: Limited Structural Assessment of 12 North Main Street, Westford, RFQ #20-15
Re: Limited Structural Assessment Report
CBI Job No. CB200291

In accordance with our Contract, CBI Consulting, LLC, a SOCOTEC Company (CBI), has prepared this limited structural building assessment of the abandoned historic mill building located at 12 North Main Street in Westford, Massachusetts.

Limited Structural Assessment
12 North Main St., Westford, MA
Photo Index
CBI Job No.: CB200291
December 4, 2020

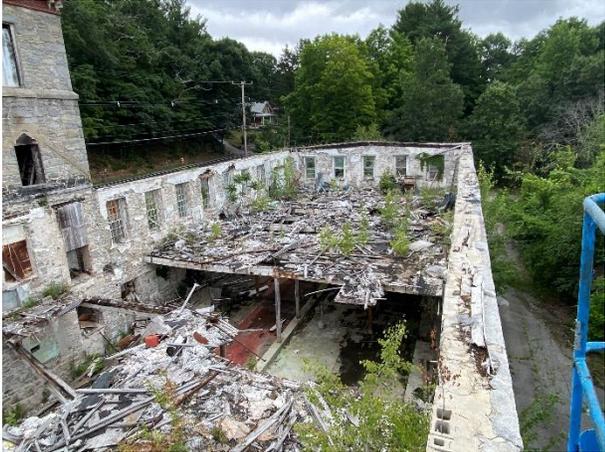
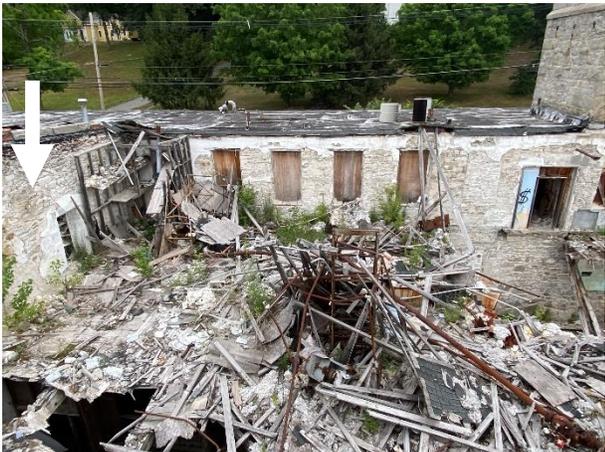
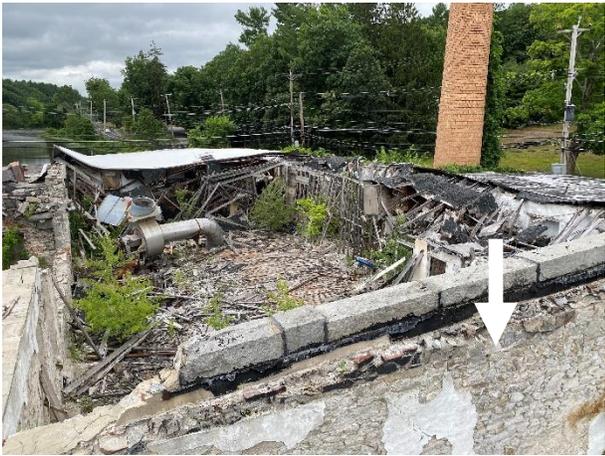
- The first-floor framing of the Central Mill was observed to be in poor condition and has been exposed to the elements since the previous stabilization efforts in 2015/2016. Based on the 'First Floor Stabilization' plan dated November 16, 2015, developed by Bargmann Hendrie + Archetype, Inc. (BHA), new 6"x6" and 8"x8" timber shoring posts were added to support the first-floor framing above in the Central Mill. Two (2) rows of timber posts were added beneath the midspan of each timber beam, on either side of the existing column line 'C' which runs in the east-west direction at the center of the Central Mill. CBI was unable to physically review the existing shoring, but from drone footage, the existing timber posts appeared to be in good condition.

CBI observed the original timber beams, and plank decking to be in poor condition and deteriorated with signs of wood rot and moisture damage. This is typical of the existing wood framing throughout the building.

| 6 | | Photo 1 of 3 – Partial overall photo of the east portion of the Central Mill first floor framing taken from a lift. |
| 7 | | Photo 2 of 3 – Partial overall photo of the east portion of the Central Mill first floor framing taken from a lift. Note the demising wall (arrow) separating the east and west sections of the Central Mill. |

| <p>8</p> | | <p>Photo 3 of 3 – Partial overall photo of the west portion of the Central Mill first floor framing taken from a lift. Note the demising wall (arrow) separating the east and west sections of the Central Mill.</p> |

- Once the central mill debris and have been safely removed from the site, CBI recommends a further evaluation of the first-floor framing to verify if there are any newly exposed areas that may require additional support for long term stability.

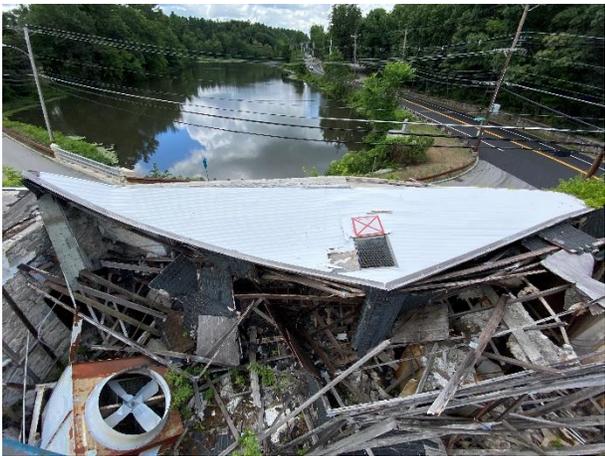
the 2015/2016 stabilization efforts. This is most notable in the area of the Central Mill to the east of the stone demising wall running north south. Based on previous reports and photos, a portion of the gabled roof to west, above Broadway St., was left in place during the stabilization efforts, and it is CBI's understanding that the gable end has since been purposefully pushed over into the interior of the building as it was determined to be a public safety hazard. These materials are still observed to be in place resting on the first-floor framing at the west end of the Central Mill.

| <p>9</p> | | <p>Close up photo taken from the lift showing the Central Mill roof system and gable end that was pushed over and resting on the first floor framing below.</p> |

- With an approved NTAWP, CBI recommends that the remaining materials and debris resting on the first-floor framing at the west end of the Central Mill be carefully removed and abated as specified in order reduce the excess load acting on the existing first-floor framing. The contractor is to be careful not to damage any of the existing first floor structural framing during this process. Additionally, the contractor shall safely remove and abate the materials and debris that will potentially impede or be touched by any personnel during the completion of the groundwater study. This includes contractors, consultants, and machinery. See Appendix B for conceptual work plan.

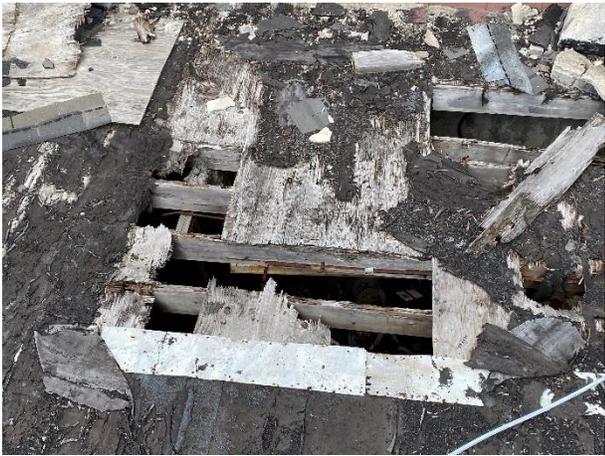
The roof systems on the North Addition and South Wing were observed to be in poor condition but are still intact, with exception to isolated areas, where the timber plank deck has deteriorated creating voids in the roof system. The roof covering the bell tower was observed to be in fair to poor condition.

| 14 | | Up close photo taken from the lift of one of the voids observed in the existing South Wing roof. |

- Provide Ice & Water Waterproofing roofing membrane over roof penetrations/failed roof locations to mitigate water infiltration to the interior of the building.

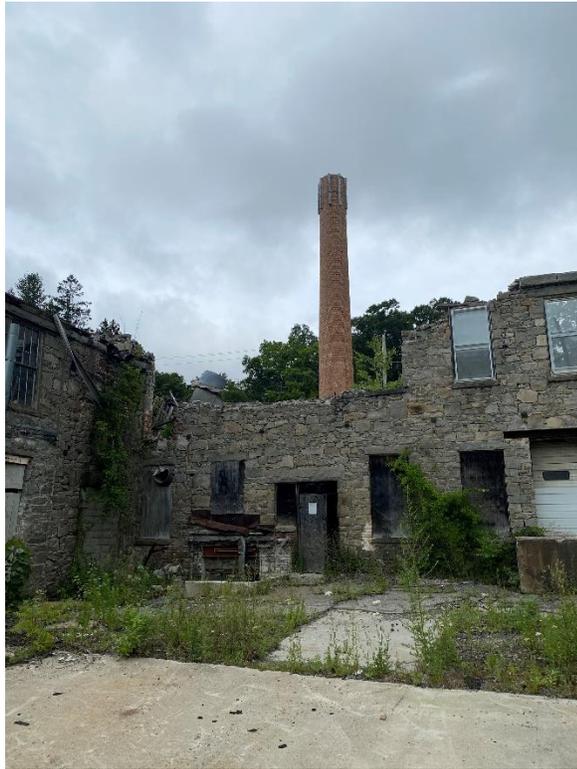
16

- At the south side of the building, where the south perimeter wall of the Central Mill meets the South Wing, the stone wall and brick masonry was observed to be deteriorated. This section of the wall, approximately 30 feet in length, appears to have collapsed down to the first-floor framing at some point since the previous stabilization efforts. The mortar at these areas was observed to be missing and has likely eroded over time due to exposure to rain, snow, and freeze thaw leaving some areas of the wall held in place by abandoned embedded steel that is showing signs of oxidation (rust).

Partial view of south elevation taken from the ground showing the section of wall that has collapsed. This wall is located at the intersection of the Central Mill south elevation and the South Wing east elevation.

- At the south side of the building, where the south perimeter wall of the Central Mill meets the South Wing, the stone wall and brick masonry was observed to be deteriorated. CBI recommends that all of the loose stone, masonry, and embedded steel on this section of the wall, which is approximately 30 feet in length, be removed.

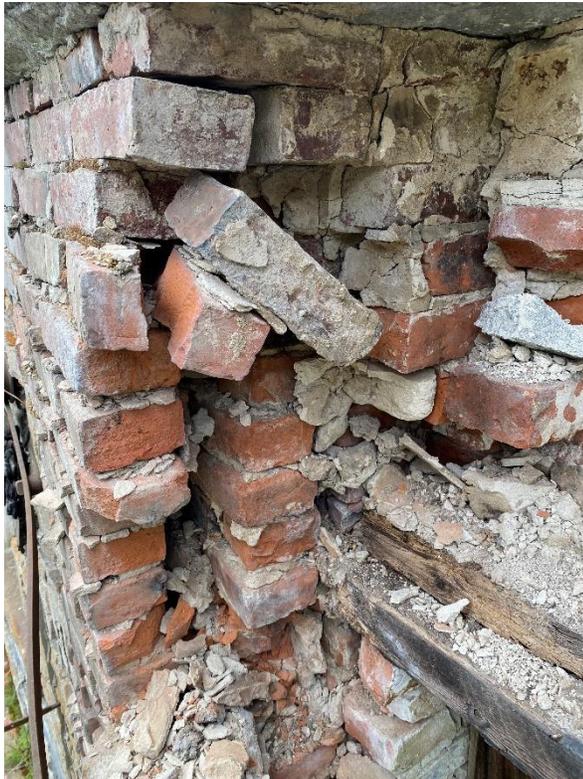
17

Photo 1 of 4 – Partial up-close view taken from the lift showing the collapsed wall on south elevation adjacent to the South Wing. Note the loose materials and debris that pose as potential fall hazards.

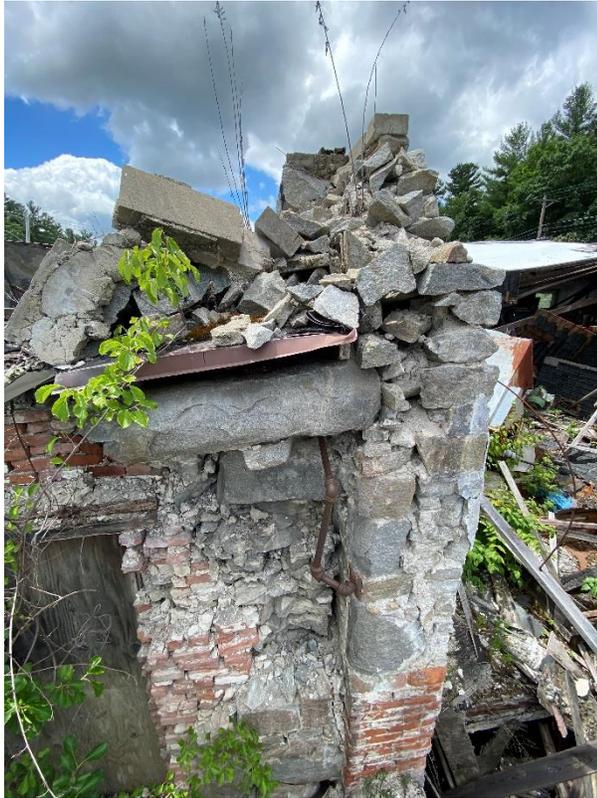
18

Photo 2 of 4 – Partial up-close view taken from the lift showing the collapsed wall on south elevation adjacent to the South Wing. Note the loose materials and debris that pose as potential fall hazards.

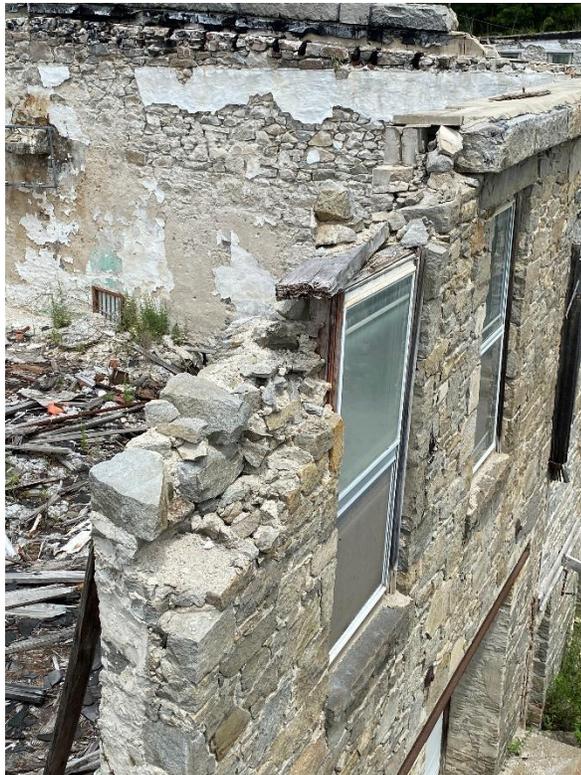
19

Photo 3 of 4 – Partial up-close view taken from the lift showing the collapsed wall on south elevation adjacent to the South Wing. Note the loose materials and debris that pose as potential fall hazards.

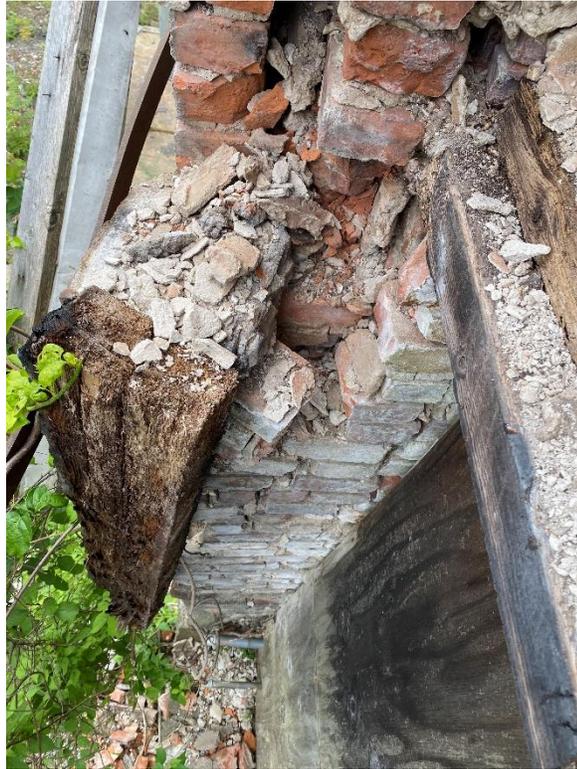
20

Photo 4 of 4 – Partial up-close view taken from the lift showing the collapsed wall on south elevation adjacent to the South Wing. Note the loose materials and debris that pose as potential fall hazards.

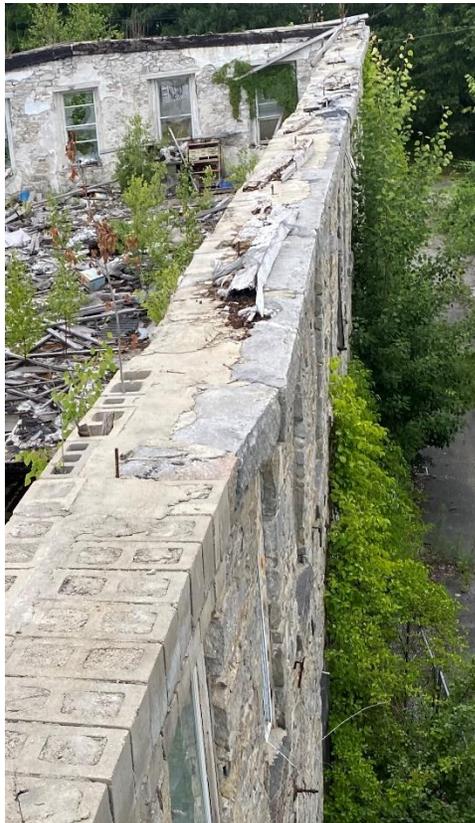
21

- A granite stone band was observed along the perimeter of the Central Mill stone wall. The stones were observed to be in good condition, but stones were observed to be missing in various locations, undermined by deteriorated mortar, and/or leaning to the exterior of the building and pose potential fall hazards.

Photo of the top of the Central Mill south wall where the existing granite stones were observed to be bowing to the exterior of the building.

- A granite stone band was observed along the perimeter of the Central Mill stone wall. The stones were observed to be in good condition, but the stones were observed to be missing in various locations, undermined by deteriorated mortar, and/or leaning to the exterior of the building and pose as a potential fall hazard. CBI recommends at a minimum that a layer of mortar be placed along the top of the Central Mill perimeter wall in order to temporarily secure loose stone and masonry construction until further repairs can be made. This section of the wall appears to have collapsed at some point since the previous stabilization efforts down to the first-floor framing.

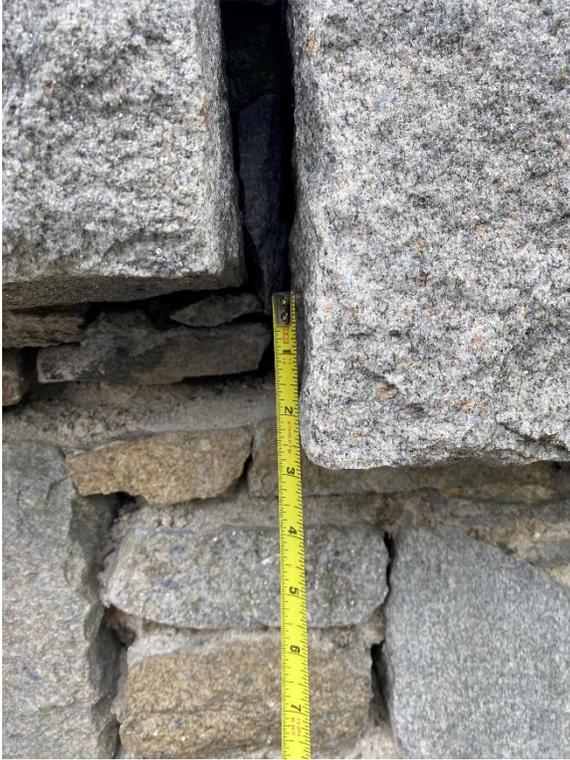
| 22 | | <p>Close up photo showing one of the granite stones at the top of the Central Mill south wall where the existing granite stones has been displaced approximately three (3) inches and appeared to be leaning away from the building. Note the sand like consistency of the remaining mortar.</p> |

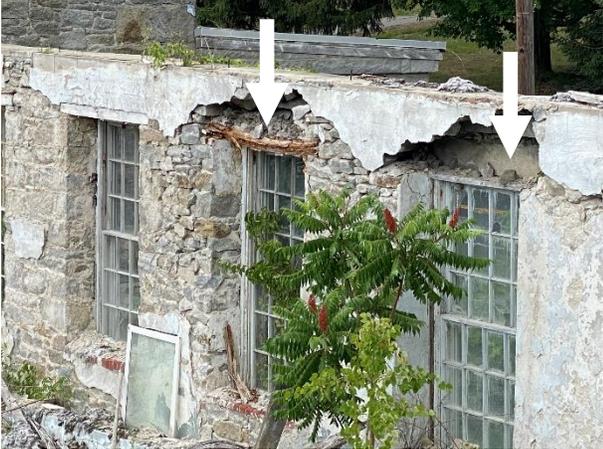
- The punched window openings were observed to be framed with a granite stone lintel above the window opening on the exterior of the building, and timber header beam on the interior. The timber headers were observed to be in poor condition and in many locations have deteriorated, which resulted in undermining and collapsing of the stone or masonry construction above.

| 23 | | <p>Photo taken from the lift showing one of the locations where the wood headers above the Central Mill punched window openings has deteriorated, undermining the stone and masonry construction above.</p> |

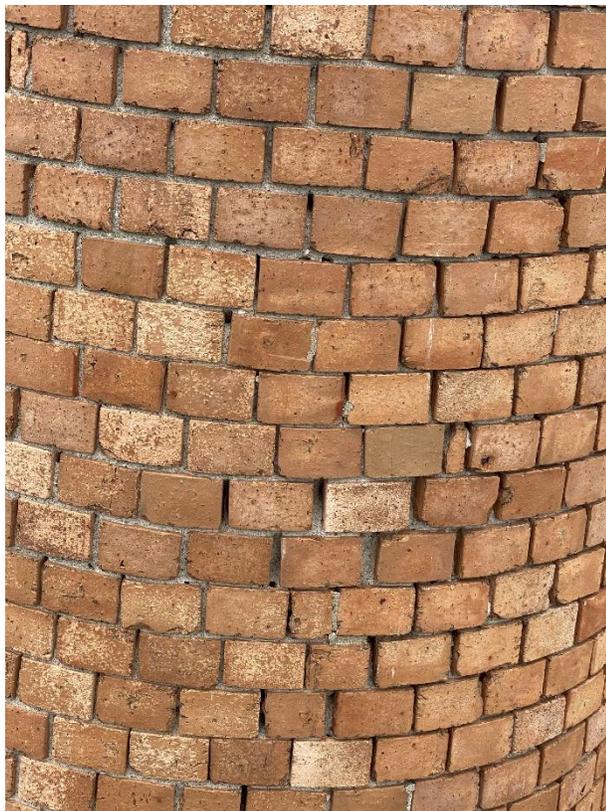
25

- Using drone footage, CBI observed that the interior and exterior mortar joints of the smokestack are severely deteriorated and missing in some areas.

Up-close photo of the Smokestack taken with the drone showing the deteriorated mortar joints.

- Engage a masonry contractor, and crane, to access the Bell Tower to remove or secure any materials that may pose as potential fall hazards. Additionally, the existing brick masonry smokestack requires deep mortar joint repointing from the exterior. Once the building has been determined safe for interior access, the interior of the Smokestack should also require 100% deep mortar joint repointing to ensure long term structural stability of the structure.

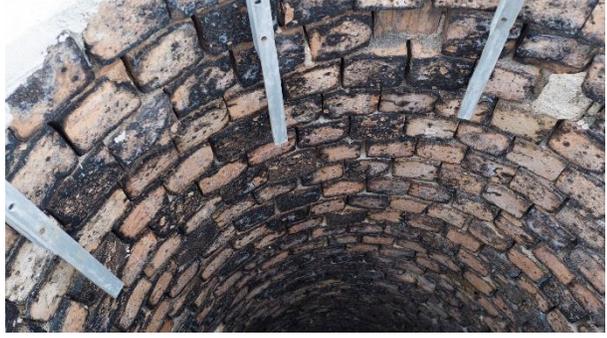
| 29 | | Interior photo 2 of 2 taken from the drone inside of the Smokestack. Note the deteriorated mortar joints. |
