STORMWATER MANAGEMENT MASTER PLAN

Volume 2: Long-Term Capital Improvement Plan

December 2018 - Revised February 2019

WESTFORD

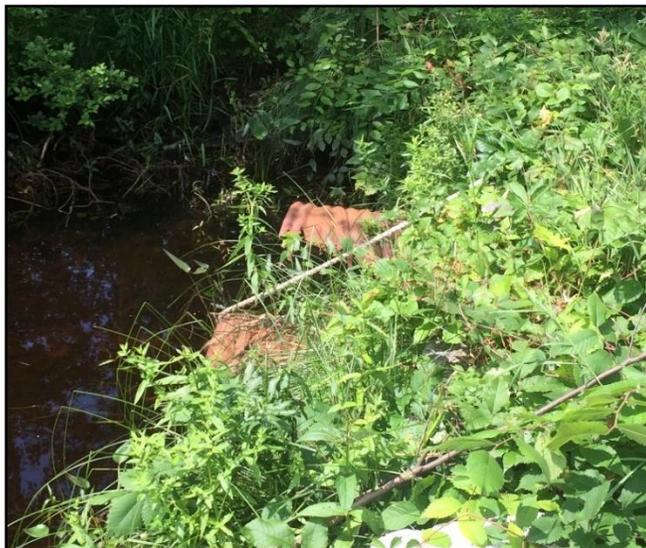
Figure 3-19 Example of Rusted and Broken Outfall at Keyes Road

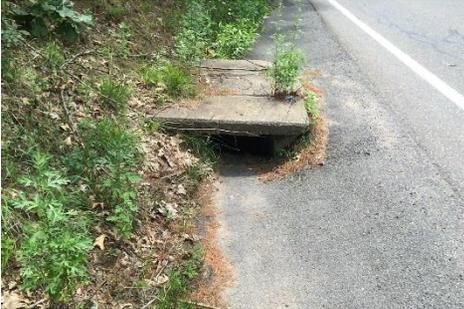
<p>There is an open paved swale with an outdated drop inlet that needs to be replaced with new catch basin with sump. Due to the current configuration, there are issues with debris buildup, and therefore there is some ponding and water backup.</p> <p>Source: Highway Department</p>	<p>Drainage Investigation/ Improvement:</p> <p>Improve mapping of drainage system in area, including swales, and replace inlet structure with a deep sump catch basin.</p>
2	<p style="text-align: center;">Forrest Road at Tyngsboro Road</p>

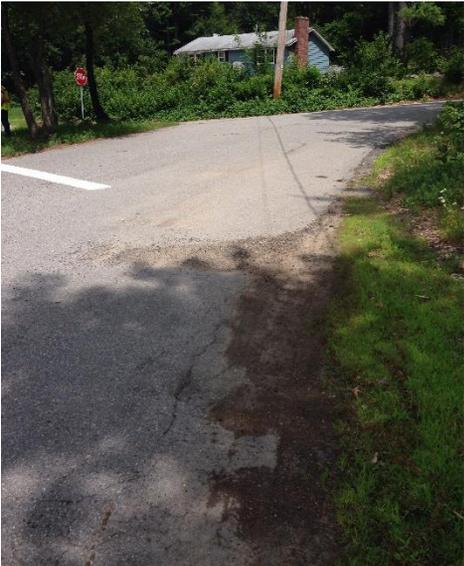
<p>There is an existing open drainage system that results in road flooding every Spring.</p> <p>Source: Highway Department</p>	<p>Drainage Investigation/ Improvement:</p> <p>Improve mapping of drainage in area including swales and other open conveyances, complete hydraulic and hydrologic modeling, and define conceptual improvements. May require survey and identification of easements.</p>

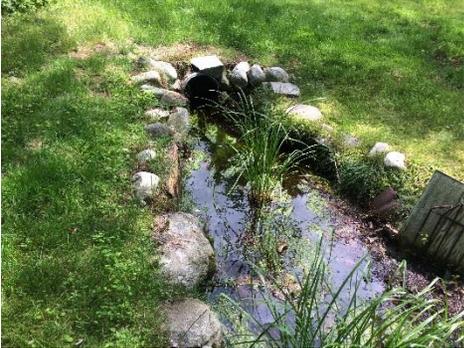
<p>This subdivision was installed with country drainage and ditches. Lack of maintenance and illegal dumping of yard waste have limited capacity of the system and resulted in road flooding every Spring.</p> <p>Source: Highway Department</p>	<p>Drainage Investigation/ Maintenance, Education:</p> <p>Need to evaluate drainage in the subdivision (including additional mapping and hydraulic and hydrologic modeling), conduct maintenance, and educate property owners about illegal dumping and flooding impacts. It may be necessary to educate owners and possibly seek enforcement to under the Town’s Wetlands Bylaw or the Discharges to the Municipal Storm Drain System Bylaw.</p>
4	<p style="text-align: center;">Hidden Valley Road</p>

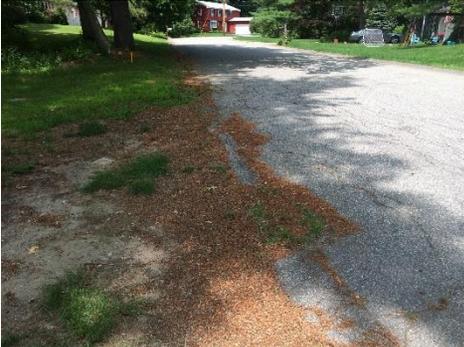
<p>Open drainage ditches need maintenance, and some segments of closed drainage system (i.e., piping and catch basins) need replacement.</p> <p>Source: Highway Department</p>	<p>Drainage Improvement:</p> <p>The open drainage ditches may be considered wetlands resource areas under the jurisdiction of the Westford Conservation Commission. Prior to drainage improvements being completed, a site visit with the Conservation Agent should be completed and potential solutions should be discussed. At a minimum, removal of sediment and organic debris buildup is recommended to be completed under a permit from the Commission.</p>

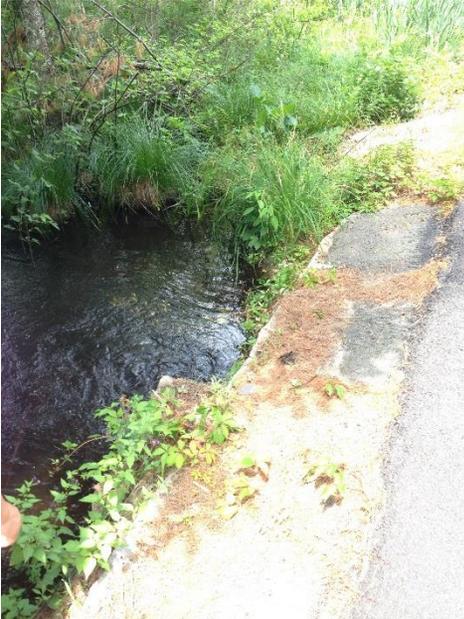
<p>The road grade is low, and beaver activities have elevated the wetlands and waterbody surface elevations, thereby causing flooding. Historically, the flooding has closed either one lane or the entire road approximately every other year. The existing culvert is buried by sediment and is typically mostly submerged. and needs replacement or upsizing. The road was recently repaved.</p> <p>Source: Highway and Police Departments</p>	<p>Culvert Replacement, Road Redesign:</p> <p>300 linear feet of road raising and reconstruction, replace culverts, permitting.</p>

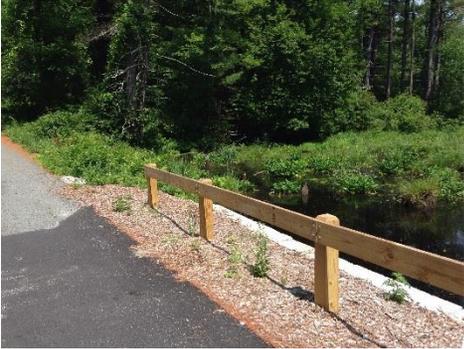
<p>Beavers cause flooding, and one nearby driveway is flooded periodically. Need to clear obstructions in wetland abutting culvert and address the beaver conflict.</p> <p>Source: Highway and Police Departments</p>	<p>Drainage Improvements:</p> <p>The solution to the flooding issue would be to install a new closed drainage system. The closed drainage system would discharge near the existing culvert and would extend to the east near #9 Long Sought For Pond Road and Gristone Road. The system would likely require up to 2 catch basins, a manhole, and approximately 300 feet of 12-inch drain pipe.</p> <p>Resolving the flooding issues caused by beavers will require routine maintenance and keeping the culvert openings clear.</p>
7	<p>Tenney Road (south of Long Sought for Pond Road and north of Keyes Road)</p>

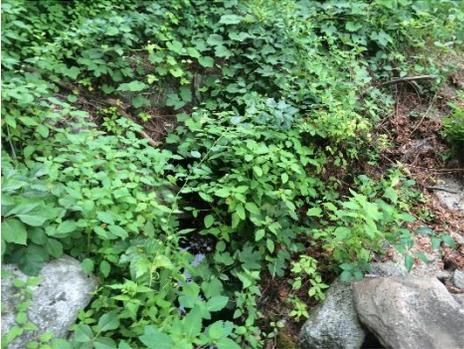
<p>Beavers cause flooding, however, the flood waters have never crossed the crest of the road. Need to replace the existing culvert, which is located off the road on a trail, just downstream and to the west of the existing Tenney Road culvert. This culvert is deteriorated and may be undersized. Potentially need to install a control structure.</p> <p>Source: Highway Department</p>	<p>Culvert Replacement:</p> <p>This culvert (approximately 60 linear feet) is smaller than the existing Tenney Road culvert and probably needs to be replaced and upsized to promote improved water flow in this area. The existing Tenney Road culvert is in good condition and does not need to be replaced.</p>

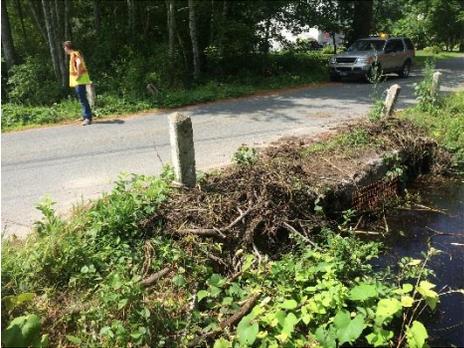
<p>Beaver dams in the area have raised the water surface elevation. There has been at least one significant flood event in the past five years. The existing corrugated metal culvert is rusted and needs to be replaced.</p> <p>Source: Highway Department</p>	<p>O&M Issue, Culvert Replacement:</p> <p>At a minimum, site needs maintenance to remove built up debris abutting culvert and impeding passage of flow. Installation of “beaver deceivers” should be considered for the beaver dams.</p> <p>Upgrade culvert to improve flow passage and wildlife passage, add guard rails to improve safety. Prior to construction this project requires design and permitting through the Westford Conservation Commission.</p>
9	<p style="text-align: center;">Dunstable Road</p>

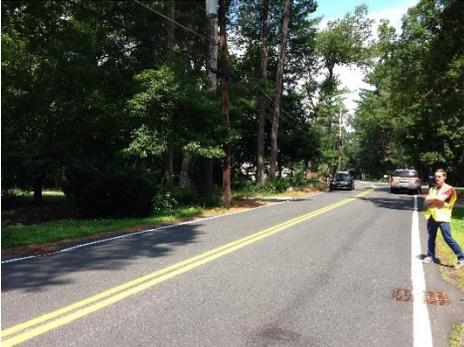
<p>This road has an open ditch drainage system. When debris or snow accumulates, it impedes flow and causes icing on the road. The system should be evaluated and maintained. A subdivision is planned for the area between those described under Location ID #9, #10, and #11, which may help solve drainage concerns.</p> <p>Source: Highway Department</p>	<p>Drainage Improvement:</p> <p>Design and install a new closed drainage system with discharge to pond down side street. Approximately 500 linear feet of drainage pipe and drainage structures. Prior to construction this project requires design and permitting through the Westford Conservation Commission.</p>

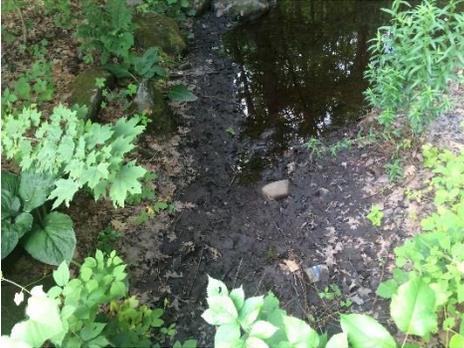
<p>This road has an open ditch drainage system. When debris or snow accumulates, it impedes flow and causes icing on the road. The system should be evaluated and maintained. A subdivision is planned for the area between Location ID #9, #10, and #11, which may help solve drainage concerns.</p> <p>Source: Highway Department</p>	<p>Maintenance:</p> <p>Further investigation is necessary to determine the solution and whether additional drainage would be necessary. Regular maintenance is also required to keep the channel and drainage clear of debris and obstructions.</p>
11	<p>Keyes Road at Slifer</p>

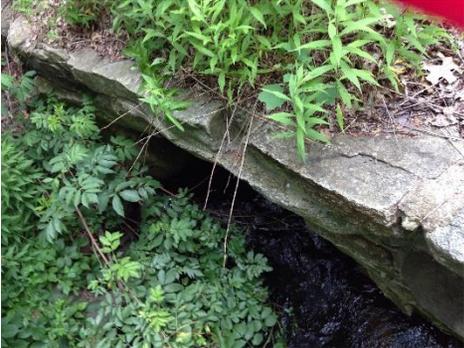
<p>The existing road elevation is low, and the swamp floods the road. The road typically floods once every five years when there is at least a 3- to 4-inch rain event in 24 hours. Flooding can cause safety issues when emergency vehicles need to pass. The road needs to be raised to solve the flooding issue. The Town has done some hydraulic modeling of the area as part of a Federal Emergency Management Agency (FEMA) Hazard Mitigation Grant. This project could be completed in conjunction with the project described under Location ID #13.</p> <p>Source: Highway and Police Departments</p>	<p>Drainage Investigation:</p> <p>Complete investigation of drainage area and prepare design alternatives for improvements.</p>

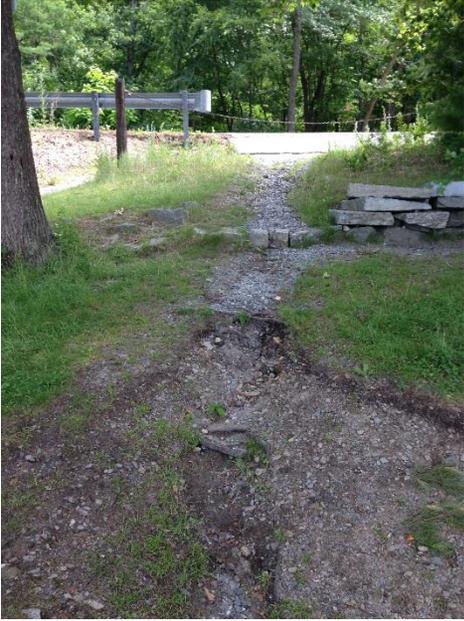
<p>The DCR parking lot at the boat launch (across the street from the photo) does not have a clear connection to the drainage system and needs to be investigated to reduce localized ponding in the parking area. This project may overlap with the Dunstable Transportation Improvement Project (TIP) project on Route 40, which is funded by MassDOT.</p> <p>Source: Highway Department</p>	<p>Erosion Control Improvement:</p> <p>Coordinate with the DCR on erosion control and slope stabilization.</p>
13	<p style="text-align: center;">Groton Road at Pages Hill</p>	<p>The Keyes Brook culvert crosses under Groton Road and needs replacement. This project is already planned under the Town’s CIP and will be funded through the FEMA Hazard Mitigation Grant.</p> <p>Source: Highway Department</p>	<p><i>Project has been completed.</i></p>

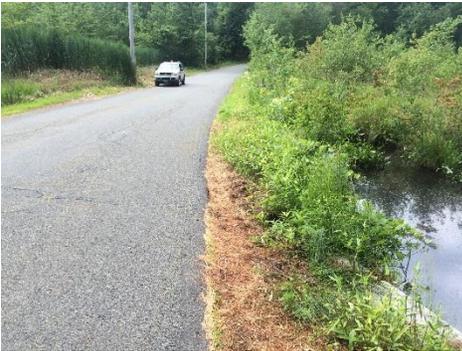
<p>Gould Road floods approximately 10 times per year with a 2- to 3-inch rain event. The flood waters can reach up to 1 foot deep. The existing culvert needs to be replaced and the road grade needs to be raised to prevent flooding. May need to up size the culvert to aid in this issue. Upstream of Keyes Pond is a beaver dam, which has had flooding impacts mitigated by installing a number of 12-inch pipes. This project will include impacts to bordering vegetated wetlands due to the need for new headwalls and retaining walls.</p> <p>Source: Highway and Police Departments</p>	<p>Culvert Replacement, Road Work:</p> <p>Design and permit a replacement culvert, raise road, and guard rails.</p>
15	<p style="text-align: center;">Groton Road at Snake Meadow Brook</p>	<p>Beavers at the existing culvert cause flooding of one house. The culvert requires routine clearing and maintenance.</p> <p>Source: Highway Department</p>	<p>Maintenance:</p> <p>Complete routine maintenance of culvert.</p>

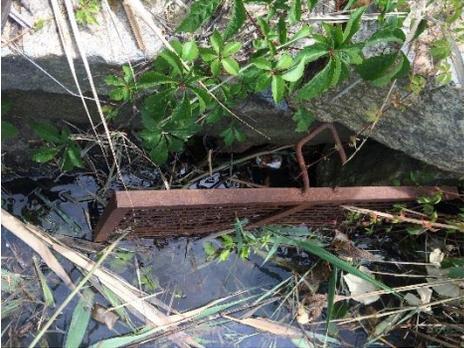
<p>The existing culvert is undersized and failing and should be upgraded.</p> <p>Source: Highway Department</p>	<p>Capital:</p> <p>This culvert will be replaced as part of the Route 40 & Oak Hill Road intersection improvement project. The existing 30-inch pipe will most likely be replaced with a new 12-foot by 7-foot embedded box culvert. The project is currently on schedule to be constructed in the summer of 2019. Construction will be funded by MassDOT through the Dunstable TIP project on Route 40.</p>
18	<p>Forrest Road between Lawson Road and Pollyanna Lane</p>	<p>There are leaching catch basins with no outfalls in this area. Flooding occurs on the side of the road. Investigation of drainage problems and connectivity is needed.</p> <p>Source: Highway Department</p>	<p>Drainage Investigation:</p> <p>Need to improve mapping in this area and determine if drainage improvements are necessary.</p>

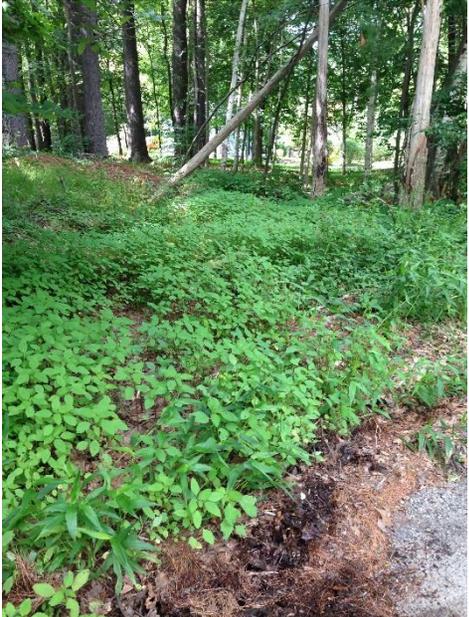
<p>The existing open ditches behind houses flow into Stony Brook, and maintenance is a challenge due to existing conditions and conflicts with private property.</p> <p>Source: Highway Department</p>	<p>Maintenance/Drainage Investigation:</p> <p>This area needs maintenance and assessment of optimal solution given wetlands permitting constraints. Assessment would include field inspections, mapping, hydrologic and hydraulic analysis, and discussions with Conservation Commission.</p>
22	<p style="text-align: center;">Lowell Road</p>	<p>There are repeated ice issues in the winter on this road due to residences sump pump discharges. The discharges also cause flooding at foot of hill and erosion of yards.</p> <p>Source: Highway Department</p>	<p>Drainage Improvement, Education:</p> <p>Connect sump pump discharges into the existing drainage system. Educate owners about need for improvement.</p>

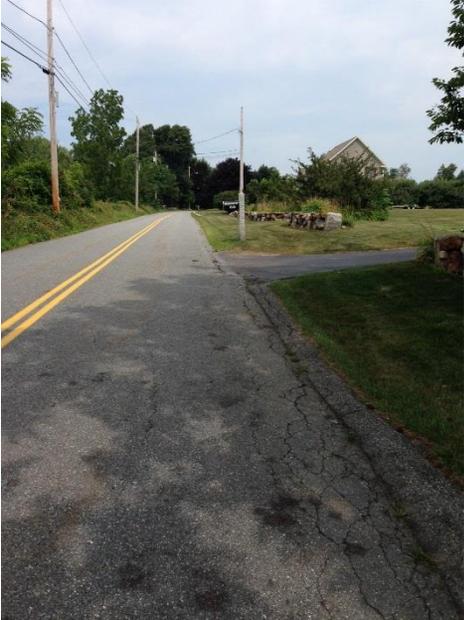
<p>This road has an open ditch drainage system. Sump pump discharges drain into the ditch. This causes winter ice issues on the road.</p> <p>Source: Highway Department</p>	<p>Drainage Improvement, Education:</p> <p>The solution may include installing a new closed drainage system in or along Chamberlain Road, extending from Hunt Road and connecting into the Swedes Crossing drainage system. The system may only be necessary on one side of the road based on topography.</p>
24	<p style="text-align: center;">West Prescott Street</p>	<p>This is an area of Forge Village with old pipe. Some of East Prescott Street had open drainage in the center of the street which discharged into a common septic/storage system. There used to be connections from each basement (and maybe sewer) into the 10-inch drainage system.</p> <p>Source: Highway Department</p>	<p>Drainage Investigation:</p> <p>Need to evaluate connectivity and drainage system update alternatives. Work includes video inspections, mapping, and dye testing, preparation of a conceptual design for improvement and development of probable costs. This area should be considered a high priority for the Town’s IDDE program.</p>

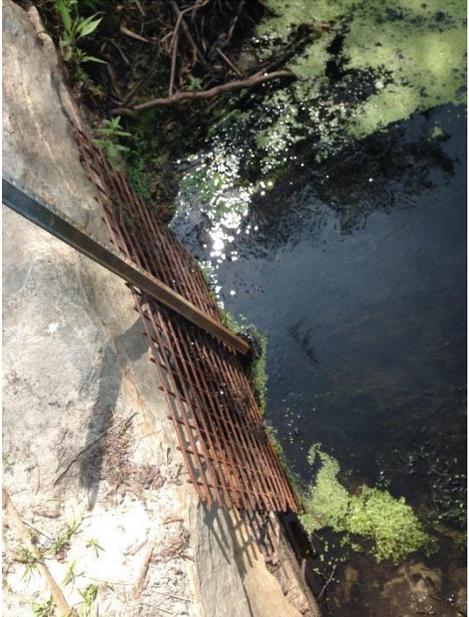
<p>The existing culvert has been replaced, but beavers create dens in the area and have caused flooding.</p> <p>Source: Highway Department</p>	<p>Maintenance:</p> <p>Routine maintenance of culvert and continued beaver management.</p>

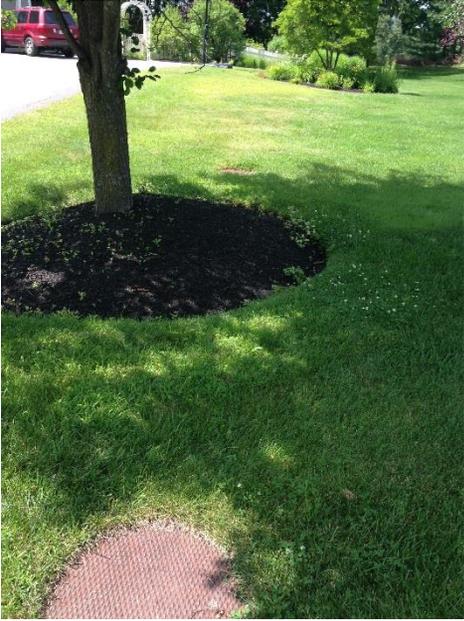
<p>There is a failing structural stormwater BMP in this location that was installed in the mid-1990s. There is an inlet to the system, but no outlet to allow water out. The system may be undersized and may not infiltrate. When the system is full, it causes surcharges out of drainage system. For these reasons, the street floods almost every rain event and impacts all residential homes along Steeple Chase Circle, Buckskin Lane, and Dobbins Road.</p> <p>Source: Highway Department</p>	<p>Drainage Improvement and Maintenance:</p> <p>Identify original design plans and sizing, open system and ownership. Complete maintenance. Identify recommended improvement alternatives and associated cost.</p>
33	<p style="text-align: center;">Old Lowell Road</p>	<p>New drainage was needed to address the existing flooding issue. Leaching basins were replaced and installed as needed.</p> <p>Source: Highway and Police Departments</p>	<p><i>Project has been completed.</i></p>

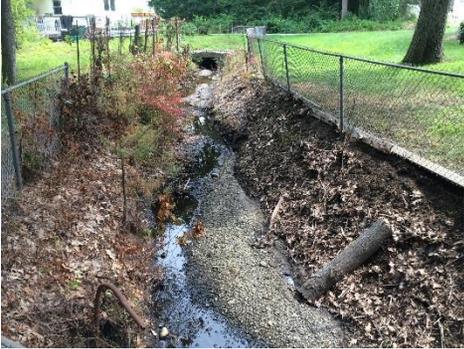
37	<p align="center">Pine Hill Road</p>

<p>All of the water flows into the golf course area, where it floods the golf course. Throughout neighborhood, houses experience wet basements. There are many places where pipes go under buildings and under roads (e.g., Oak Hill Road). Some of the ditches are full of organic materials from residents dumping leaves and yard waste. Overall, there are issues with capacity in the drainage system. The culvert may need replacement. This area could benefit from additional investigation.</p> <p>Source: Highway Department</p>	<p>Drainage Investigation:</p> <p>This area should be investigated. A potential long-term solution would be to install a closed system from Woodbine Terrace or Williams Avenue to the golf course near Nabnasset Pond. This could reduce the yearly maintenance and sediment and organic debris filling that typically occurs over the years. The Highway Department spends time each spring and fall clearing the open channels, removing trees, removing sediment, etc. by hand.</p> <p>Need to educate residents, study, map, wetlands evaluation, and permit project. Need to look at old mapping to see where stream would have been. Consider culvert replacement.</p>

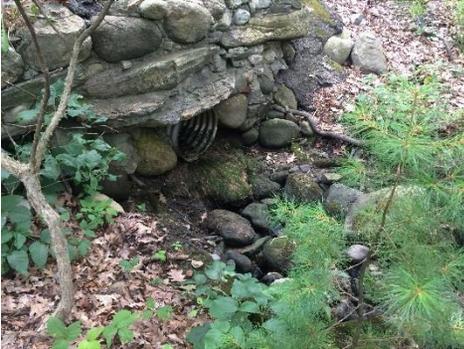
<p>Flooding has been reported in this area, and the culvert capacity likely needs to be increased given current sizing and overall watershed.</p> <p>Source: Highway and Police Departments</p>	<p>Culvert Replacement:</p> <p>Design, permit, and replace culvert with larger box culvert.</p>

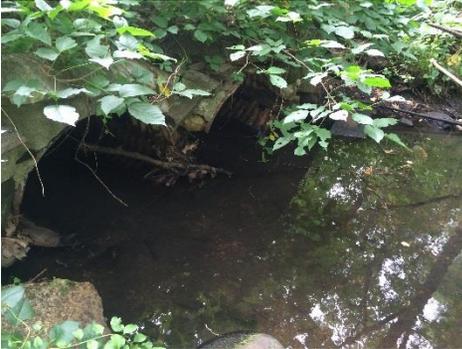
<p>The existing culvert is not performing as designed. After three inches of steady rain, the culvert does not have enough capacity due to maintenance and structural integrity issues and Concord Road floods slightly.</p> <p>Source: Highway and Police Departments</p>	<p>Culvert Replacement:</p> <p>Culvert is scheduled to be replaced by the end of 2018.</p>

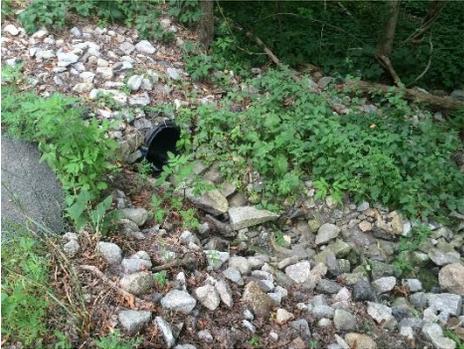
<p>An improperly designed existing drainage layout results flooding of the street. Roadway and drainage improvements are included as part of capital planning. The existing drainage is clay pipe and may be capped at Providence Street. The impact on downstream problem areas (as described under Location ID #29 and #30) would need to be assessed.</p> <p>Source: Highway Department</p>	<p>Drainage Investigation and Improvement:</p> <p>Confirm mapping in this area and CCTV inspect the drainage system. Drainage will be addressed in the future TIP project.</p>
42	<p>East Boston Camps</p>	<p>Puddles form due to undersized drainage discharging in the area of the railroad. The catch basin in the East Boston Camps parking area and another directly across the street at #1 Plain Road are connected and discharge to Stony Brook after passing under the railroad tracks. It is possible that the outlet pipe has failed.</p> <p>Source: Highway and Police Departments</p>	<p>Drainage Investigation:</p> <p>Need to investigate how the drainage is currently connected, where it discharges, and condition of infrastructure. The drainage to the north at the intersection of Plain Road and Depot Street should also be investigated to determine if it is currently connected to this system, or, if improvements are recommended, if it should be connected to the system in the area of the railroad.</p>

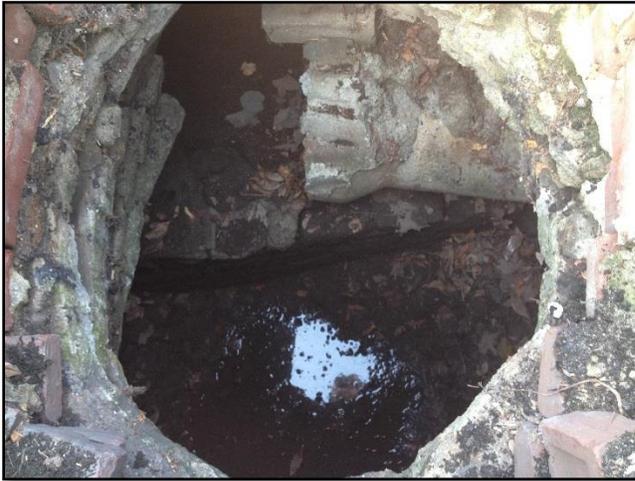
Figure 5-6 Example of Structure in Fair Condition

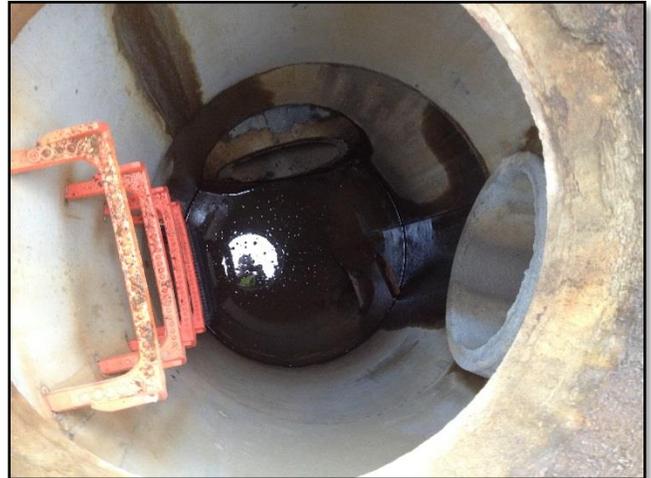
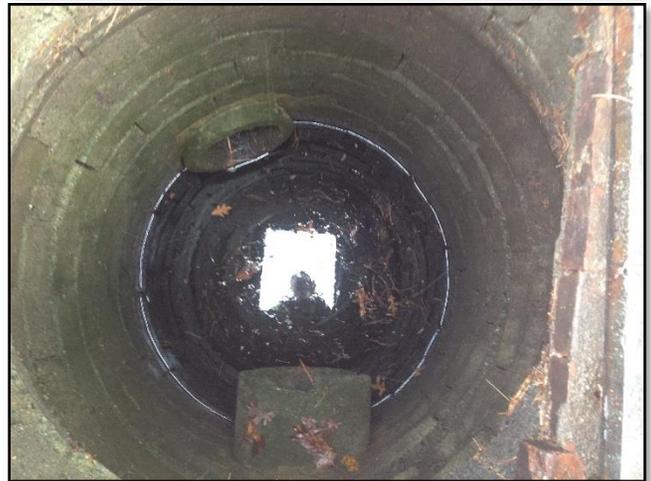
Figure 5-7 Example of Precast (top) and Block (bottom) Drain Structures in Good Condition

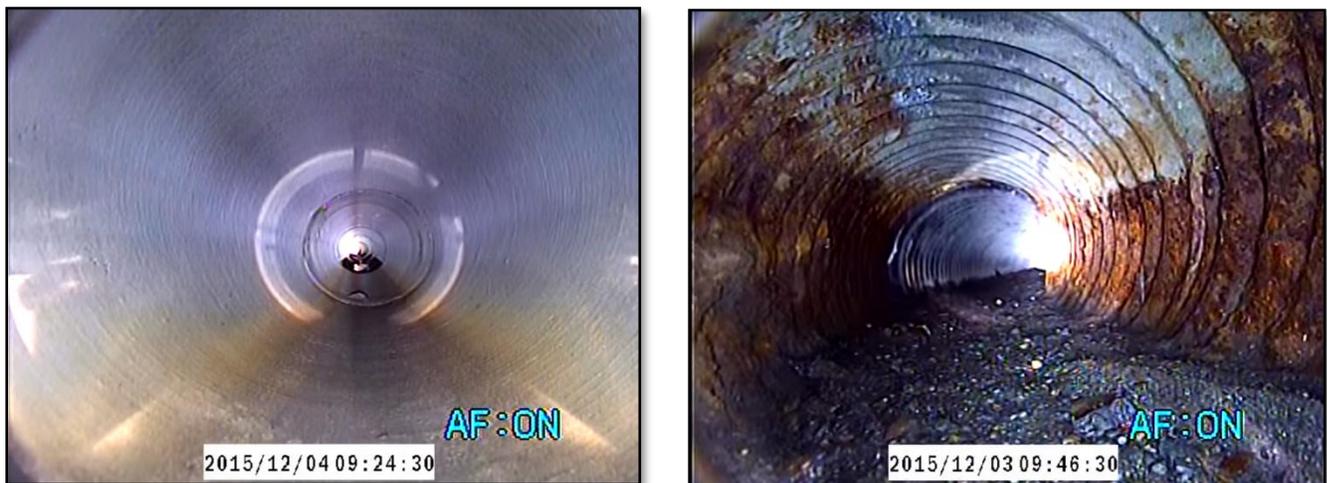
Figure 5-8 Example of Inspected Drain Pipe in Good Condition (left) and Fair Condition (right)

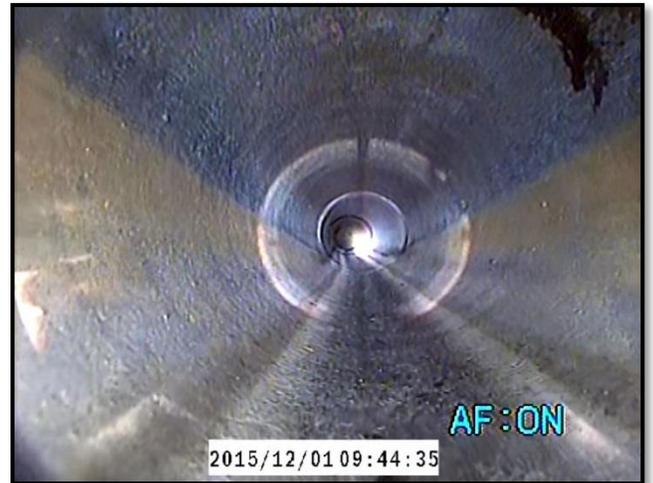
Figure 5-12 Example of RCP Drain Pipe with No Debris or Sediment Buildup
