FORMER ABBOT WORSTED COMPANY MILL #1  
12 North Main Street, Graniteville, Westford, MA

PROGRESS MEETING  
September 24, 2015

**Bargmann Hendrie + Archetype, Inc.**  
**Structures North Consulting Engineers, Inc.**

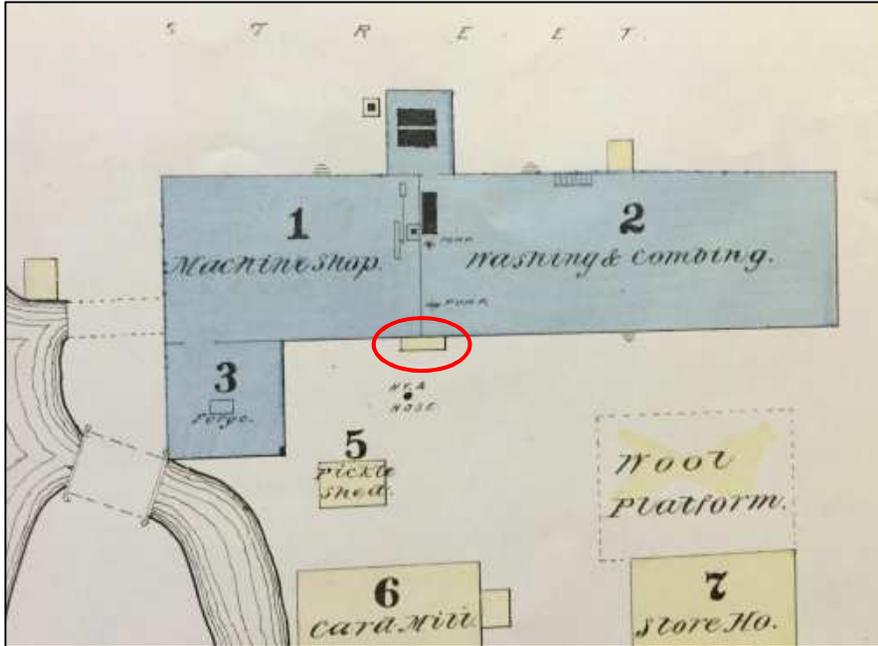
Prior to full occupancy by Abbot Worsted Company, Mill #1 was used by Charles G. Sargent & Sons as a machine shop. A wood-framed lean-to (shown circled) straddling both sides of the fire wall between Mills 1 and 2 housed privies; the addition survives in poor condition.

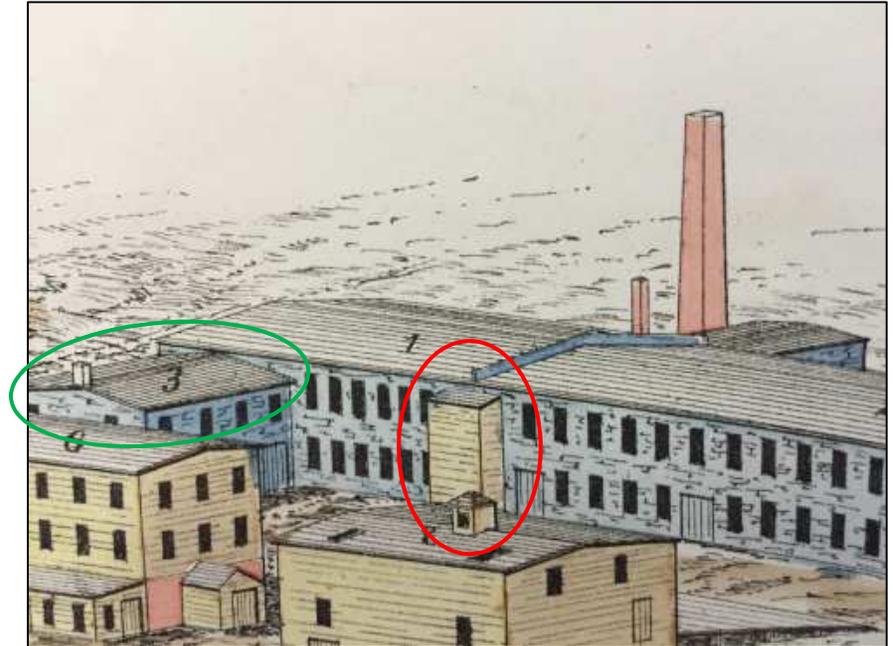
Crop from G.G. Sargent's Sons 1877 Survey #5011 (Barlow), which includes the wood-framed privy lean-to (circled in red). The Mill #3 "Forge" ell is illustrated with a shallow-pitch gable roof (circled in green) rather than the extant shed roof ; this may have been a drafting error. Color plan and bird's eye view courtesy of ATHM.

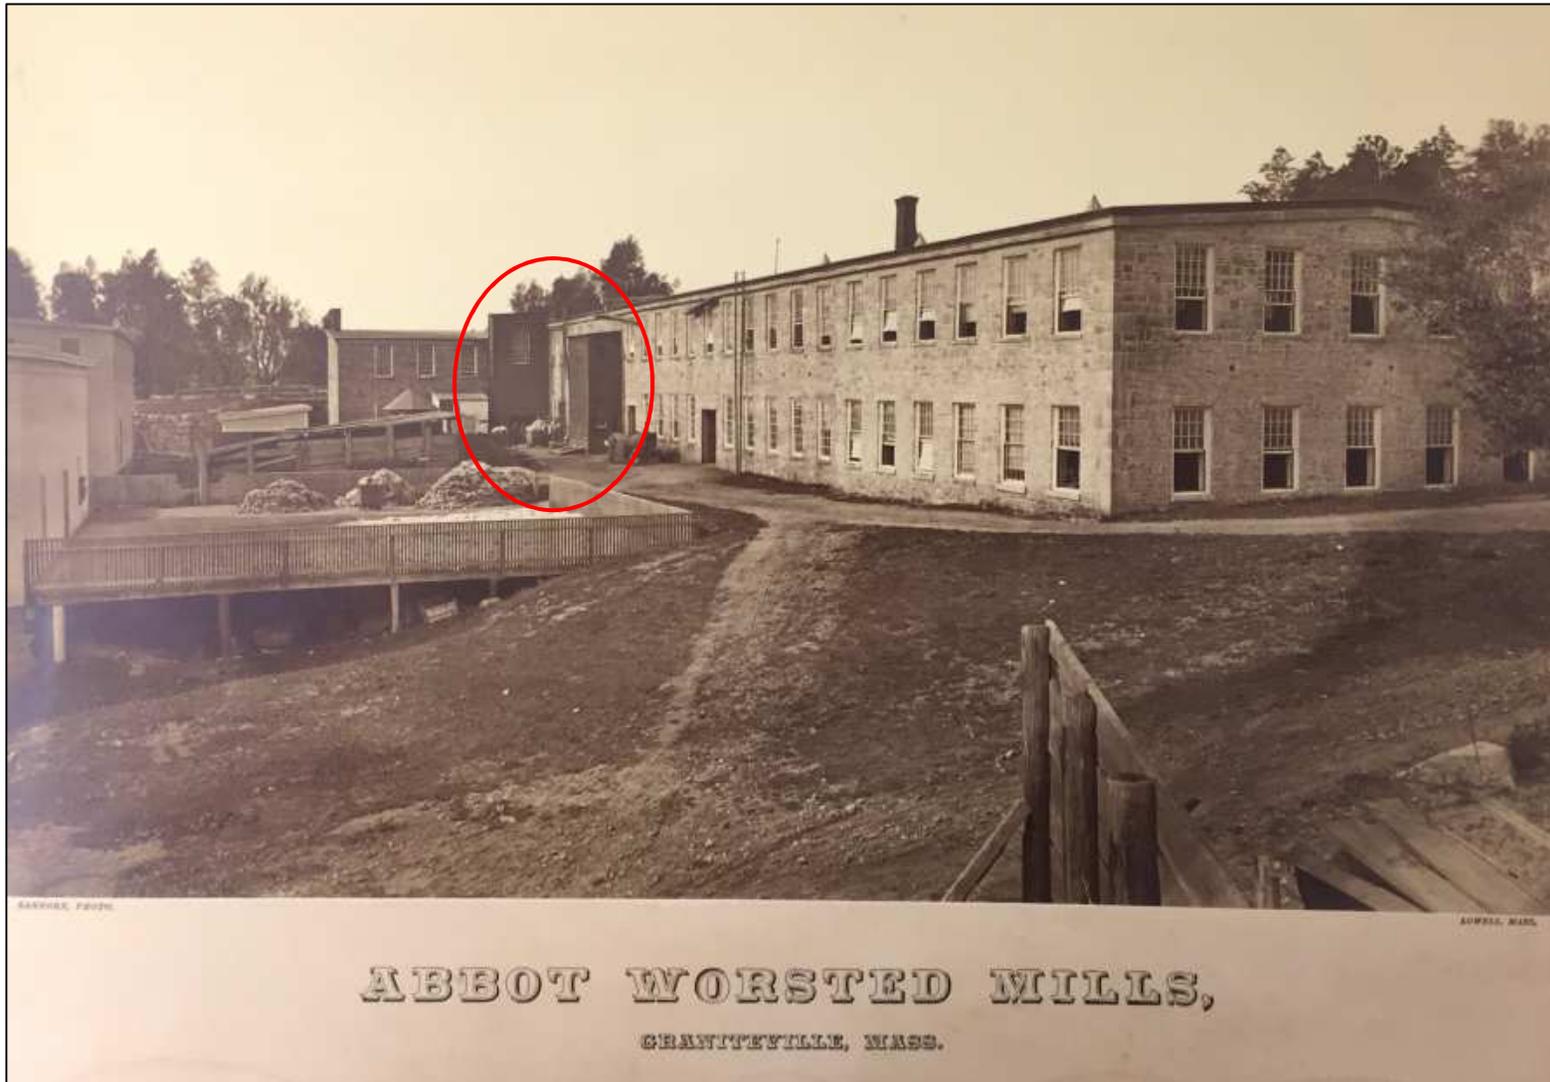
Undated (probably ca. 1878) photo from J.V. Fletcher Library collection; note privy and stair tower.

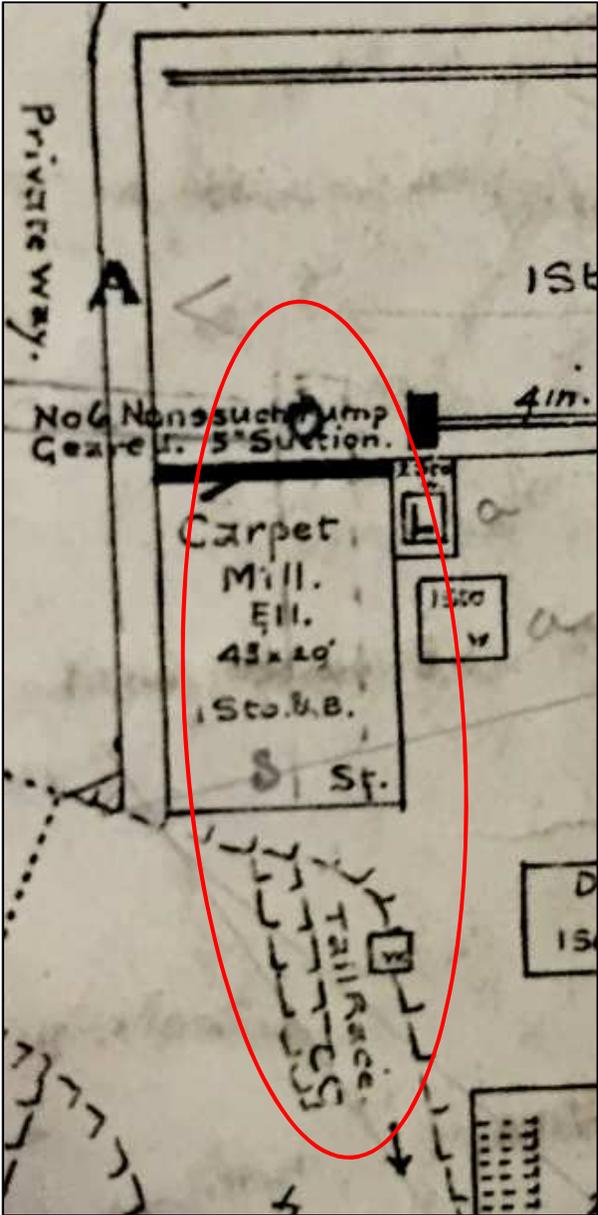
Crop from 1890 Insurance Map (ATHM); note penciled-in sluiceway.

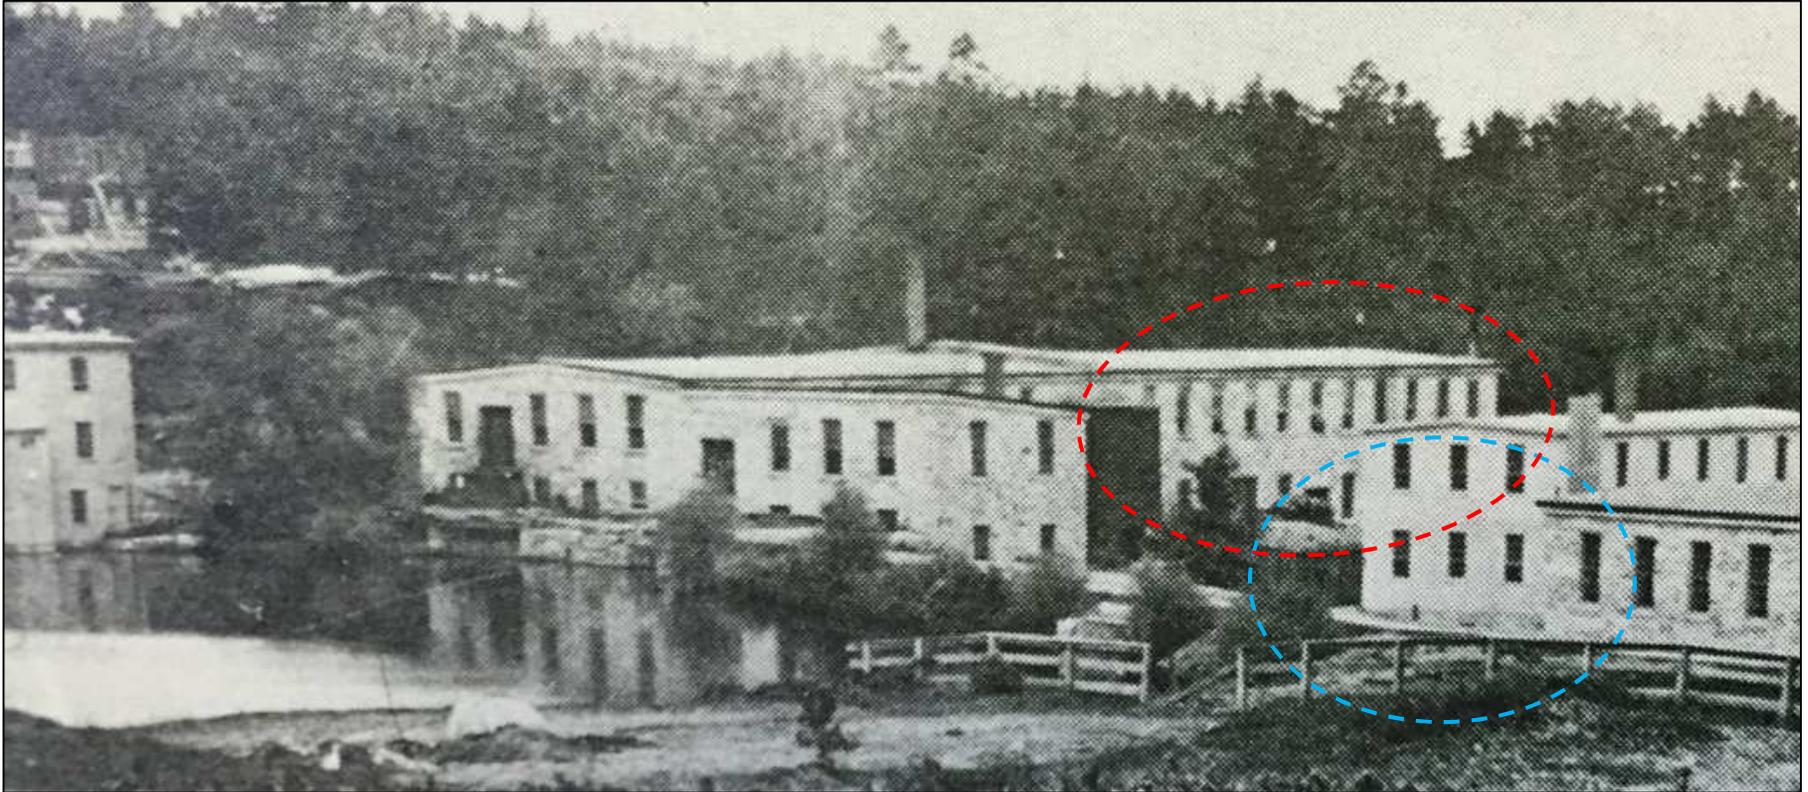
This photograph from the J.V. Fletcher Library collection appears to predate 1880 – well before the bell tower was constructed. The building is shown extended 6 additional window bays!

The privy lean-to (center of photo) clad in flush wood siding is painted black at this juncture. The extant Sargent's Sons building north addition does not yet appear. Curiously, the original smokestack does not appear here, nor does the wood picket fence at Broadway.

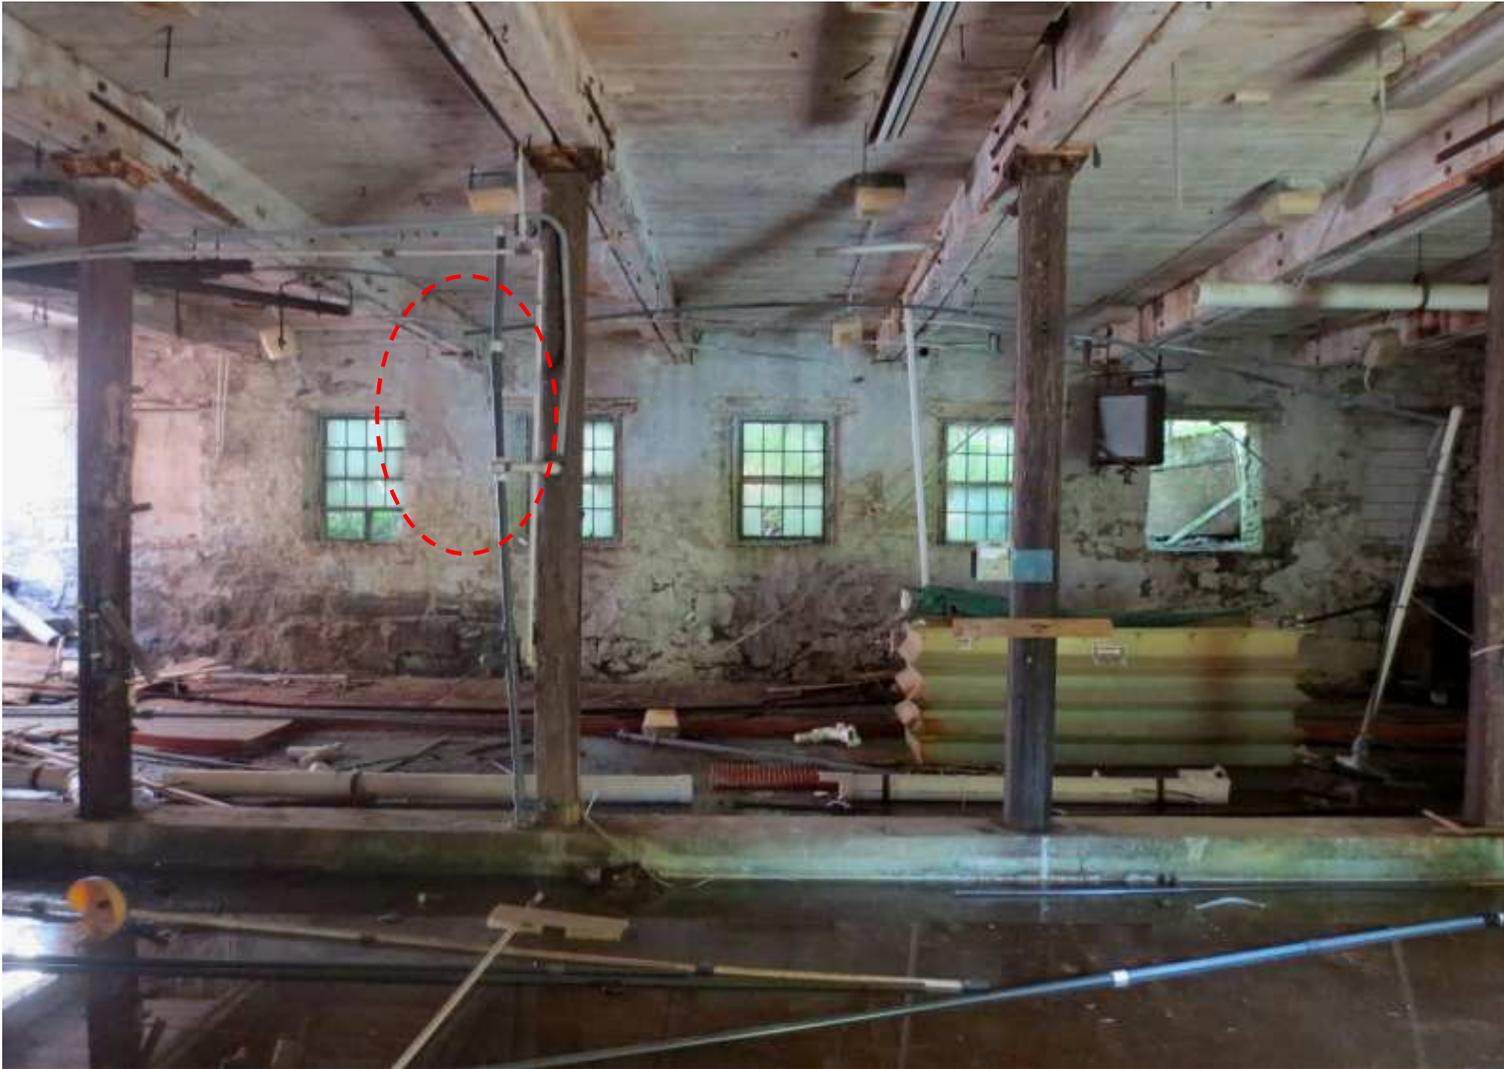
Basement level, east end, looking north.

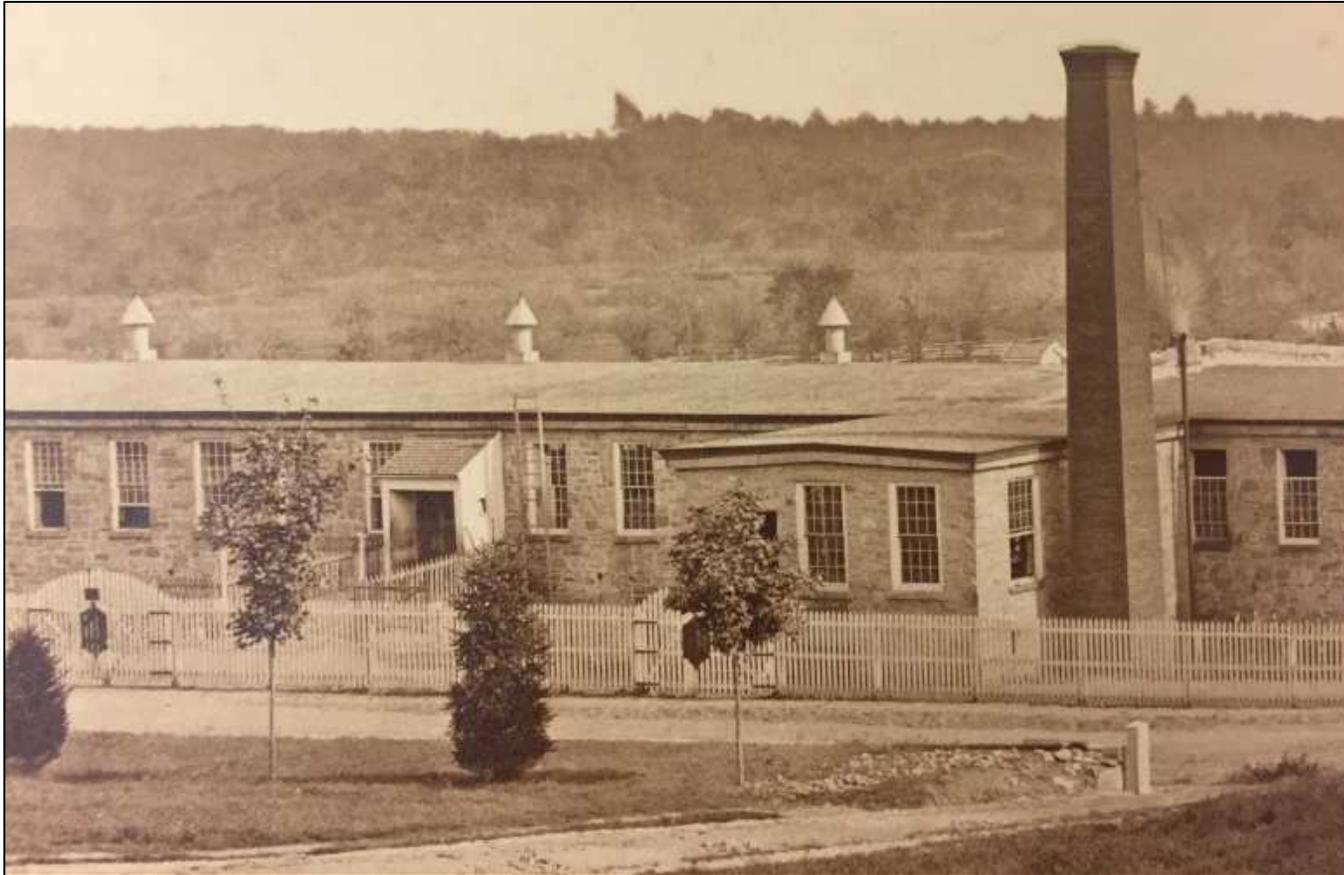
Enlarged portion of photo from the J.V. Fletcher Library collection illustrates the original boiler wing.

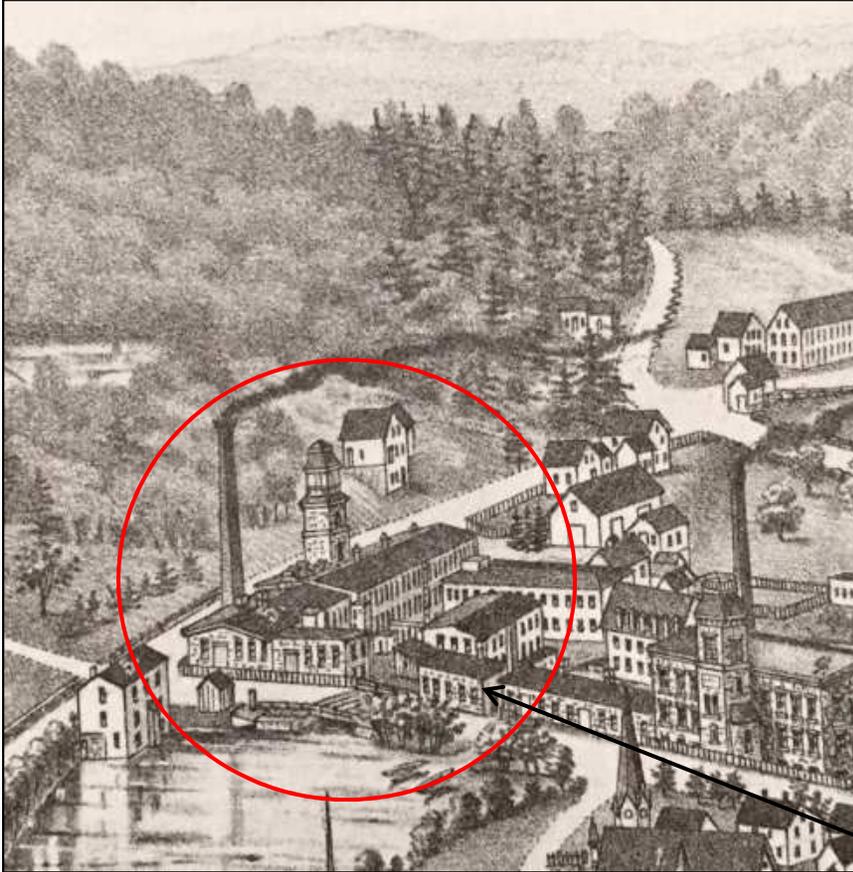
Inset from 1886 L.R. Burleigh bird's eye view of Graniteville; note the apparently exaggerated height of the bell tower. The original, square smokestack is indicated, as are the privy lean-to and what appears to be a stair tower between Mill #1 and the Mill #3 ell.

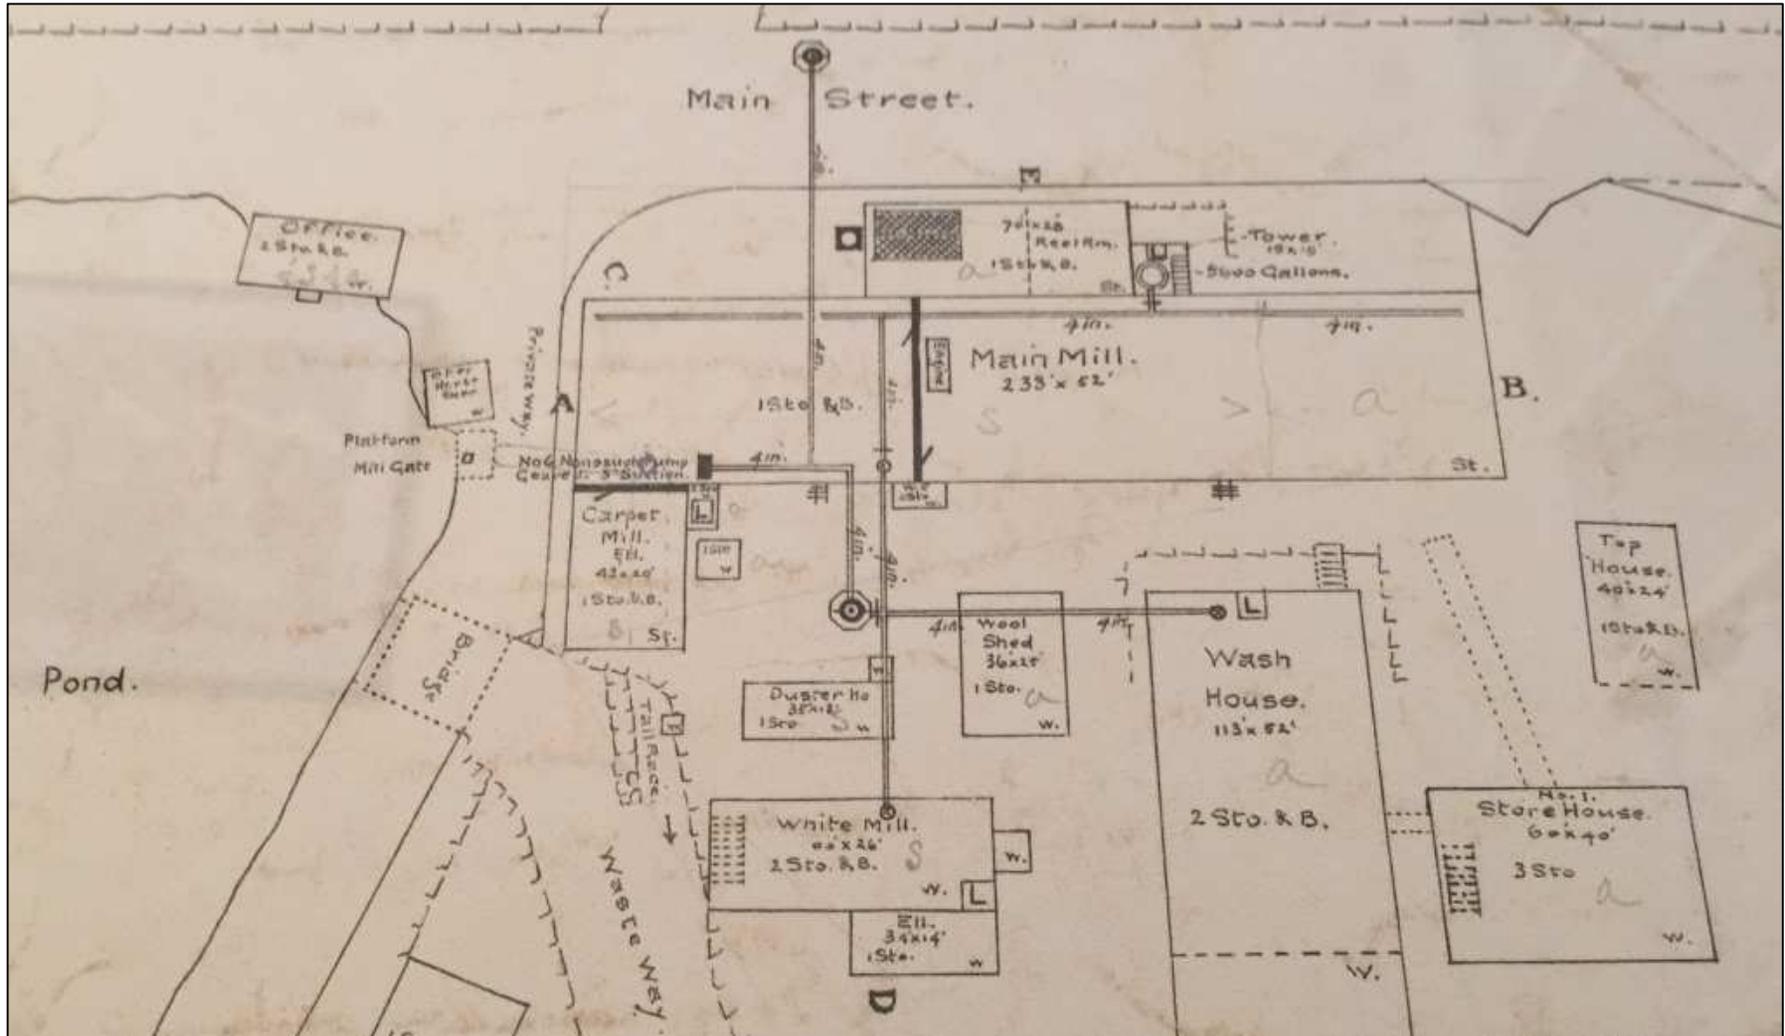
1890 Associated Mutual Insurance Co. map (courtesy ATHM) illustrates **fire suppression system** (hydrants and pipes) and 5,600-gallon **water tank in bell tower**. A stone retaining wall encloses a portion of the tower area.

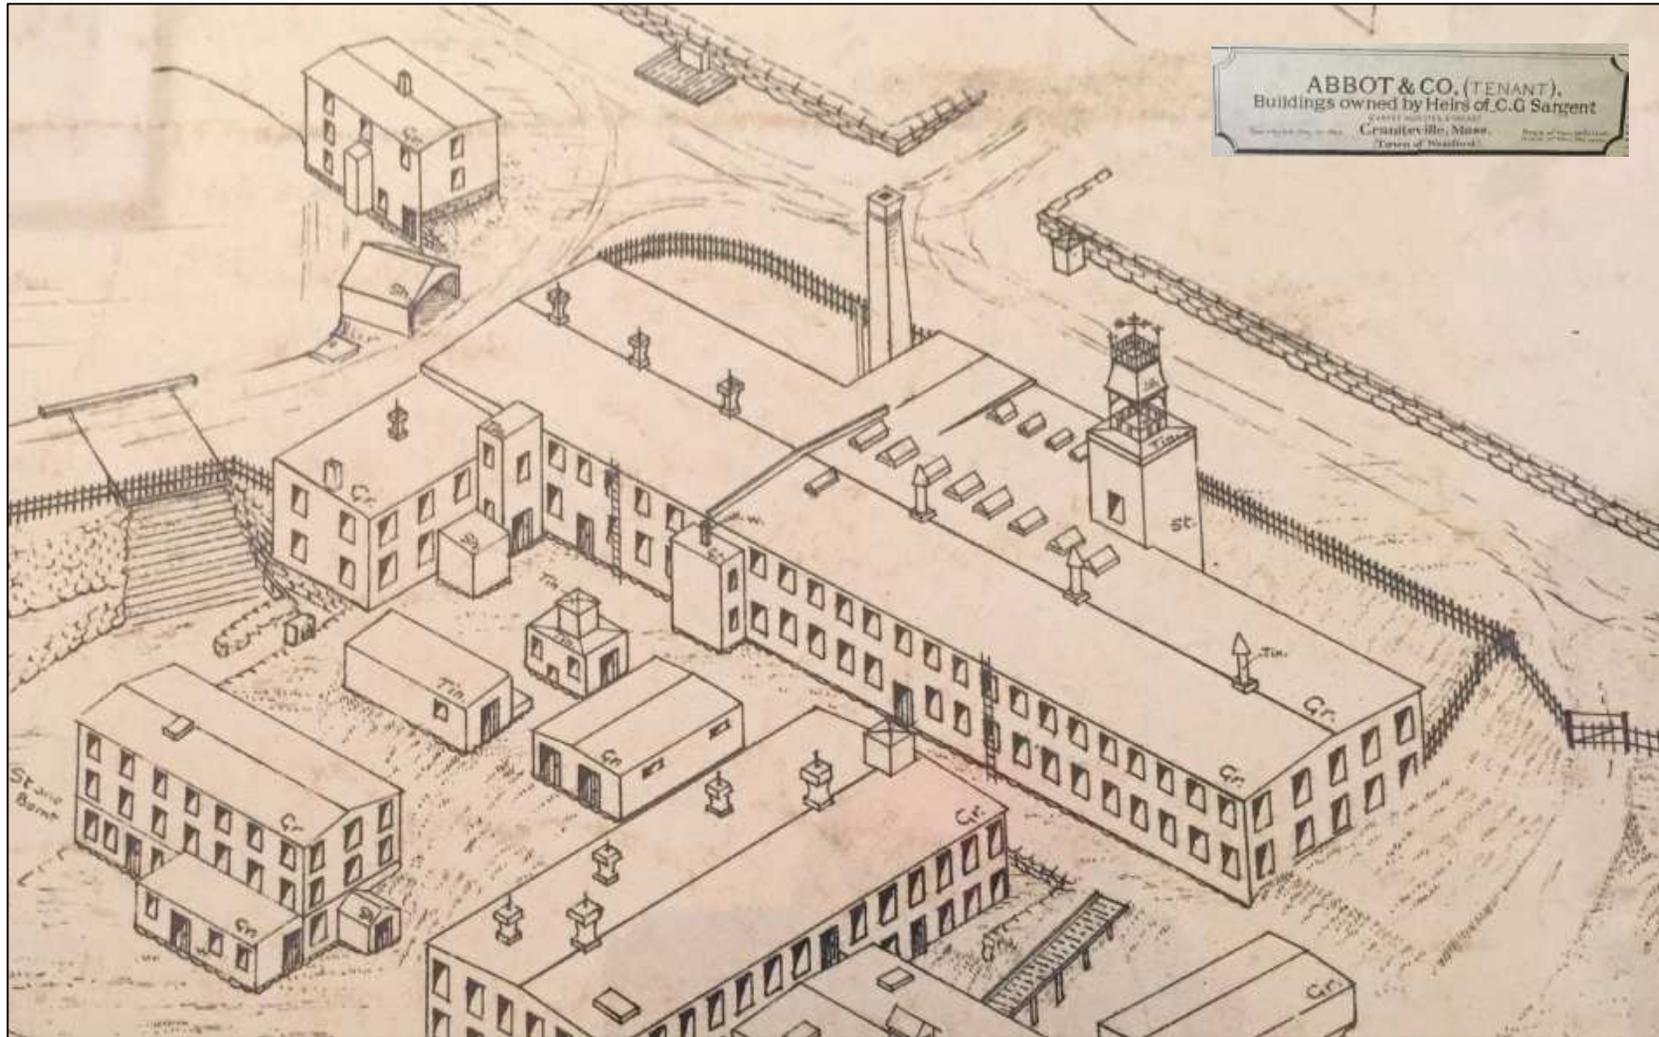
1890 Associated Mutual Insurance Co. survey bird's-eye view; the boiler wing and adjacent square-plan chimney are still intact, but have been expanded and joined by the bell tower. Note various features and amenities.

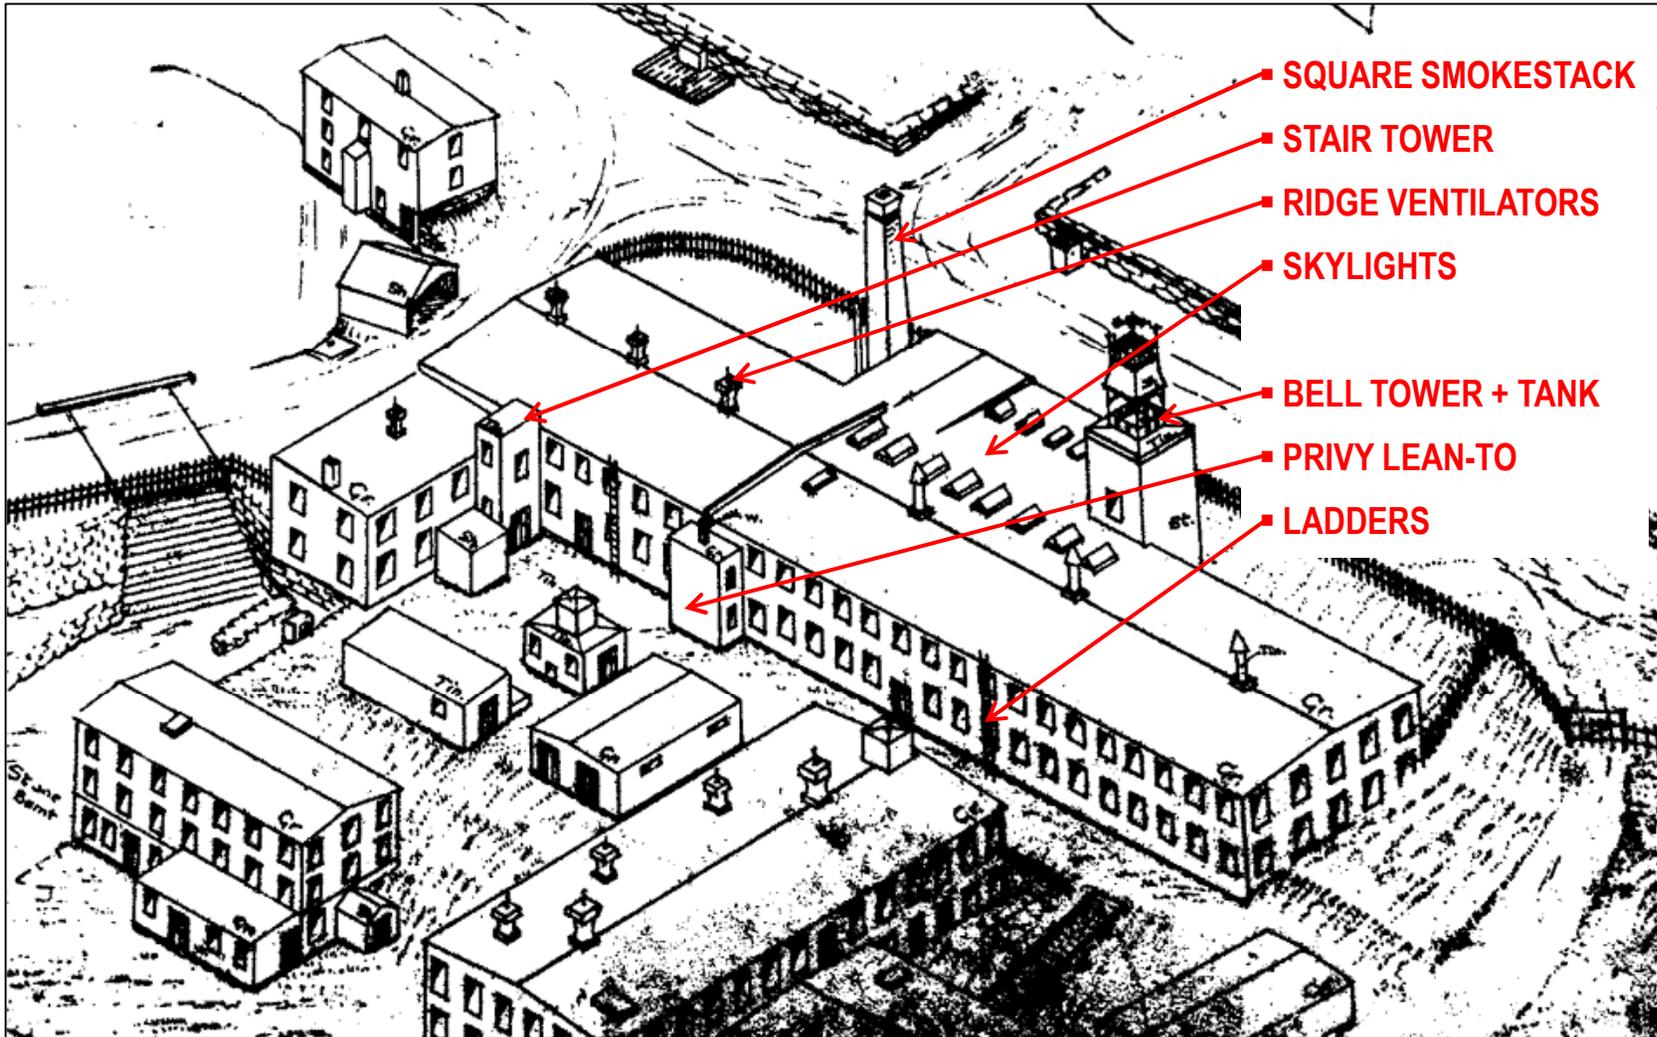
1890 Associated Mutual Insurance Co. survey bird's-eye view; the boiler wing and adjacent square-plan chimney are still intact, but have been expanded and joined by the bell tower . Note various features and amenities.

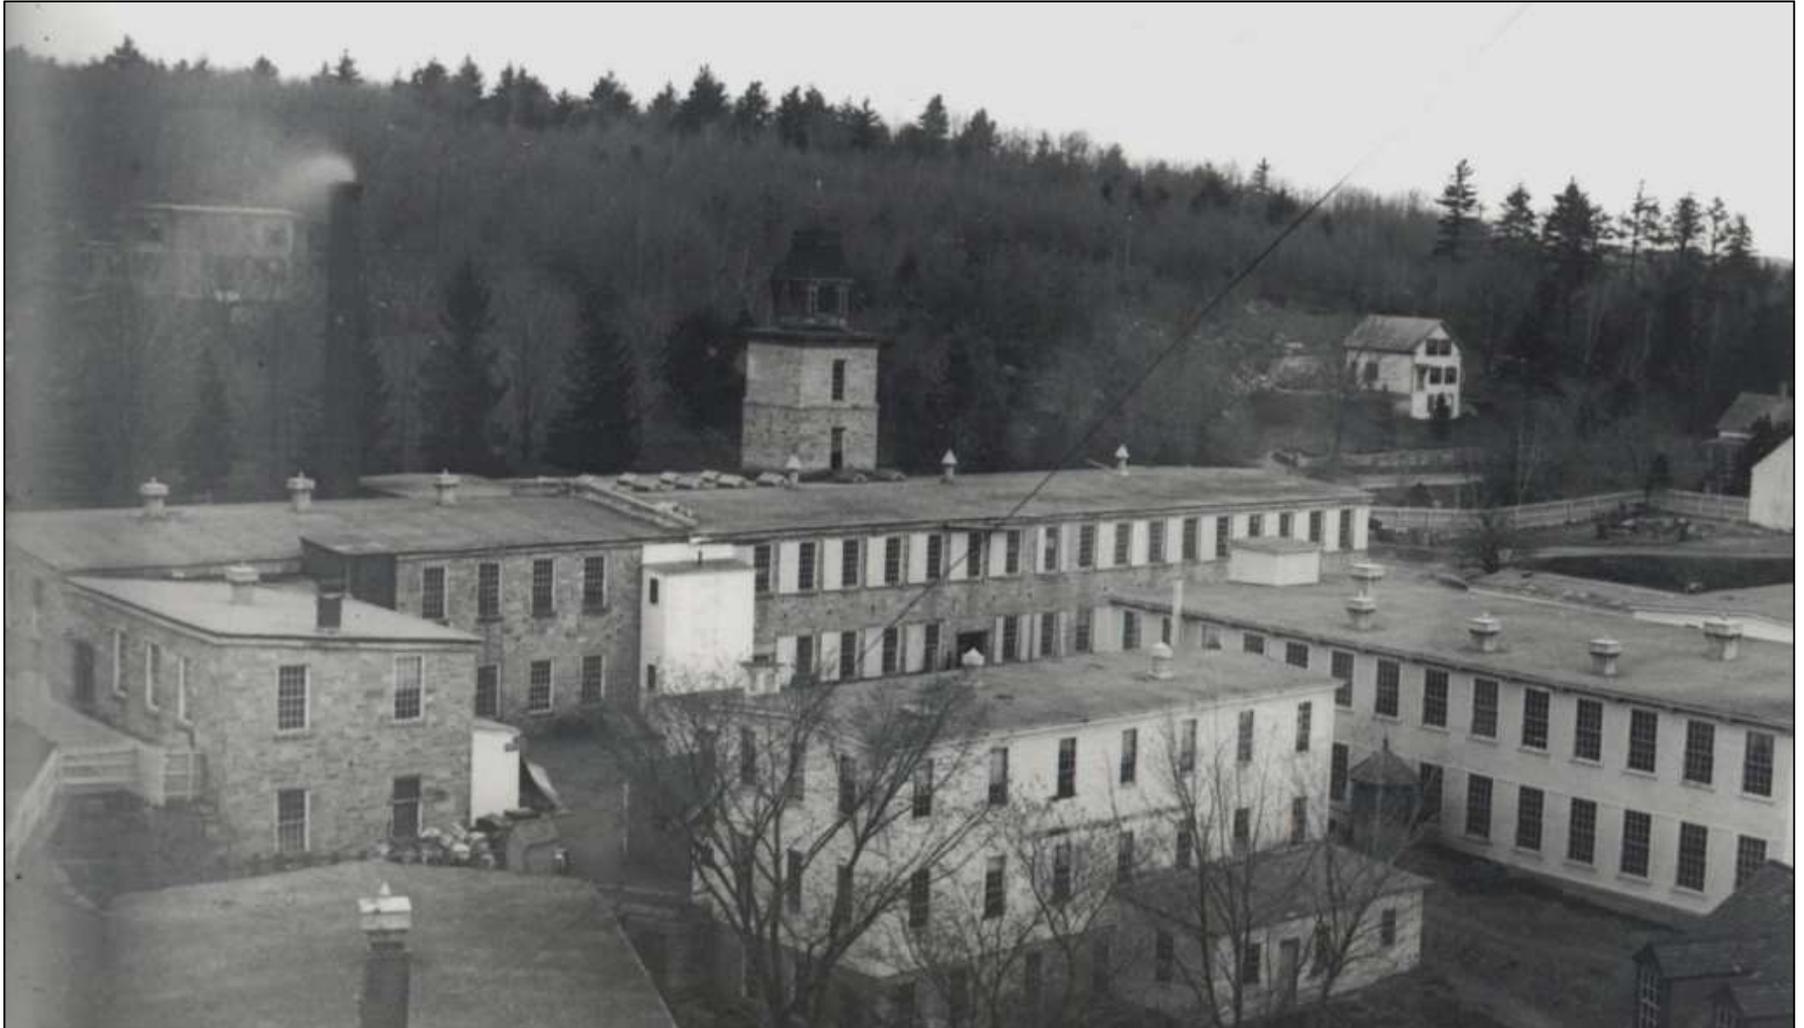
In this Quincy W. Day photograph shot in 1900, the square smokestack remains. The roof access and/or fire escape ladders have been removed and the Mill #2 windows have been protected with shutters.. (Source: WHM and HS)

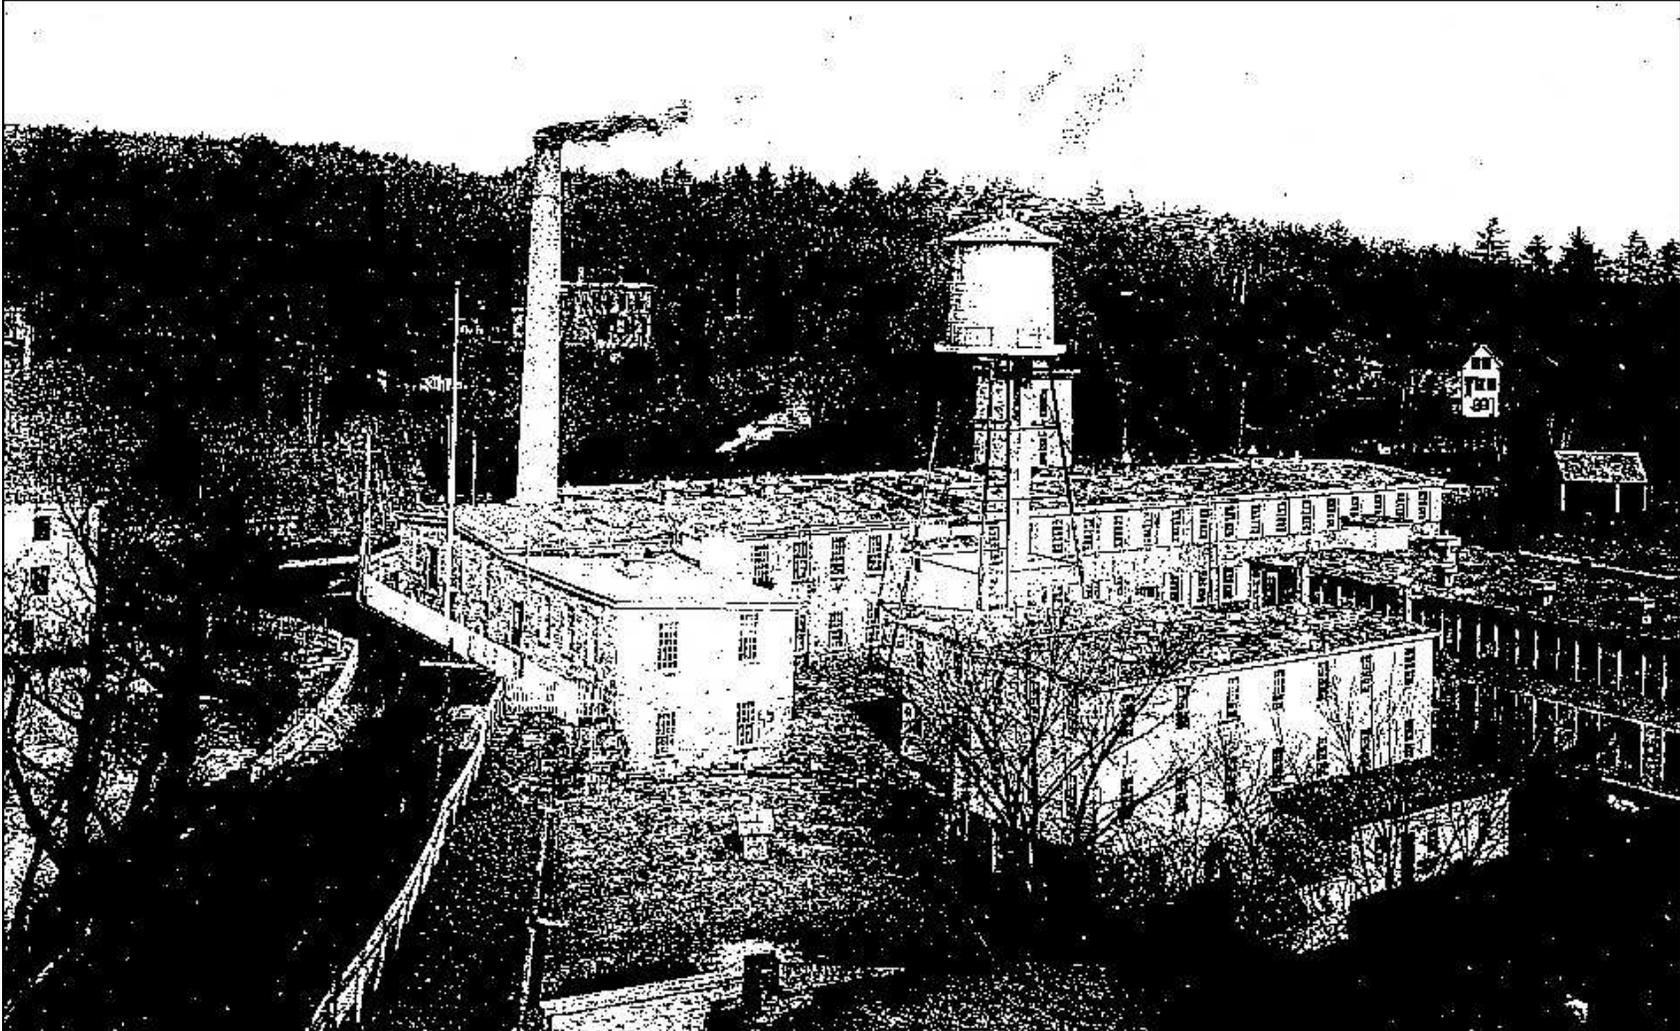
In this undated photograph, the extant hollow-cored radial brick chimney and a new staved-wood cistern elevated on steel pylons appear.

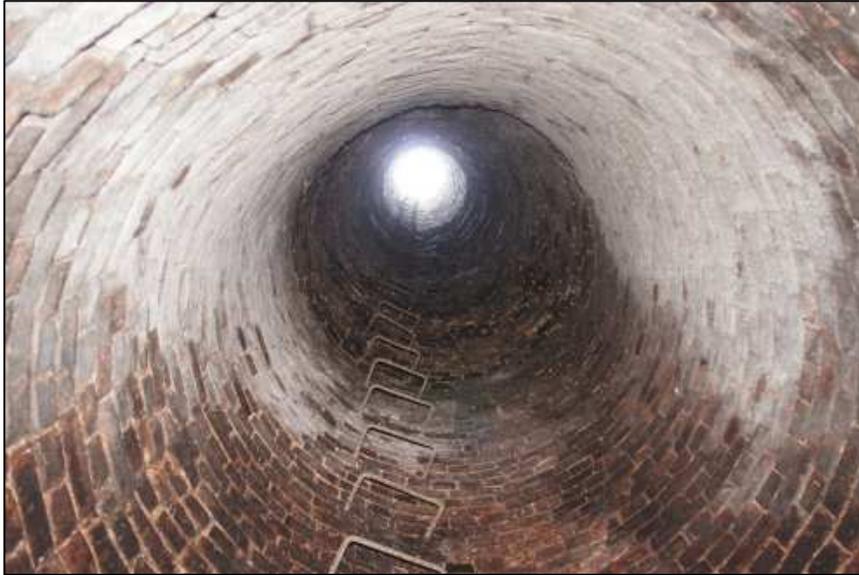
According to the Graniteville Historic District nomination form, the extant cylindrical smokestack constructed of radial brick (see brick photo below) was erected ca. 1880, but insurance drawings and Quincy Day photographs show that the original smokestack survived until at least 1900.

The extant smokestack was probably erected just after the turn of the century.

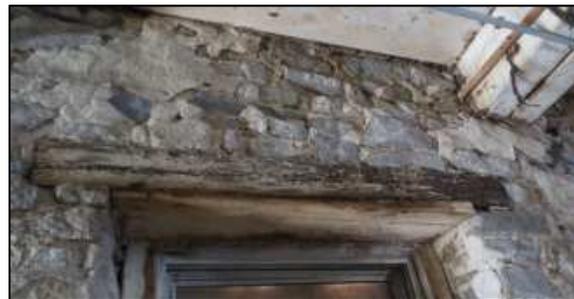
Wood, masonry, moisture

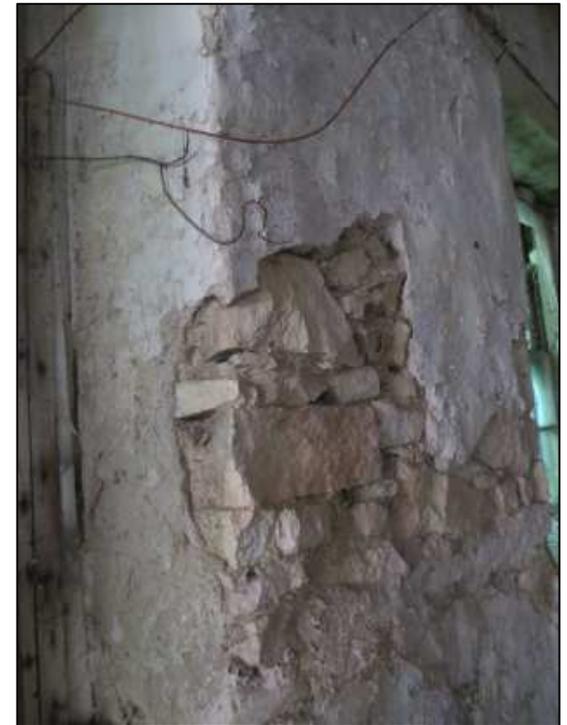
Interior plaster exposed to weather

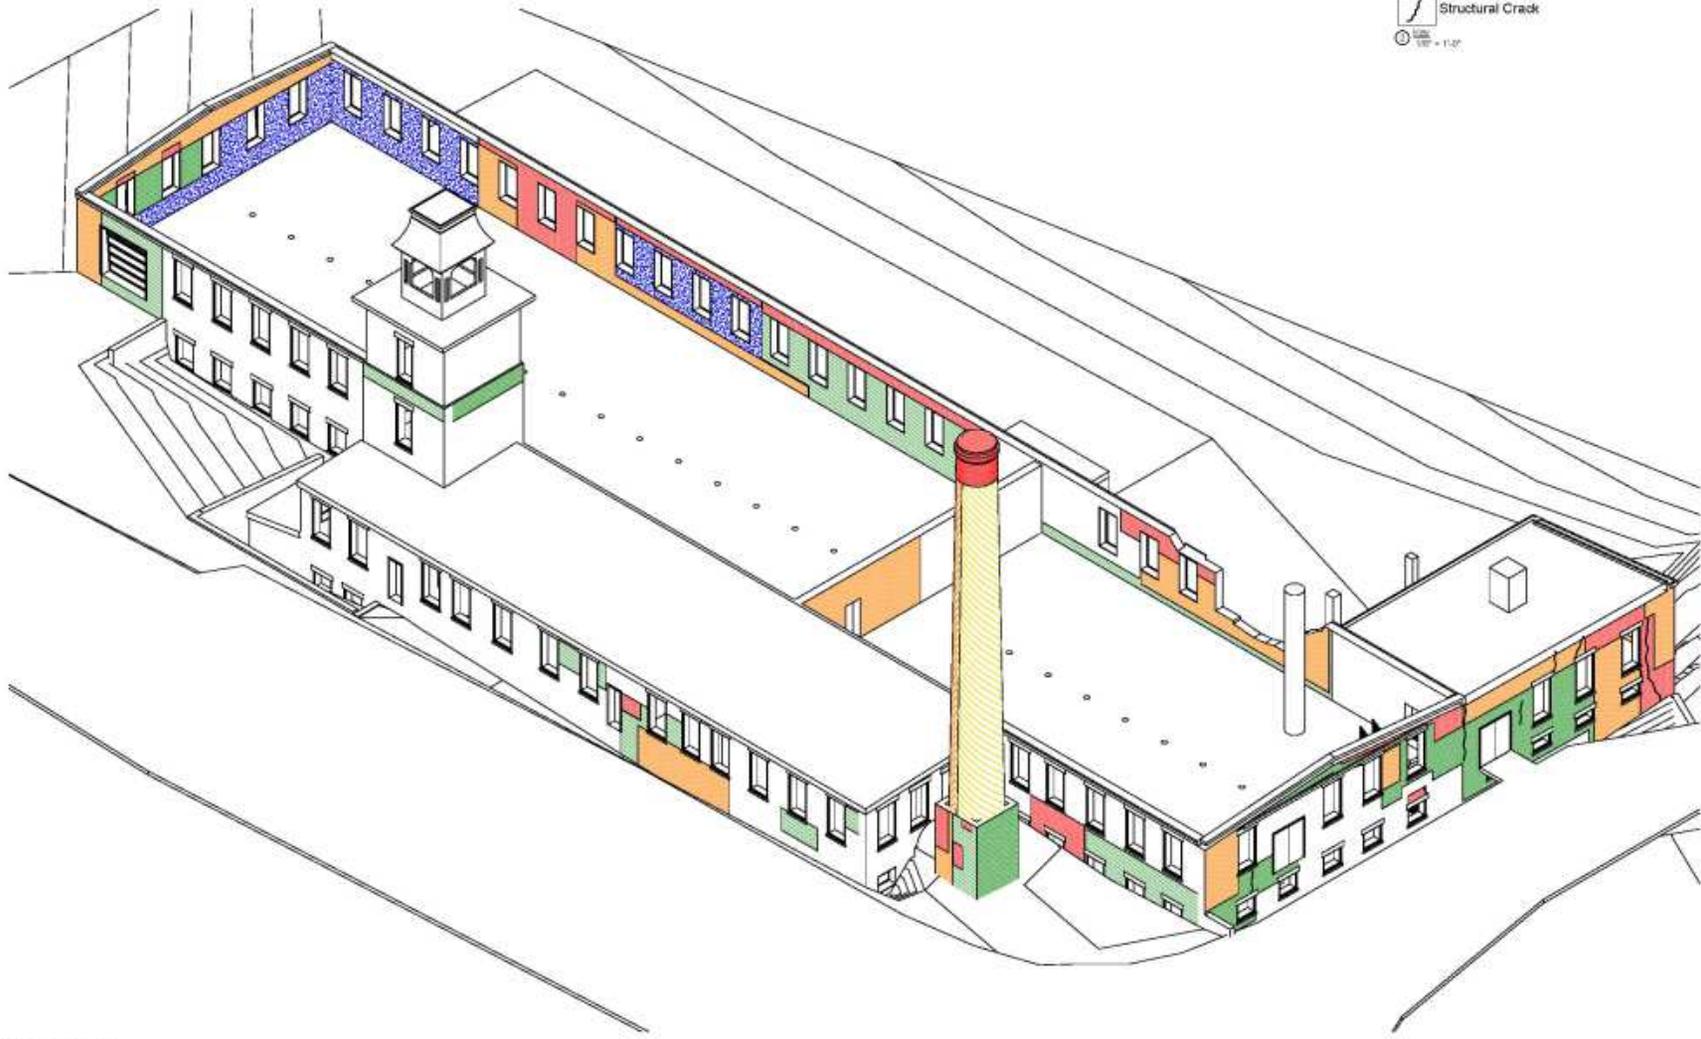
- Surface covered with bonded plaster.
  - Intact but with scattered to moderately eroded mortar joints.
  - Deeply eroded mortar joints and scattered loose bricks or stones.
  - Badly deteriorated, friable mortar, stones loose, shifting.
  - Structural Crack
- 1/8" = 1'-0"

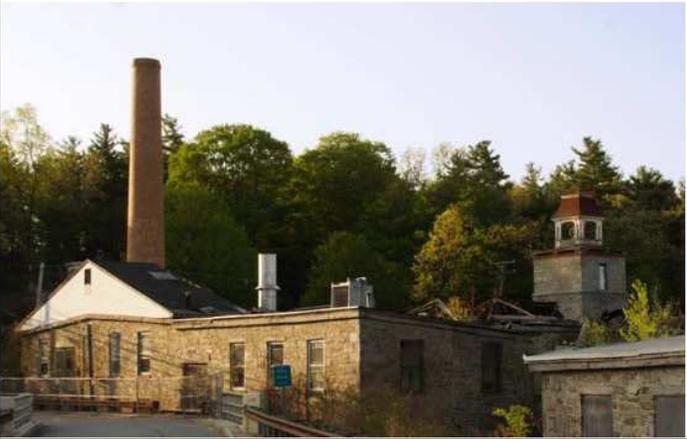
<p>Demolish and remove entire building complex, including floor slabs, foundations and footings. Demolish smokestack. Fill subterranean pits flush with grade with crushed stone and clean gravel fill.</p>	<p>Provide temporary timber and/or steel shoring and bracing to stabilize extant floor beams and cantilevered masonry wall segments, throughout. Maintain tarps at vulnerable (e.g., upward-facing rubble stone) masonry areas. Deeply cut and point most eroded and loosened masonry to prevent further damage or collapse; inject cracks with hydraulic lime grout; install crack monitor gauges. Provide temporary PVC roof drains as required.</p>	<p>Deconstruct and remove all timber floor framing and decking and designated masonry wall segments at main mill block and other badly-deteriorated areas. Brace and shore existing framing and masonry as required at south ell, bell tower and north wing. Rebuild loosened and/or collapsed masonry; deeply cut and point most eroded mortar joints to prevent further damage while re-setting loose stones; inject cracks with hydraulic lime grout; install crack monitor gauges. Provide metal cap flashing at all vulnerable (e.g., upward-facing) masonry areas.</p>	<p>Deconstruct and remove all timber floor framing and decking and designated masonry wall segments at main mill block and other badly-deteriorated areas. Repair/reset/rebuild deeply eroded stone masonry areas. Rebuild loosened and/or collapsed masonry; deeply cut and point most eroded mortar joints to prevent further damage while re-setting loose stones, conventionally cut and point remaining masonry and inject cracks with hydraulic lime grout. Ered wood- and/or steel-framed canopies to protect exposed masonry; integrate shade shelters, pergolas and/or viewing platforms as applicable.</p>
