**FORMER ABBOT WORSTED COMPANY MILL #1**  
**12 North Main Street, Graniteville, Westford, MA**

**PROGRESS MEETING**  
**12 NORTH MAIN STREET TASK FORCE**  
**July 22, 2015**

**Bargmann Hendrie + Archetype, Inc.**  
**Structures North Consulting Engineers, Inc.**

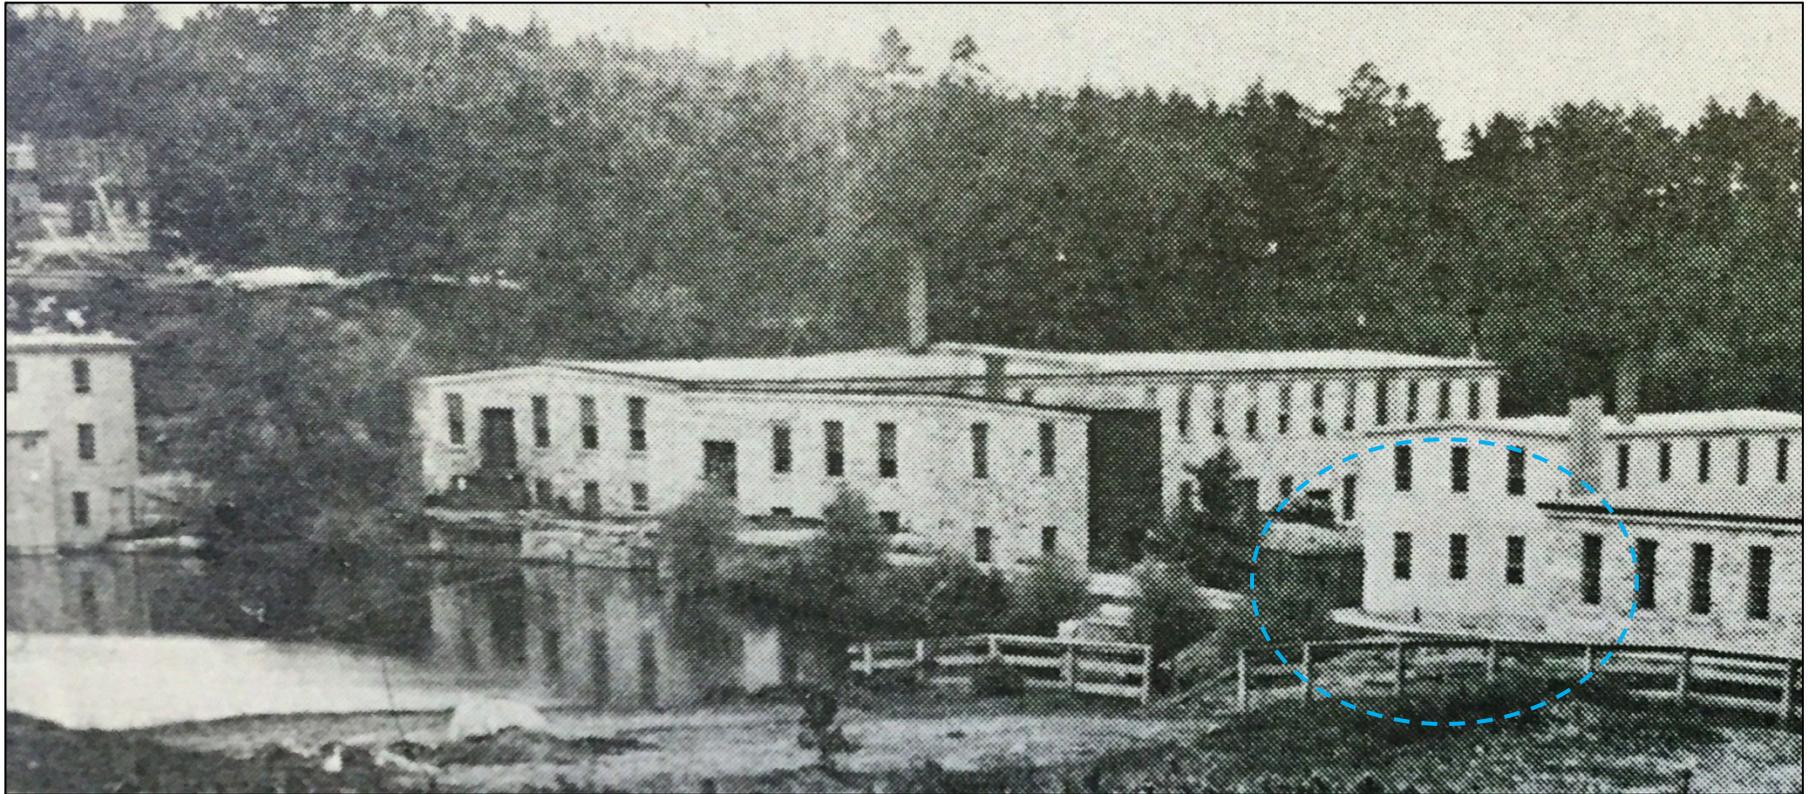
This photograph from the J.V. Fletcher Library collection appears to predate 1880 – well before the bell tower was constructed. Curiously, the original smokestack does not appear here, nor does the wood picket fence. The privy lean-to (center of photo) clad in flush wood siding is painted black at this juncture. Note that the Mill #3 wing has a shed roof sloping away from Broadway. The extant Sargent's Sons building north addition does not yet appear.

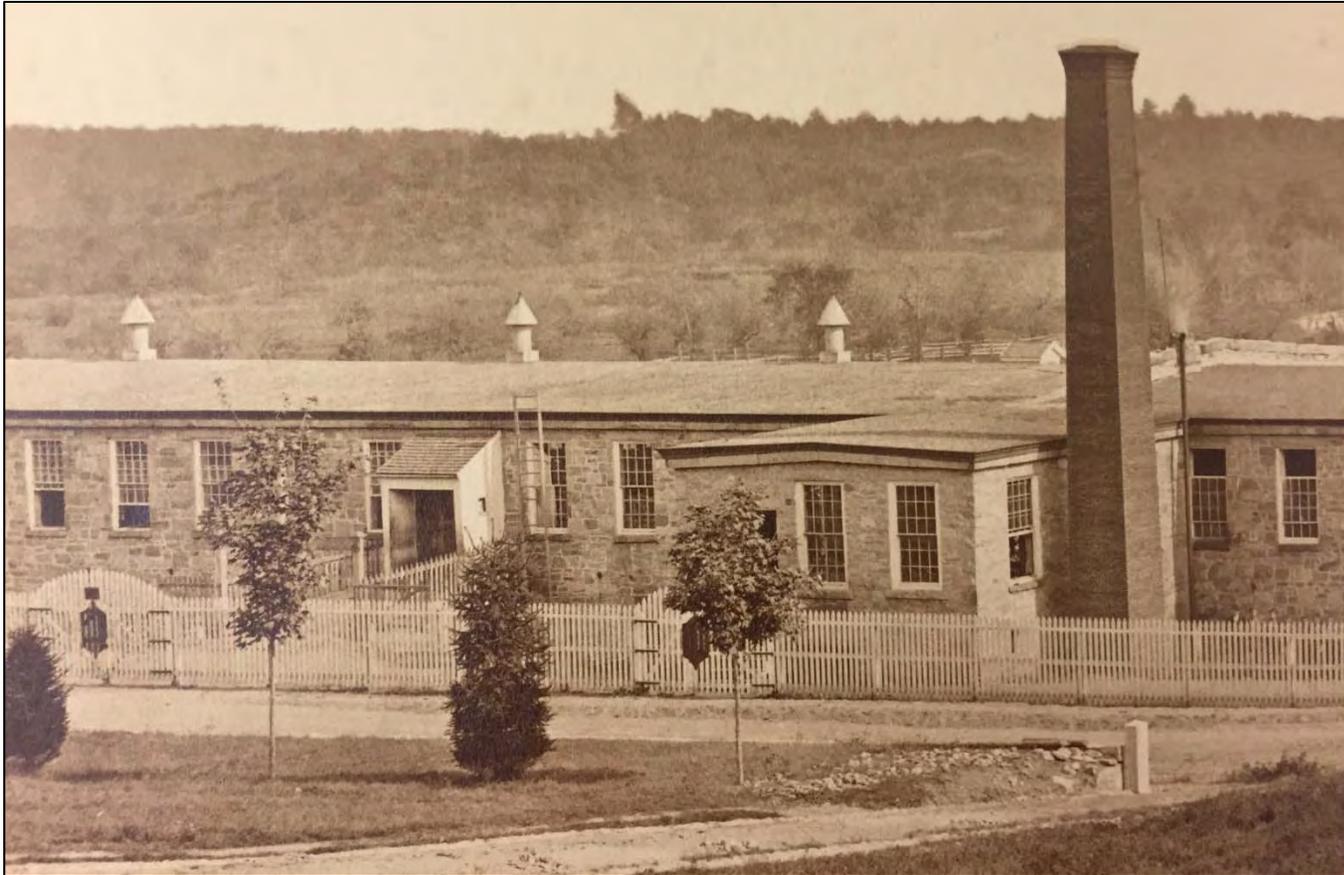
Enlarged portion of photograph from the J.V. Fletcher Library collection illustrates the original boiler wing; extant iron or steel roof beams may belong to this wing.

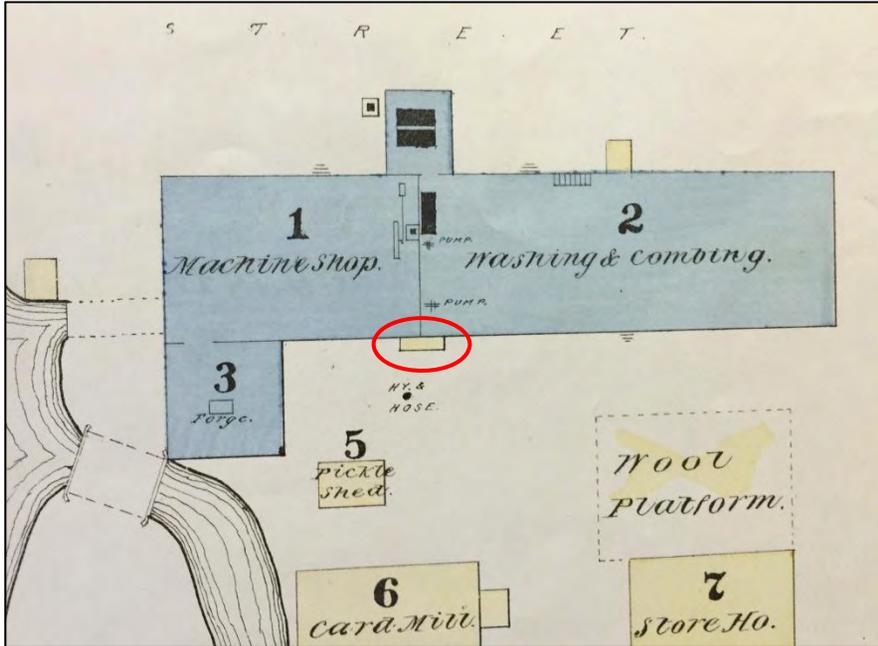
Prior to full occupancy by Abbot Worsted Company, Mill #1 was used by Charles G. Sargent & Sons as a machine shop. A wood-framed lean-to (shown circled) straddling both sides of the fire wall between Mills 1 and 2 housed privies; the addition survives in poor condition.

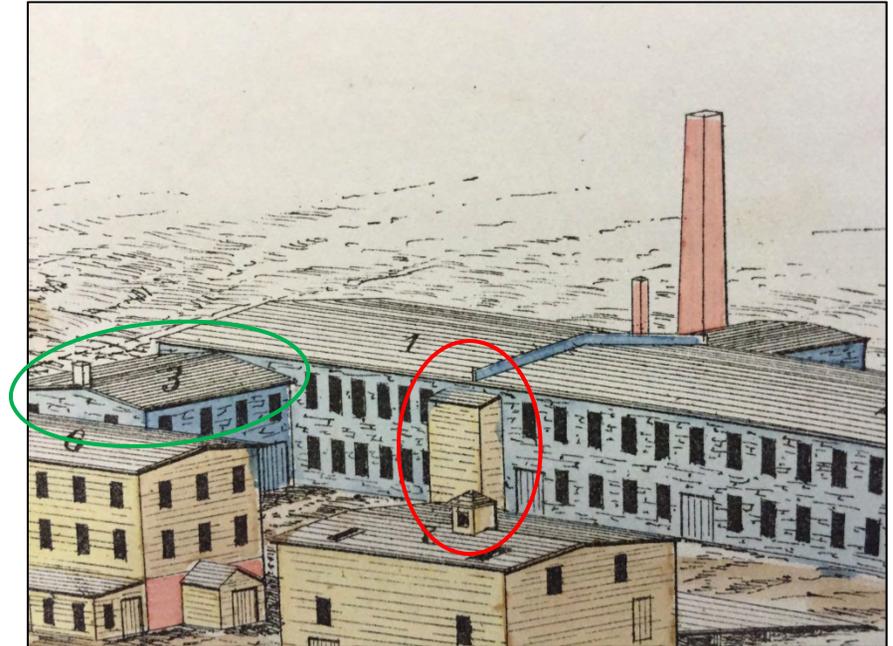
Crop from G.G. Sargent's Sons 1877 Survey #5011 (Barlow), which includes the wood-framed privy lean-to (circled in red). The Mill #3 "Forge" ell is illustrated with a shallow-pitch gable roof (circled in green) rather than the extant shed roof; this may have been a drafting error. Color plan and bird's eye view courtesy of ATHM.

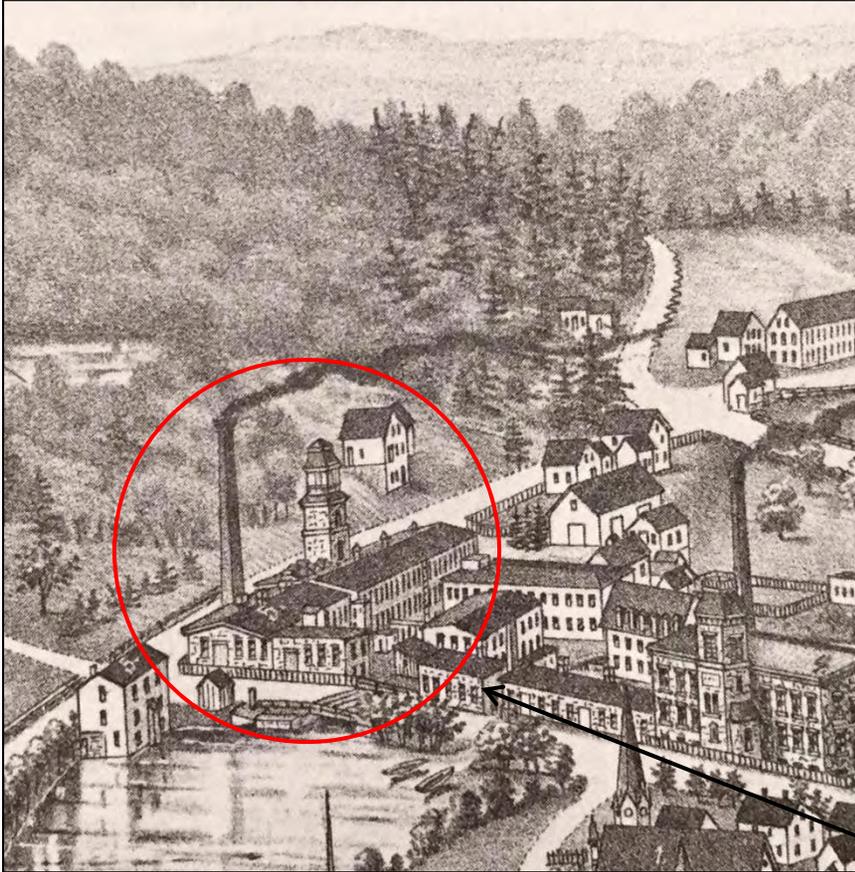
Inset from 1886 L.R. Burleigh bird's eye view of Graniteville; note the apparently exaggerated height of the bell tower. The original, square smokestack is indicated, as are the privy lean-to and what appears to be a stair tower between Mill #1 and the Mill #3 ell.

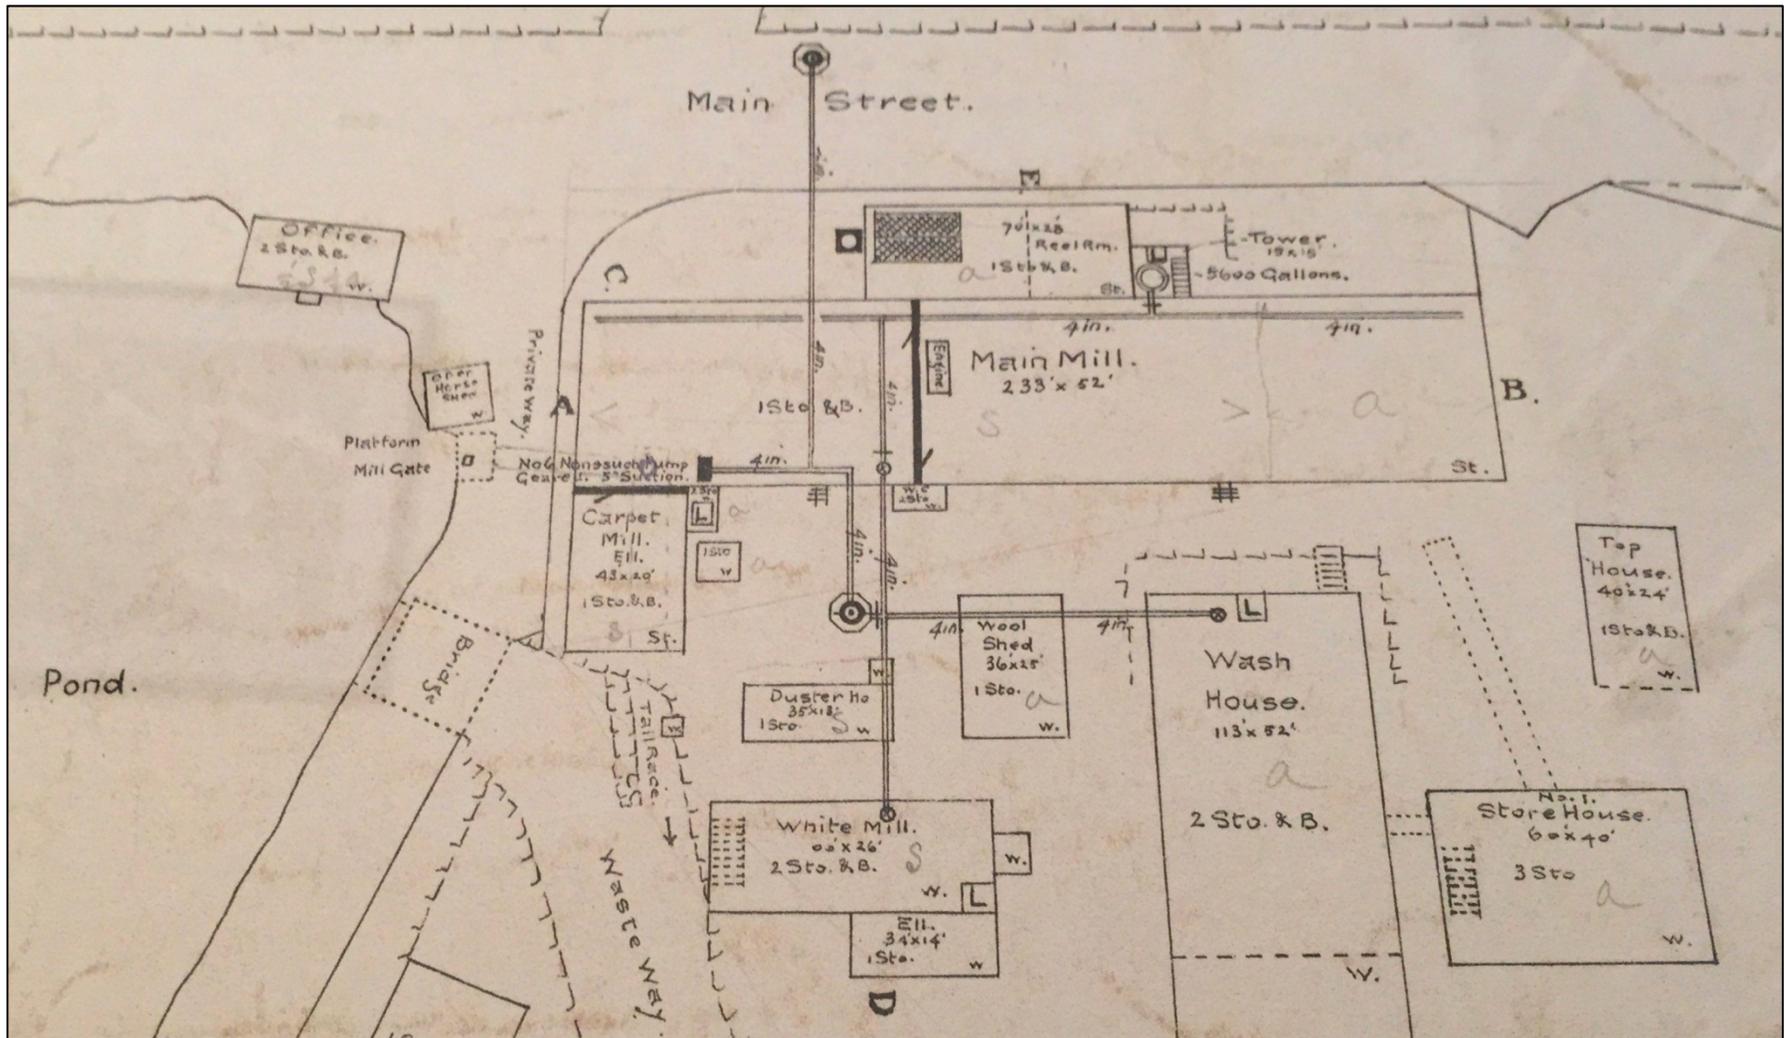
1890 Associated Mutual Insurance Co. map (courtesy ATHM); note fire suppression system (hydrants and pipes) and 5,600-gallon water tank indicated in bell tower. A stone retaining wall encloses a portion of the tower area.

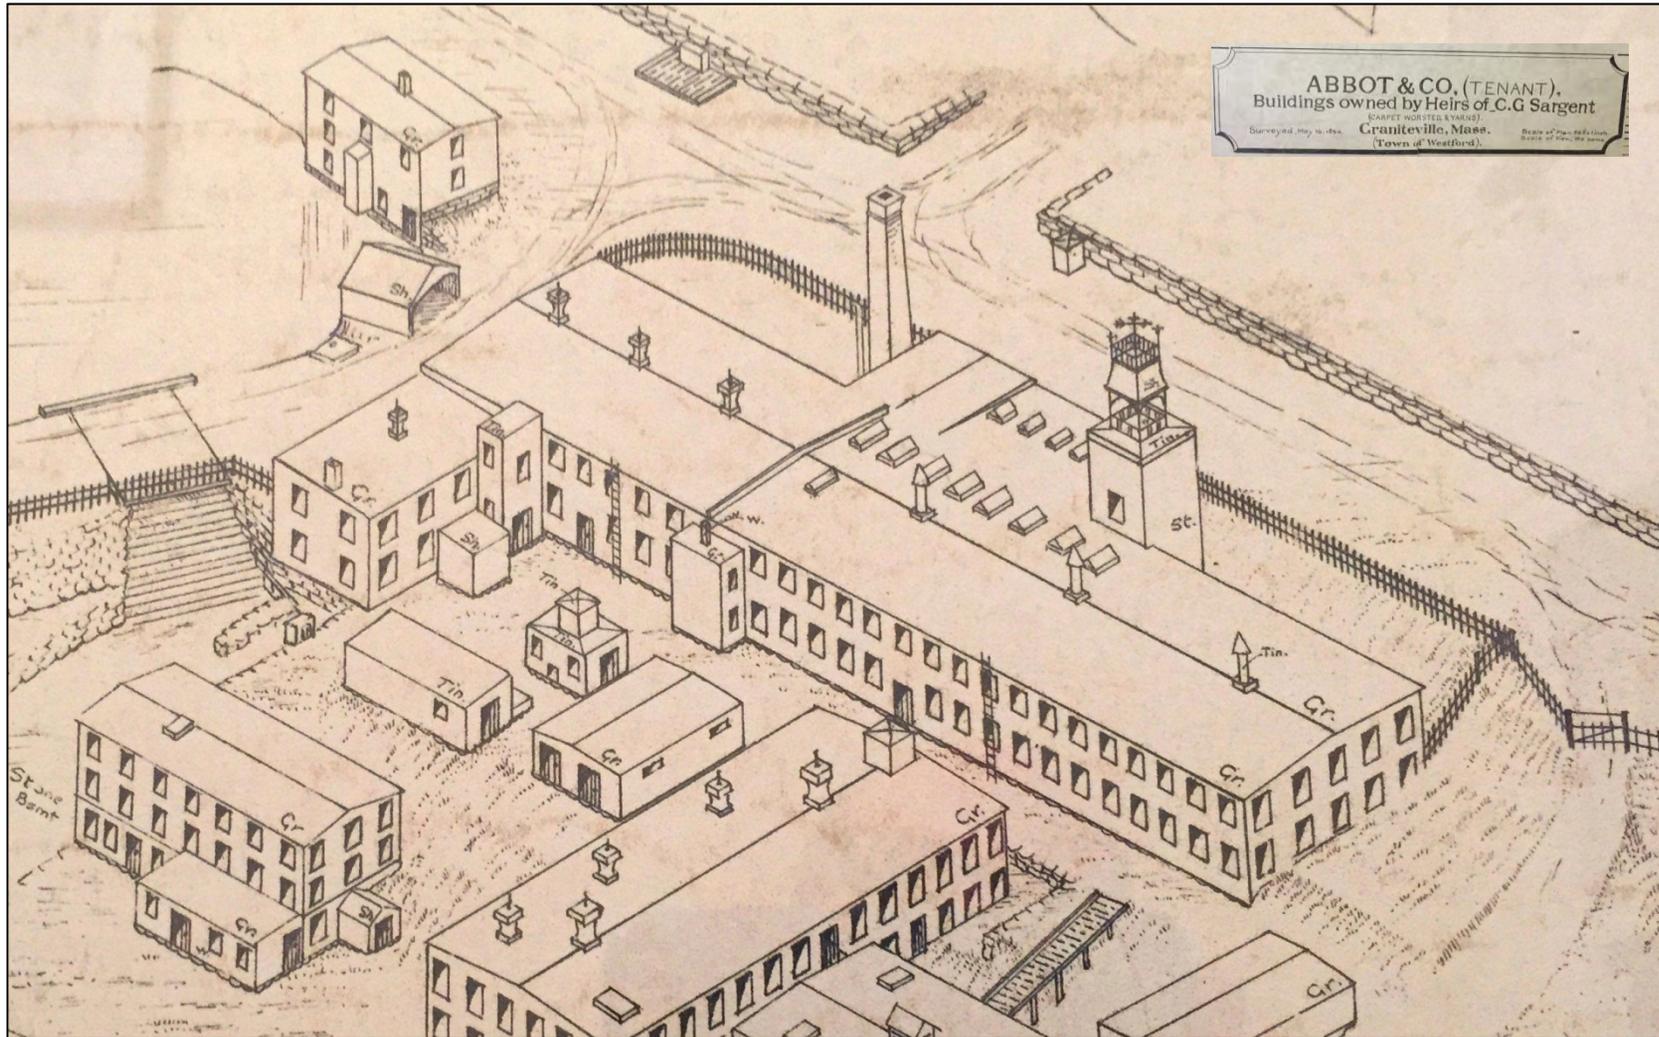
1890 Associated Mutual Insurance Co. survey bird's-eye view; the boiler wing and adjacent square-plan chimney are still intact, but have been expanded and joined by the bell tower. Note various features and amenities.

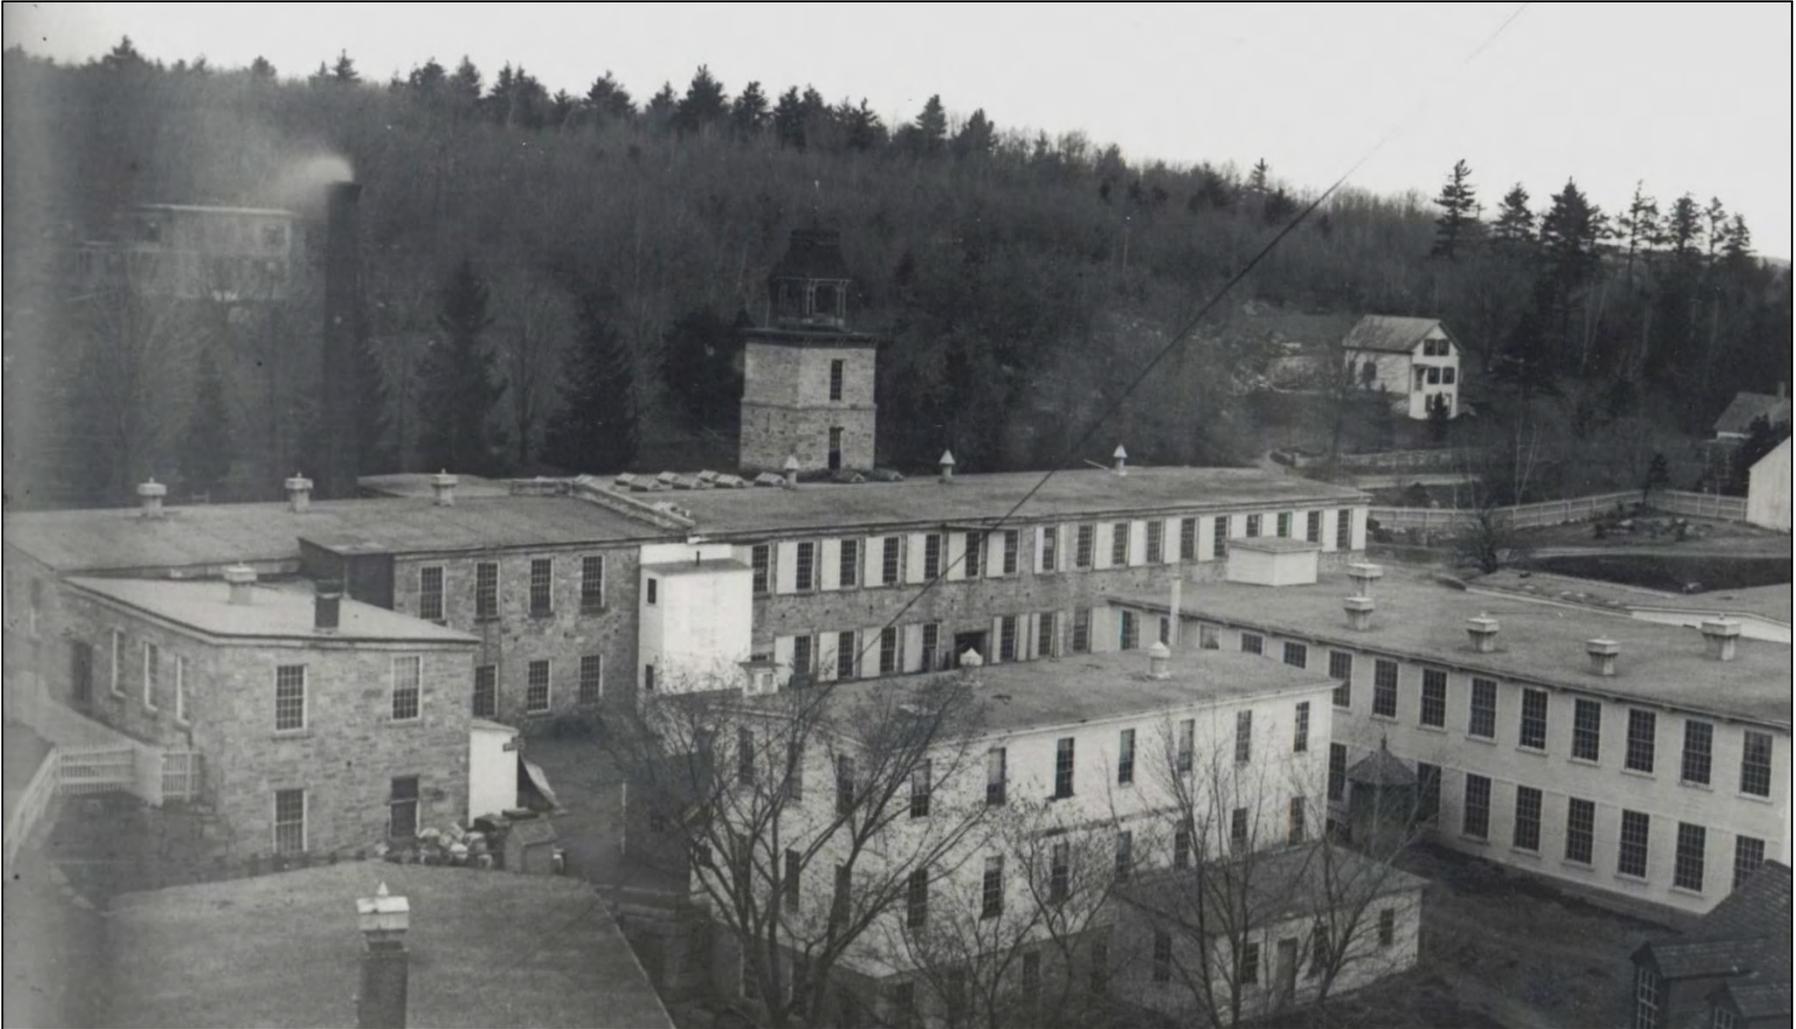
In this Quincy W. Day photograph shot in 1900, the square smokestack remains. The roof access and/or fire escape ladders have been removed and the Mill #2 windows have been protected with shutters.. (Source: WHM and HS)

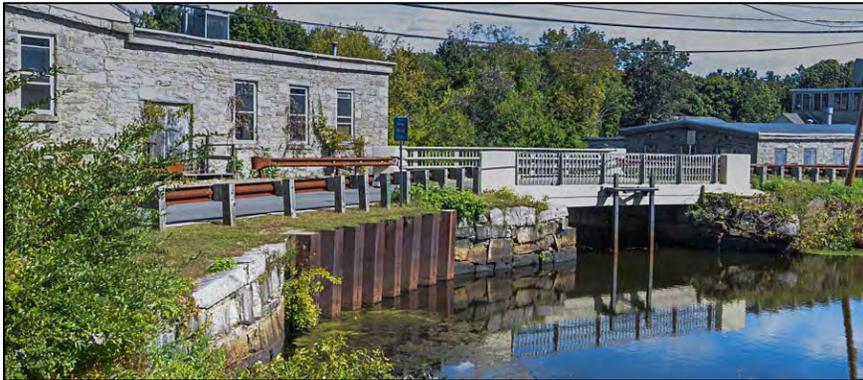
Extant mill pond edge walls and sluiceway date to ca. 1857.

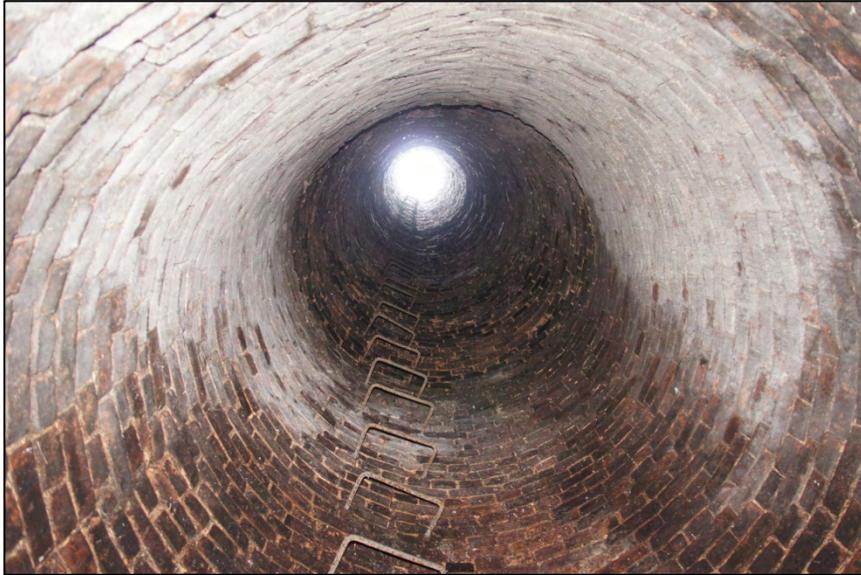
According to the Graniteville Historic District nomination form, the extant cylindrical smokestack constructed of radial brick (see brick photo below) was erected ca. 1880, but insurance drawings and Quincy Day photographs show that the original smokestack survived until at least 1900.

The extant smokestack was probably erected just after the turn of the century.

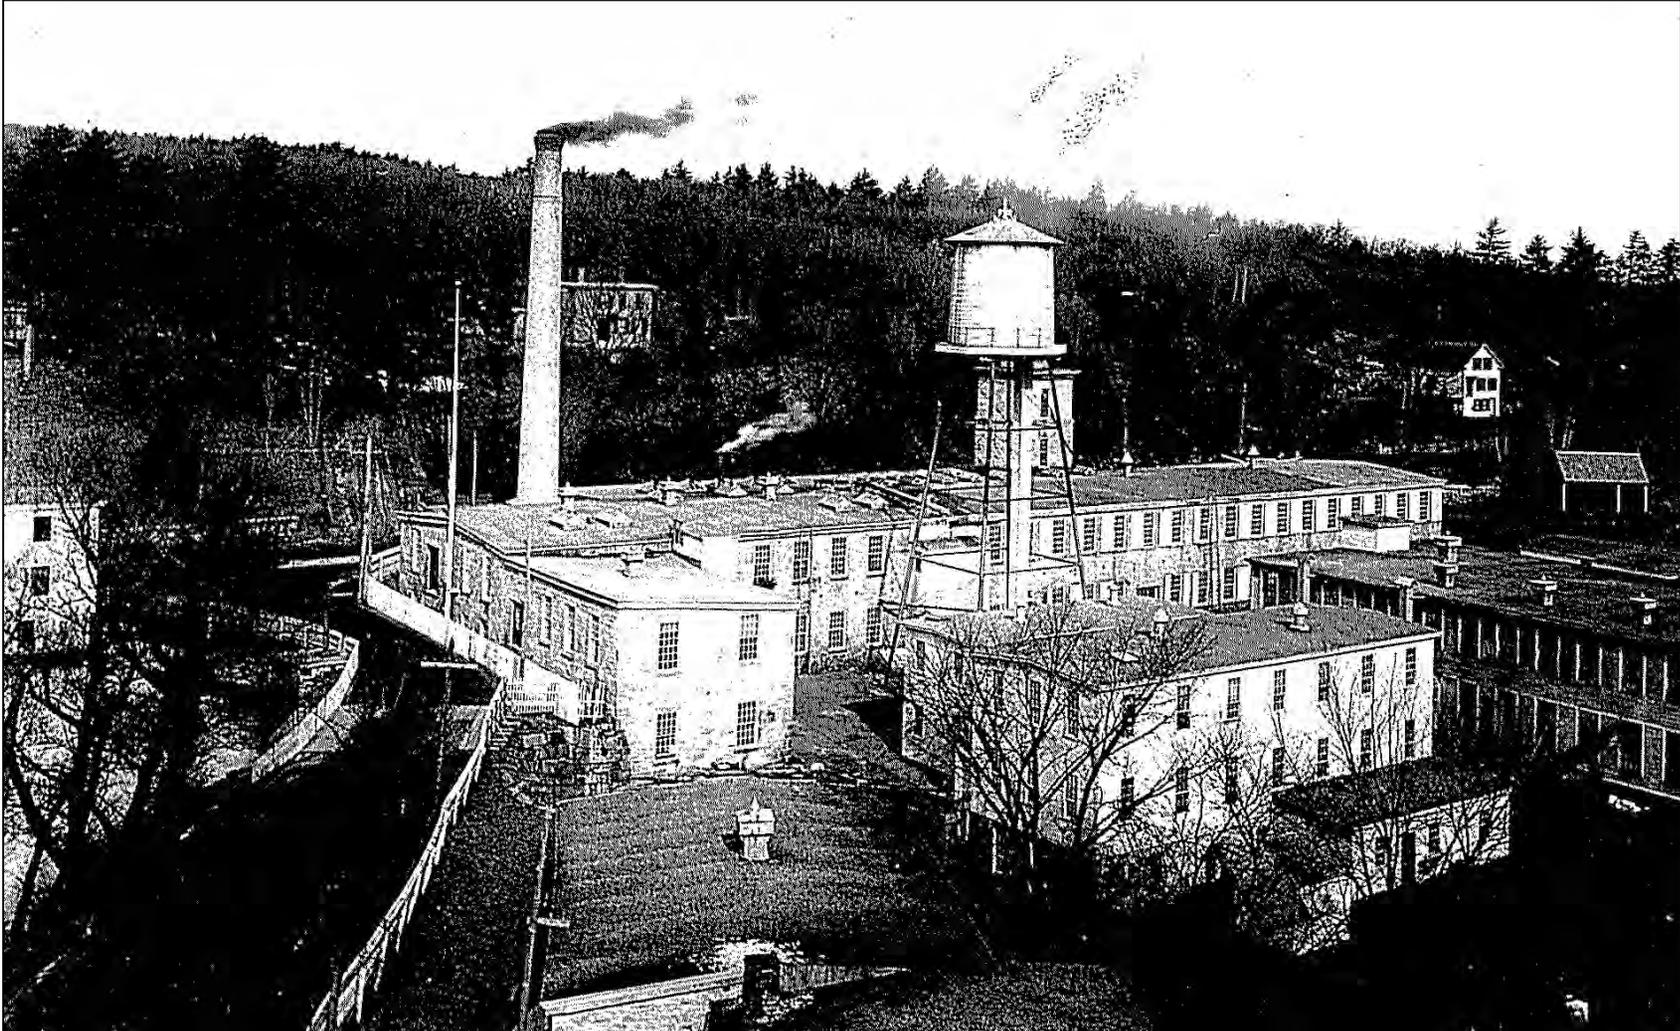
In this undated photograph, the extant hollow-cored radial brick chimney and a new staved-wood cistern elevated on steel pylons appear.

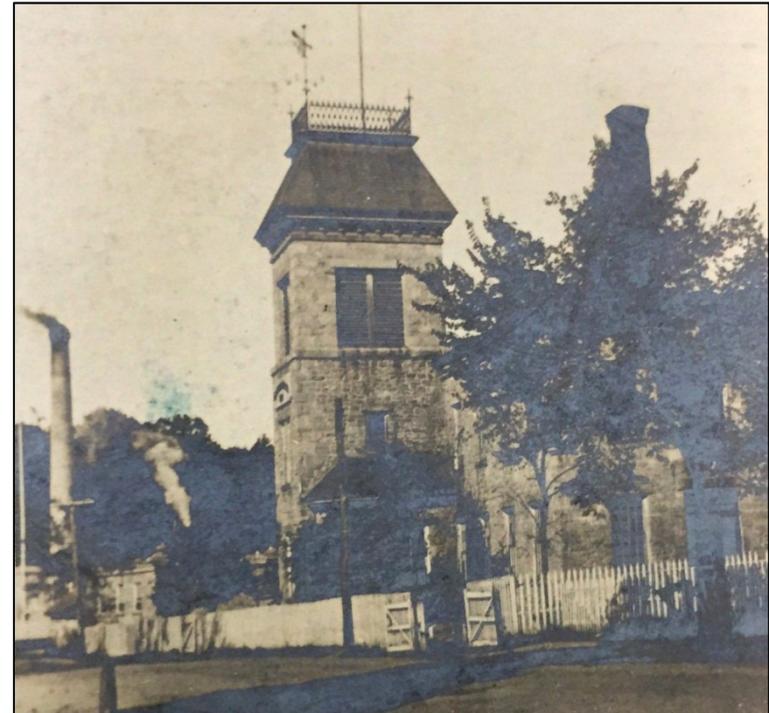
Ca. 1906 photo illustrates the new (soot-stained?) smokestack beyond and includes telephone wires and the flag pole, far left. The white picket fence appears to be a C.G. Sargent's Sons "standard" feature.

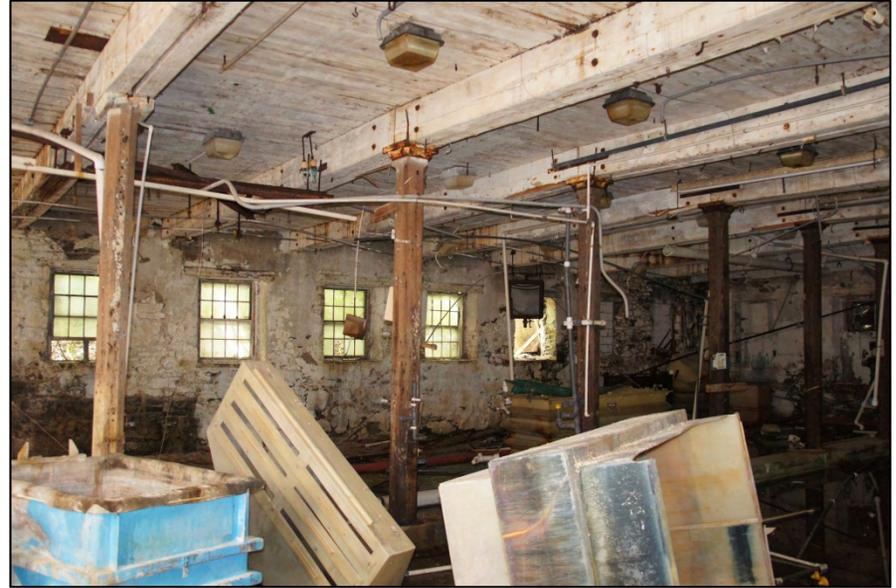
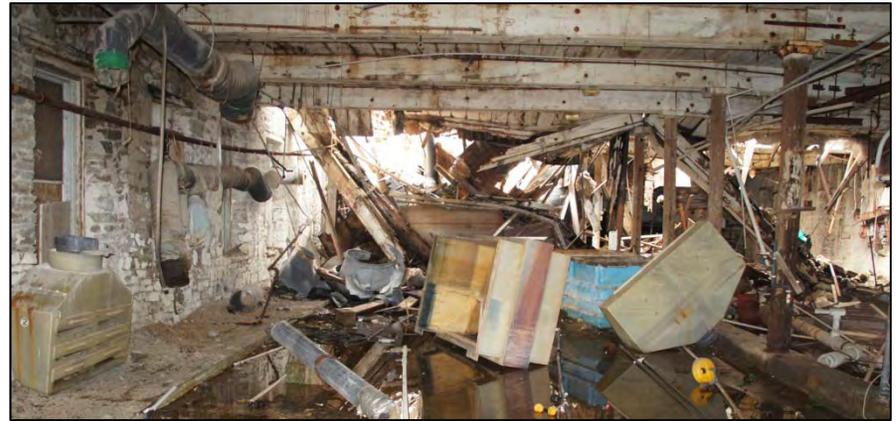
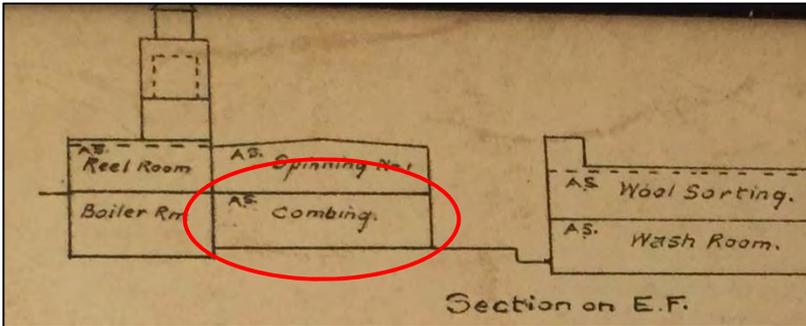
Cross-section from 1890 Associated Mutual Insurance Co. map (courtesy ATHM).

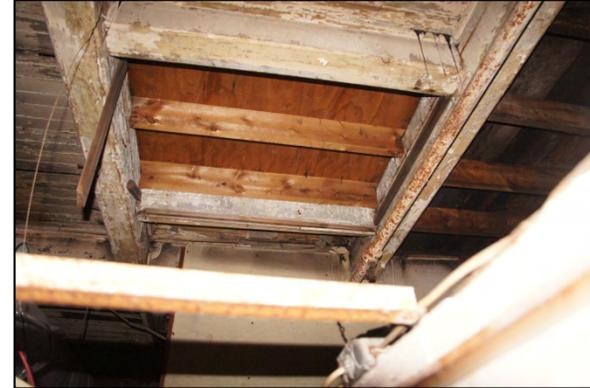
Boarded-over skylight opening.

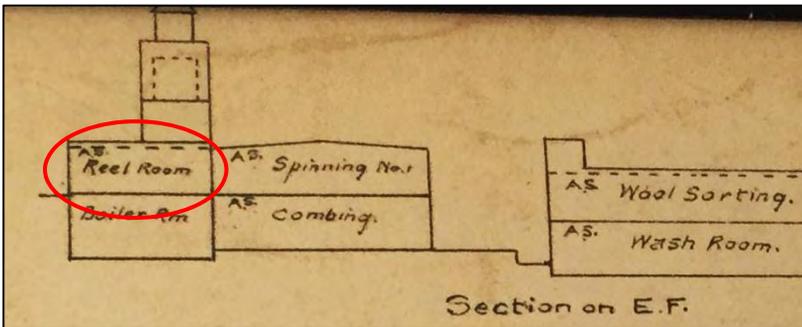
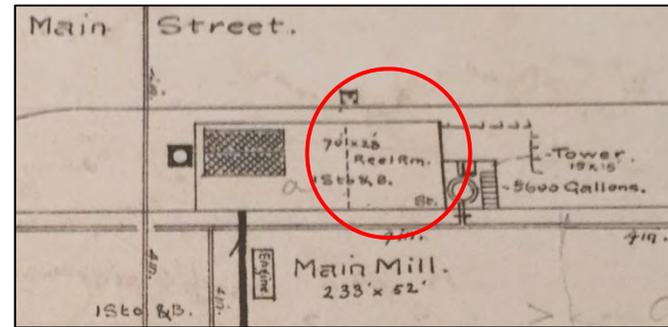
Cross-section and plan from 1890 Associated Mutual Insurance Co. map (courtesy ATHM).

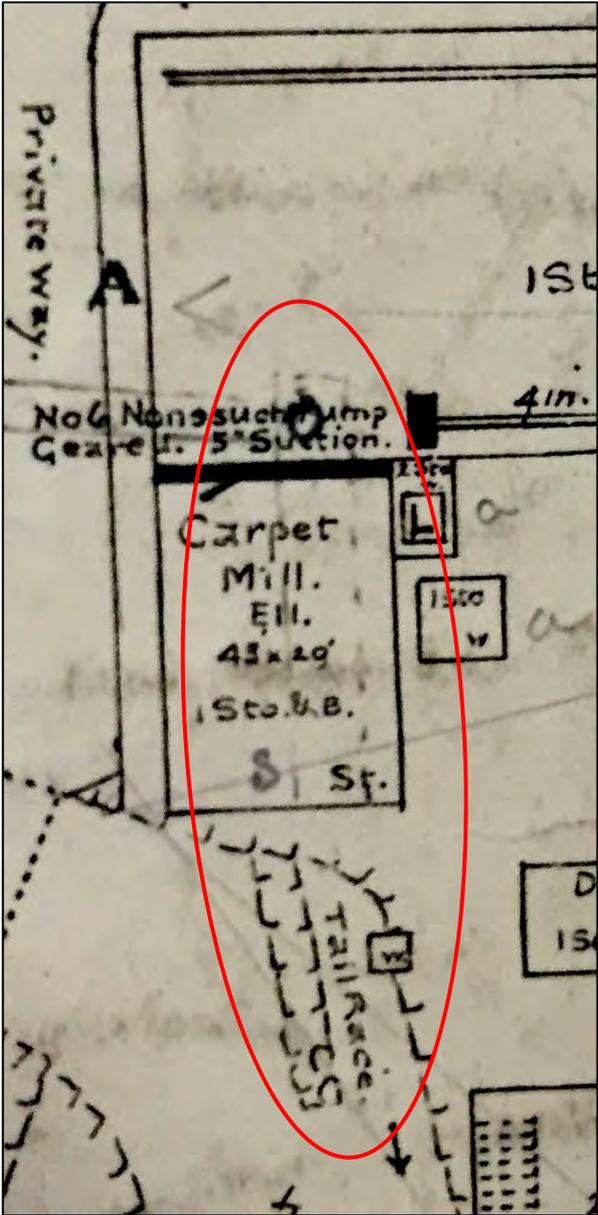
Crop from 1890 Insurance Map (ATHM); note penciled-in sluiceway.

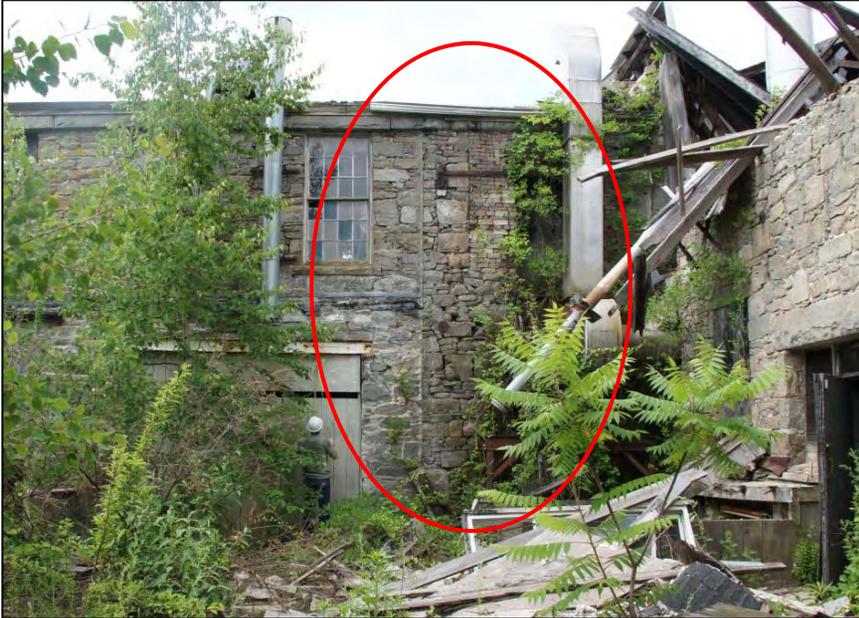
East façade of Mill #3 "ell"; note ghosting in stone masonry of former stair tower addition.

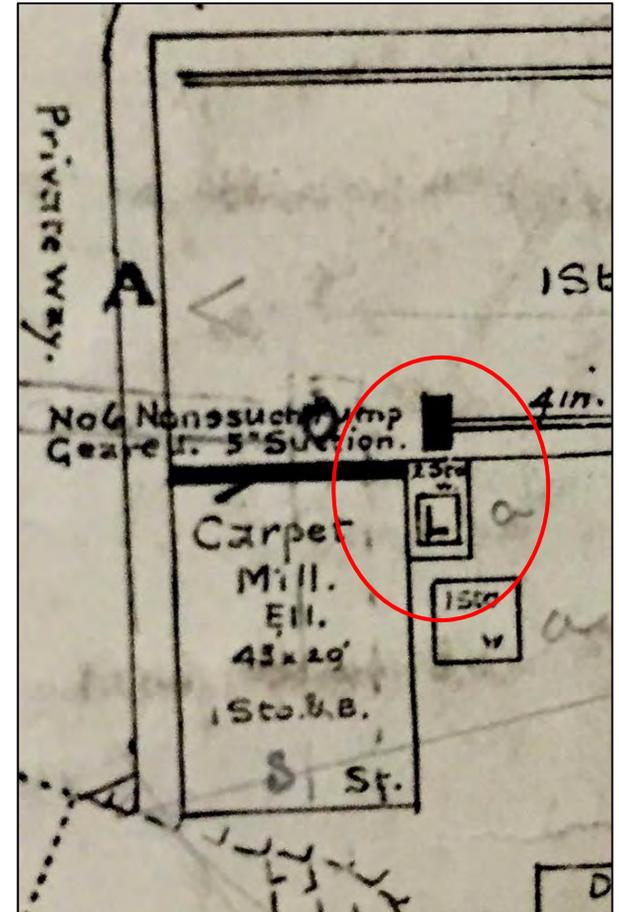
Crop from 1890 Insurance Map (ATHM); note 1-story lift/elevator, designated "L."

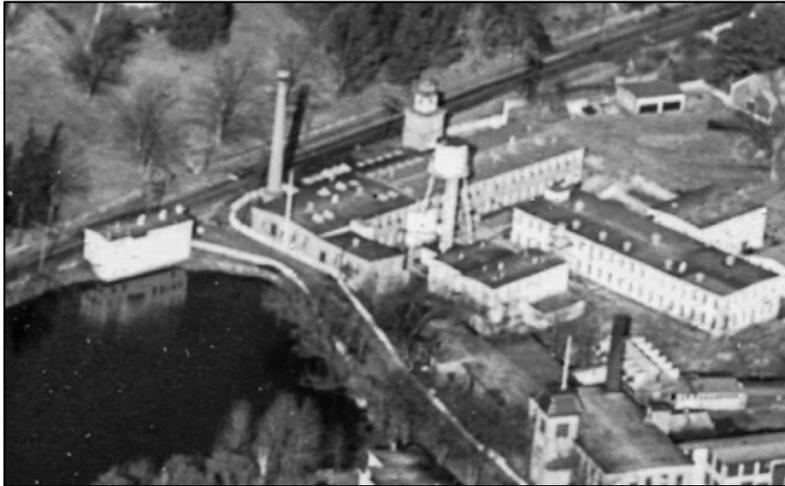
Ca. 1955 aerial photo; water tower and wood fencing were still extant. (The 1866 mill office building was enlarged during the 1920s-30s and demolished ca. 1958.)

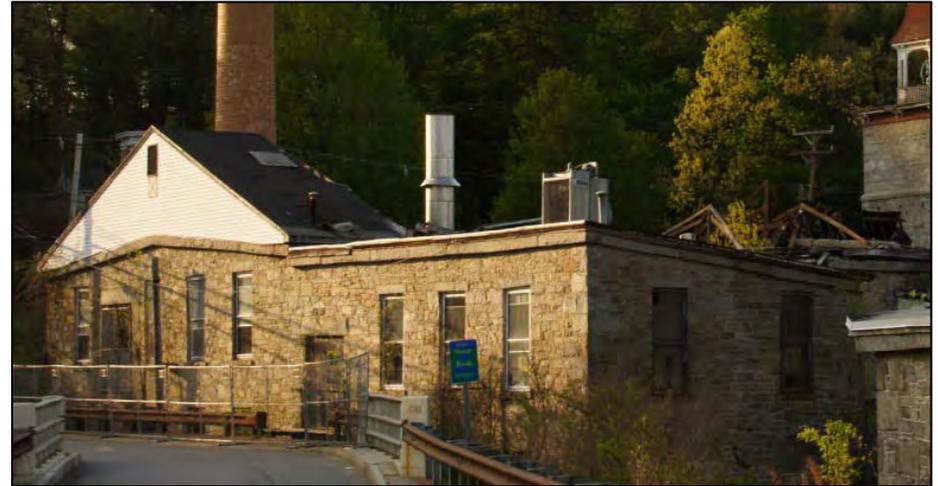
The low-pitched gable roof of Mills #1 and #2 was removed and replaced with a prefabricated truss system after 1970.
