12 NORTH MAIN STREET PROJECT UPDATE

Town of Westford Select Board Meeting
April 8, 2025

NEXT CRITICAL STEP: STRUCTURAL ASSESSMENT

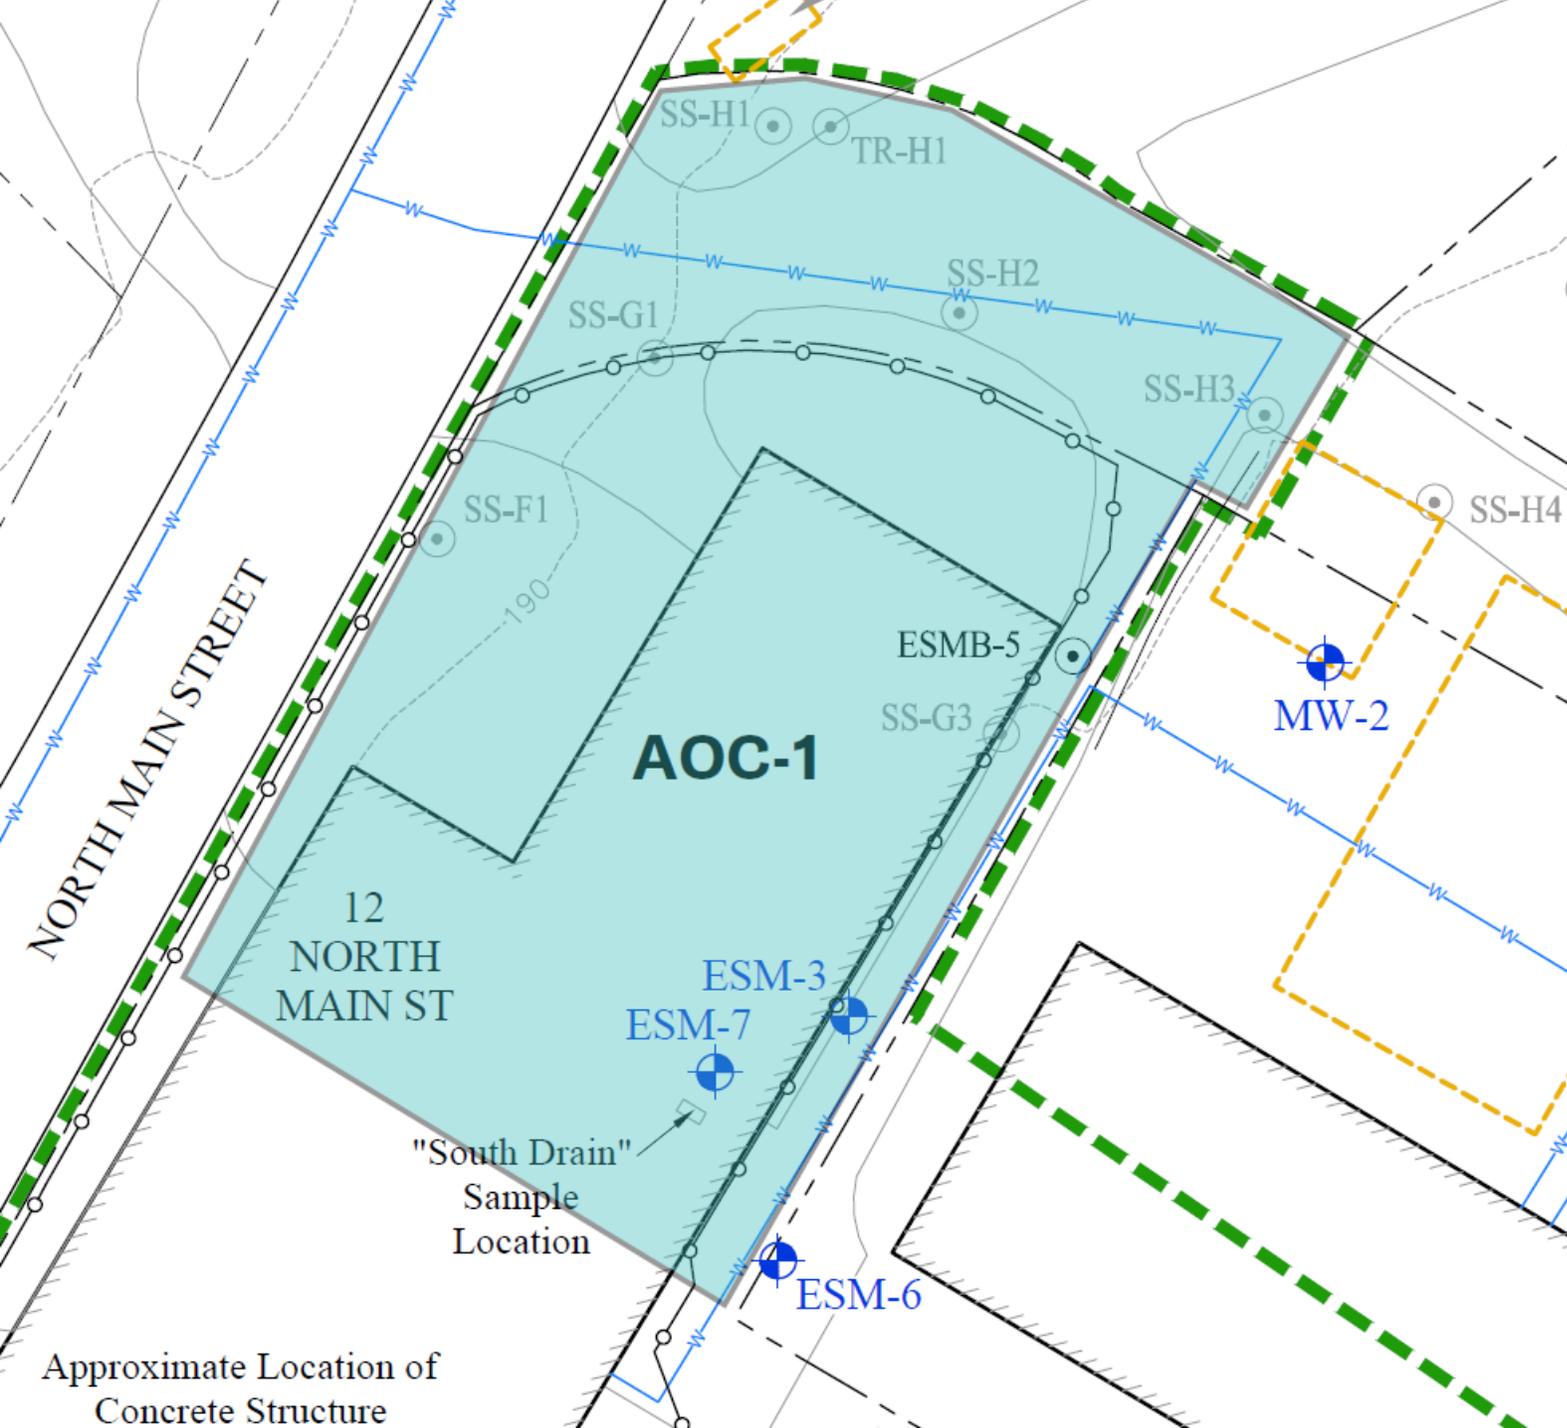
AOC-1

- Northern portion of the mill building and immediate surrounding area
- Building footprint inaccessible due to unsafe conditions
- Historical metals impacts to drains and groundwater
- Ongoing groundwater investigation and potential pilot study to develop water treatment, if necessary
- Assessment funded by MassDevelopment Grant

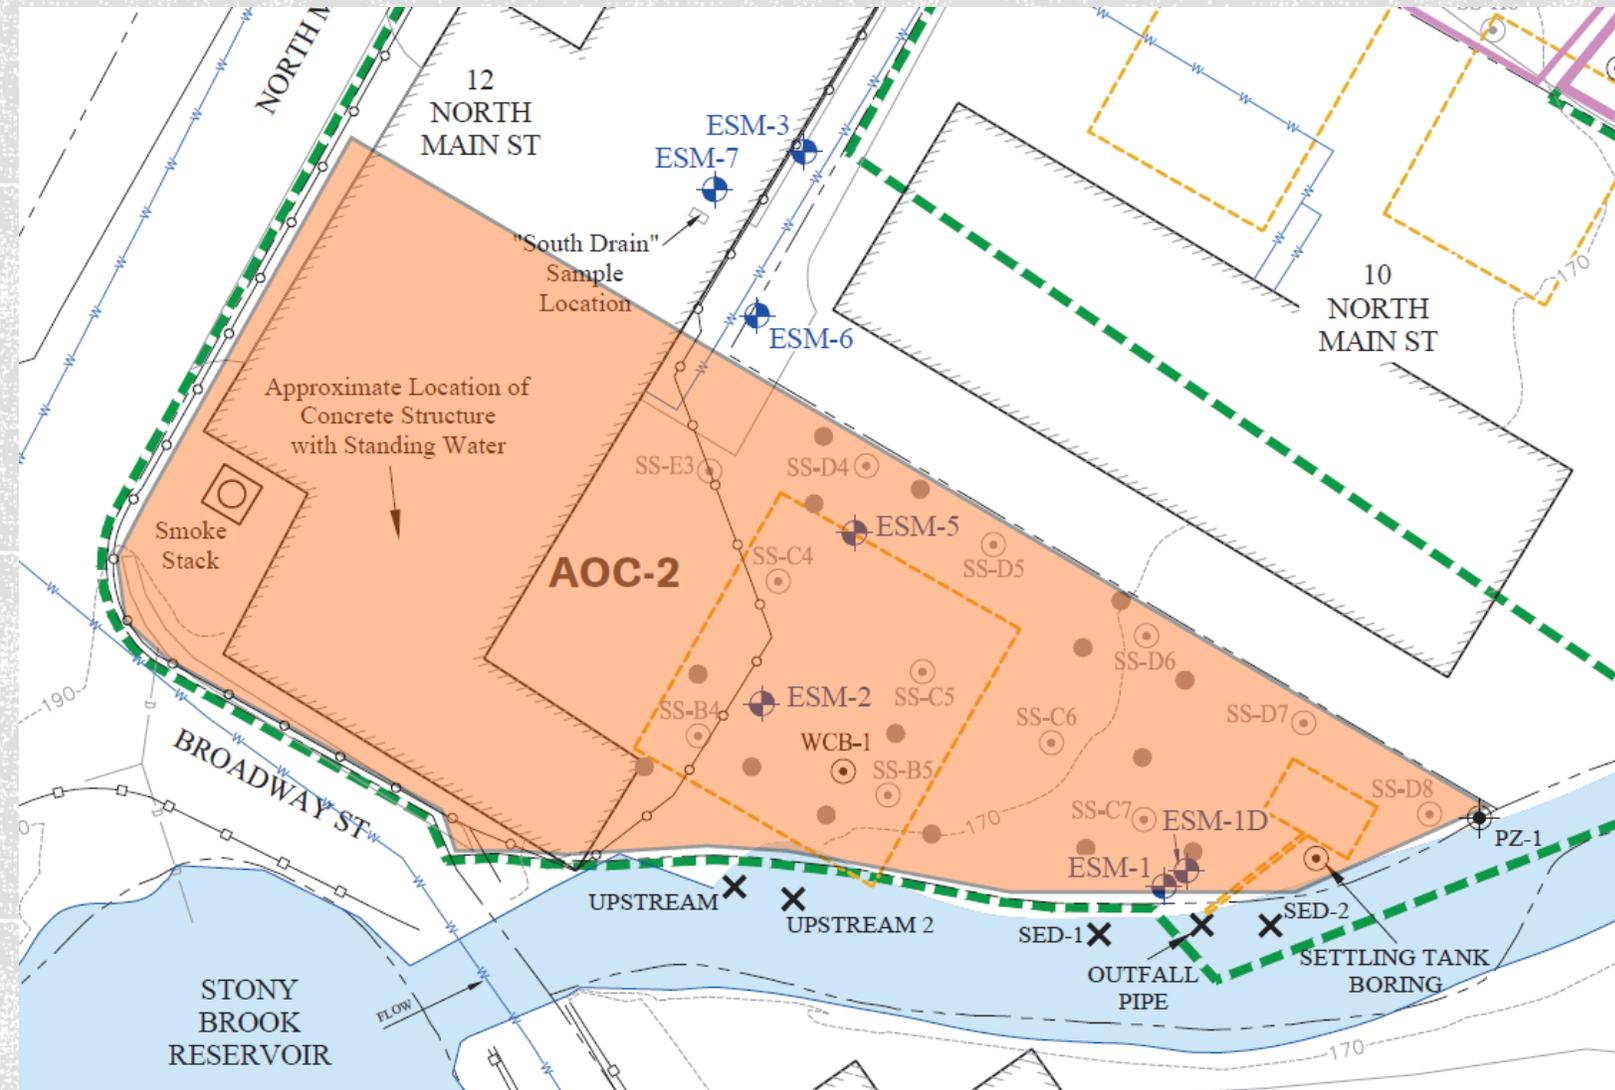
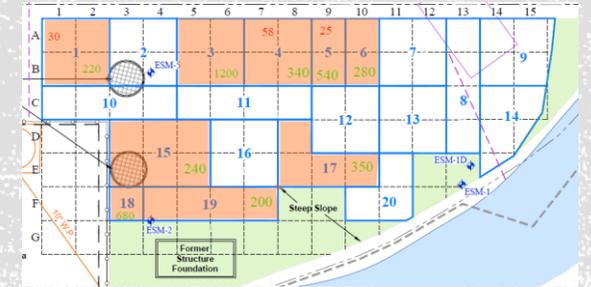
AOC-2

- Southern portion of the Site building and undeveloped area to the southeast.
- Building footprint is inaccessible due to unsafe conditions
- Lead and Arsenic impacts to surface soil from historical electroplating waste
- 2022 remedial action (limited soil excavation and off-site disposal)
- Pending remedial action (soil excavation) planned for early April
- Cleanup funded by MassDevelopment Grant

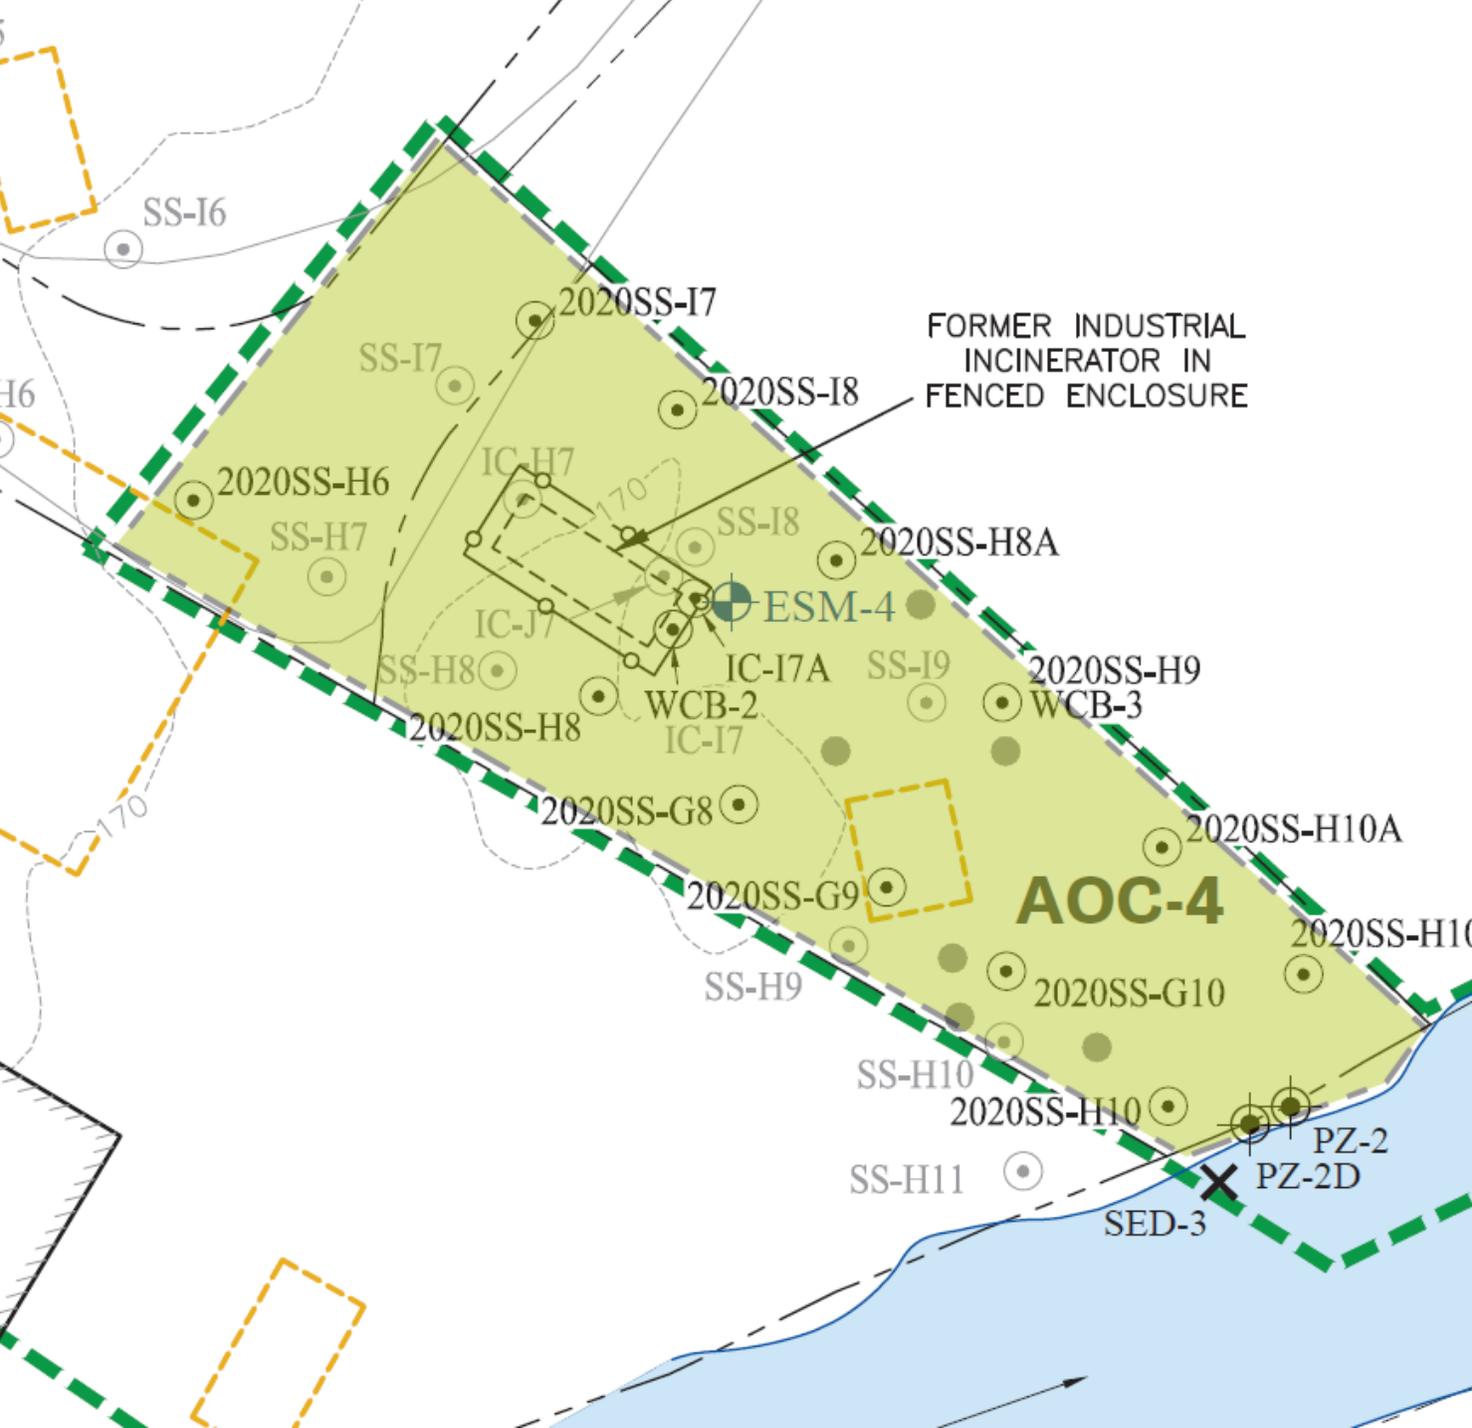
AOC-4

- Eastern portion of the mill complex surrounding the 300 SF incinerator
- Historical lead and dioxin impacts to surface soil, some at Imminent Hazard concentrations
- No hazardous materials identified during HBMS
- Ongoing soil investigation to define contaminant extents
- Pending incinerator demolition (early April) and soil excavation (TBD)
- Remediation funded by EPA Cleanup Grant

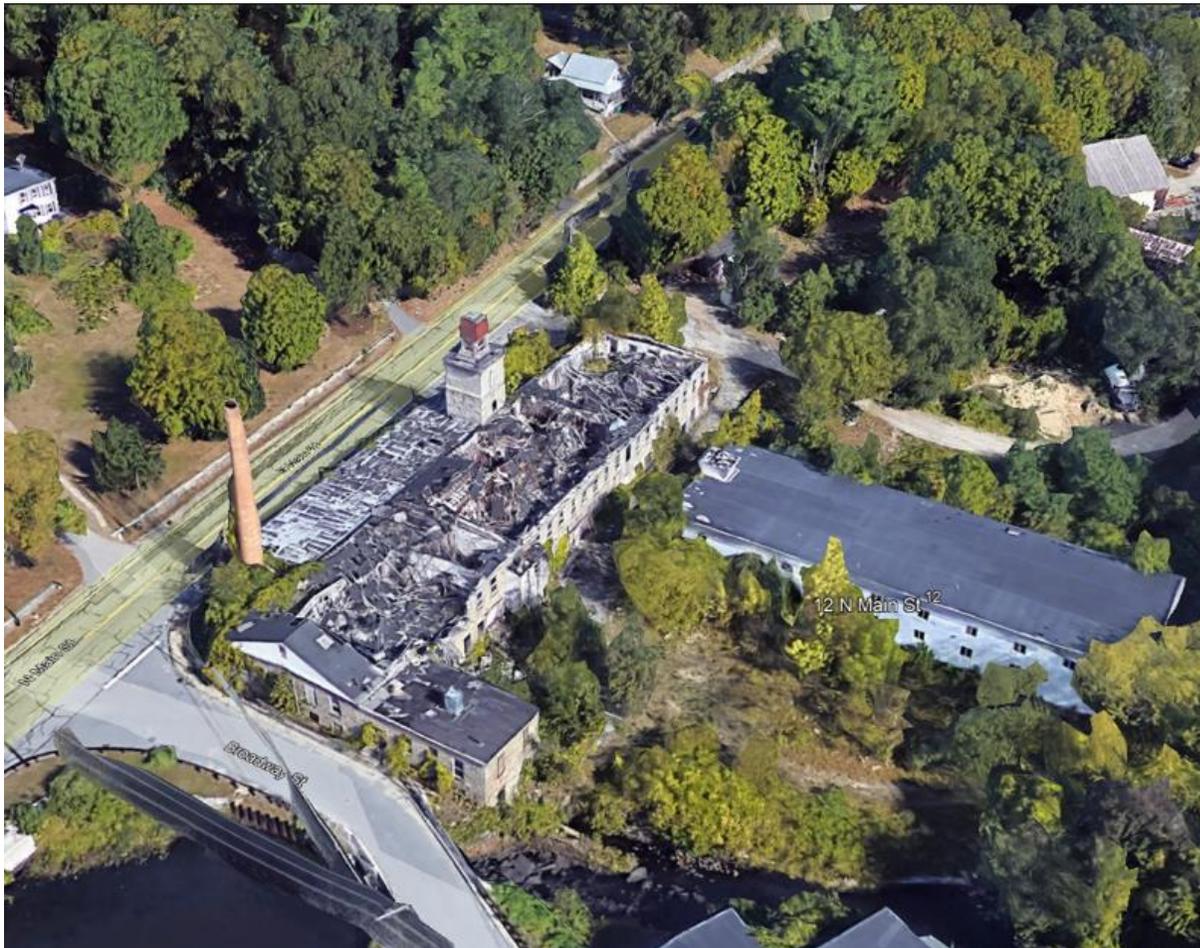
BUILDING COMPONENTS

1 = Main Mill

2 = Belltower

3 = North Addition

4 = Machine Shop

5 = Carpet Mill/South Wing/Forge

6 = Smokestack

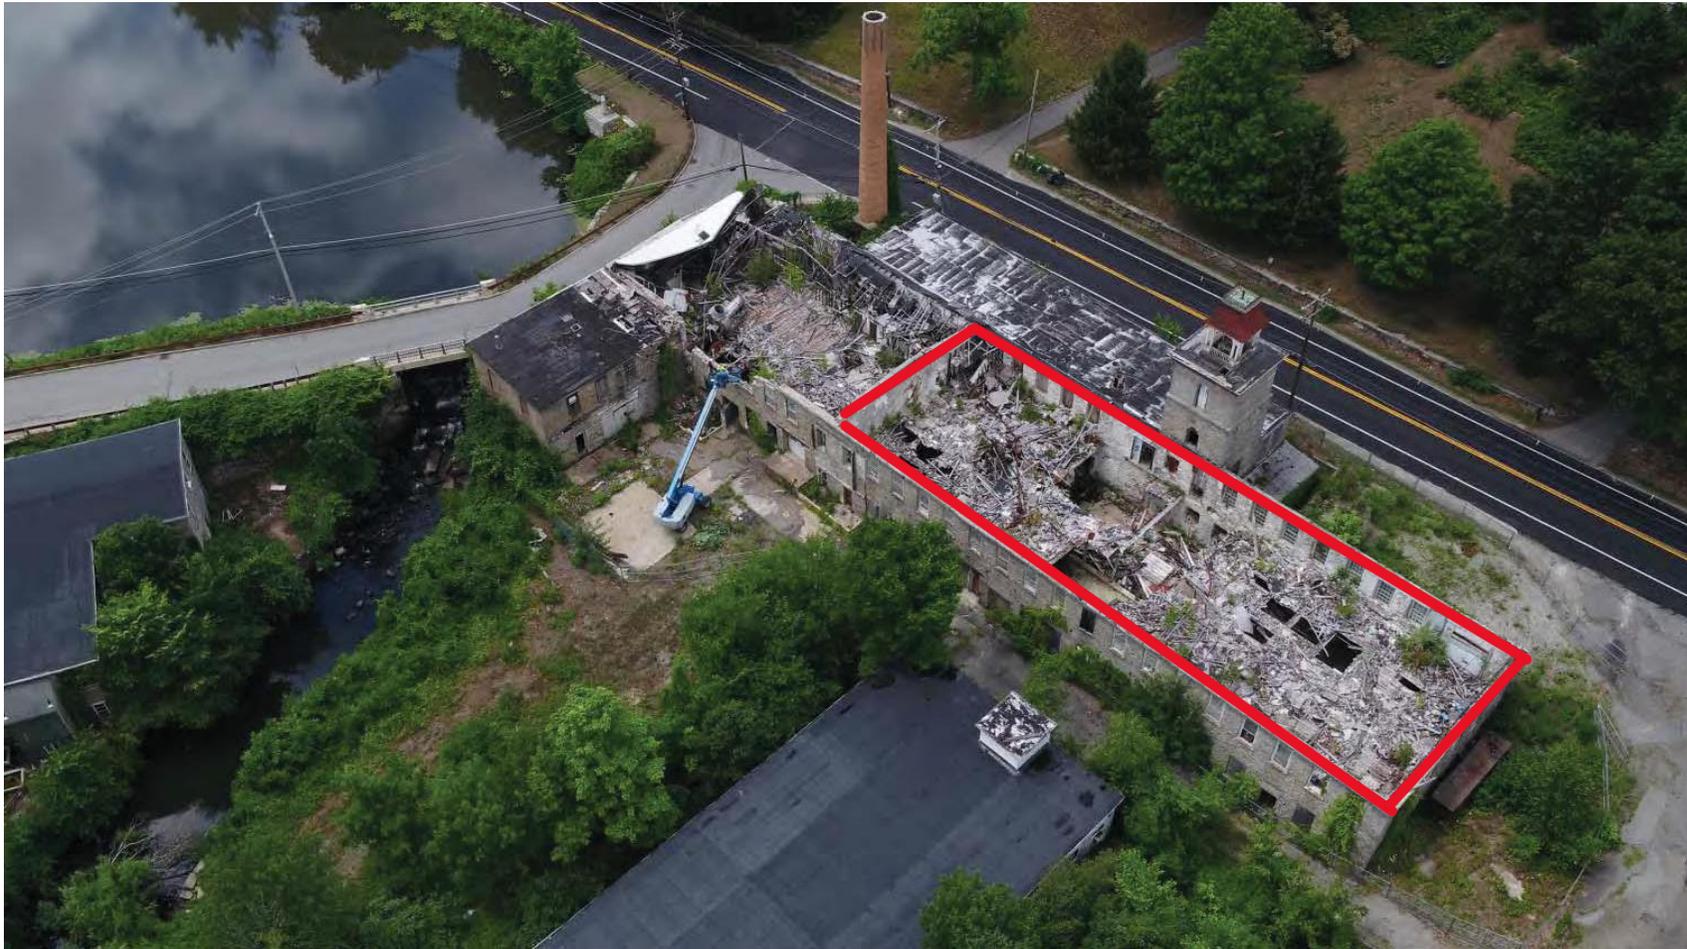
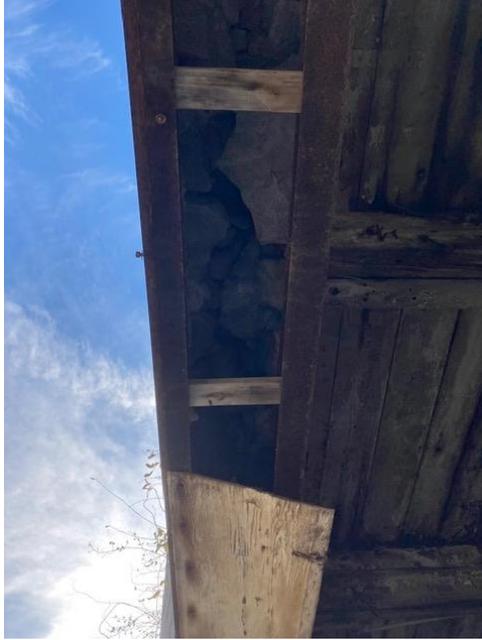
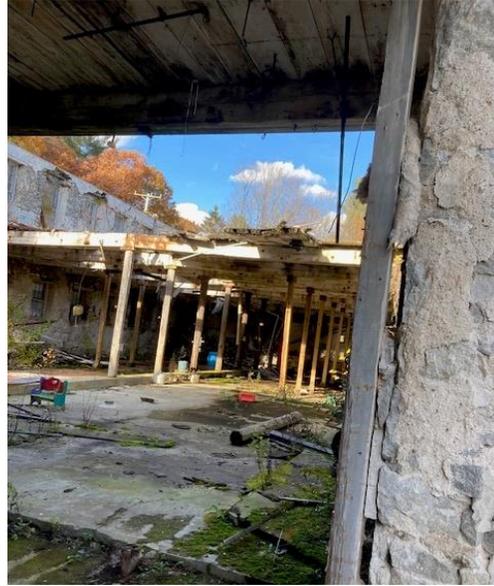
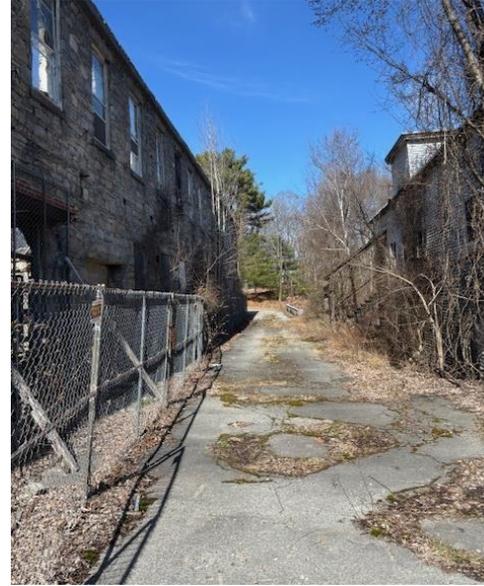
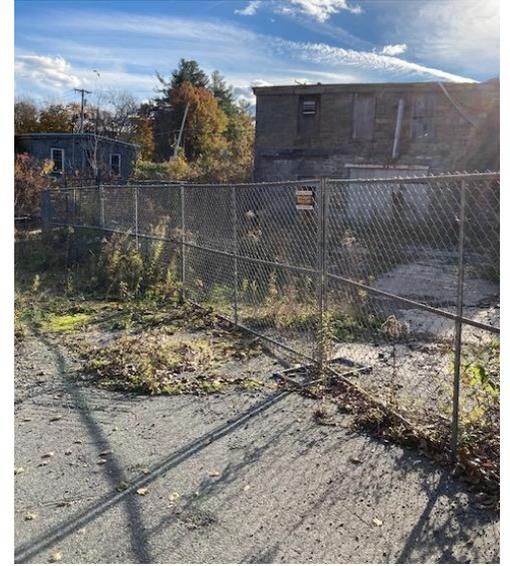
1: MAIN MILL

- Currently lacks a roof, and in comparatively poor condition
- Less visible from North Main Street and Broadway Streets
- Biggest impediment to access back portion of property and to conduct assessment in the interior of the structure
- If this were to collapse, could create issues relative to the 10 North Main Street building and property
- Portion of structure most likely to impact onsite septic system capacity given its location

Based on this information, the Land Use Management Department (LUMD) recommends that this portion of the building be considered for demolition

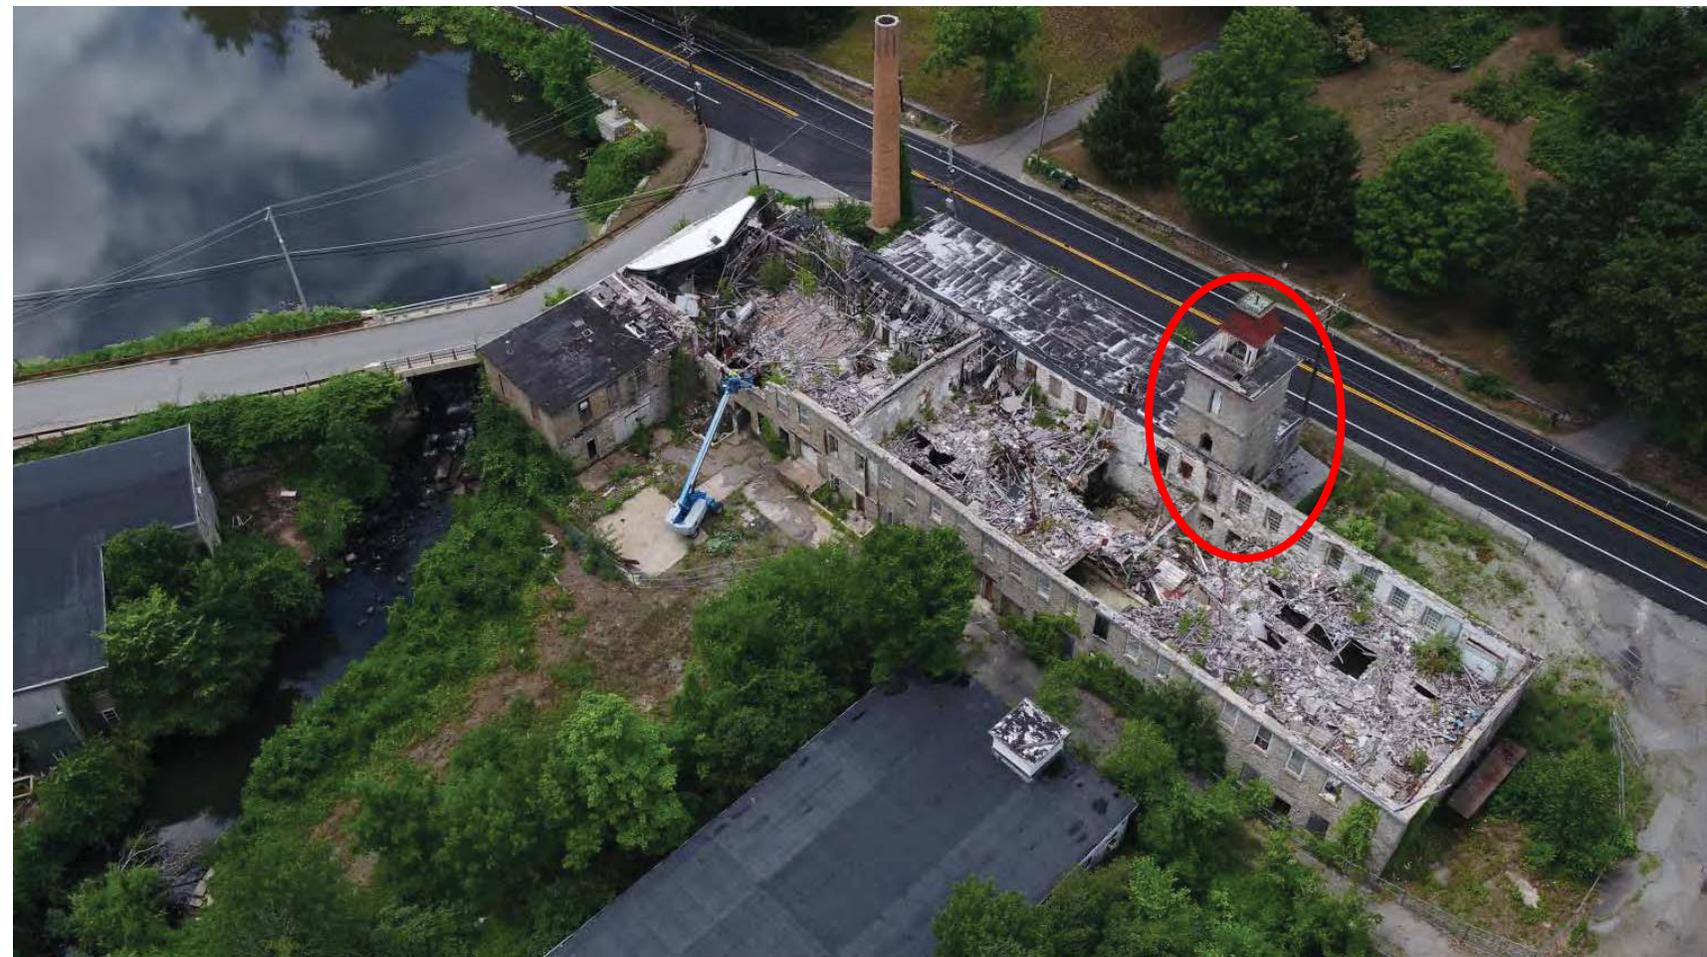
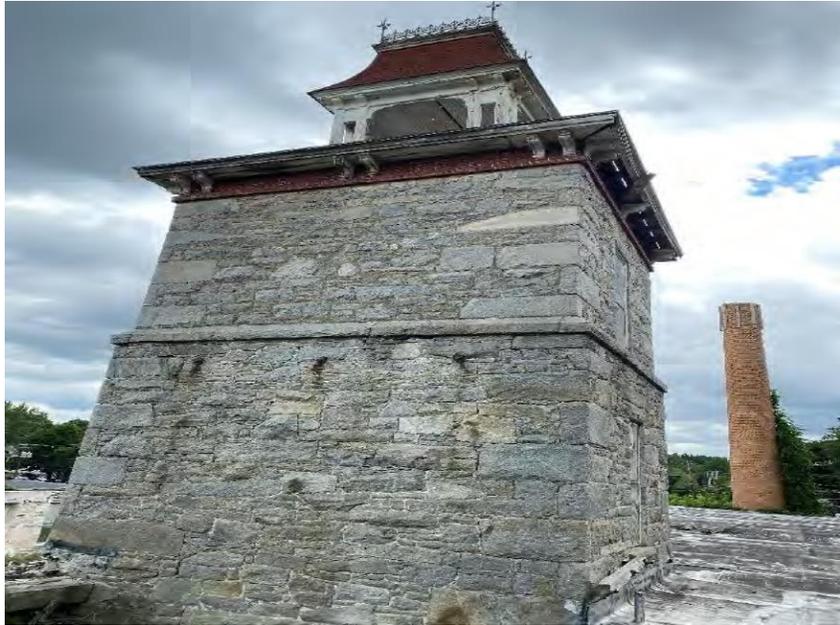
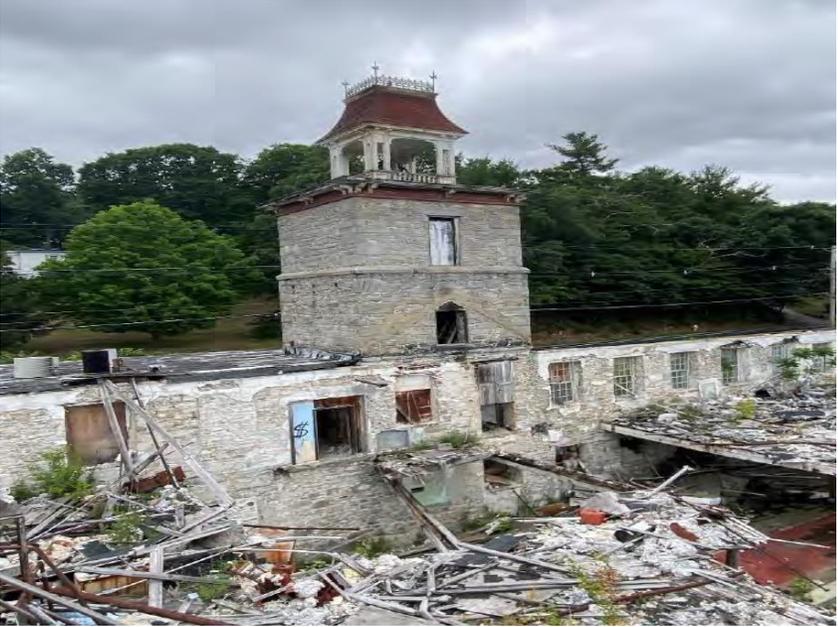
2: BELLTOWER

- Highly visible to the surrounding neighborhood
- Belltower in more sound condition relative to other portions of the structure
- Belltower arguably the most iconic element of the structure

LUMD recommends exploring and prioritizing preservation of the belltower

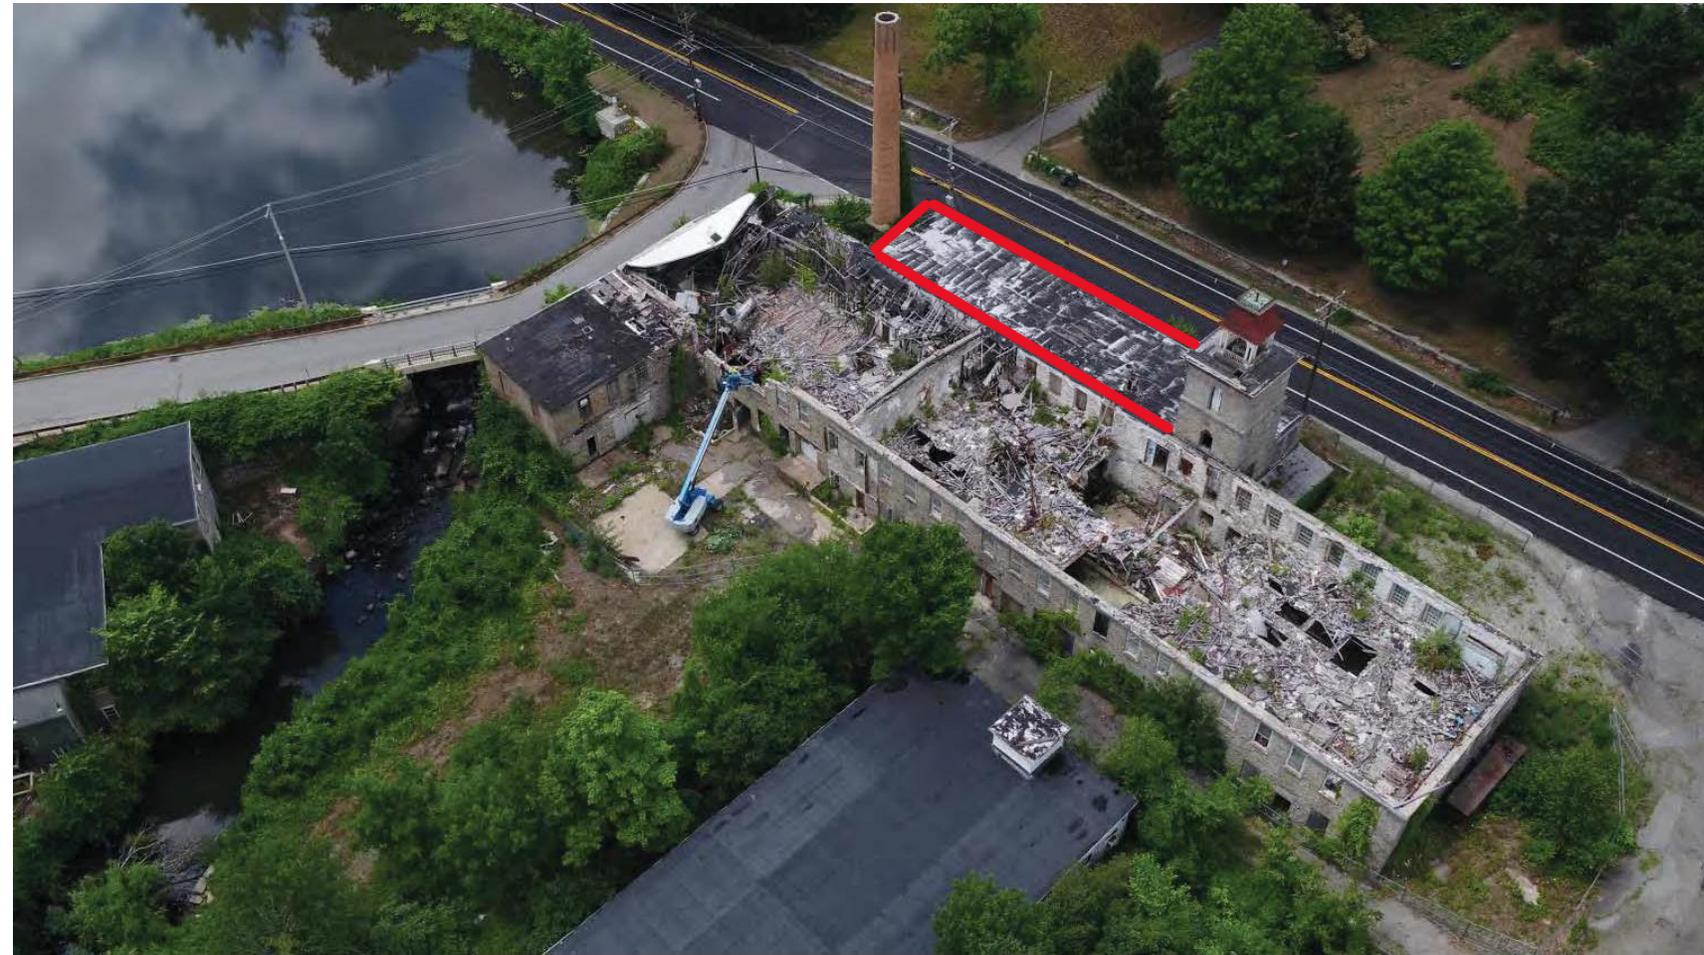
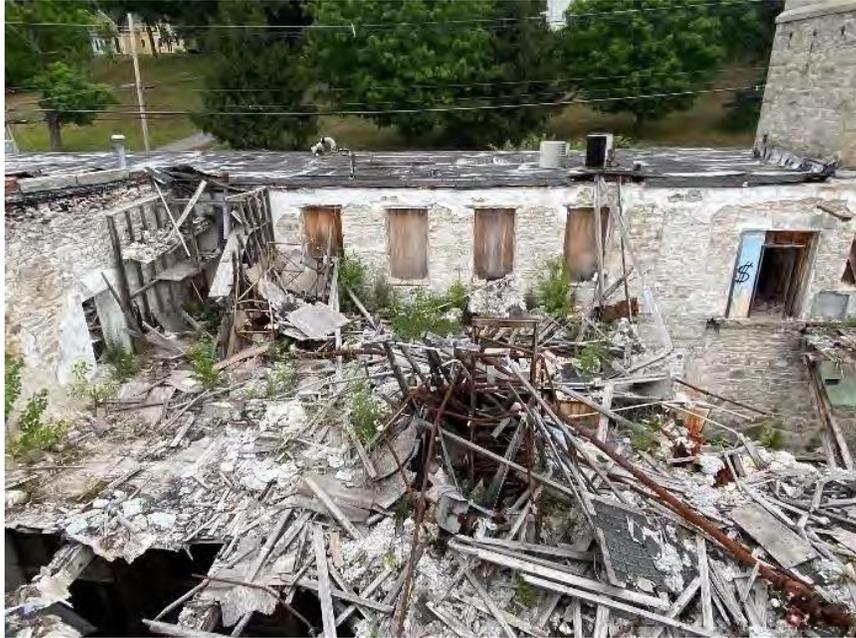
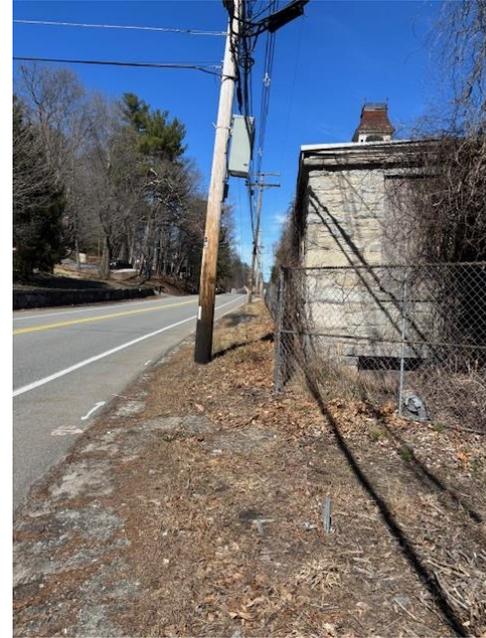
3: NORTH ADDITION

- Highly visible from North Main Street with Belltower connected to portion of the structure
- Adds to the streetscape/ pedestrian experience by providing sense of the building massing

LUMD recommends one of the following options:

- Preserve at least the front façade, with back and side wall portions to be demolished
- Preserve the front and side wall façades, with back wall demolished (preferred)
- Preserve entirety of this component

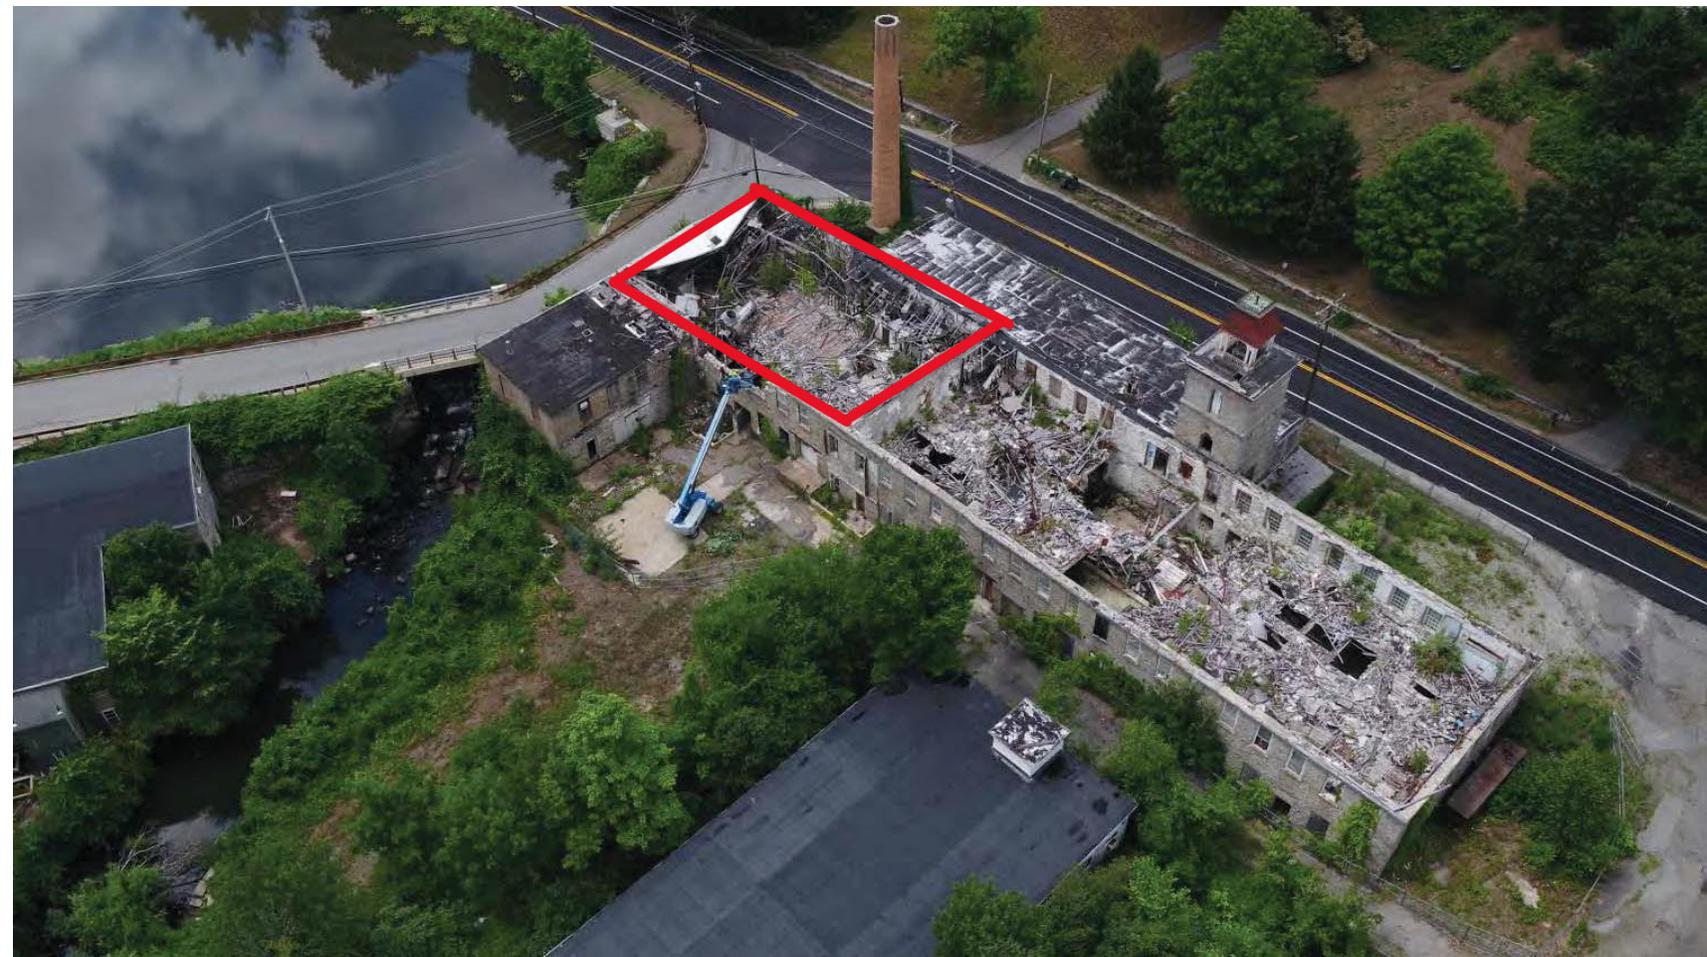
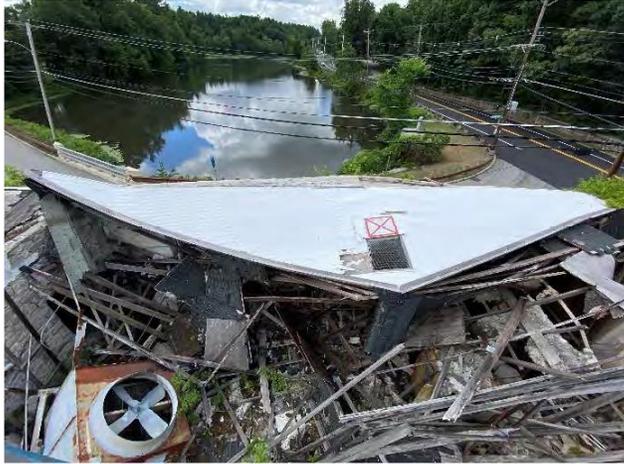
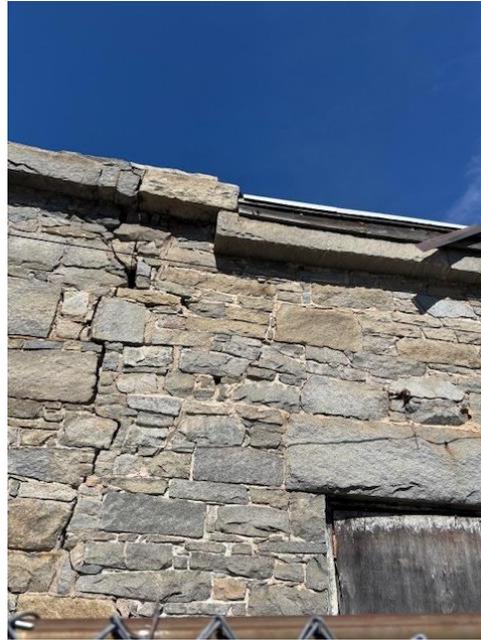
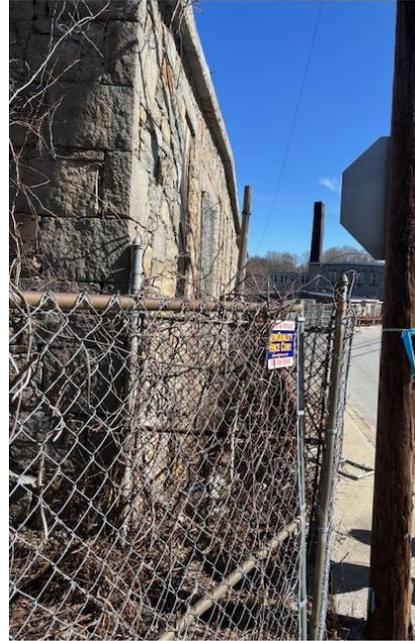
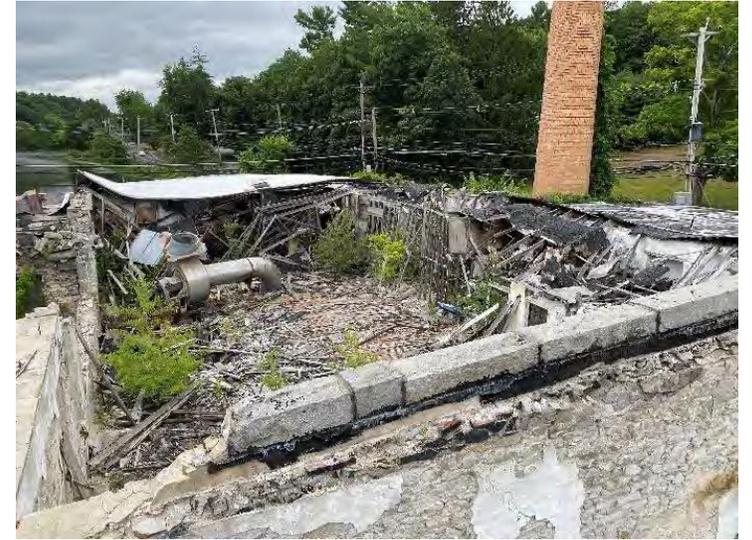
4: MACHINE SHOP

- Portions have experienced partial collapse, while portion closest to dam is in better condition than remainder of building
- Portion of this component lacks a roof
- Exhibiting wall cracking, likely some evidence of settlement
- As stated in the structural report “The Mill appears to rely on a granite block retaining wall (not part of the building, but appears to support the dam at the Reservoir, adjacent roadway and grade)”

LUMD recommends partial demolition (back wall) while simultaneously working with the Engineering Department and their dam consultant to assess the dam and western wall integration

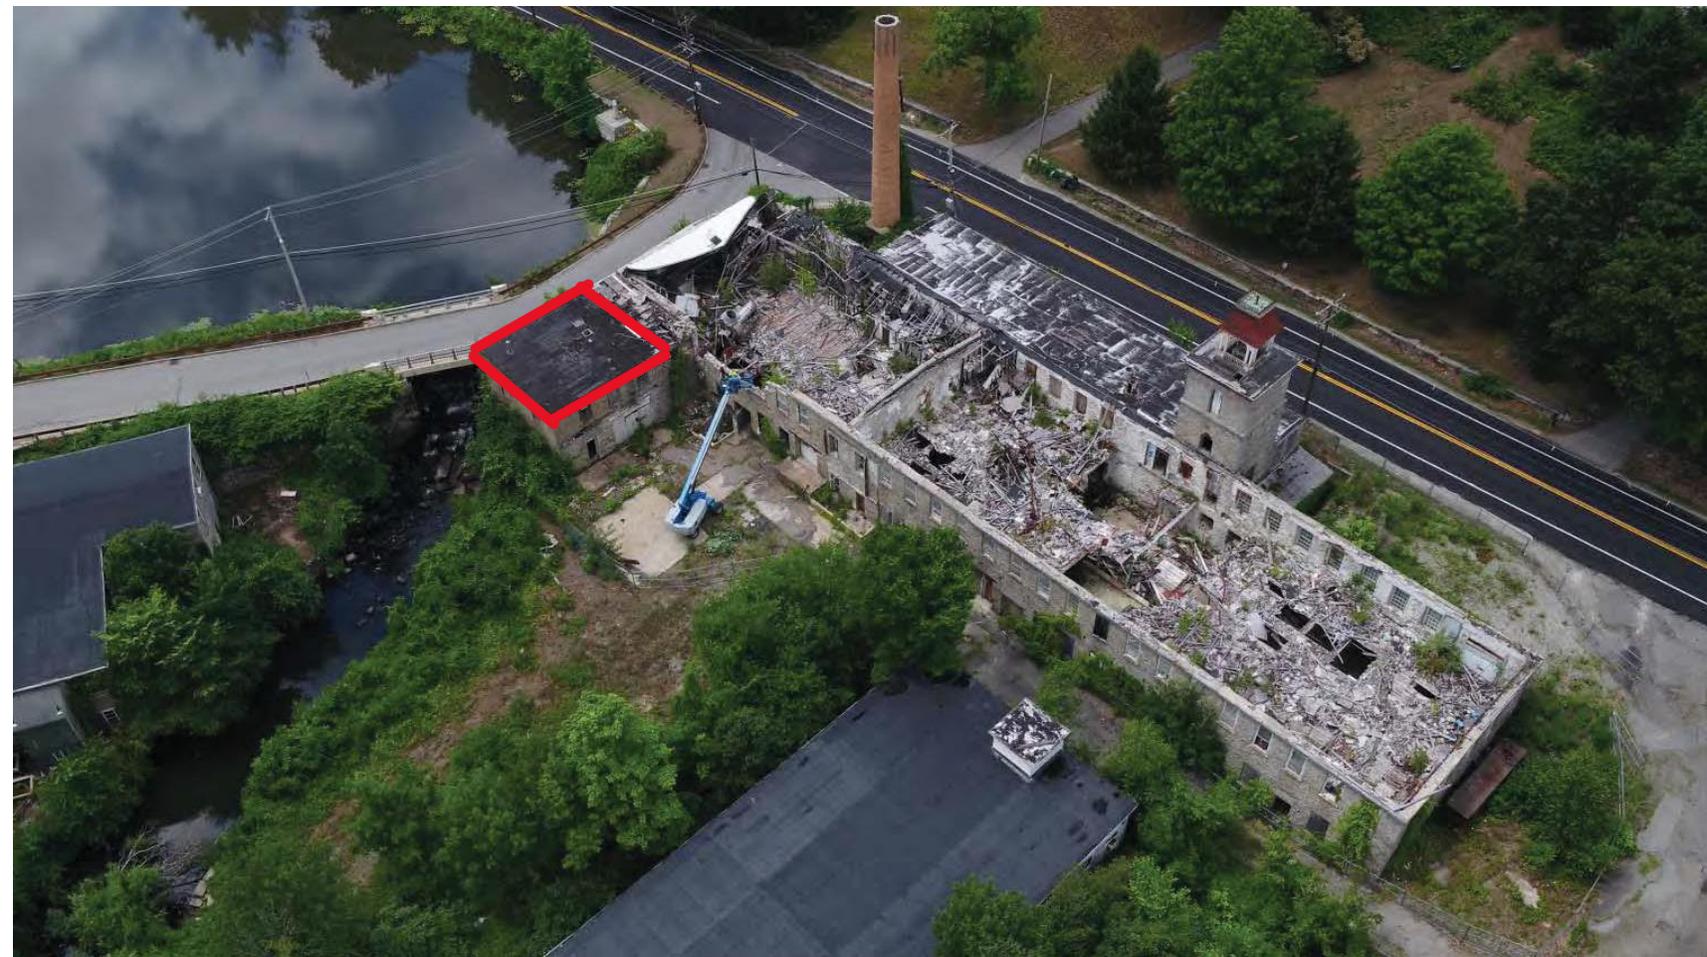
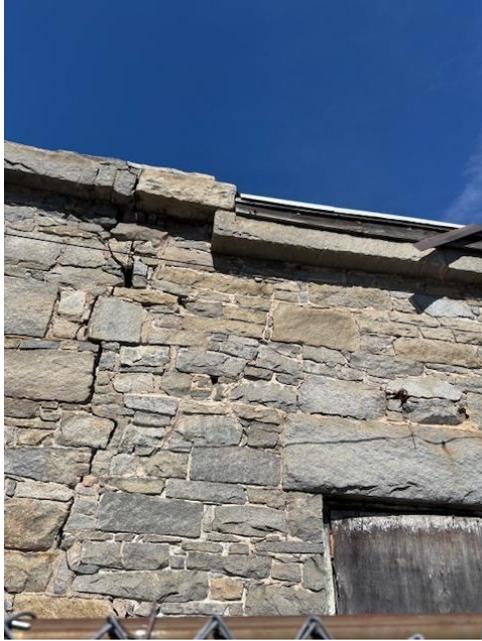
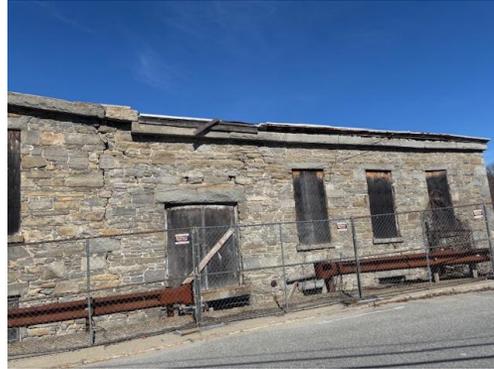
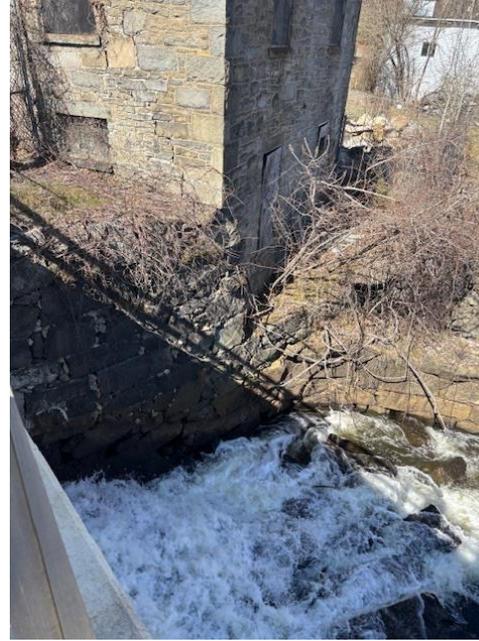
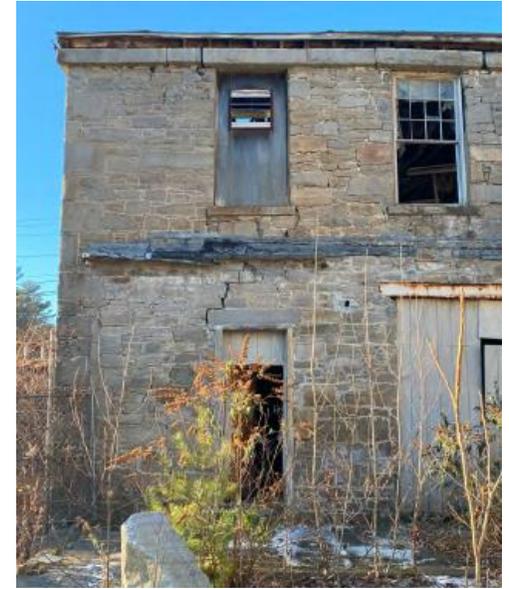
5: SOUTH WING/ CARPET MILL/ FORGE

- Generally in better condition than other portions of the building
- Also exhibiting wall cracking, likely some evidence of settlement
- Initially appears to be integral to the Stony Brook dam - demolition activities could impact the dam
- Likely contains some of the most historical components

LUMD recommends exploring and prioritizing preservation of the South Wing
