Westford Community Preservation Funding Application

Project Name: Pageant Field Wall Restoration _____

Budget: Pageant Field stone and wall restoration

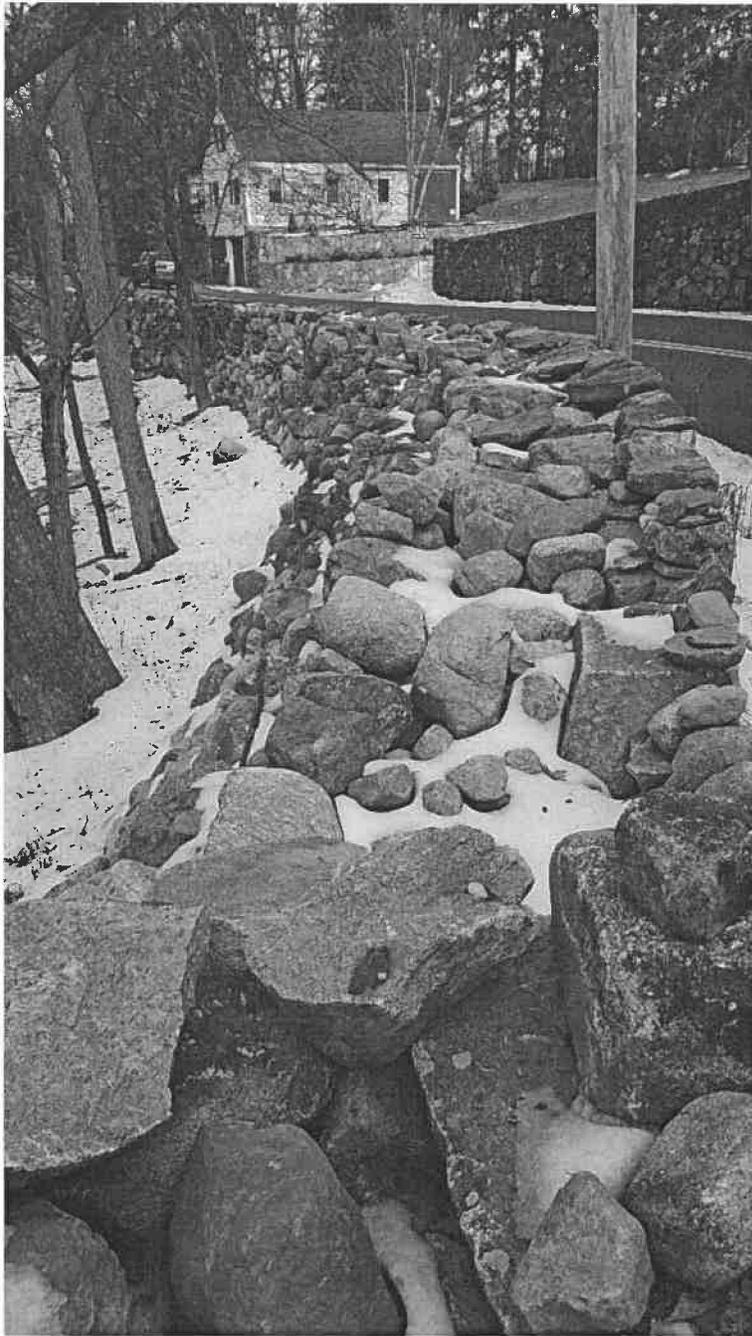
This Project approved in 2017 by the Community Preservation Committee funded in the amount of \$35,000.00 has restored approximately sixty percent of the stone wall on the historic Pageant Field. The original wall construction did not anticipate the stresses of traffic, water drainage and snow plowing. The restoration of the wall has required additional reinforcement due to the hydrostatic bulging and collapsing of the wall into the field in numerous areas. See Attachment E: Restored Wall Section

To compensate for the above conditions the contractor was required to tear down entire sections of the collapsed wall, install new foundations and provide bulwarks for long term stability.

Due to the hydrostatic stresses on the original pageant field wall the contractor was required to reinforce sections of the restored wall. This resulted in an increase in time and cost of the project.
